Memorandum
11345.4
MAIN

SUBJ: NPDES PERMIT VIOLATION, FC-599 LIFT STATION

SUBJ: BROKEN SEWER MAIN (18")

SUBJ: SEWAGE BYPASSES AT LIFT STATIONS 1776 AND M-241; AREA INSPECTION OF

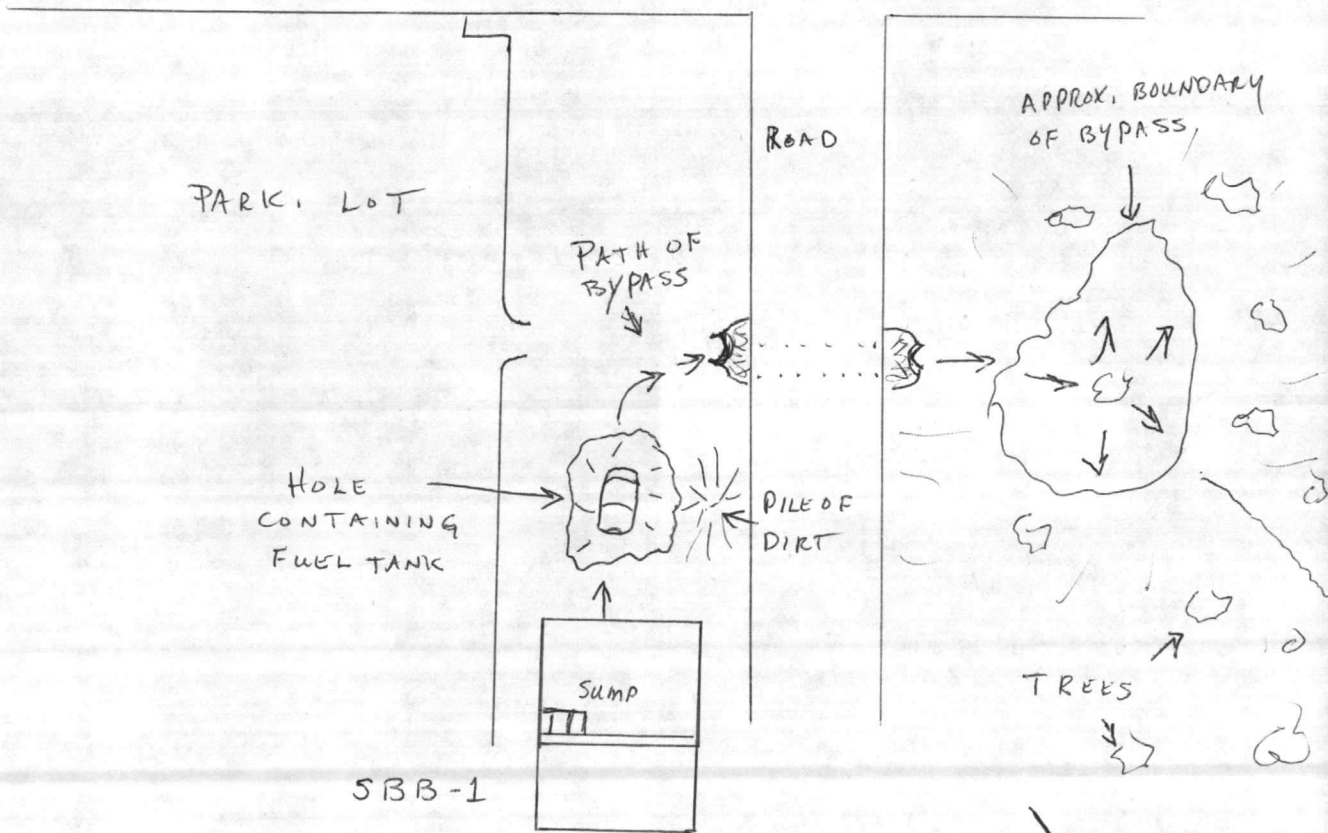
SUBJ: REPORT ON SEWAGE BYPASS AT SBB-1, COURTHOUSE BAY ON OR ABOUT
22 JUNE 85

1. Visited site at 1130, 24 June 85, with Richard Phelps, NREAD summer employee. We talked with Billy Carlyle, Wastewater Treatment, concerning the bypass. He said the bypass occurred sometime Saturday night or Sunday morning (22 or 23 June). Volume of bypass was sufficient to overflow the pump station sump (8,000 - 9,000 gallon capacity) and a nearby open hole containing a fuel tank (approximately 500 gallon capacity tank and approximately 10,000 gallon capacity hole) and then flow through a nearby culvert and pool in a low, semi-wooded area about 50 feet by 50 feet.
2. The only physical evidence of a spill was damp earth. No solids were noted; they probably settled in the pump station sump. Entire area appeared clean. No foul odor noted.
3. See attached sketch.
