**RUNWAY FRICTION MEASUREMENTS
AND
AIRFIELD PAVEMENT CONDITION SURVEY
MARINE CORPS AIR STATION (HELICOPTER)
JACKSONVILLE, N.C.**

Subj: Airfield Pavement Condition Survey and Runway Friction
Measurements, Marine Corps Air Station (Helicopter), New River,
Jacksonville, North Carolina

1. Enclosure (1) contains the results of field tests and visual
statistical evaluation of the pavement at the airfield and is submitted
in accordance with reference (a).

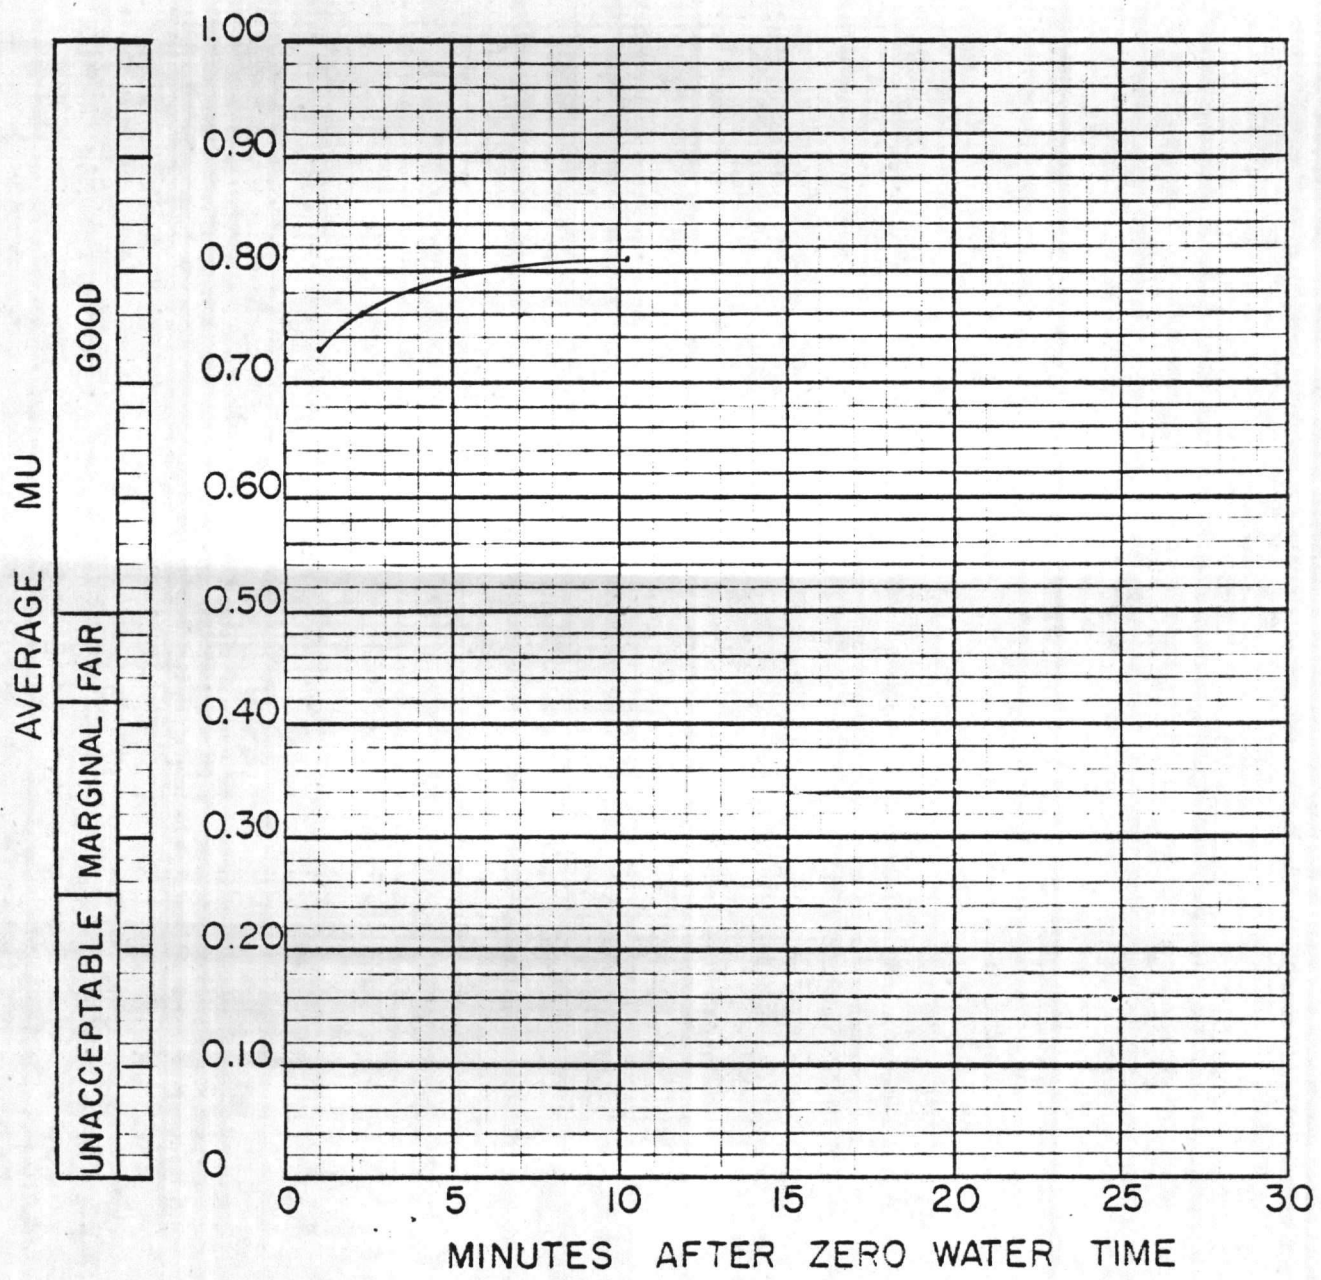
RUNWAY 5-23 SECTION A STATION 33+00-43+00
left center

REMARKS: Excellent drainage on test section.

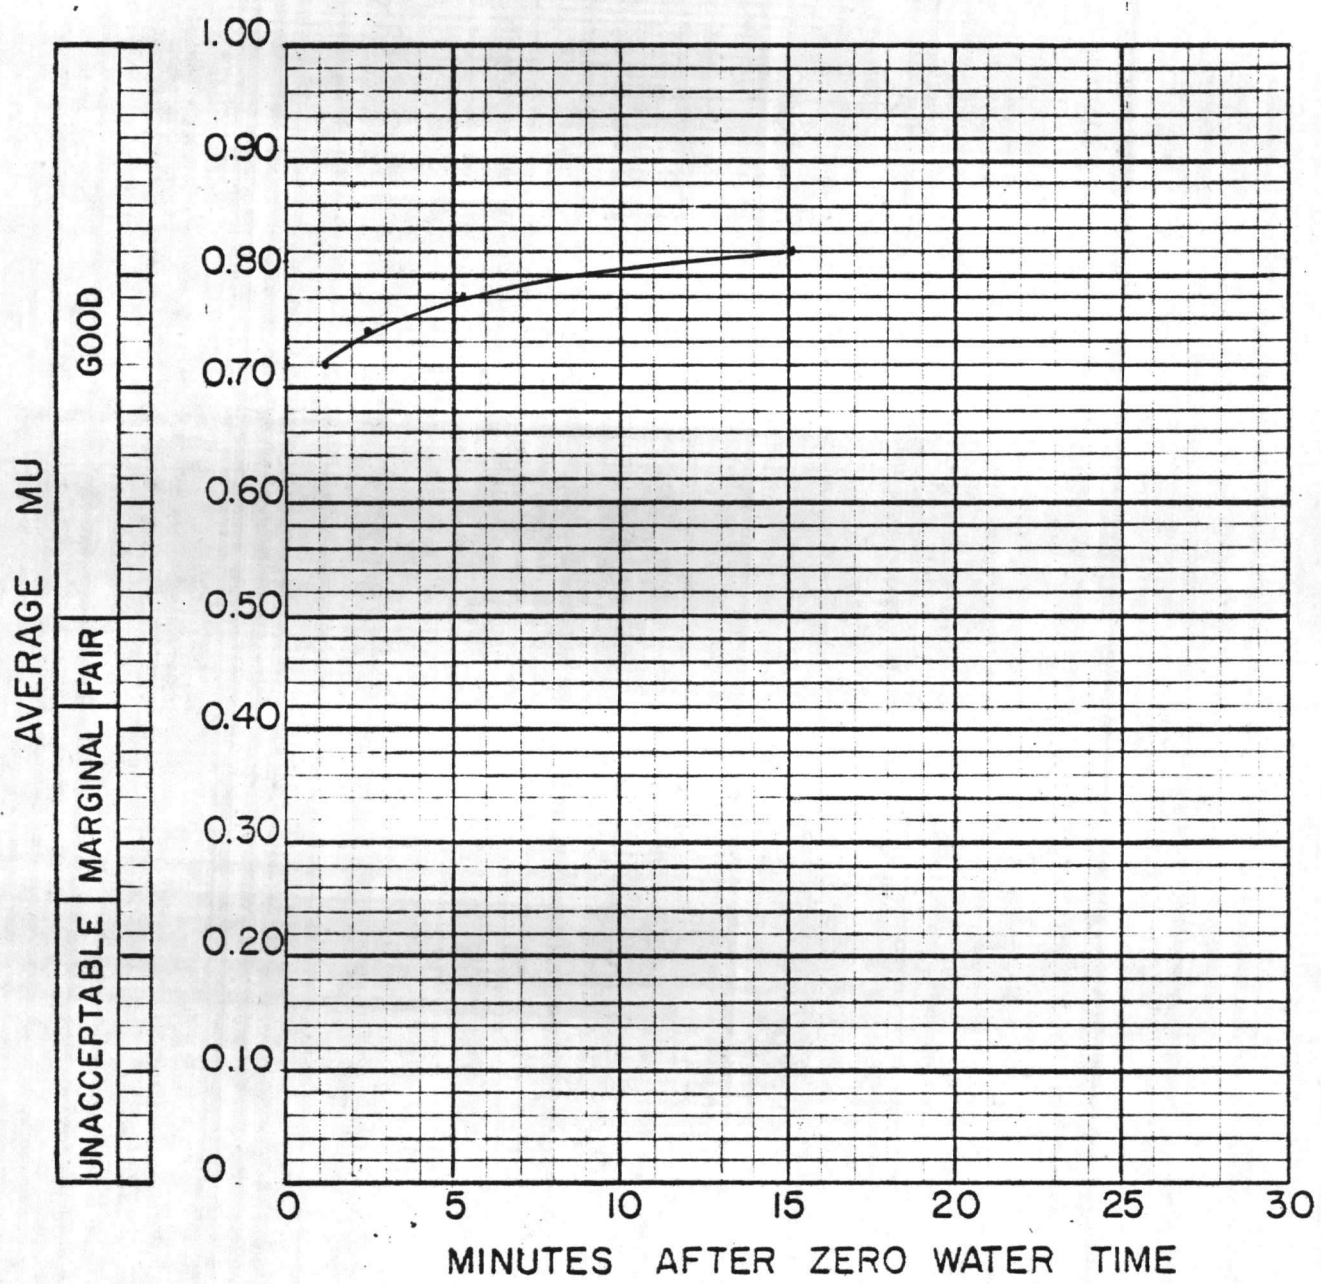
RUNWAY 5-23 SECTION B STATION 33+00-43+00
right center

REMARKS: Excellent drainage on test section.
Slight ponding station 36+00 to 38+00.

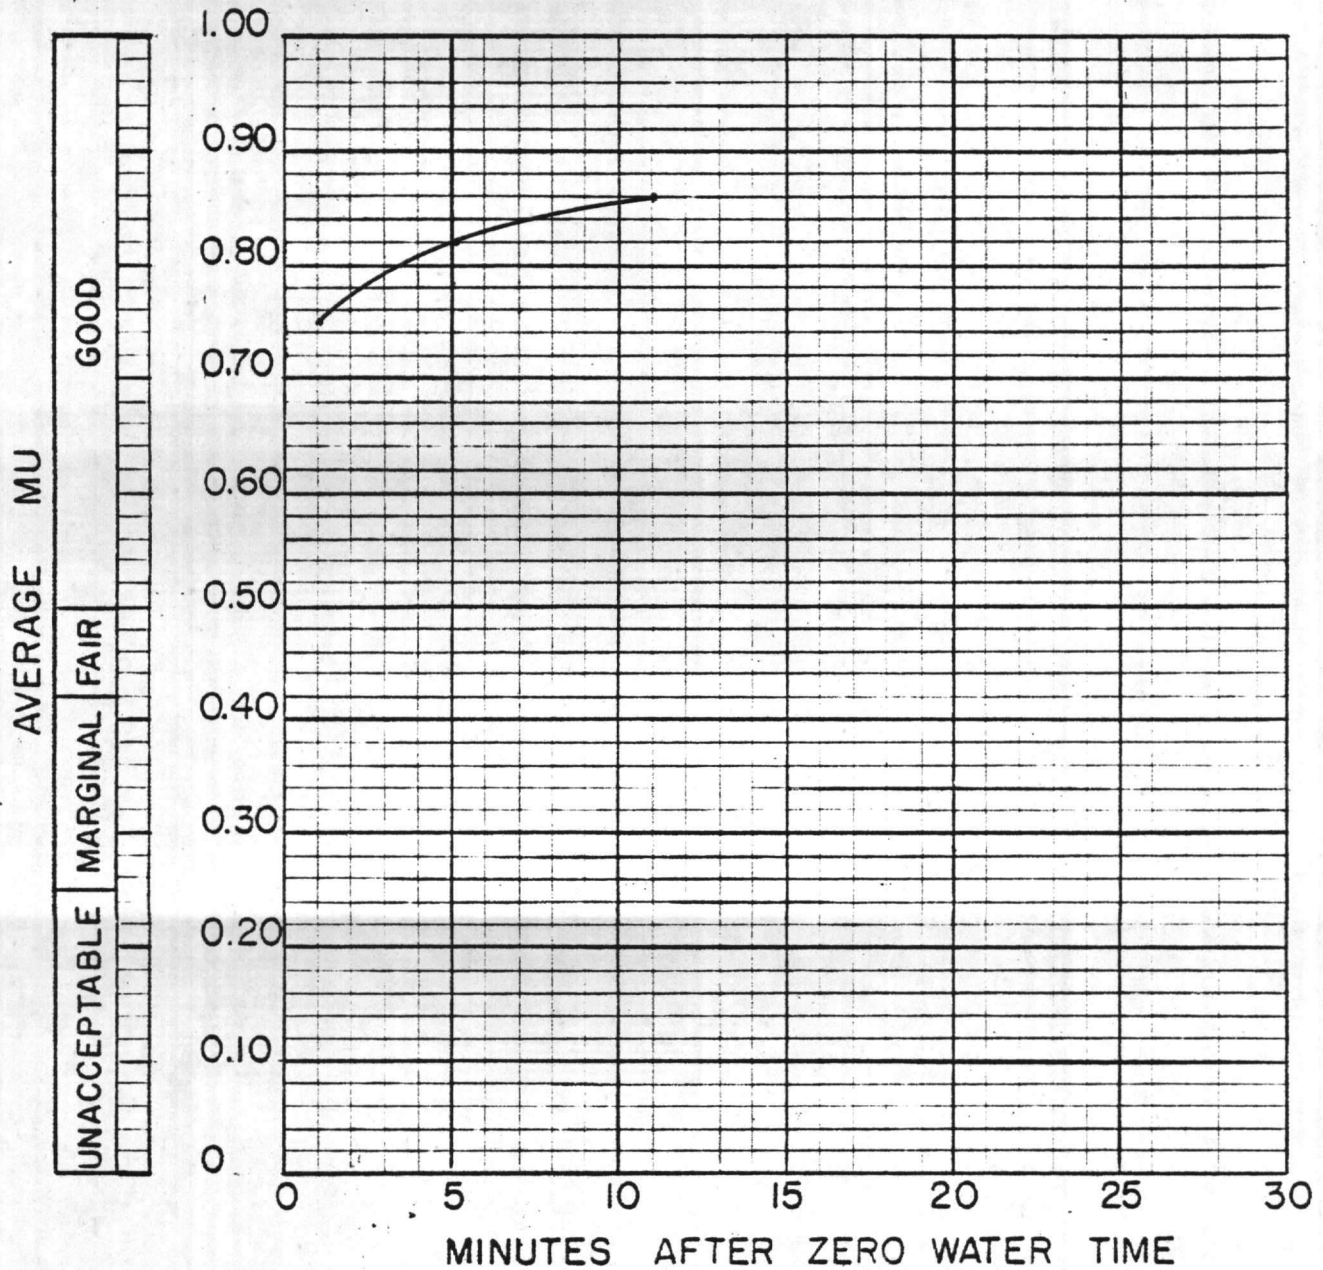
RUNWAY 5-23 SECTION C STATION 5+00-15+00
left center

REMARKS: Excellent drainage on test section.

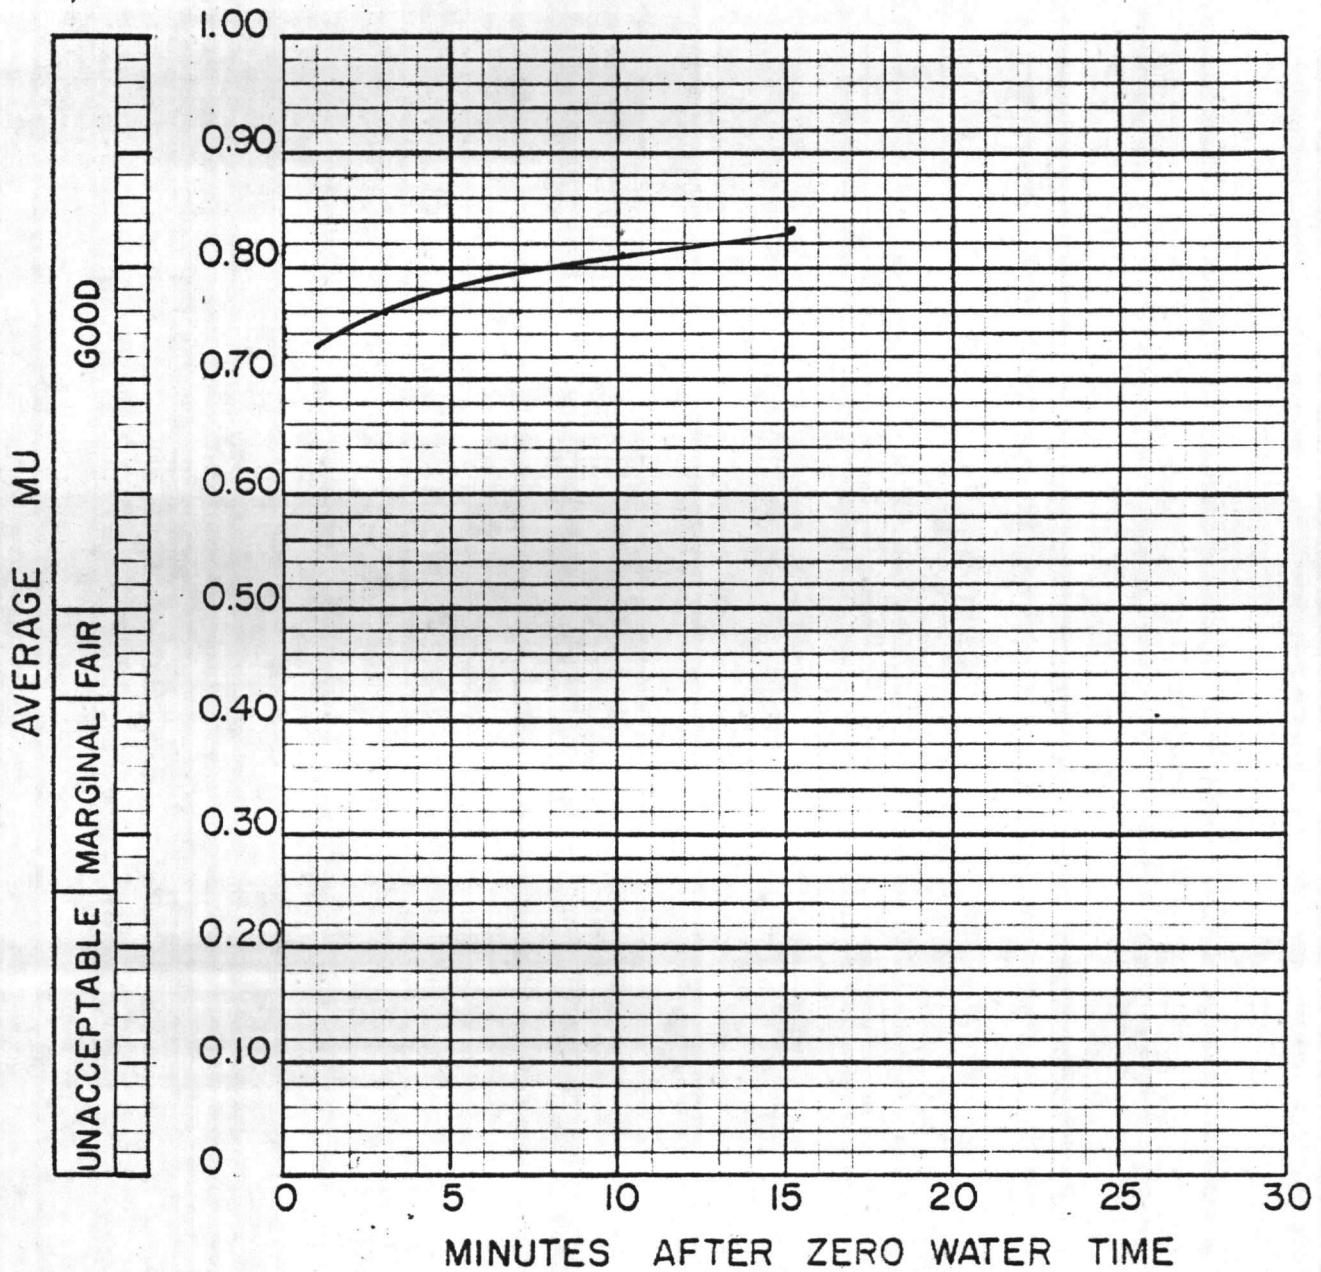
RUNWAY 5-23 SECTION D STATION 5+00-15+00
right center

REMARKS: Excellent drainage on test section.

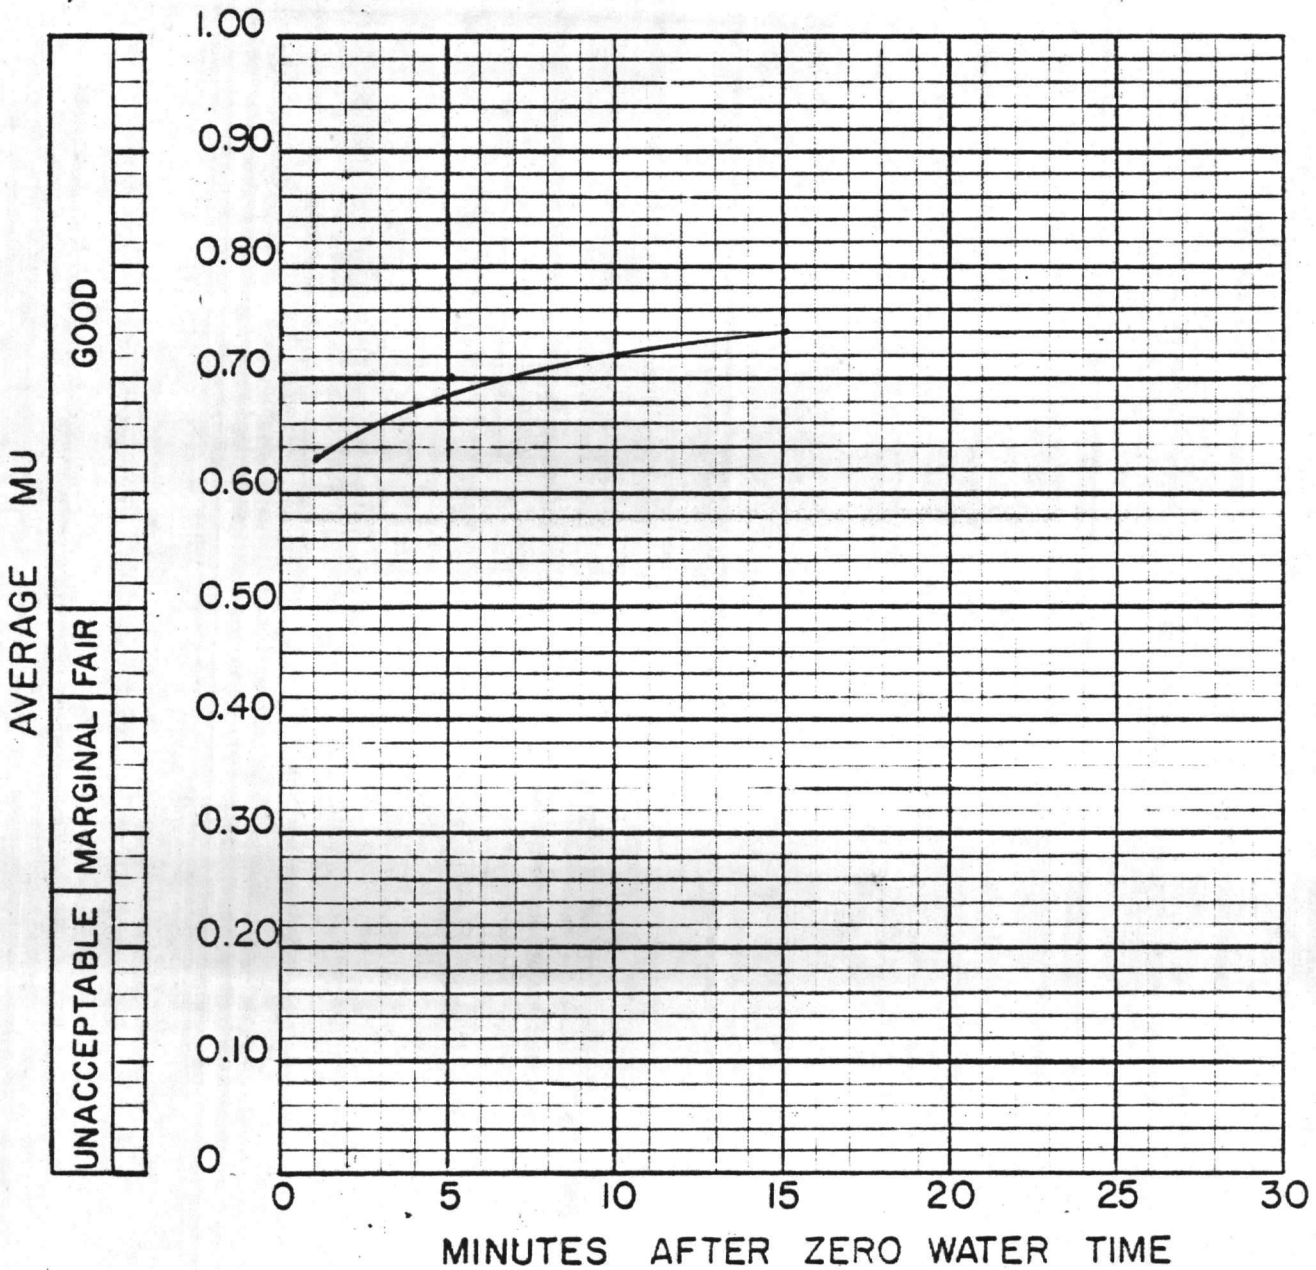
RUNWAY 18-36 SECTION E STATION 10+00 to 20+00
Right of center

Good drainage on test section with some isolated ponding.

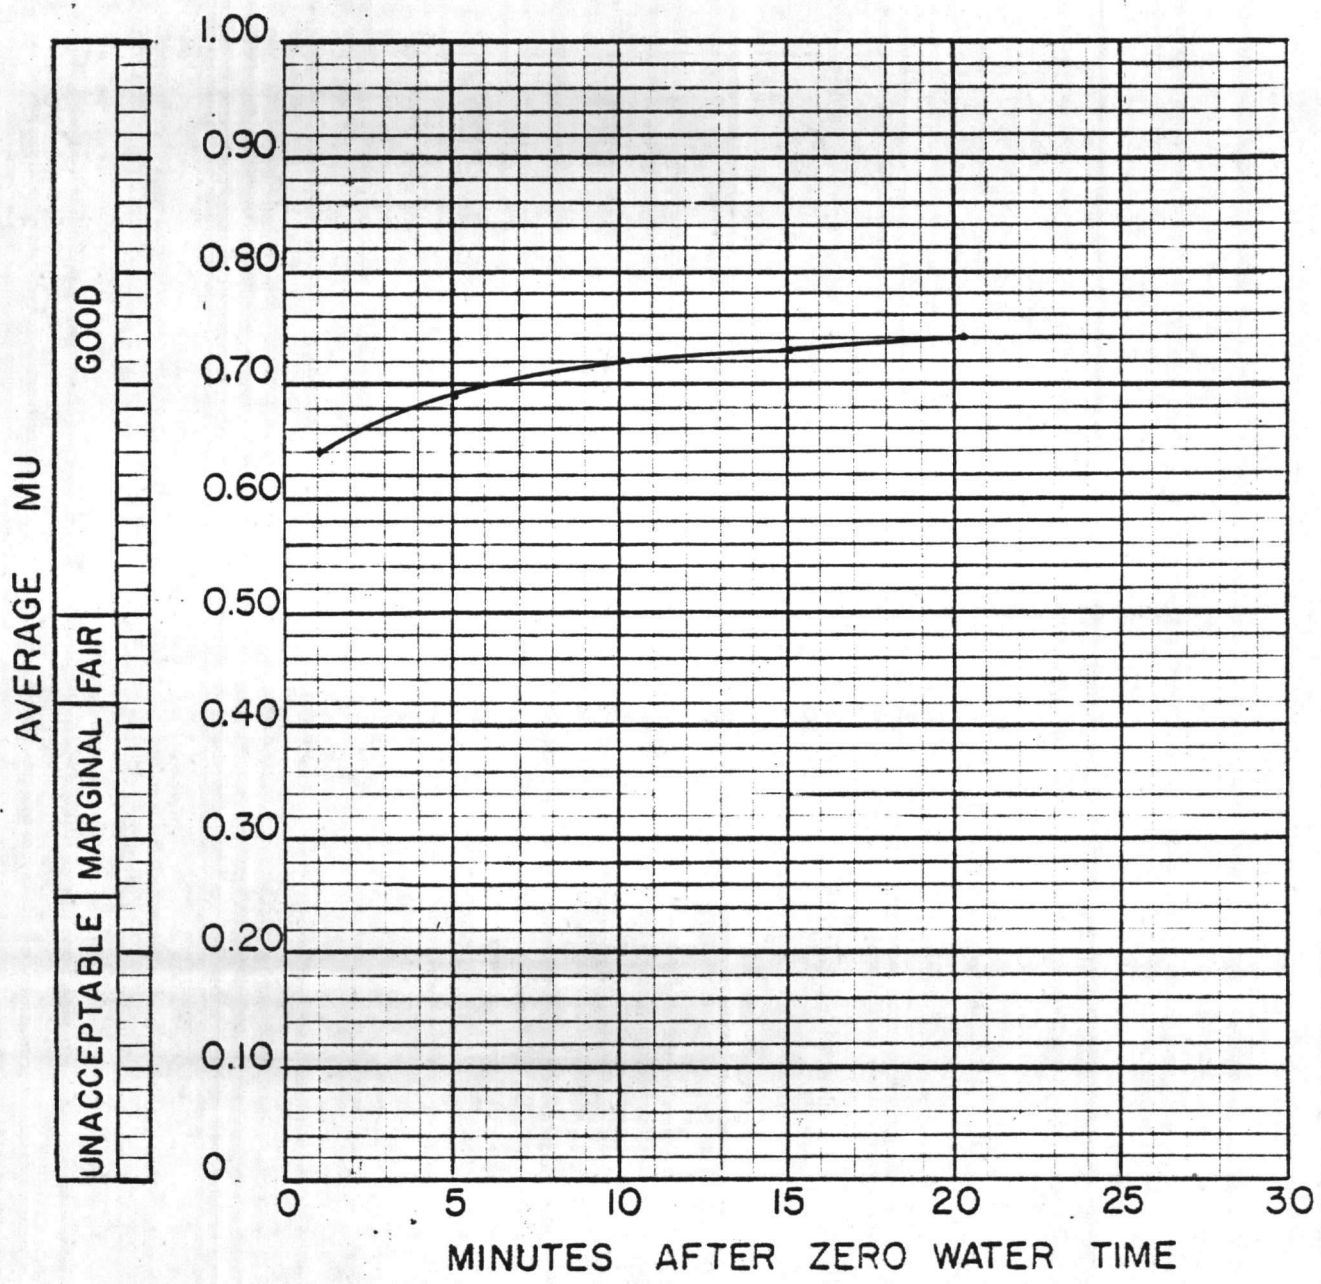
RUNWAY 18-36 SECTION F STATION 10+00 to 20+00
 Left of centerline

Good drainage on test section with some isolated ponding.

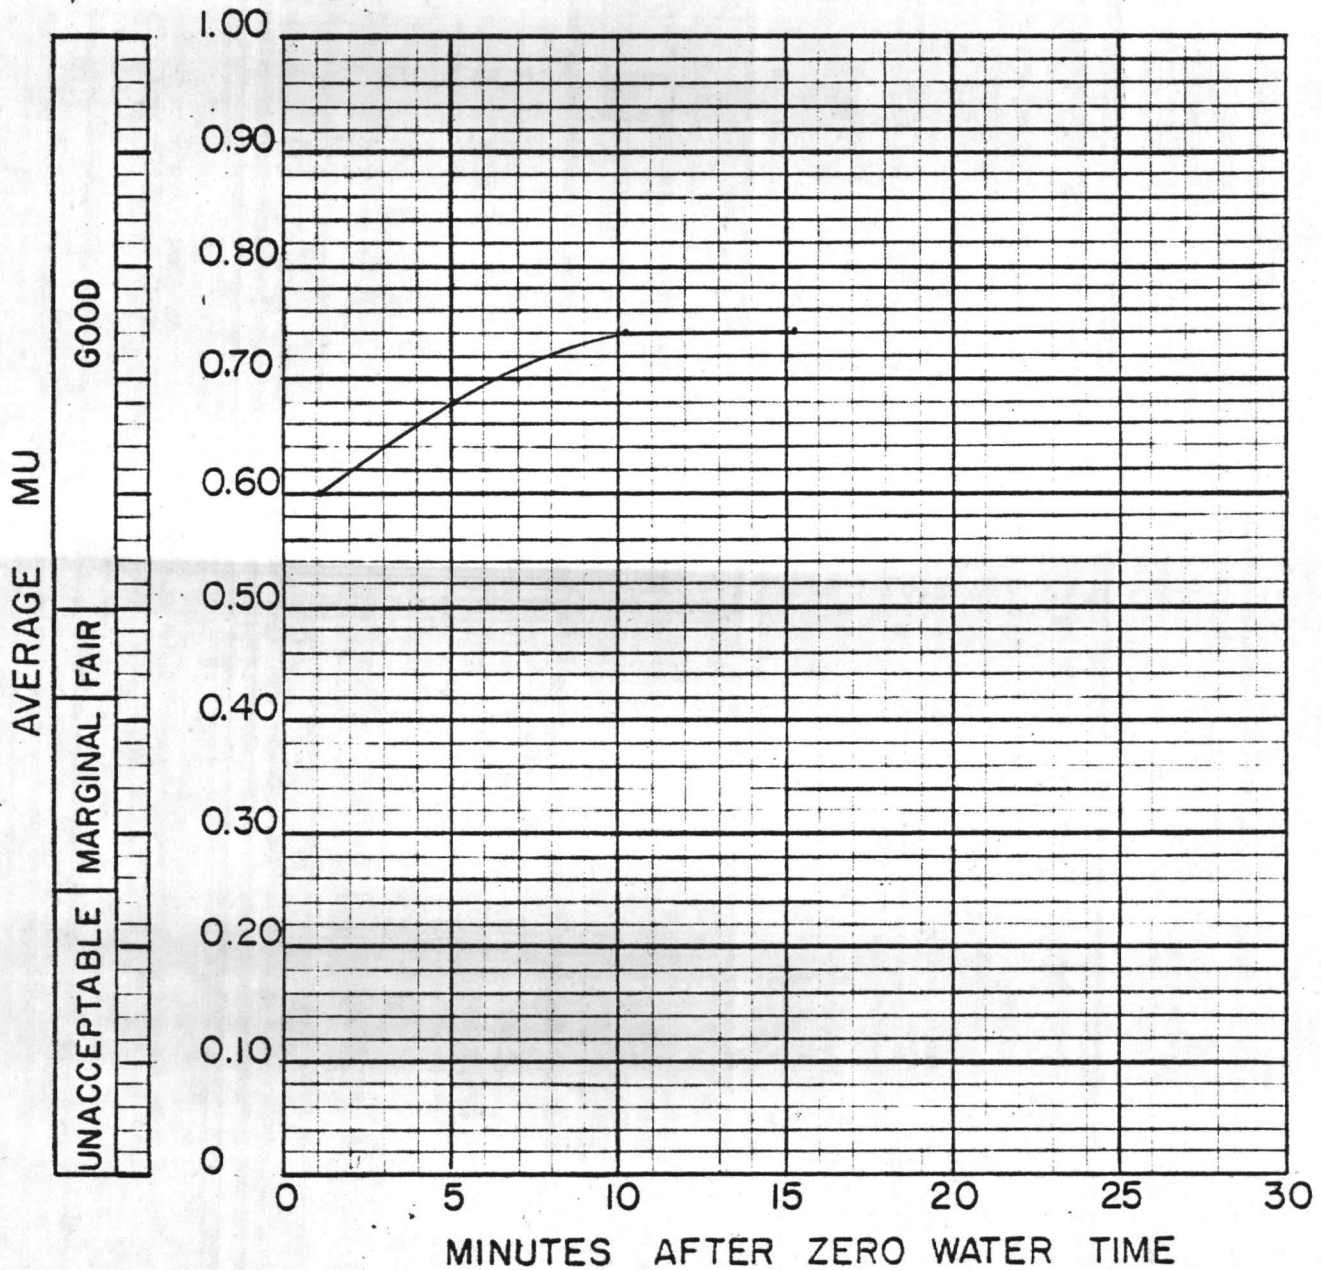
RUNWAY 18-36 SECTION G STATION 35+00 to 45+00
Left of Centerline

Good drainage on test section with slight ponding between station 35+00 to 38+00.

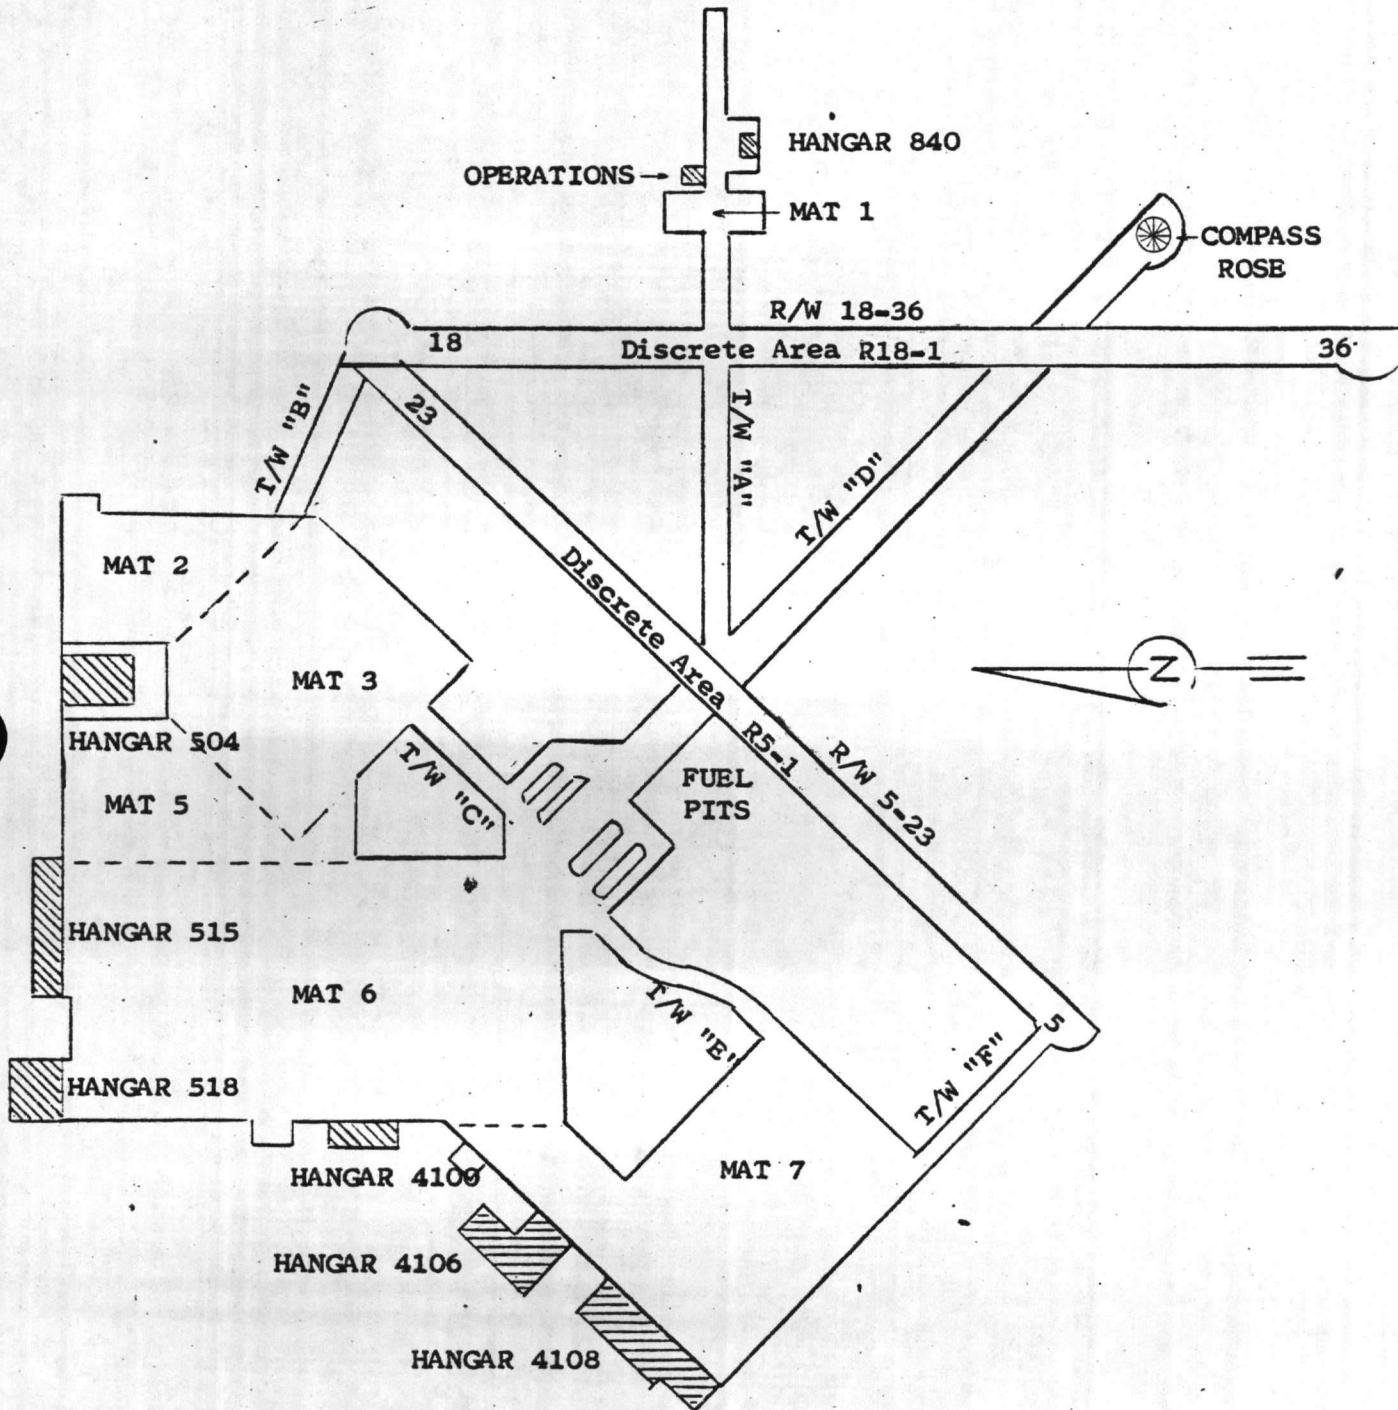
MCAS (H) NEW RIVER
 JACKSONVILLE, N.C.
 DISCRETE AREA LOCATIONS

Pavement from station 0+00 to 2+00 has severe cracking.
Majority of cracks ~~one~~-sixteenth inch wide.

Majority of cracks could become pattern cracking in neas future.
 Majority of cracks one-eighth inch wide.

It is recommended that initial steps be taken to include an overlay for runway 18-36 in the MILCON Program for the station. This runway will be in dire need of an overlay in 3 to 5 years. The slurry seal did a good job of "buying time" to allow normal scheduling of expensive maintenance. Runway 5-23 should not require any major maintenance for approximately another five years provided it is not grossly overloaded during this period.
