Upper Shavers Fork – Before and After Photographs

Problem Areas for 2012 Construction Season

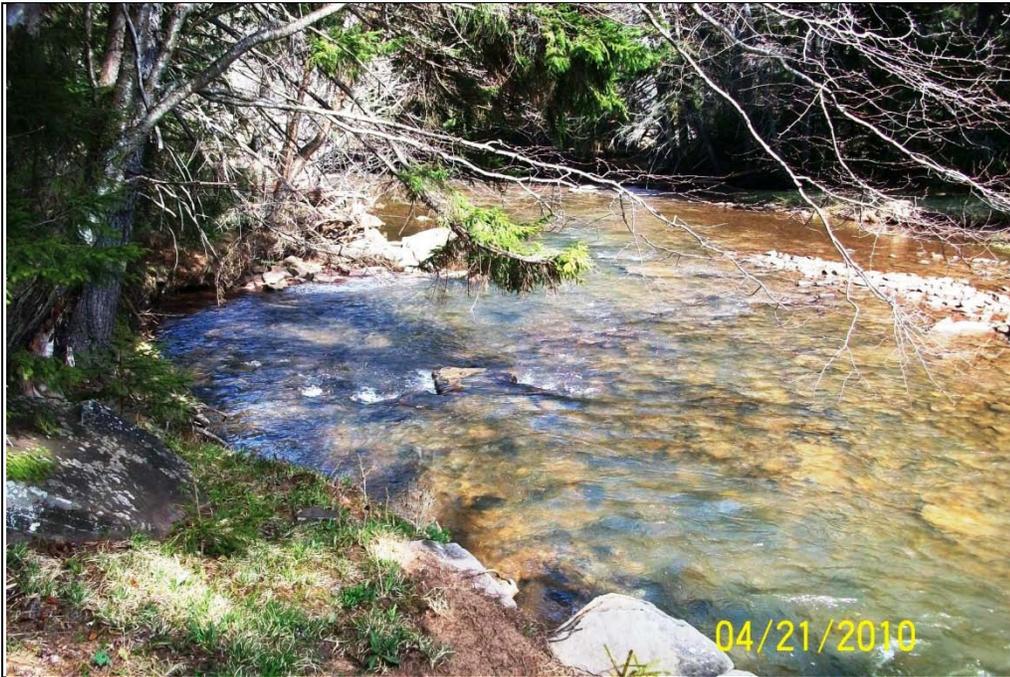
Station 434 - Shallow Pool Downstream of Rocky Run

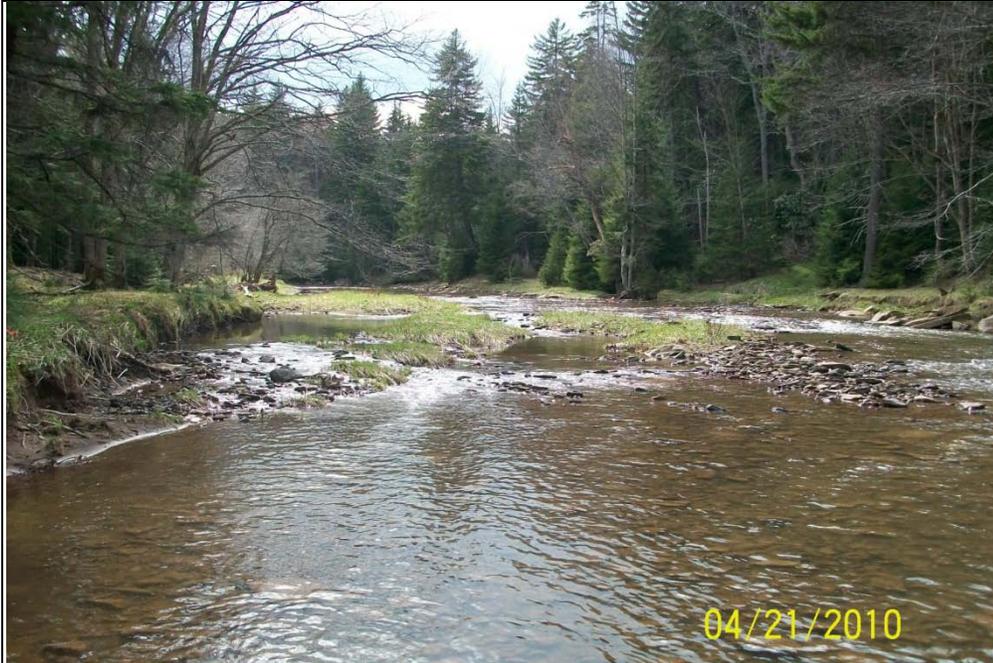
Station 435 - View Upstream (Before) showing over-wide channel, formation of mid-channel bars, and unstable banks.

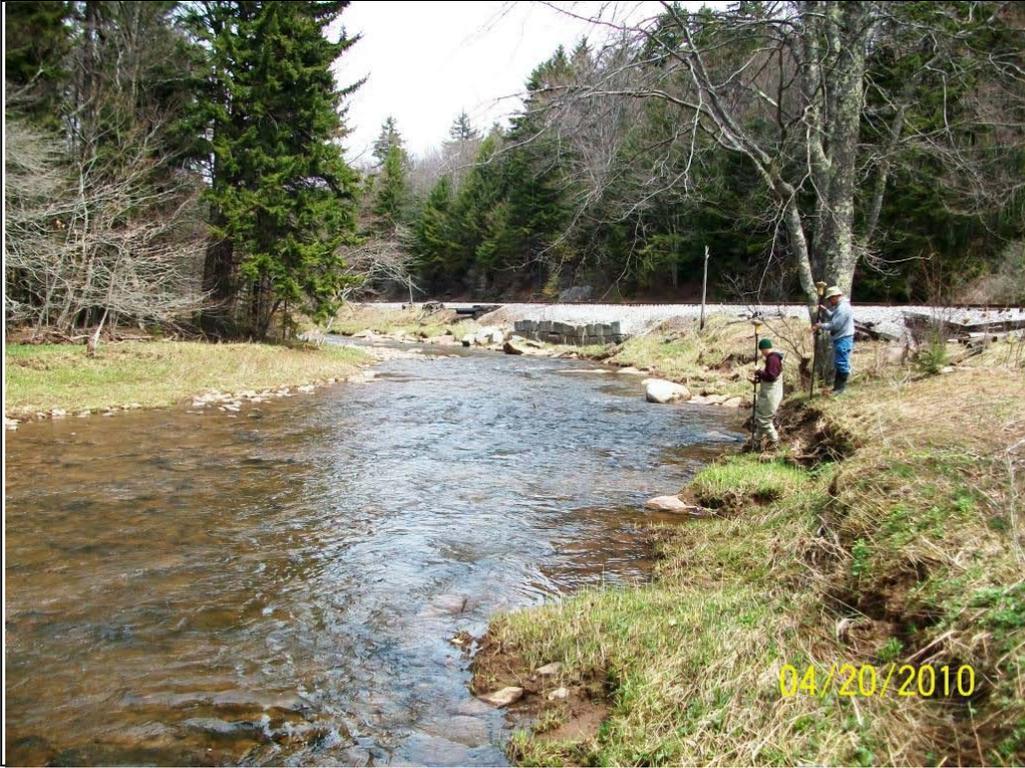
Station 437 – Unstable streambank and no fish habitat

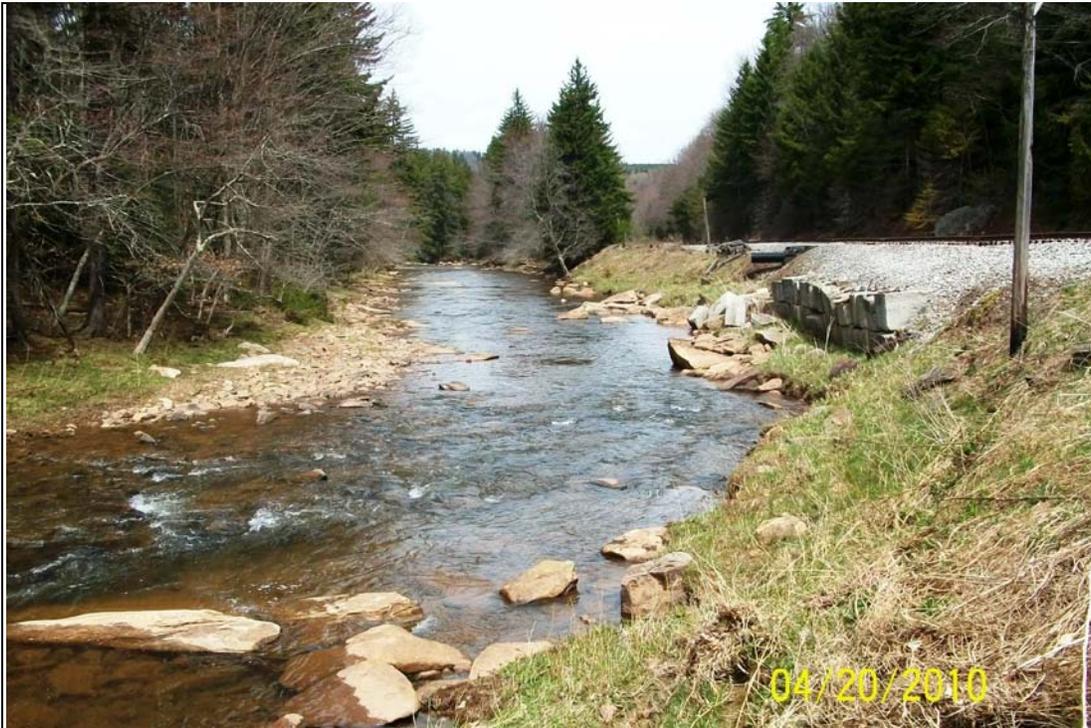
Station 441 – Wide channel with poorly defined thalweg (Before)

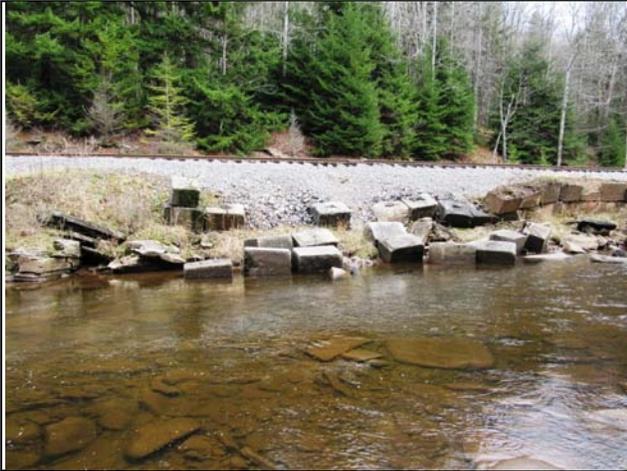
Station 465 – Fallen Blocks will be replaced with a bankfull bench and J-Hook rock vane

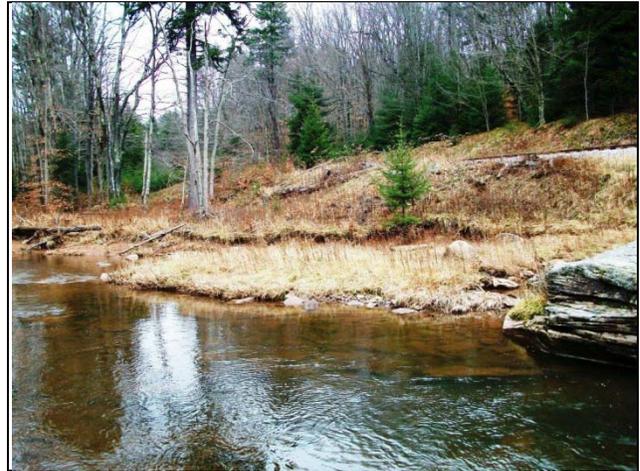
Station 486+35 – Eroded streambank will be repaired using brush mattresses & large woody debris

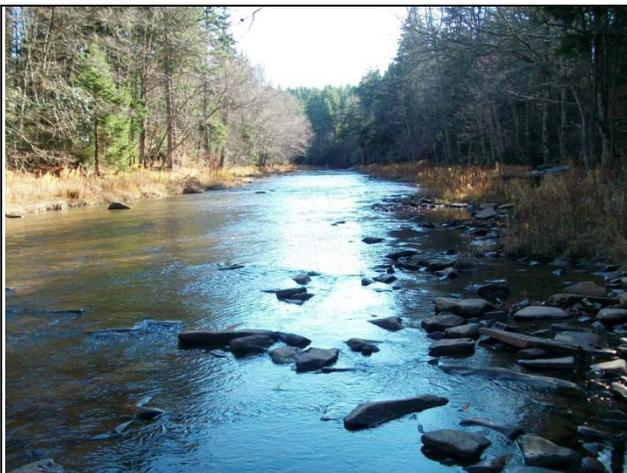
Station 510 – Straight and wide stream reach will be narrowed using alternating single wing deflectors and thalweg enhancement.

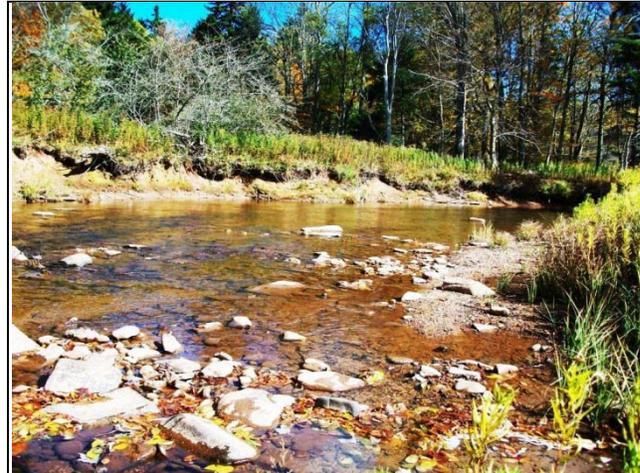
Station 558 – Eroded bank will be stabilized using toe wood and reinforced earth with live stakes. The use of toe wood will create fish habitat where it is currently absent.
