OPERATING EXPERIENCE SUMMARY

U.S. Department of Energy
Office of Health, Safety and Security
OE Summary 2006-14
December 8, 2006

Wearing Arc Flash Clothing Can Save Your Life

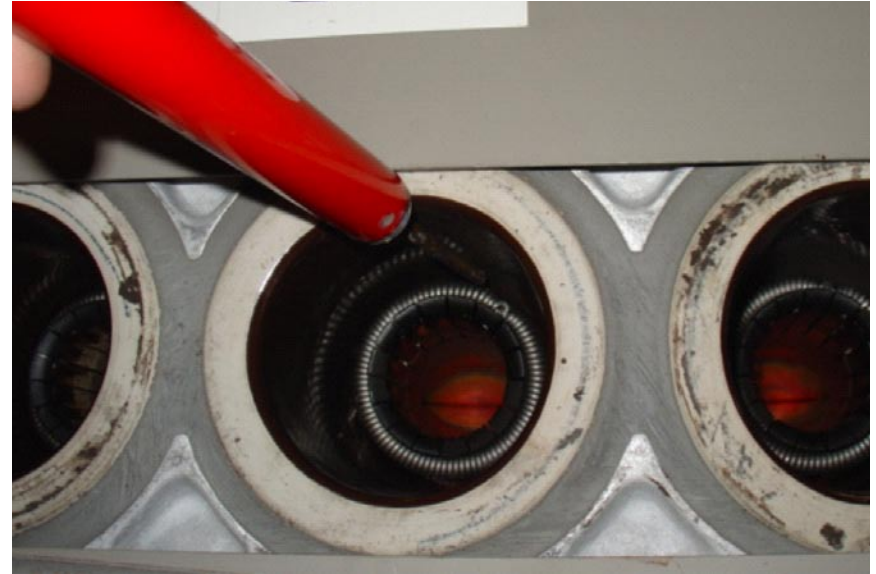
This switchgear has a grounded steel shutter that covers the holes when the circuit breaker is not installed in the cubicle. The shutter can be opened to expose the energized stabs for phase testing. However, the grounded edge of the steel shutter remains very close to the opening where the voltmeter probes are inserted.

Investigators suspect that the metal edge of the voltmeter probe touched the metal edge of the shutter as the electrician inserted the probe. As the probe tip moved closer to the energized stab, an initial arc jumped to the probe. When the electrician saw

Figure 1-1. Holes where the energized stabs are located and metal shutter

and heard the arc, he immediately started to leave. As the probe was withdrawn from the hole, the arc grew in length, forming conductive gases that produced a phase-to-phase fault. Investigators believe that within 2 to 3 seconds of the initial arc, ionized air provided a conductive path between electrical phases, resulting in the arc blast.

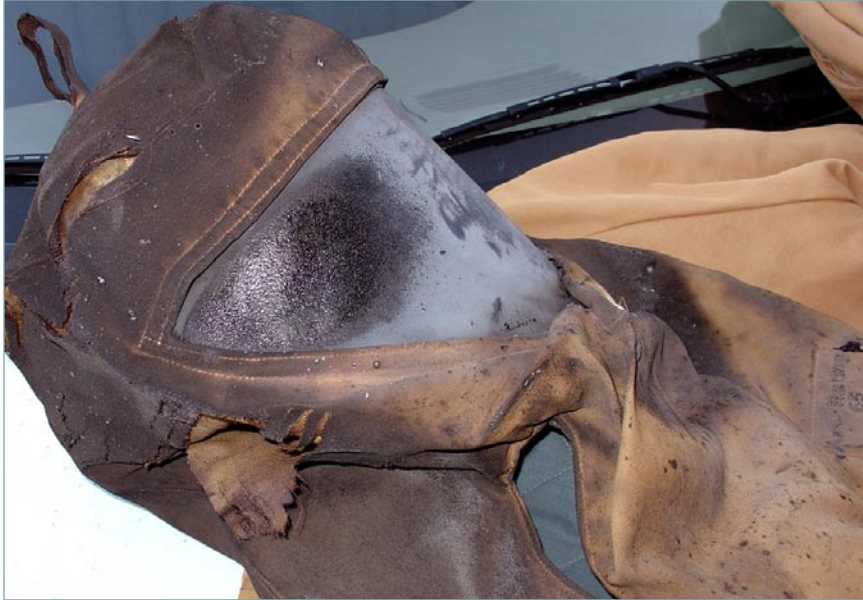
The electrician’s PPE prevented him from being injured when the arc flash occurred. Figure 1-2 shows the condition of the 65-calorie flash hood after it was exposed to the tremendous heat energy of the arc flash; the inside of the hood looked like new. For comparison purposes, Figure 1-3 shows a new flash hood similar to the one worn by the electrician.

Figure 1-2. Damaged flash hood

The event at the Wood River Refinery underscores the importance of wearing PPE that is appropriately rated for the work being performed. Looking at the burn damage to the arc flash hood and its face shield, one can only imagine the injuries that the electrician might have sustained if it had not been worn. Electrical safety program administrators and electrical maintenance organizations should ensure that NFPA 70E has been implemented for arc flash protection.

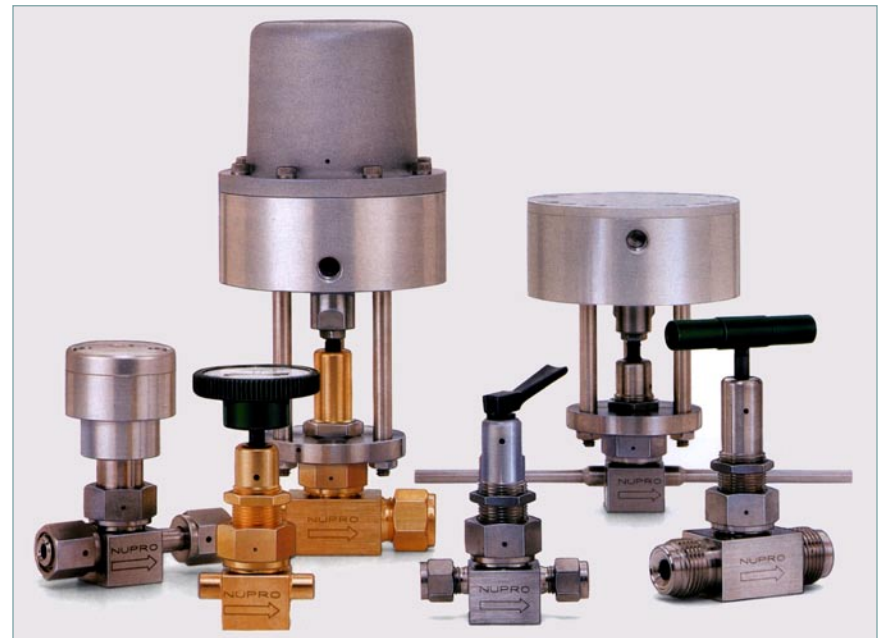
An examination of procurement records and subsequent discussions with the vendor revealed that due to several mixups with vendors and product numbers, the valves that had been ordered and installed in 2001 were composed of a polychlorotrifluoroethylene (PCTFE) stem tip and a Teflon®-coated stainless steel bellows gasket, instead of the desired Vespel stem tip and silver-coated stainless steel (SS) bellows gasket. PCTFE stem tips and Teflon-coated bellows gasket are more vulnerable to beta-particle degradation than those procurement personnel believed they had ordered.

Figure 2-1. Valves used in tritium service

These events illustrate the importance of verifying the composition of purchased safety-significant equipment, especially when the possibility exists for premature failures because of material incompatibility. In such cases, requisition paperwork should instruct inspection personnel to inspect every item received to be sure it complies with purchase specifications.

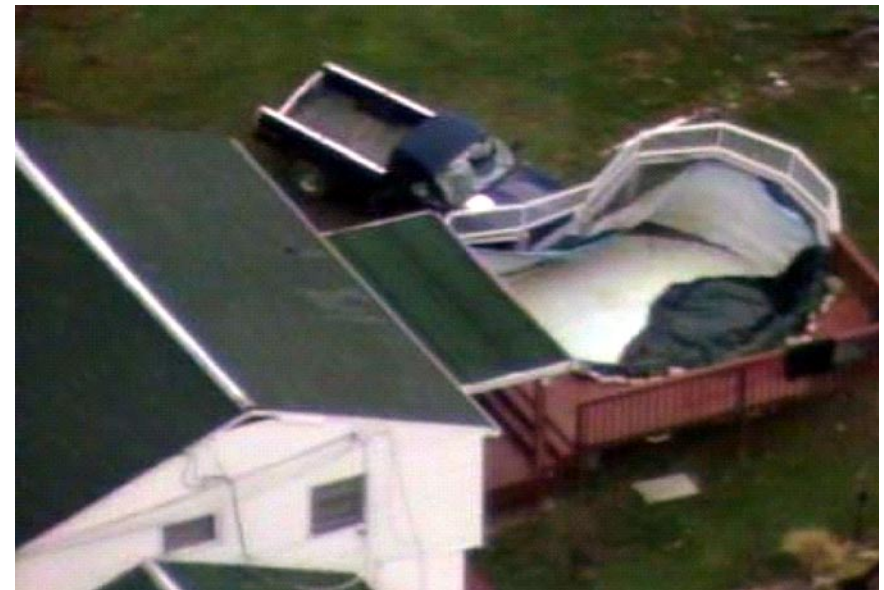
Figure 3-1 shows the aftermath of an accident that occurred near Pittsburgh, Pennsylvania, on the first day of hunting season in 2006. A deer leaped through the front window of a pickup truck, killing the driver, and the truck veered off the road, hit a tree, and ran into an outdoor swimming pool.

Figure 3-1. Pickup runs into outdoor pool after a deer jumps through windshield
