**U.S. Department of Energy
Office of Health, Safety and Security**

Accident Investigation Report

**Fatality at the Strategic Petroleum Reserve
Bryan Mound Site, September 13, 2011**

November 2011

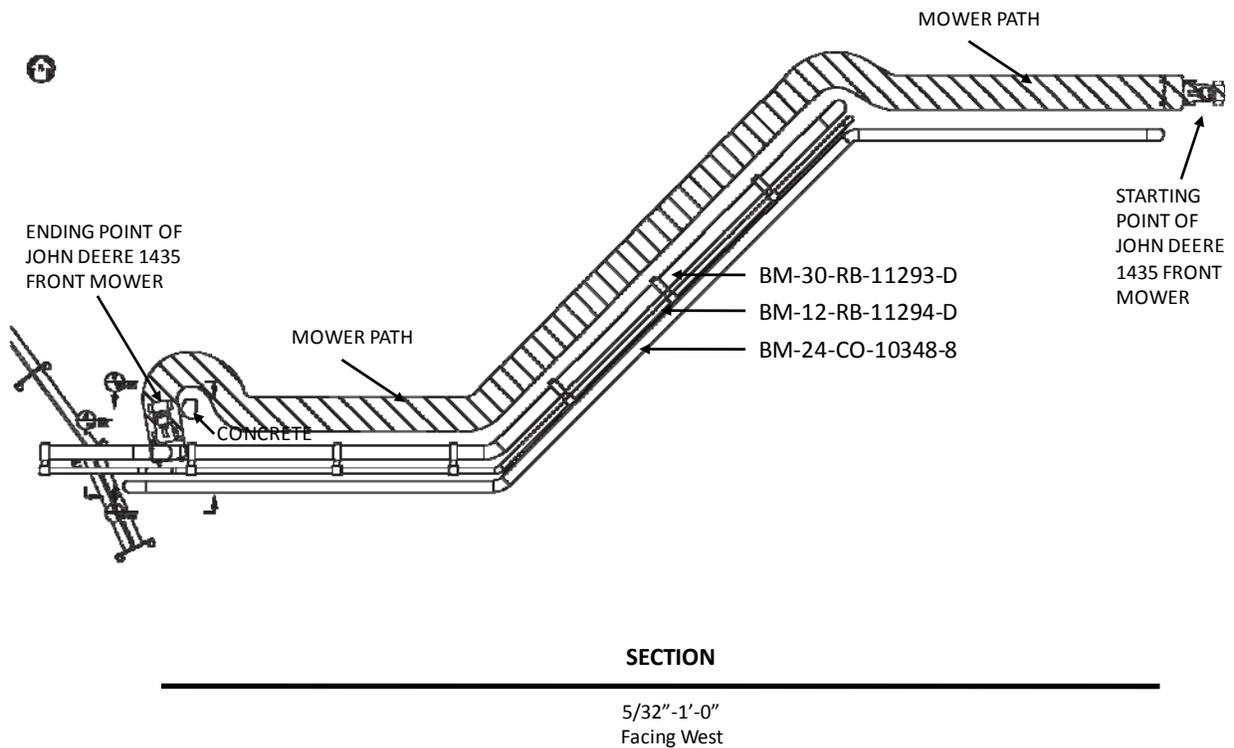
Figure 2-3: Path of Mower along Pipes

Sometime between 1120 and 1125 hours, GC1 began to operate Mower 1. The path cut in grass (Figure 2-3) indicates that GC1 mowed west about 128 feet, then southwest about 173 feet, then west about 90 feet before making about an 18 foot radius turn for about 200 degrees around an unmarked concrete obstruction before Mower 1 contacted three large elevated pipes oriented east and west. The path cut in the grass indicated that GC1 was in control of Mower 1 and that he made straight cuts and accurate turns before contacting the pipes (Figure 2-3). After completing a 180 degree turn around the unmarked concrete obstruction, GC1 was about eight feet from the nearest above ground pipe and needed to either stop or quickly maneuver Mower 1 to prevent contact with the pipe. The reason GC1 did not stop or maneuver Mower 1 before contacting the pipes was not determined. Sometime between 1125 and 1130 hours, Mower 1 and GC1 struck three large elevated pipes with significant force (Figure 2-4).

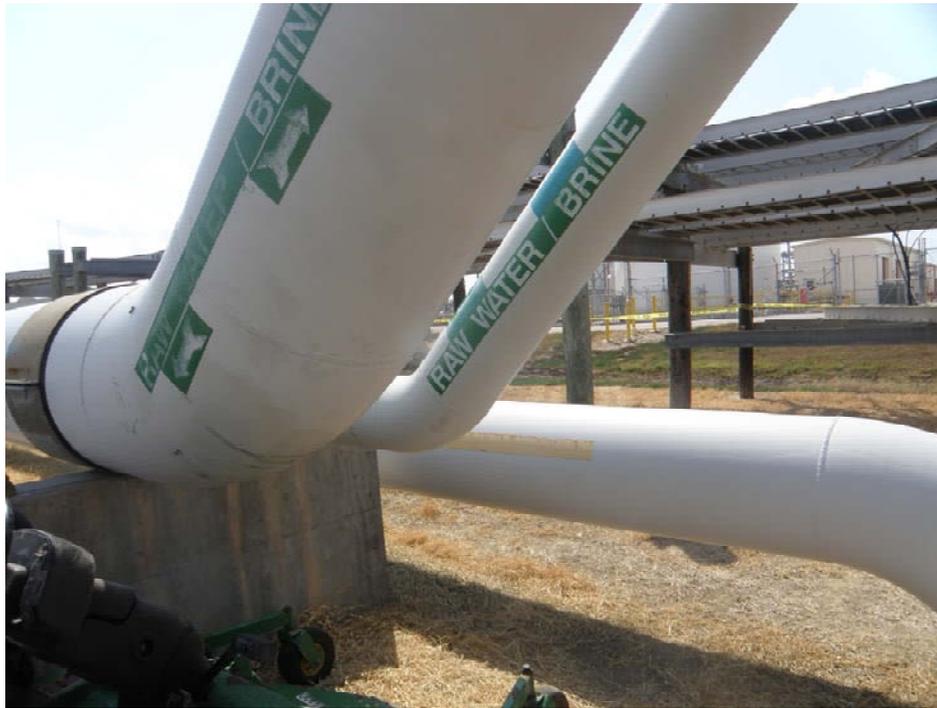
Figure 2-4: Photograph of Section of Pipes Struck by GC1

The steering wheel of Mower 1 passed under the largest pipe at an elevation of 4 feet 0 inches above grade and Mower 1 continued south-southeast until the right vertical part of the Roll Over Protection Structure (ROPS), located behind the driver's seat, contacted the nearest pipe (Figure 2-5). When the right vertical part of the ROPS contacted the nearest pipe, Mower 1 pivoted horizontally until the left vertical part of the ROPS contacted the same pipe and stopped forward motion. Sufficient energy remained that when forward motion stopped Mower 1 pivoted on the right and left vertical parts of the ROPS and lifted the mowing attachment with sufficient force to strike the farthest pipe. In that position there were only a few inches of clearance between the seat and the pipe. At the time this report was finalized, the final autopsy report had not been issued, but preliminary verbal and written reports from the Galveston County Medical Examiner's Office indicated that GC1 had sustained significant blunt force trauma that resulted in a severed spinal cord and internal bleeding.

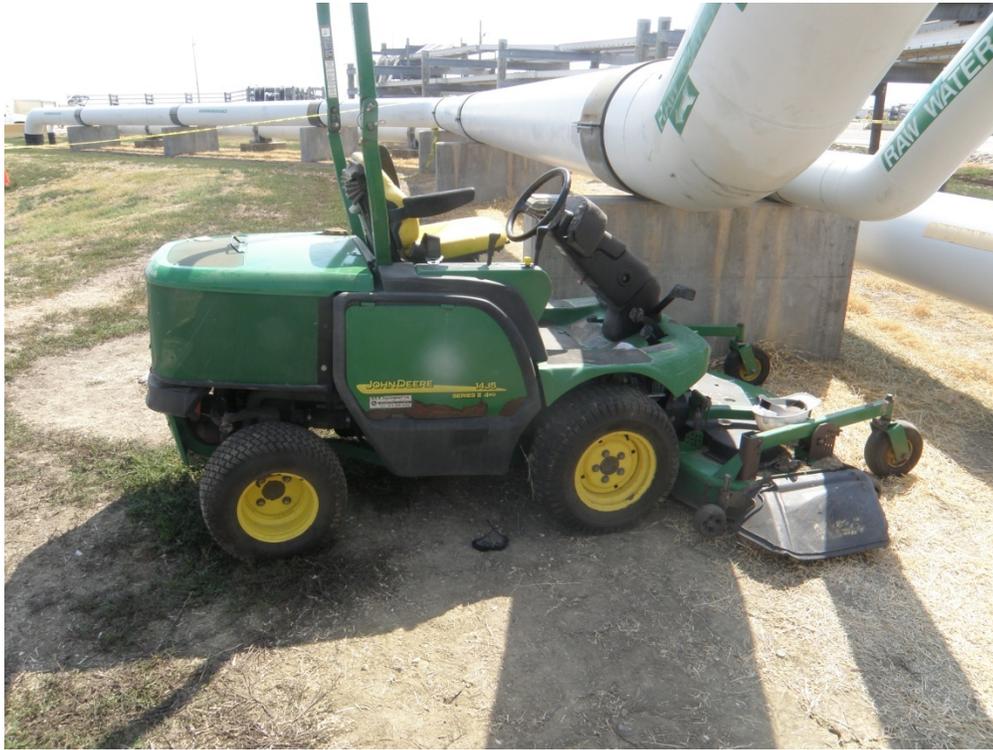
Figure 2-6: Position of Mower after Accident

- Mower 1 was backed away from the largest pipe with the mower deck still extended under the two additional pipes (Figure 2-6),

- The left and right turn brake pedals were abnormally depressed compared to the “normal” position depicted in the John Deere Operator’s Manual. The left turn brake pedal was also depressed further to the floor than the right turn brake pedal,

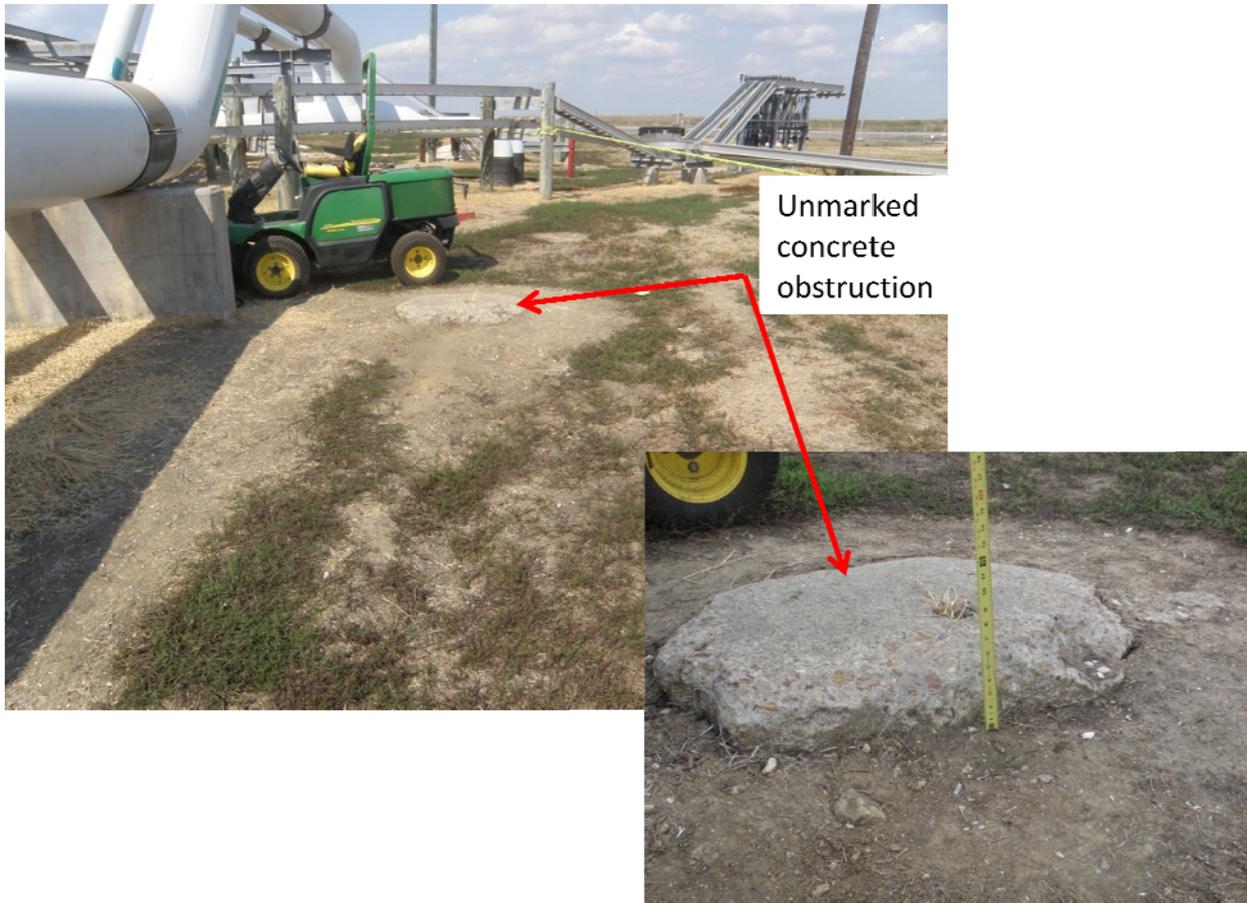
**Figure 2-7: Location of Unmarked Concrete Obstruction
GC1 Maneuvered Around**

- There was an unmarked concrete obstruction near Mower 1 that GC1 steered around prior to impacting the pipes (Figure 2-7),
- The mower seat appeared to be bent back when compared with the drawing in the John Deere Operator’s Manual,
- The steering column was bent down – probably as a result of the impact,
- There were a number of scratches and scrapes on the mower and the piping that appeared to result from the mower impact,

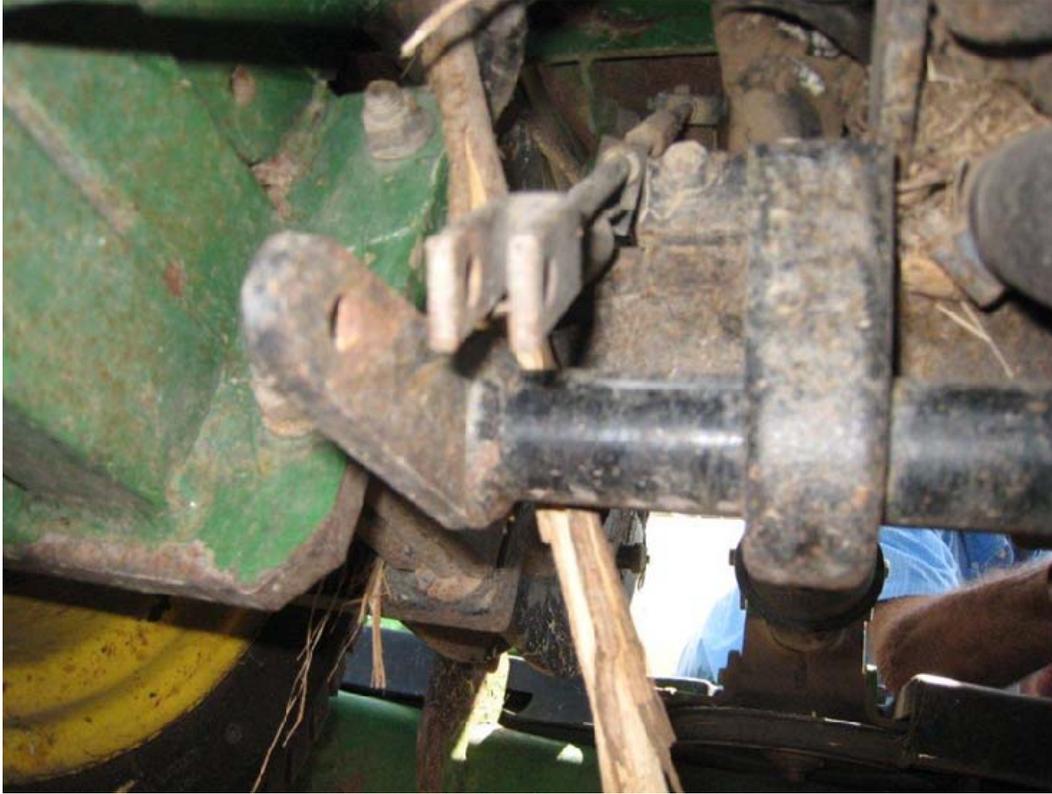
Figure 2-8: Disconnected Tie Rod (and Missing Pin) with Stick Wedged in Frame

- There was a tie rod directly below the left and right turn brake pedals and underneath the Mower 1 frame that was disconnected. A stick of approximately 3/4 inch diameter and over a foot in length was wedged near the disconnected tie rod. A smaller stick was also wedged below the larger stick (Figure 2-8),

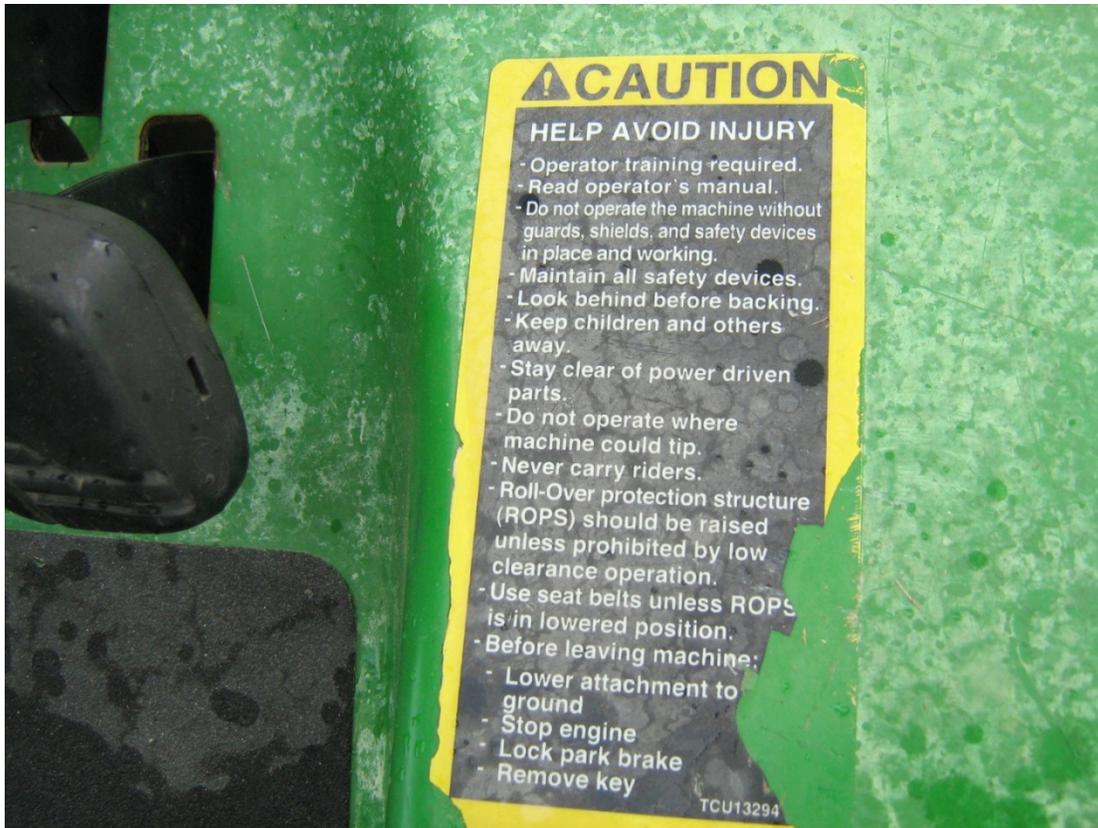
Figure 2-11: Warning Label found on the Front of Mower 1

The John Deere Model 1435 Front Mower Series II has a number of safety features and/or controls that are pertinent to this accident including the braking system, seat restraint system, ROPS, PTO, steering system and accelerator system (forward and reverse pedals). This mower is also placarded with a number of machine safety (warning) labels. The warning label on the front of the mower (Figure 2-11) states that operator training is required, to know all controls, and to read the Operator's Manual. The warning labels on the ROPS are provided in both English and Spanish. On September 28, 2011, the Board observed that the warning labels for Mower 1 were in place in accordance with the Operator's Manual; however the DM equipment tag (BMEQ-315) was missing from the left side of the mower deck.

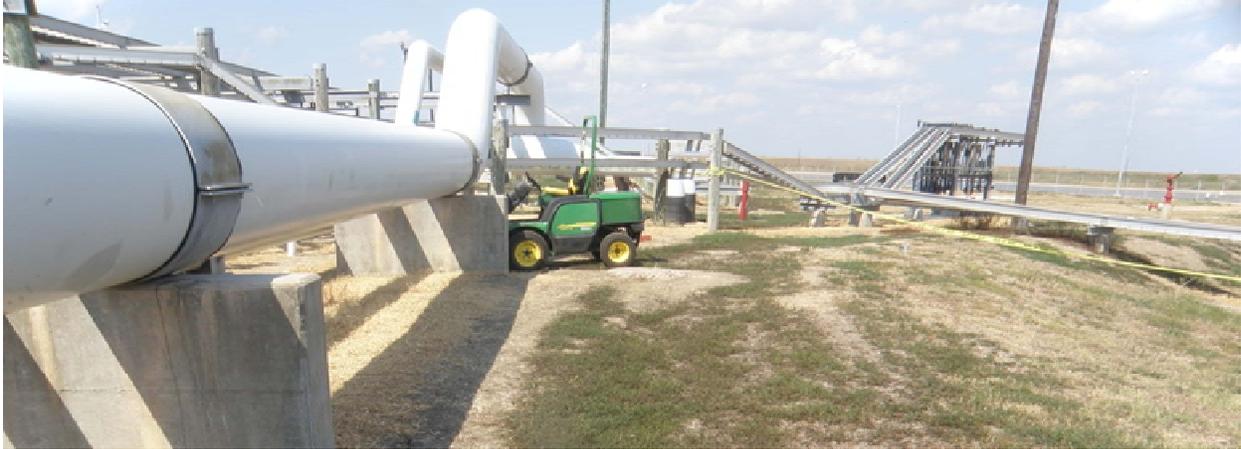
Figure 2-12: Mower 1, Located to the Southwest of the Area Mowed by GC2 - Infrastructure and Piping Blocks Line of Sight

Another responsibility of supervision, along with security, is to ensure that the DM escort policy is followed for new employees. On the morning of the accident, the SMT had assumed escort responsibilities for GC1, a new hire. When the ERT drill was announced, the SMT transferred these responsibilities to GC2, GC3, and GC4. Later that morning when GC3 and GC4 left GC1 with Mower 1, GC3 and GC4 assumed that GC2 had escort responsibilities for GC1 although GC2 was at a considerable distance from GC1 and was not directly informed by either GC3 or GC4 that they were leaving GC1 unattended. Chapter 3, page 15 of DM Manual ASI5600.1, *Security Operations Manual*, states that the escort must retain "visual and vocal control of the visitor at all times," and that the visitor "is restricted to the immediate area of the escort and the visitor may not under any circumstance separate from the escort." The line of sight between GC1 on Mower 1 and GC2 was obscured by infrastructure and piping as shown in Figure 2-12 and Figure 2-13.

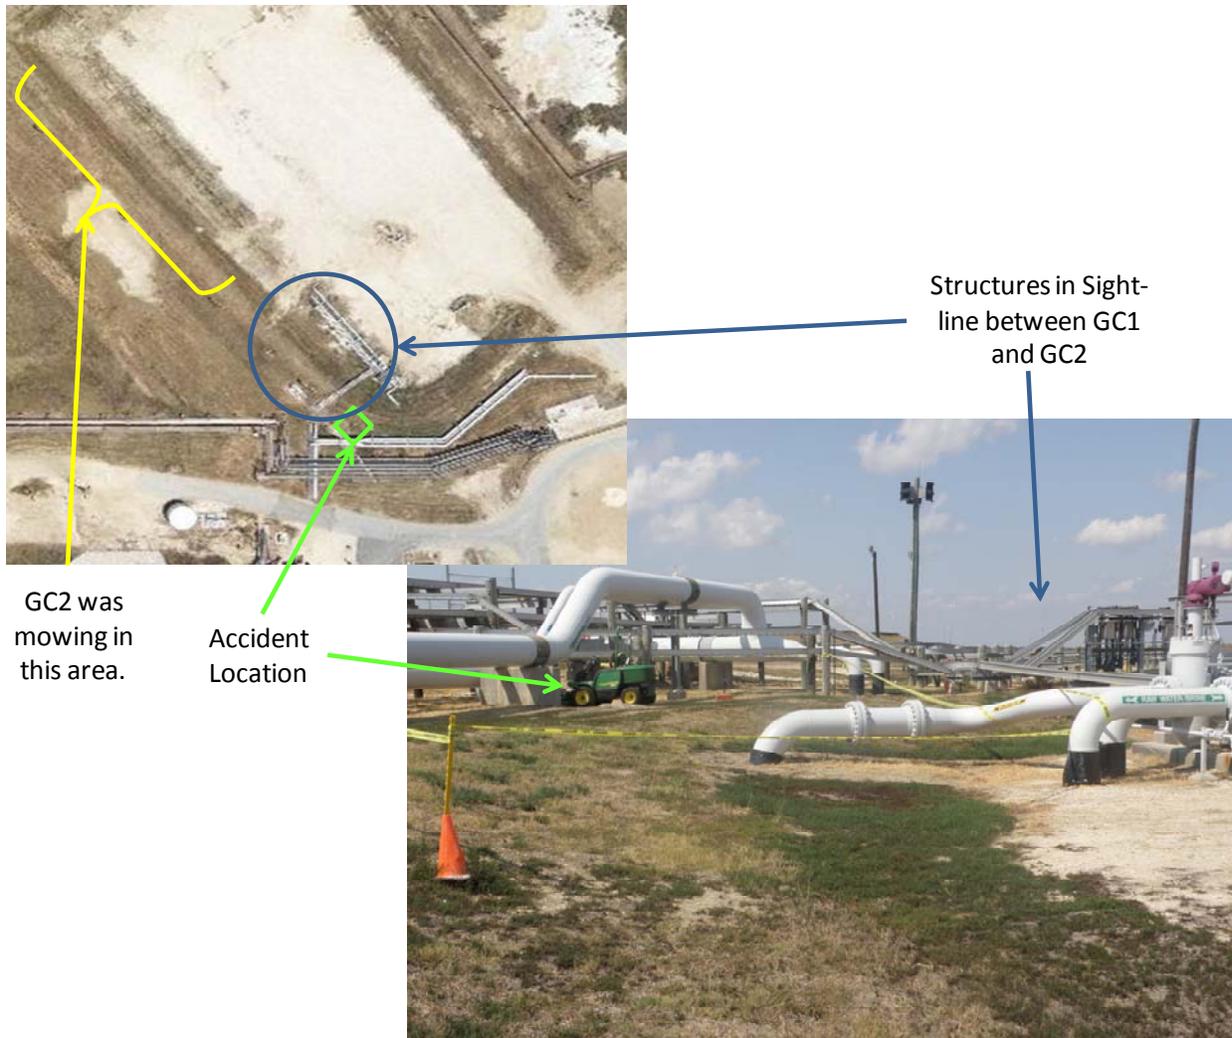
Figure 2-13: Line of Sight interrupted by SPR-BM Site Piping and Infrastructure

Furthermore, on the day of the accident, the DM escort policy was not enforced as required. Based on a review of the accident scene, and the number of physical obstacles observed and noise associated with the mowing operation, the Board concluded that at the time of the accident GC1 was not in the immediate area of the escort (GC2), nor was GC2 in continual visual or vocal control of GC1. Furthermore, it is not clear to the Board if GC2 was aware that he was the escort for GC1 at the time of the accident or aware of the escort responsibilities.
