Flower Garden Banks National Marine Sanctuary Mooring Drilling Cruise Report M/V SPREE July 28–30, 2008

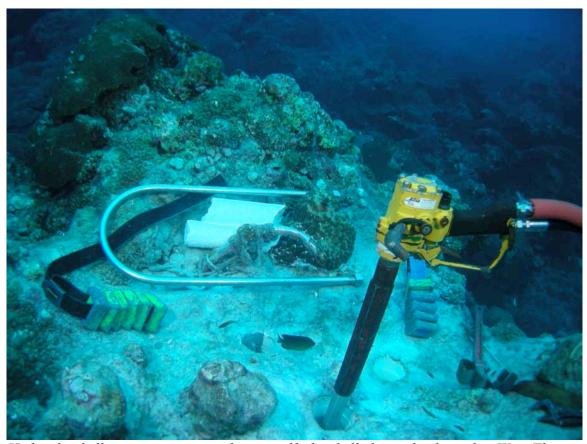
Hydraulic drill rig sitting in one of a pair of holes drilled into dead coral at West Flower Garden Bank for Buoy #3. The new U-bolt sits in the background next to the old U-bolt, which has been twisted and broken. Coral cores which have been removed during the drilling process are also visible. The weight belts are used by the drillers to provide extra downward weight during the drilling process.

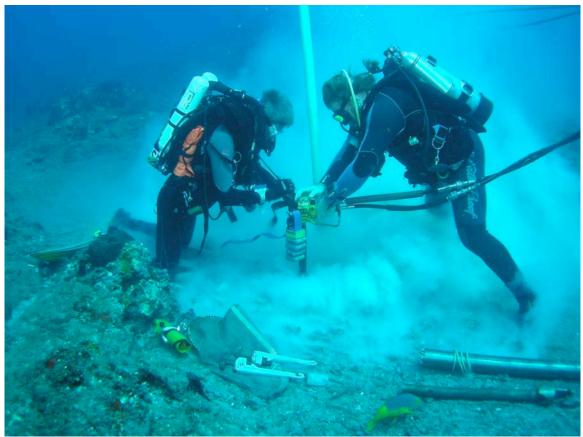
Frank Wasson (right) and David Snyder (left) drilling at Stetson Bank Buoy #2. The specialized drill bit can be seen in the foreground.

Paired U-bolt holes, approximately 6 feet in length, were drilled into the claystone at Stetson Bank Buoy #2, and about 3 feet into dead coral heads at West Flower Garden Bank #5 and #3, and East Flower Garden Bank #2, at sites selected by sanctuary staff.

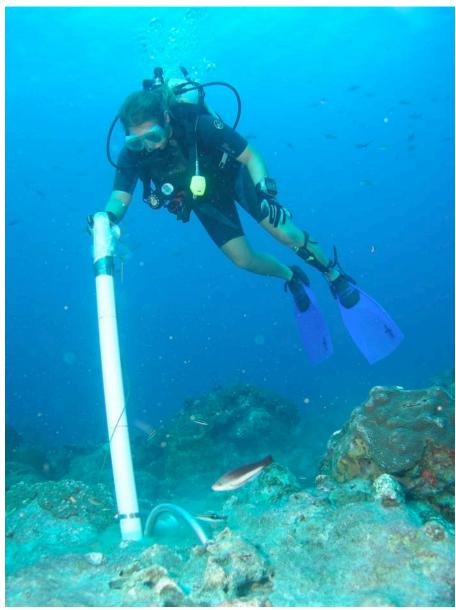
A queen parrotfish supervises Tracy Hamburger as she pours cement around a newly placed U-bolt on West Flower Garden Bank.

After the paired holes were drilled, cement was premixed and loaded up into long PVC tubes, which were carried down by divers. The tubes were uncapped, and cement was poured into the holes around the U-bolt that had been placed into the drilled holes.
