## Safety Alert: Hydraulic Hoist Cylinder Failure on Komatsu 680-E Trucks

**EQUIPMENT:** All 445E, 510E, 630E, AND 685E HAULPAK® Trucks with "Super Cylinder" Hoist Cylinders

**SUBJECT:** Product Improvements to Hoist Cylinders

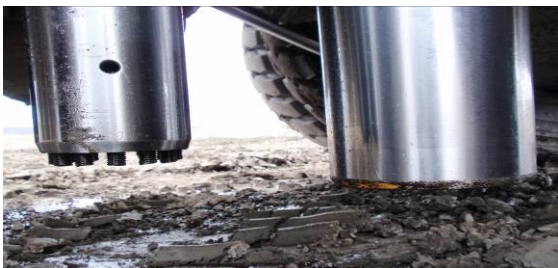
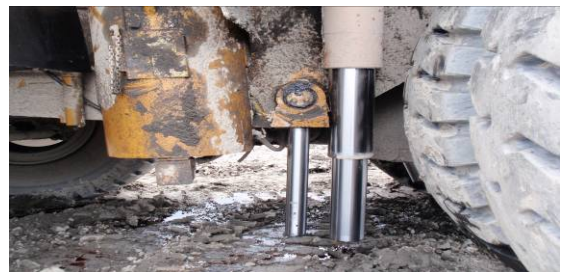
Hoist Cylinder Failure

A Komatsu 685-E haul truck was operating at a surface coal mine when the bolts for the third stage piston bearing retainer from both Hoist Cylinders failed, allowing the dump bed to fall abruptly onto the frame of the truck. The truck operator was not injured; however the operator withstood a severe jolt. The Komatsu truck utilizes a hoist limit switch intended to stop the cylinders from full extension. However, it was determined that this switch was not properly maintained and allowed the cylinders to extend beyond their normal limit. When the cylinders extended to the maximum travel, a “slide hammer” effect occurred between the piston and barrel head, causing repeated jolts. This condition most likely stressed the bolts and caused the failure over the dump cycles. Upon inspection of the two hoist cylinders, it was determined that one of the cylinders had six (6) bolts that held the retainer and the other cylinder had twelve (12) bolts.

A Haulpak service bulletin, number 529, Section L (18 March '94) was issued for the 685E truck that provided for a Hoist Cylinder Rework Kit, MK3567. This kit provided parts and instructions for improving the method of retaining the third stage piston bearing retainer. The rework kit uses 12 - 5/8” UNRC grade 9, 12-point capscrews, and a single, hardened washer plate. Even though this rework kit has been available for years, it appears that 6-bolt cylinders are still in service. As in this case, the hoist cylinders on the truck were mismatched with different bolts in the cylinders. This mismatch may have contributed to the failure. It is recommended that maintenance records for the hoist cylinders be reviewed or that the cylinders be inspected to ensure that both cylinders have the twelve bolt modification. In addition, mines should inspect the hoist limit switch to make sure it is properly adjusted and working. Mine operators should discuss this situation with their maintenance departments, truck operators, and their cylinder rebuild shops. Mines should not accept rebuilt cylinders that have the 6-bolt design. Mine operators should also determine if truck operators are experiencing occurrences where the hoist cylinders are extending to the maximum limit. This may be detected by the operator feeling a hard jolt when the truck is dumping or a change in the sound of the hydraulic pump when the cylinders are fully extended.

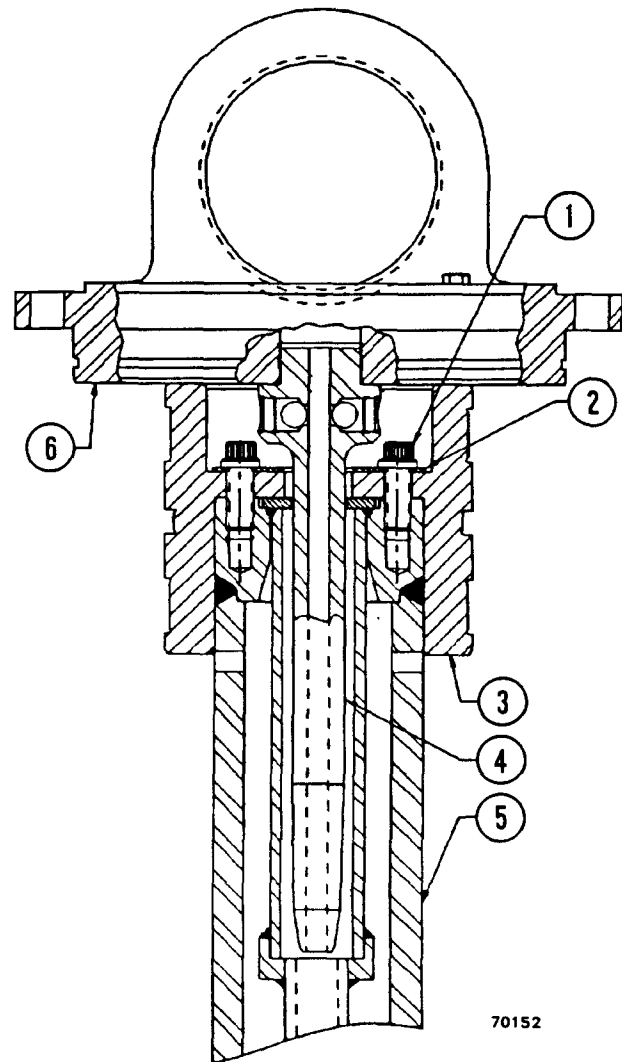
FIGURE 1. CYLINDER, 3rd STAGE

The Hoist Cylinder Rework Kits, MK3567 for the 630E and 685E and MK3569 for the 445E and 510E, provide the parts and instructions for improving the method of retaining the third stage piston bearing retainer. On existing cylinders, the retainer is held by six 5/8" UNC grade 8 hex head capscrews with hardened flat washers. The new method uses twelve 5/8" UNRC grade 9, twelve point capscrews (1, Figure 1) and a single, hardened washer plate (2). This provides a significant increase in the clamping force exerted on the piston bearing retainer (3).

When a cylinder is disassembled, the Rod Eye Structure (5) should be modified according to rework drawing ED5217 for the 630E/685E or ED5201 for the 445E/510E which adds six more tapped holes. When reworking the Rod Eye Structure, plug all external piston openings to prevent internal contamination. A new bearing retainer ED5224 will be required (3). The quill assembly (4) must be removed from the cylinder head (6) and chamfered as shown on rework drawing ED5219. After modification, the following parts should be renumbered with the same part numbers as used in the production cylinders, but with a prefix "R" in front of the number to indicate a reworked part.

1. Make certain threads on capscrews and threads in rod eye structure are clean and dry (free of oil and solvent).
2. Using Loctite 'LOCQUIC' Primer "T" (TL8753, or equivalent), spray mating threads on capscrews and threads in rod eye structure.

3. Apply Loctite Sealant #277 (VJ6863, or equivalent) to mating threads of both capscrews and threads in the rod eye structure.
4. Install capscrews (1, Figure 4) and hardened washer plate (2) and tighten capscrews to 250 ft. lbs. (209 N.m) torque.

*However, if a truck has experienced a failure of the third stage piston bearing retainer/rod eye structure, the opposite cylinder may also have been overstressed, and should be checked for broken or stretched bolts in the 3rd stage piston area. Such damage would require BOTH cylinders to be repaired and/or reworked to the new configuration.*
