# Yukon Delta National Wildlife Refuge

*Contaminant Assessment*

Yukon Delta National Wildlife Refuge  
Contaminant Assessment

October 2009

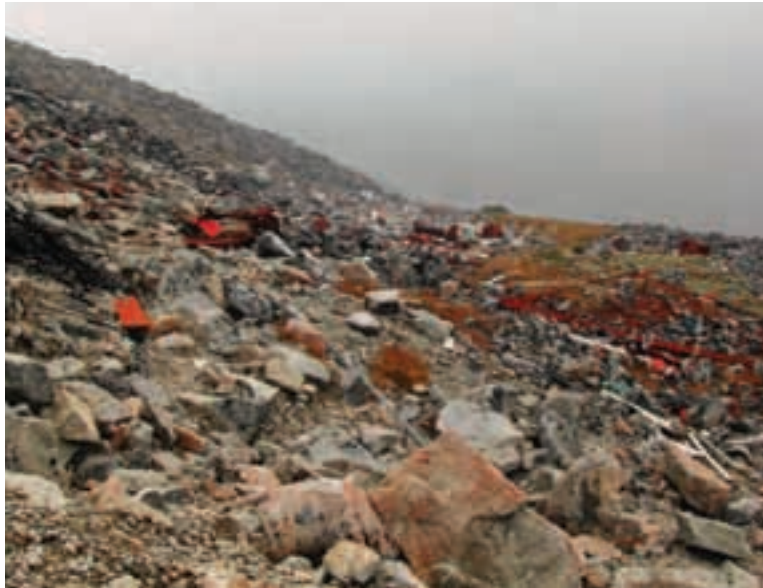
*Hundreds of fuel barrels and other debris were rolled downhill from the Cape Romanzof LRRS road. D. Rudis/USFWS photo*

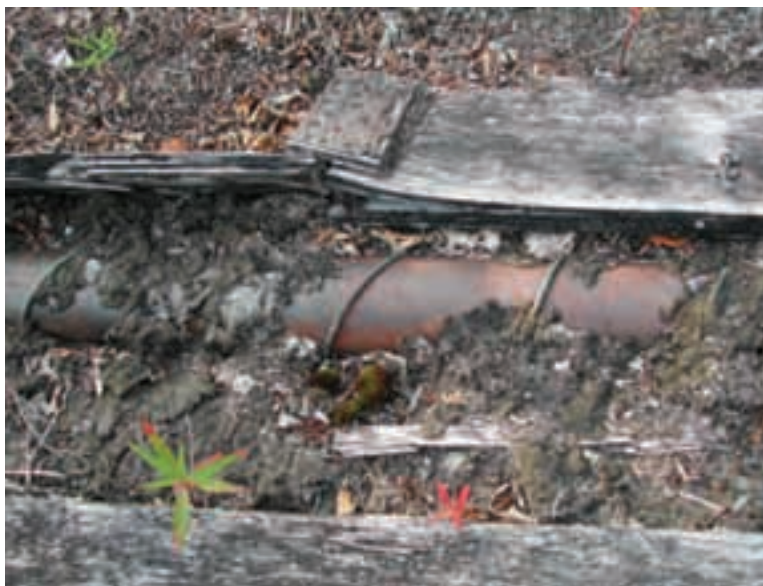
*BIA Administrative site building debris and buried pipe are typical hazardous materials found on site. D. Rudis/USFWS photo*

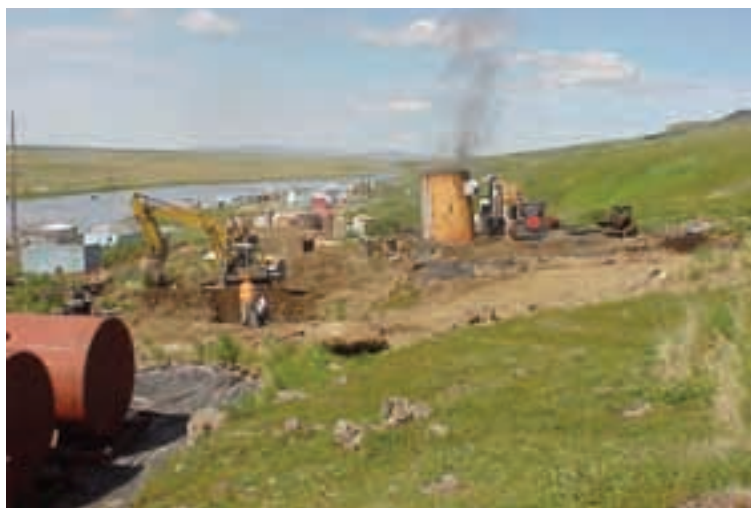
Thermal remediation was used to clean petroleum hydrocarbon contaminated soils at the Nightmute School site. Engineering/USFWS photo.

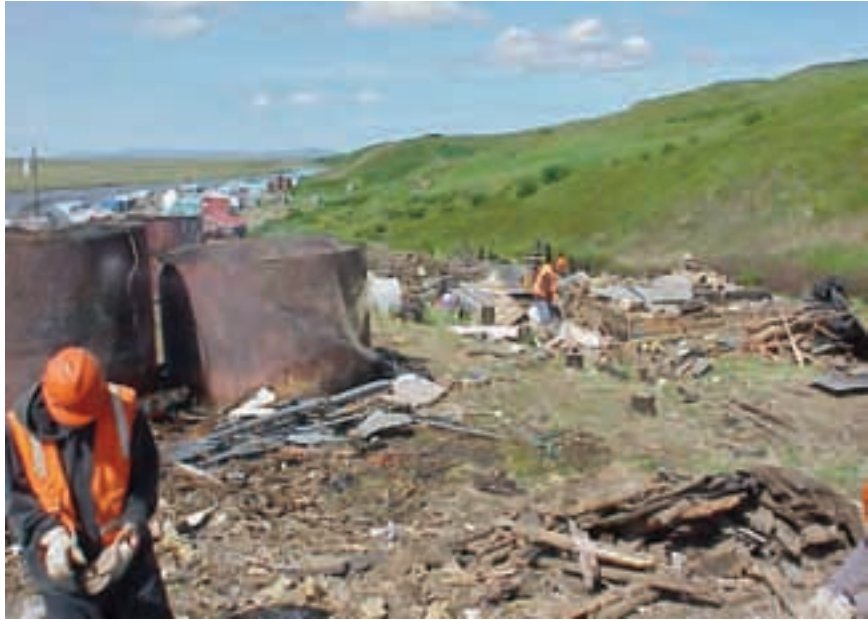
*Nightmute School cleanup project in 2002 included removal of asbestos-containing materials, building and tank farm demolition, and other waste removal. Engineering/USFWS photo*

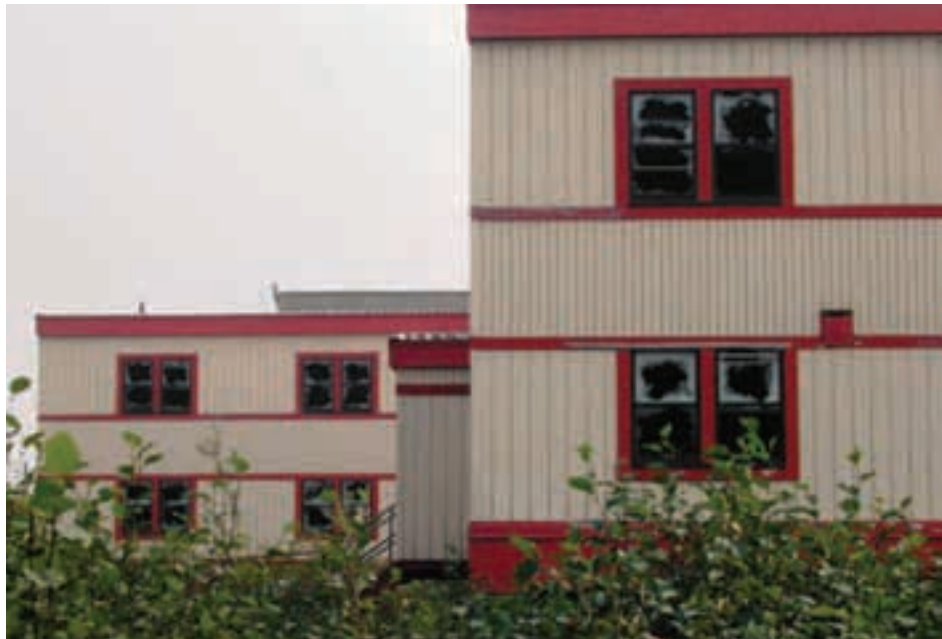
*Buildings and other structures at this site pose safety and hazardous waste dangers. D. Rudis/USFWS photo*

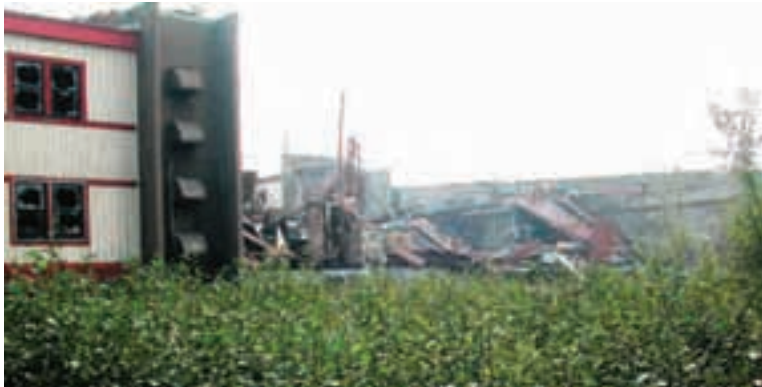
*The BIA Administrative Site buildings contained asbestos, and many were partially burned in vandalism activities. D. Rudis/USFWS photo*

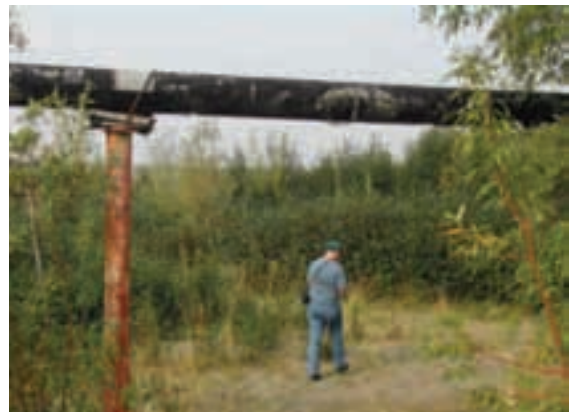
*Asbestos piping is elevated, but other asbestos waste is found throughout the BIA Administrative site. D. Rudis/USFWS photo*

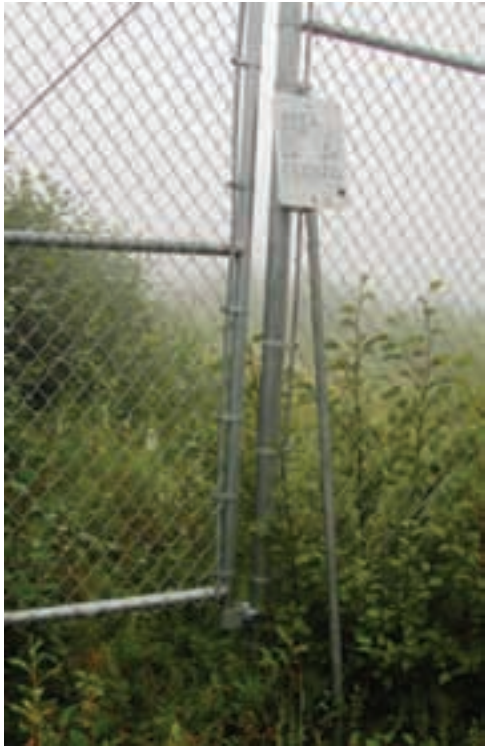
*Exclusion fencing and signage around the closed BIA site sewage lagoon is inadequate to prevent trespass. D. Rudis/USFWS photo*

grass seed and allowed to return to native vegetation. The lagoon cells were enclosed by a chain link fence, and institutional controls (ICs) for the site included posted “closure” signs. Service personnel had no problem accessing the site by crawling under the fence during an August 2005 site visit. We noted that the site was completely revegetated with a variety of herbaceous species, and alder was growing on the higher spots.

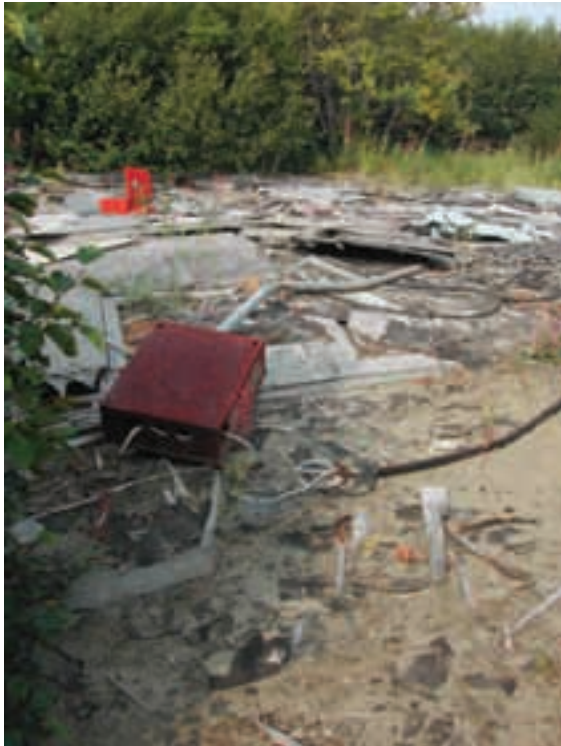
*Building debris and trash is found scattered throughout the BIA Administrative Site. D. Rudis/USFWS photo*

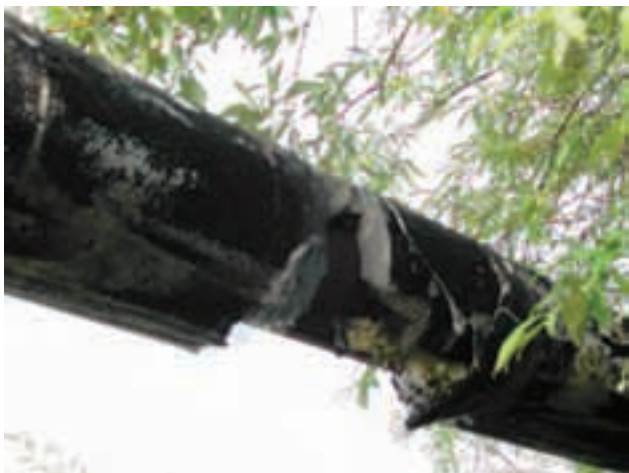
*Asbestos waste, including piping, is found throughout the BIA Administrative site. D. Rudis/USFWS photo*

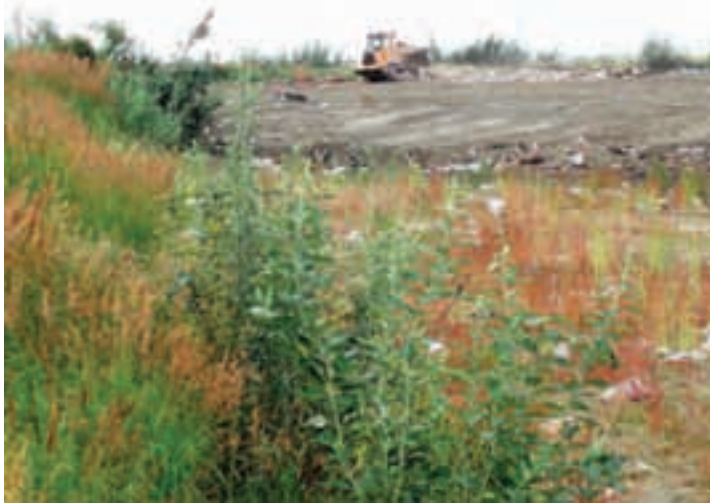
*The Bethel City Landfill is on a former Tactical Air Navigation (TACAN) site. This site is federal Refuge property, as stated in an opinion provided by the DOI Solicitor's office January 16, 2003. D. Rudis/USFWS photo*

During the August 16, 2005, site visit, Service personnel noted active landfill operations, including solid waste bulldozing and capping; and metal, appliance, and auto disposal areas. As the landfill covers more than two acres, a survey would be needed to determine the Refuge parcel.

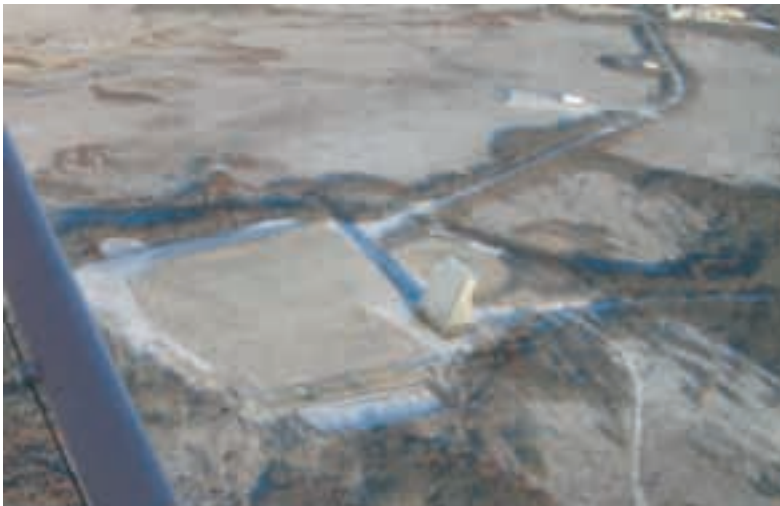
*Bethel U.S. Air Force White Alice site is a DoD withdrawal from the Refuge. This site has a history of contaminant problems. P. Johnson/USFWS.*

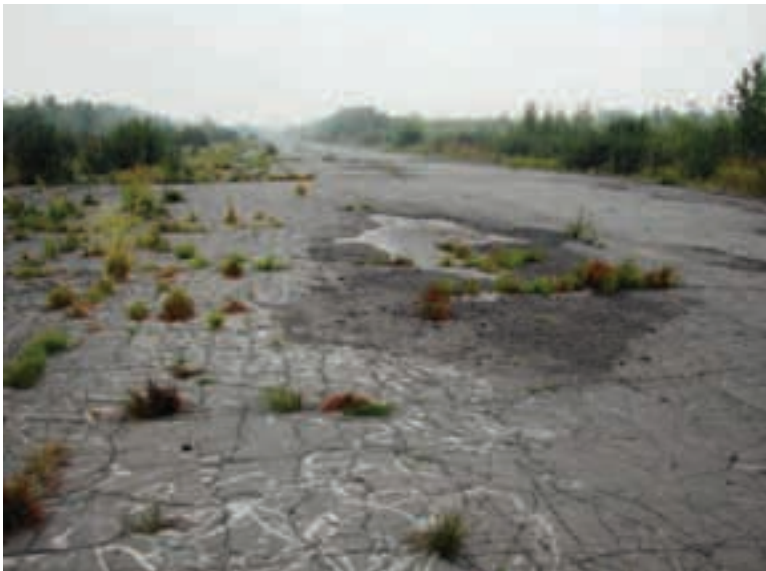
*The Jack Todd Army Airfield airstrip, constructed for WWII use, is currently in disrepair. D. Rudis/USFWS photo*

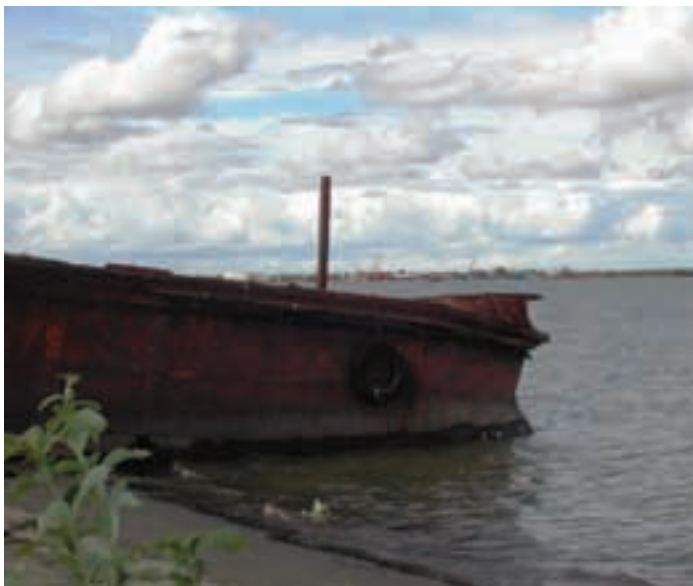
*Along the shore by the Jack Todd Army Airfield, landing craft and other heavy machinery was abandoned. D. Rudis/USFWS photo*

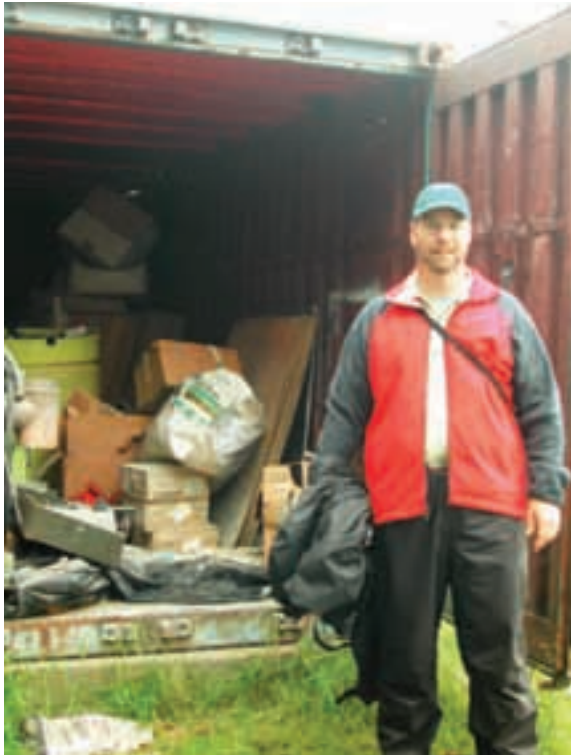
*A Conex trash storage container on the Akiak ANG site and Philip Johnson. Conex contents are unknown and could contain hazardous materials. D. Rudis/USFWS photo*

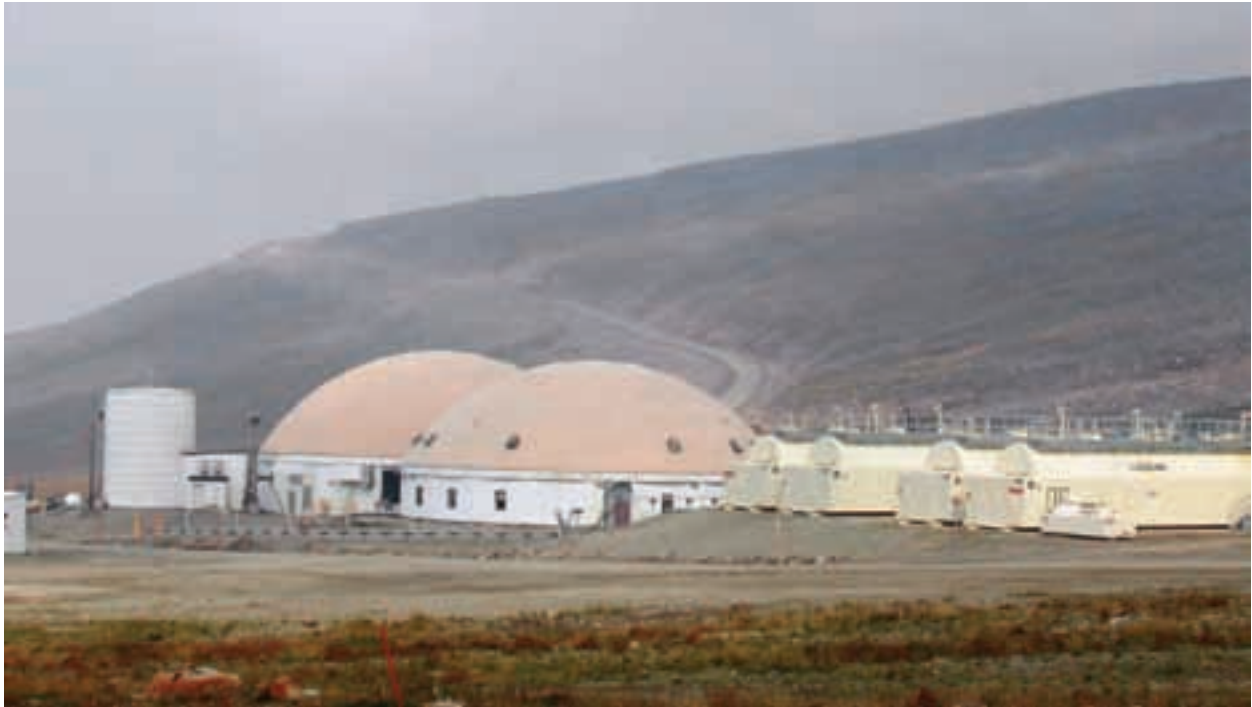
*The Cape Romanzof LRRS base station and fuel storage area. This site has a history of fuel spills. D. Rudis/USFWS photo*

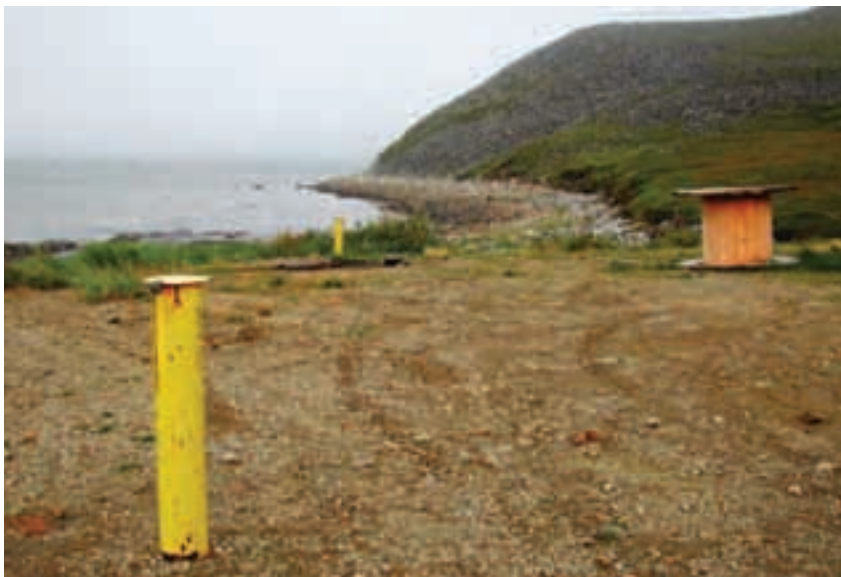
*Cape Romanzof LRRS site landfills are graded and have closure signs. Those with surface and groundwater contamination have monitoring wells. D. Rudis/USFWS photo*

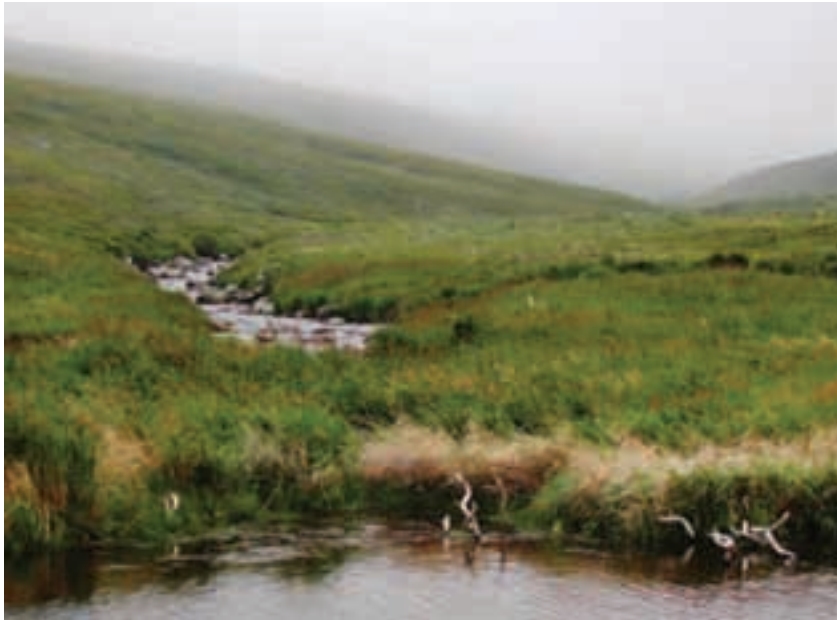
*Fowler Creek drains the Cape Romanzof LRRS. A 1992 Service report found creek sediments and biota were contaminated with petroleum hydrocarbons; biota also had PCB and DDT-related compounds. D. Rudis/USFWS photo*

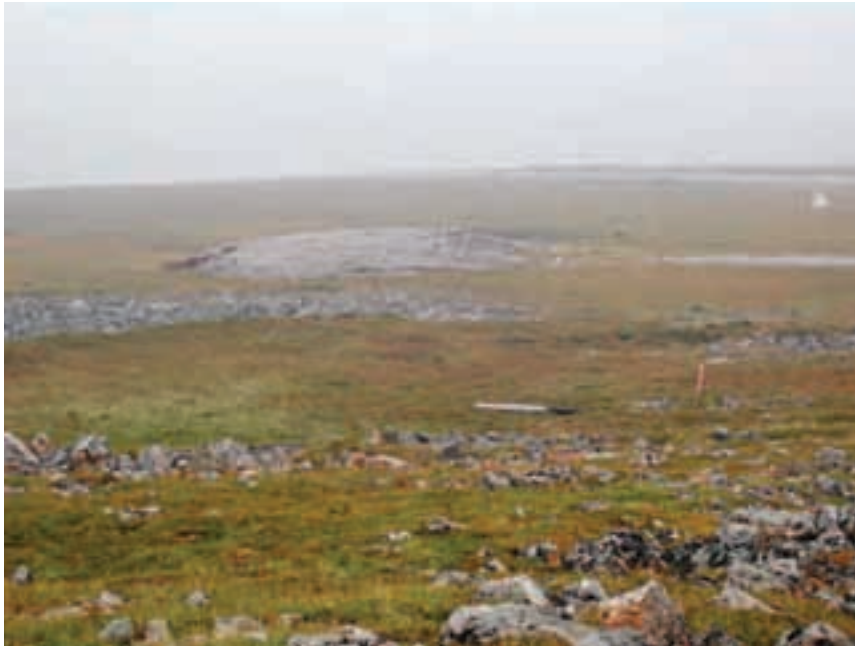
*The 1992 Service study found that Landfill Number 2 (LF03) at the Cape Romanzof LRRS was a primary contributor of contaminants, including PAHs, PCBs, chlordane, lead, and cadmium to Fowler Creek sediments. D. Rudis/USFWS photo*

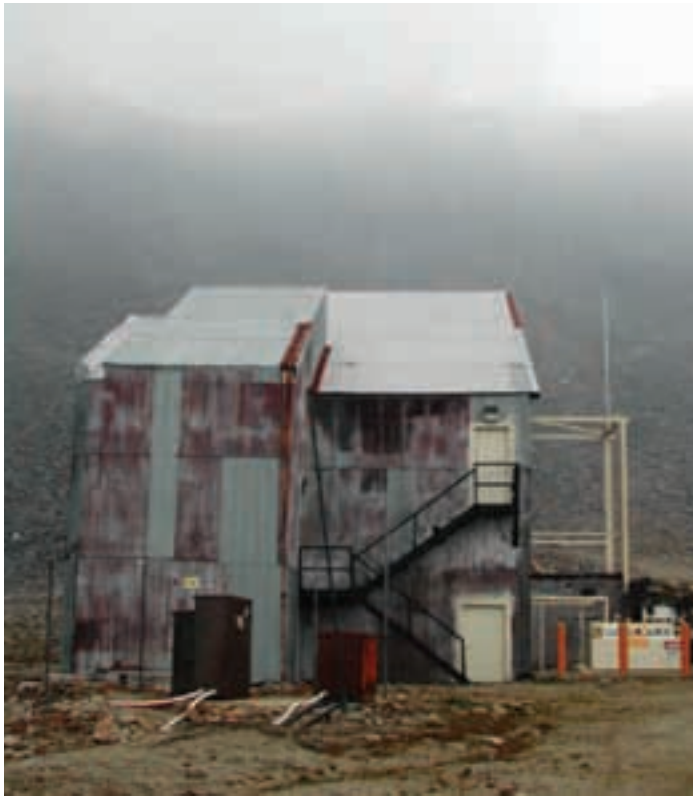
*The former tramway building at the Cape Romanzof LRRS has PCB-contaminated paint and friable asbestos. PCBs and petroleum based lubricating oil were used on tramway cables. D. Rudis/USFWS photo*

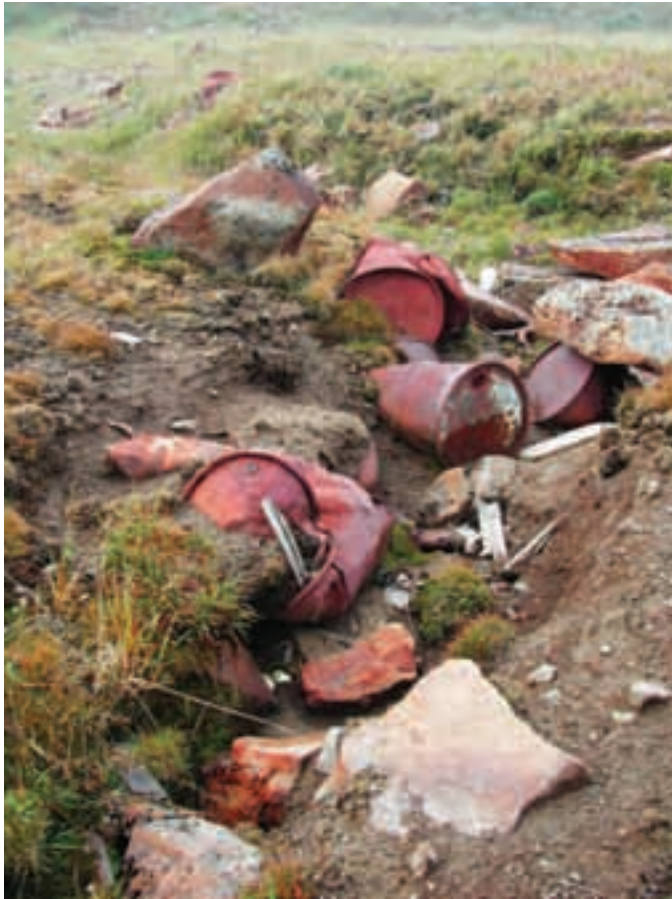
*Barrel dumps are found throughout the Cape Romanzof LRRS.  
D. Rudis/USFWS photo*

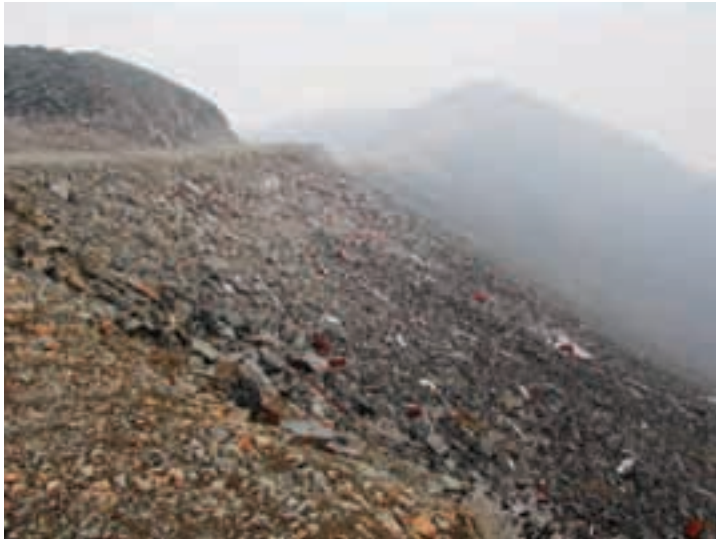
*Debris covers the hillside near the Towak Mountain tower at the Cape Romanzof LRRS. D. Rudis/USFWS photo*

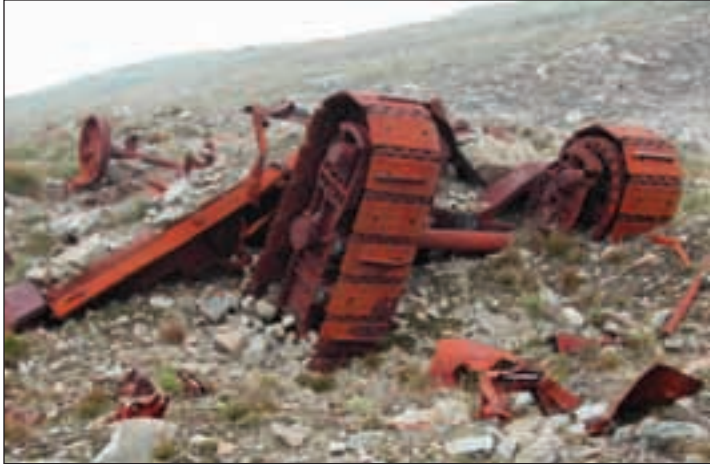
Abandoned equipment is found throughout the Cape Romanzof LRRS.  
D. Rudis/USFWS photo

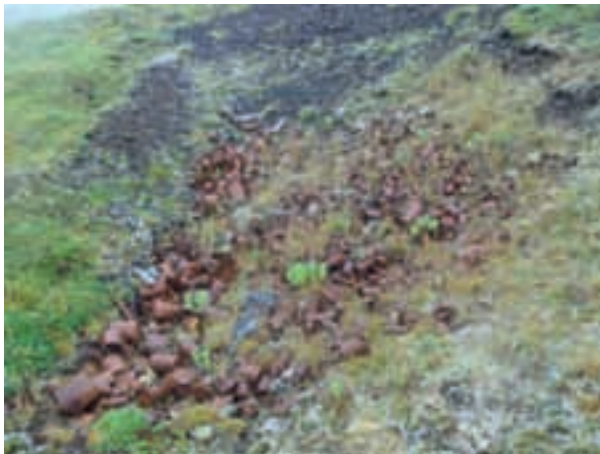
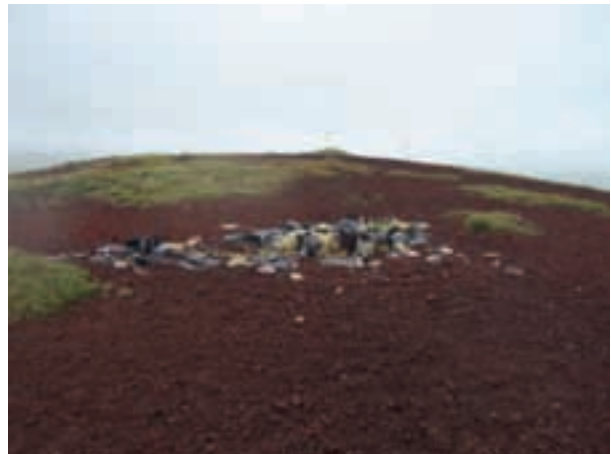
*Debris left on Tern Mountain, Chefornak, Alaska. USFWS photos*
