**UNITED STATES AIR FORCE**  
**AIRCRAFT ACCIDENT INVESTIGATION**  
**BOARD REPORT**

**C-17A, T/N 00-0173**

**3<sup>RD</sup> WING**

**DATE OF ACCIDENT: 28 JULY 2010**

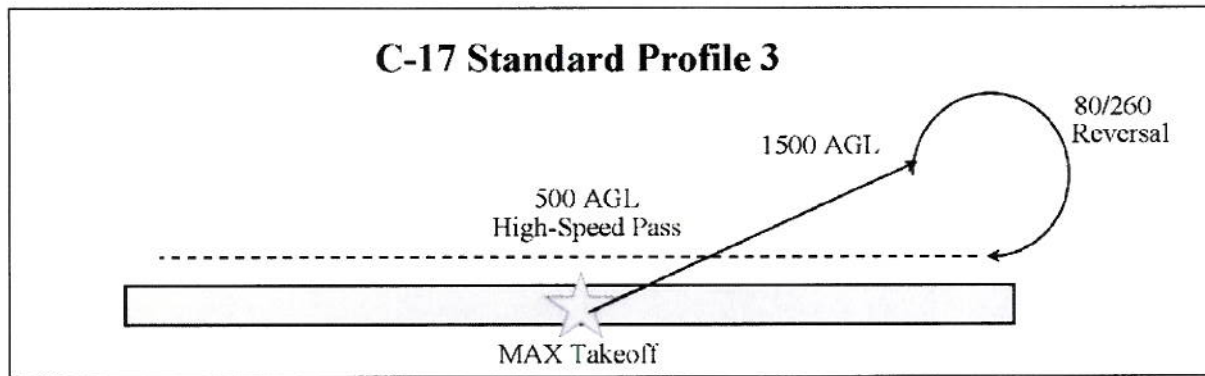
Profile 3 (Abbreviated)

The 500-foot AGL high-speed pass is accomplished by descending from 1,500 feet to 500 feet AGL during the 80/260-degree reversal turn. Upon reaching 500 feet, the aircraft accelerates to 250 kts, flying past the spectators at “show center” (the center of the viewing area; represented by the star in the diagram). (Tab BB-6)

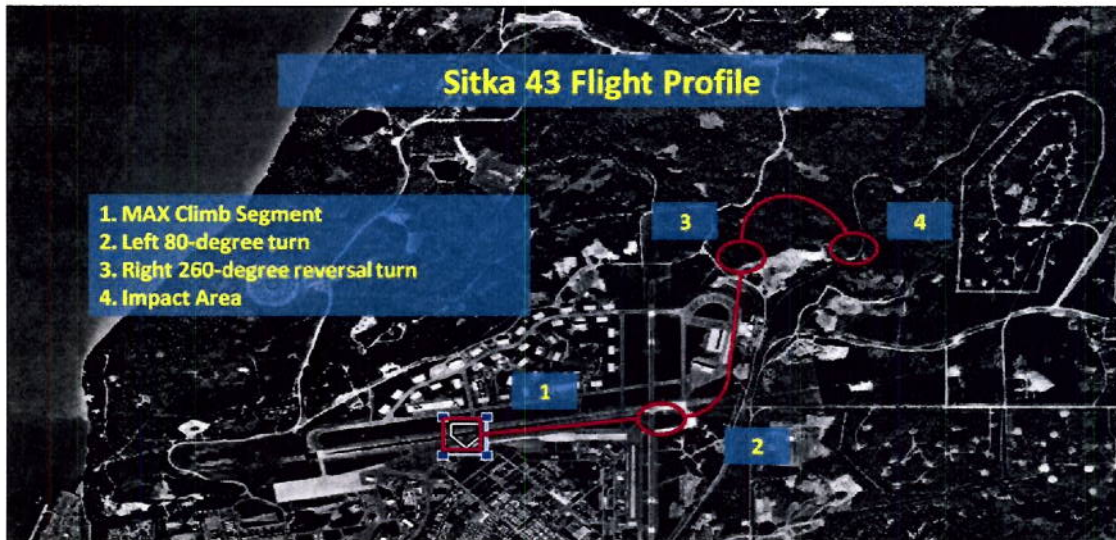
Five seconds prior to impact, the slats fully retracted. Approximately two seconds prior to impact, the MP was able to initiate a left roll of the aircraft, however, the roll rate was minimal due to the stall. (Tab L-3, CC-3 through CC-27) The stall protection system remained active until impact.
