London Avenue Canal Load Test – Small Load Test Site Selection

By Noah Vroman (ERDC), Dr. Thomas Brandon (VPI), and Neil Schwanz (MVP) Objectives:

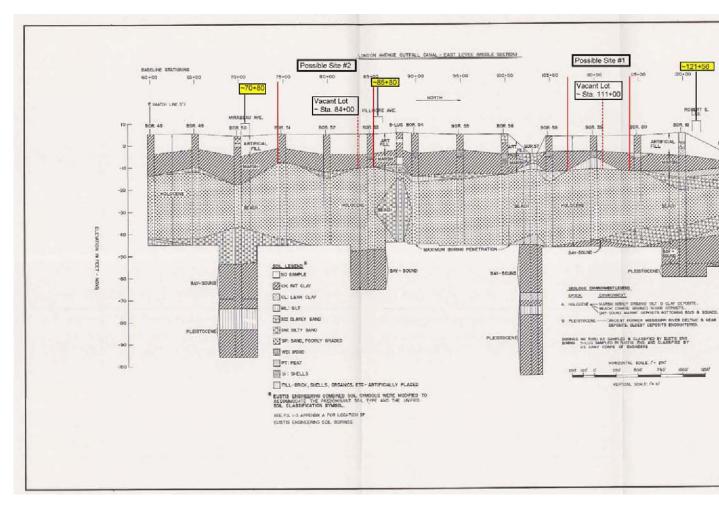
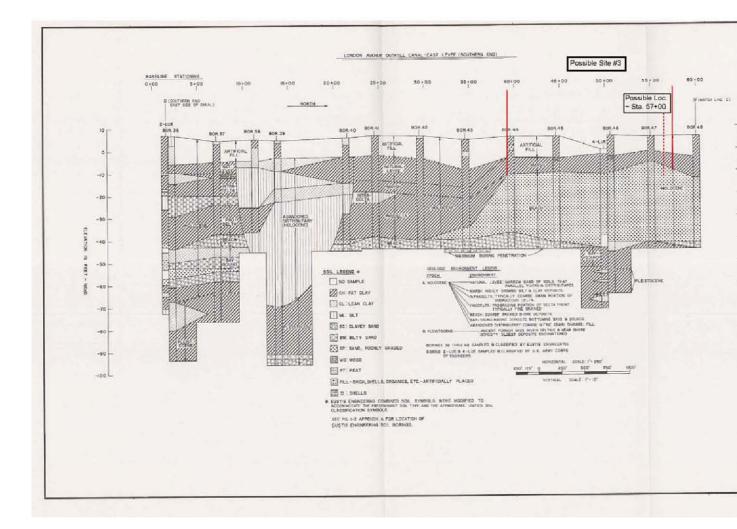
Figure 1. GDM Geological Profile showing potential sites #1 and #2. Figure 2. GDM Geological Profile showing potential site #3.

Based on field observations and data from the GDM, the three most critical sites are east bank just south of Robert E. Lee Avenue between GDM stations 107+00 to 114+00, east bank just south of Fillmore Avenue between GDM stations 74+50 to 85+00, and east bank south of Mirabeau Avenue between GDM stations 39+30 to 57+50. Note the levee along the west bank from Mirabeau Avenue to Robert E. Lee Avenue was examined and subsequently excluded from consideration because of the massive rock fill that has been placed over the protected side levee fill for vehicle access, which provides a more robust levee section that is less likely to allow gap propagation to the beach sand, as compared to the east levee section where rock fill does not exist.

These three potential sites are highlighted on the GDM geological profile as shown in Figures 1 and 2.

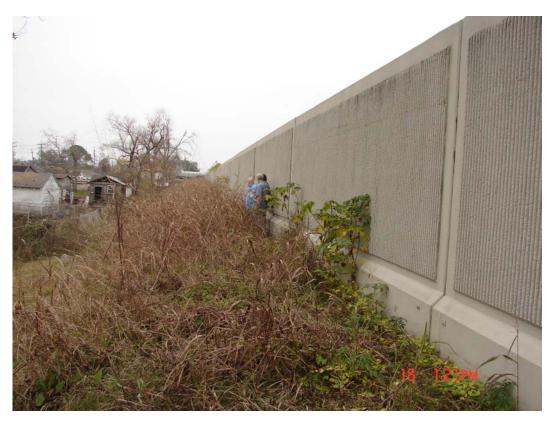
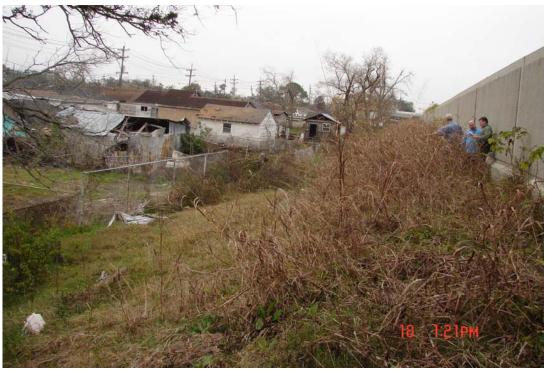
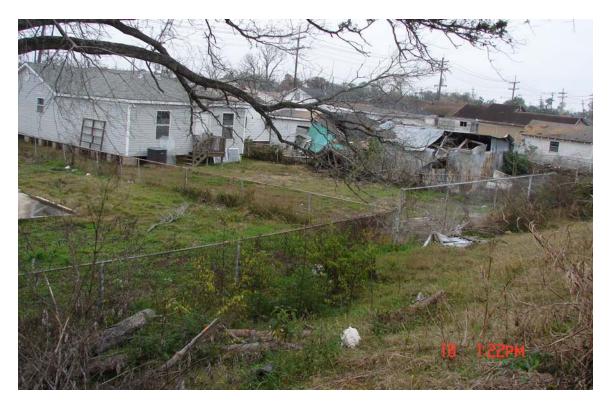
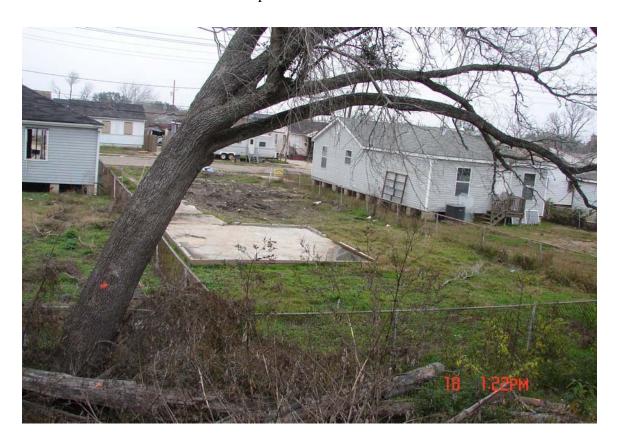
Figure 3. Aerial Photo of Potential Site #1. Figure 4. Photo of potential site #1, view looking south. Figure 5. Photo of potential site #1, view looking south.

Using the information from the GDM and the construction drawings, this reach has a top stratum thickness ranging from 8 to 9 feet with the elevation of the base of the marsh layer ranging from -13 to -15 feet, NAVD88. The sheet pile used in this reach is a cold-rolled sheet pile with a tip elevation of -21.5 ft (NAVD 88) (-20.0 feet NGVD). GDM borings 59 and 60 span this reach with boring 60 just outside the reach area. The blow counts in the beach sand are

These low blow counts are a reason for concern as the failure mechanism that controls this reach may actually be pore pressure induced instability instead of seepage and piping. If this is the case, then failure of the levee during testing may be more catastrophic offering less warning. Analysis of this section of levee prior to testing will be valuable in order to predict the behavior during the field test.

The site of interest in this reach is located at a vacant lot @ GDM station 111+00. This site is shown in the photographs below (Figures 4 through 8). The vacant lot is appealing as it allows easier access with equipment and instrumentation to the levee. The property line (fence line) throughout this reach is at the protected side toe of the levee.

There is some reason for concern at Site #1 because of low blow counts in the sand. The controlling failure mechanism at site may be pore pressure induced instability, as opposed to seepage and piping. Therefore, there is little to no visual warning signs for this failure mechanism. In addition, the sites adjacent to vacant lots (Sites #1 and #2) are attractive if purchasing or leasing it is considered. This would allow easier access for equipment and instrumentation during the test. The property boundaries along the east bank of the canal are at the protected side toe of the levee and offer basically no access to the toe, which is critical for instrumentation. Field work is needed in order to make the final site selection. This work is necessary to verify elevation, stratification, and soil properties. The field work required at each site includes:

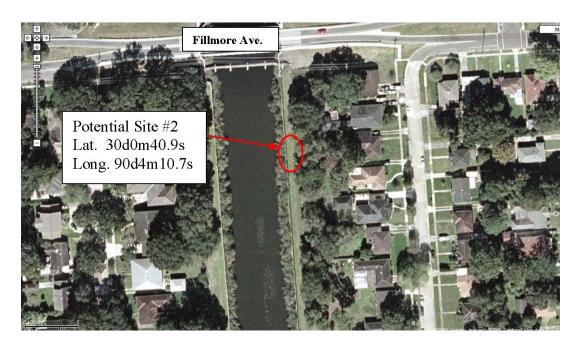
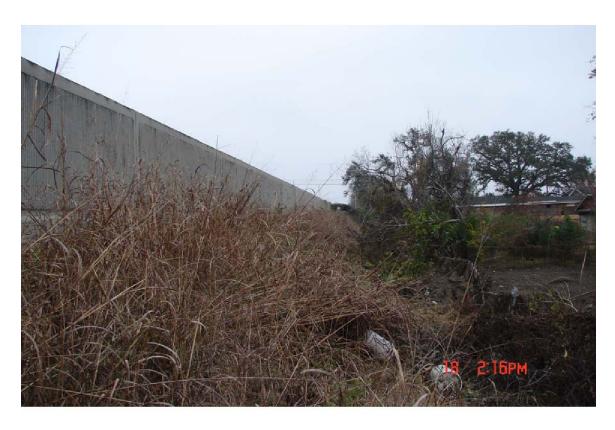
Figure 9. Aerial Photo of Potential Site #2.

This reach has a very thin top stratum providing low resistance to heave. The top stratum thickness ranges from 6 feet to 11 feet. The sheet pile used in this reach appears not to be a cold-rolled sheet pile (based on construction photos) like Potential Site #1. In this reach, the sheet pile has a tip elevation of -17.5 ft (NAVD 88) (-16.0 feet NGVD). GDM borings 51, 52, and 53 span this reach with boring 51 at the southern end of the reach and boring 53 at the northern end. The blow counts in the beach sand are relatively higher in this reach than in the reach for potential site #1. The blow counts for the beach sand are listed in the table below for the borings.

These higher blow counts suggest that the failure mechanism that controls this reach will likely be seepage and piping.

The site of interest in this reach is also located at a vacant lot @ GDM station 84+00. This site is shown in the photographs below.

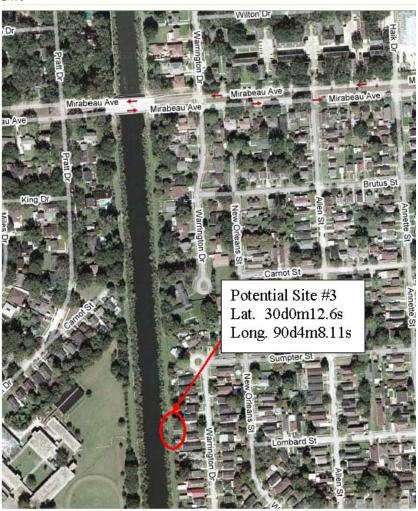
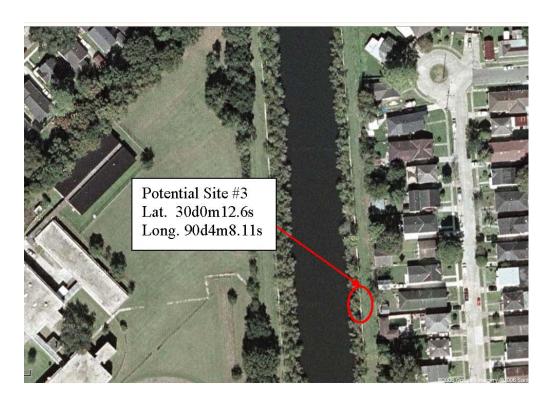
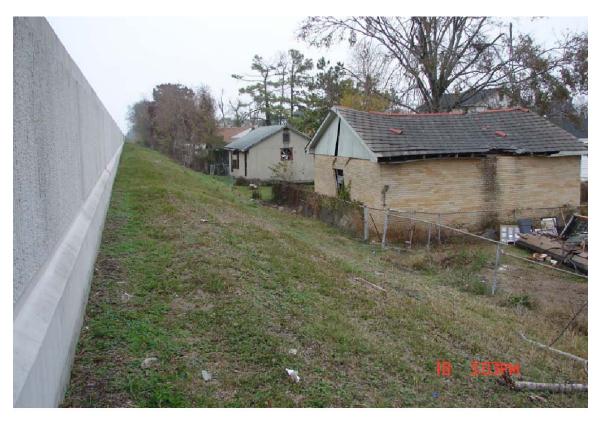
Figure 12. Aerial Photo of Potential Site #3.

This reach has the thinnest top stratum along the canal. The top stratum thickness ranges from 5 feet to 7 feet. The type of sheet pile at this site (hot-rolled vs. cold-rolled) is undetermined. The sheet pile has a tip elevation of -19.0 ft (NAVD 88) (-17.5 feet NGVD). GDM borings 44 through 47 span this reach with boring 44 at the southern end of the reach and boring 47 at the northern end. The blow counts in the beach sand are relatively higher in this reach than in the reach for potential site #1. The blow counts for the beach sand are listed in the table below for the borings.

These higher blow counts suggest that the failure mechanism that controls this reach will likely be seepage and piping.

The site of interest in this reach is located at @ GDM station 57+00. This site is shown in the photographs below.
