SAFECOM Summary July 2011

FOREST SERVICE AVIATION RISK MANAGEMENT

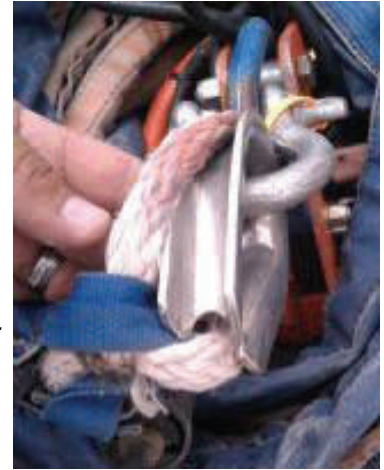
SAFECOM 11-683: The pilot made note of the ``play`` between the thimble of the synthetic line at the ``bottom`` of the long line. After completing one back haul mission the manager confirmed the ``play`` and removed the line from service. **CORRECTIVE ACTION:** Maintenance Inspector was notified and concurred. A new long line was sent by the contractor the next day. RASM comments: The AMI provided this input ``This was good communication by the pilot to the crew. The swedges had come loose allowing the thimble in the long line to rotate freely which could cause the line to fail thru abnormal wear. Great job by the pilot!`` Thanks for giving us an experience to keep in mind as we work with synthetic lines.

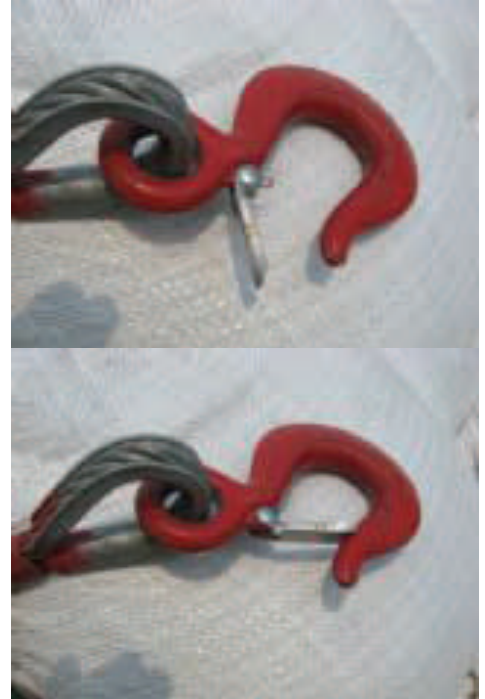
SAFECOM 11-592: A helicopter was supporting a small fire with blivets from its base. Just prior to the helicopter coming in for another blivet and swivel, a request was made to add a net, lead line and swivel for backhaul. A net, lead line and swivel were quickly located and attached to the load just as the helicopter was coming in to pick up the load. On arrival however, the lead line was present but not the swivel or net. On inspection, it was found that the lead line's keeper gate was bent and completely open. The flight out to the fire from the base was approximately 20 minutes, and the pilot did not encounter any difficulties and was not aware when the net and swivel departed the load. The old style lead lines are slowly being replaced with the yellow locking hooks. As the base was also being used to provide logistical support for the Las Conchas Fire, we believe that it is possible that the lead line did not originate at the base, but was likely from one of the many Helicopter Support Kits provided to the fire. **CORRECTIVE ACTION:** An After Action Review was held with the crew and we went over the inspection criteria for the lead lines and the preference that, whenever possible, the newer hooks be utilized instead of the older hooks with the keeper gates. The Net and swivel have not as yet been located. RASM comments: The spring loaded keeper gates have long been identified as a weak link. We have mitigated this risk by using keeper-less swivels and are phasing keeper-less lead lines into our system. Great awareness report for others. When possible, do not use the lines with keepers. Glad no one was hurt when the net departed the load. Thanks for the discussion item.

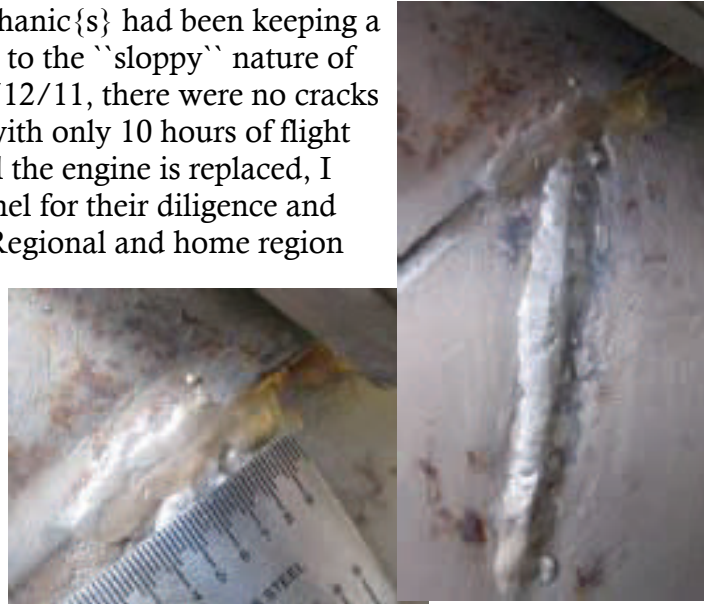
SAFECOM 11-611: I was approached by the pilot who requested additional pre-flight inspection time to do a maintenance run-up. About an hour later, the pilot requested the managers come down to the aircraft. The pilot explained that they had discovered a crack in an exterior weld on the combustion chamber case. Upon run-up, at flight idle power, high pressure, hot air was detected leaking from this location. Notably, the pilot and mechanic{s} had been keeping a close eye on this location during daily inspections due to the ``sloppy`` nature of the welds {see attached photos}. However, prior to 7/12/11, there were no cracks or leaks. This is a newly installed overhauled engine with only 10 hours of flight time on it. Although the A/C will be unavailable until the engine is replaced, I gave genuine ``thank-you`s`` to the contractor personnel for their diligence and attention to detail. **CORRECTIVE ACTION:** Both Regional and home region maintenance inspectors were notified of the issue and unavailability. The vendor is seeking a replacement engine, and upon installation, required documentation will be submitted prior to returning the A/C to availability status. RASM comments: Another great catch on the part of our vendors. Nothing beats a good thorough pre-flight inspection. Kudos for the attention to detail. The engine was replaced and the aircraft returned to contract availability.

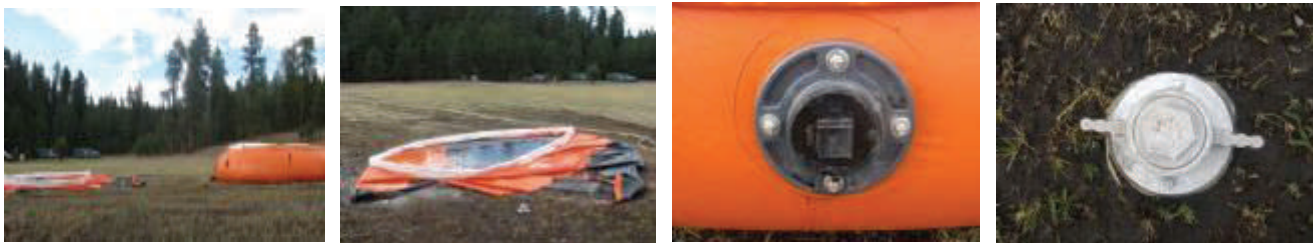
SAFECOM 11-641: NARRATIVE: {Helitack} "Helicopter was coming in for his last bucket before going back to helibase due to weather. As he was lowering his bucket into the 4800 gallon pumpkin, he brought his bucket from the downhill side to the uphill side. As he was pulling up, the pumpkin started to cave in from the fitting, tearing the pumpkin from the fitting on up. He immediately set his bucket on the ground to have helitack personnel see if there was any debris left in his bucket. The helitack found the fitting from the pumpkin inside. Due to fast turnarounds in Division Tango, the crews and pumps were having trouble keeping up with the helicopter. There seemed to be some slop in the pumpkin at the time of the incident". {Pilot} "It looked like there was multiple hoses used to fill the pumpkin. The hoses were in the top of the pumpkin. It looked like there were clamps on the hoses. I was making quick turns, about 2 minutes, using a 600 gallon fast bucket. Ground personnel could only keep up one pumpkin full {previously they were using 2 pumpkins and only dipping out of the one not being filled}. On 1 dip the bucket got hung up on something. While trying to free the bucket, the bucket bumped into the side of the pumpkin and split pumpkin. I was not applying power to lift at the time." The pilot was clear that he did not feel that using the pumpkins was a safety issue. He viewed this as a creative solution to a problem that operationally didn't work out. He didn't think it was a significant issue, so he didn't report the incident to the helibase or helicopter manager. **CORRECTIVE ACTION:** Immediate corrective action – Do Not have hoses or anything else hanging over the top of the pumpkin while helicopter is using it. Although this did not contribute to the incident, it did appear in the review, and was dealt with. Additionally, helitack reported that the pumpkins were drained earlier in the day. When questioning the strike team leader, they were told that the dip site pumpkins would not be used that day. This led to a rush to fill the pumpkins and keep them full. Immediate corrective action for this was to give dip sites a "heads-up" prior to sending helicopters to them. RASM comments: We have seen issues with buckets and snorkels catching on various items in a water source {logs, buckles, fittings etc}. The submitter presents some immediate ideas- not going over the top while operational, providing enough time to fill and maintain the water load of the pumpkin. General awareness of the potential for catching fittings and briefing on the issue are also mitigations.

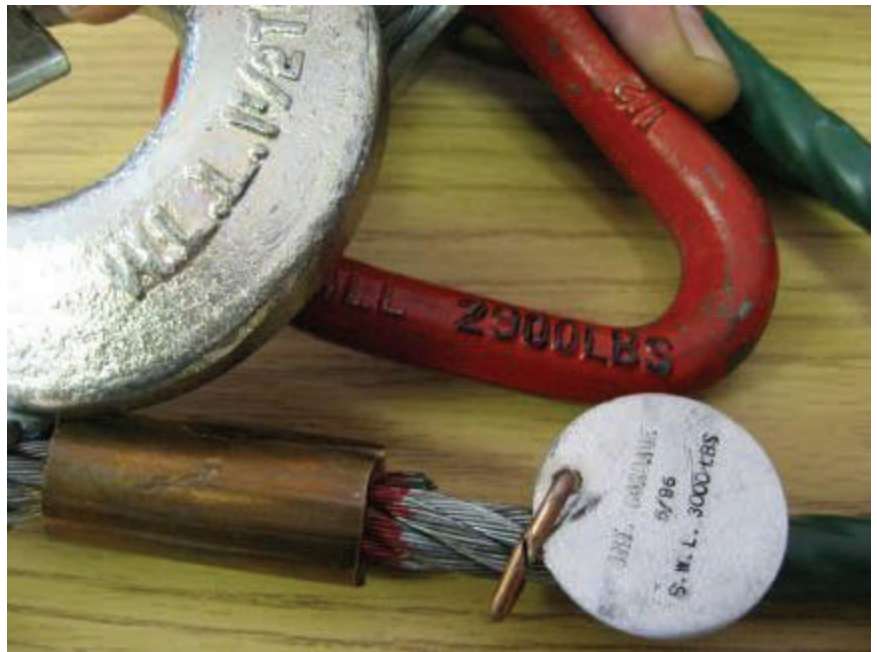
SAFECOM 11-665: Following a previous mishap involving a lead line hook/safety gate failure, we undertook an inspection of all lead lines and swivels at the EU Helibase. As the EU helibase was utilized by both zones of the fire and multiple crews, we had collected a wide variety of lead lines and swivels, most of which originated from the cache system and ordered up for this incident. One of the new lead lines, utilizing the older hook/safety gate system had different markings than we are used to. Having worked on a program that maintained records of all its equipment, I was familiar with the markings and requirements of the rigging. From Google: Safe working load {SWL} is the load that a lifting

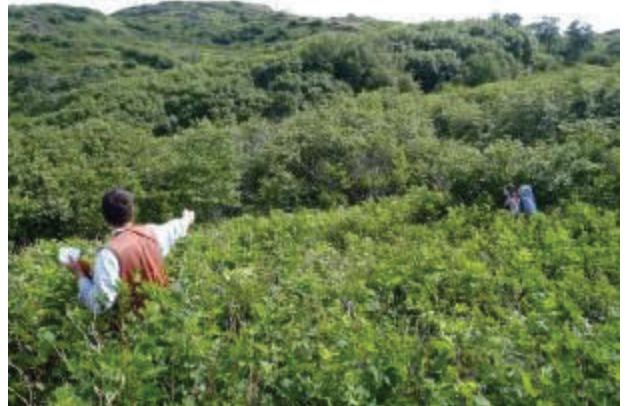
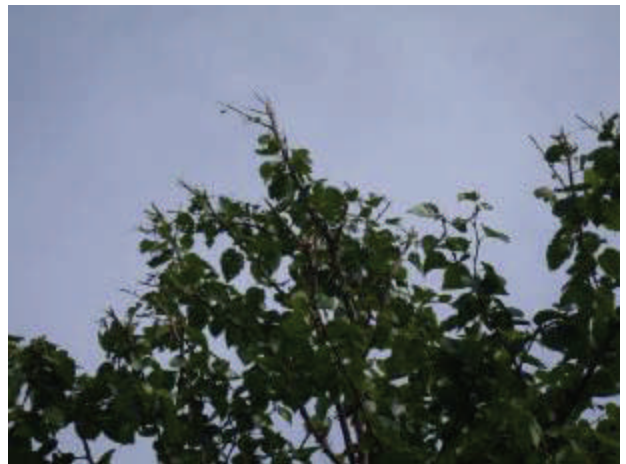
SAFECOM 11-721: The flight mission was to fly from a boat to transport field crew to a forest inventory and analysis plot on Amook Island within the Kodiak Island archipelago. There were five crewmembers, including the helicopter manager and the pilot in the helicopter at the time of the incident. The helicopter manager was in the left rear forward facing passenger seat. Upon arriving within the general area of the plot, a high level recon was performed to assess possible landing zones {LZ}. An LZ approximately 36 ft by 46 ft in size was selected near the plot location on a knoll with significant 4' salmonberry shrub cover surrounded by taller alder and a few small birch trees down slope. The crew agreed on the selected LZ on top of the knoll and the pilot then began the landing approach from the south {i.e., heading north}. As the tail boom swung from a 6 o' clock position to a 3 o' clock position, the tail rotor made contact with the top of a tree on the pilot side of the helicopter. Due to the swiftness of the maneuver and the counterclockwise nature of the turn, the helicopter manager was only able to see the obstruction as the rotor strike occurred and immediately notified the pilot. The pilot immediately pulled up and gained elevation from the LZ. The crew proceeded to look for an alternate LZ and another was found approximately 700 feet away and utilized shortly after. Upon landing at the alternate LZ, the helicopter manager discussed with the pilot that the tail rotor had been hit and a crewmember suggested that the helicopter be shut down and the tail rotor examined. The pilot did not feel the LZ was good for shutting the helicopter down in and decided it would be examined back at the boat and not on-site. After all 5 crew members exited and unloaded the helicopter, the pilot slowly took off up the slope and said there was an even better LZ up the slope for pick up. The pilot did not land and continued to depart. The helicopter manager made contact with the pilot via hand held radio, emphasized there had been a rotor strike and stated that the rotor needed to be examined. **CORRECTIVE ACTION:** After the helicopter departed, the manager contacted the boat via satellite phone and the supervisor was informed of the rotor strike incident. Subsequently, the necessary steps to address the situation were conducted by the supervisor and crew involved in the incident. The helicopter was taken off of availability and the RAMI was notified. The helicopter was examined on the boat by the pilot and color was observed on the tail rotor blades but no apparent damage to the blade surfaces. The crews were picked up at the end of the day with an alternate helicopter since the tail rotor had not been inspected by a certified mechanic. At the end of the day the field crew hiked to the site of the incident. The birch tree that came into contact with the tail rotor had about 1 foot of the top portion clipped off. No other damage to the tree was noted. RASM Comment: The helicopter was repaired at a maintenance facility in Kodiak, Alaska. This incident was classified as an Incident With Potential {IWP} and an investigation team was sent to Kodiak. The investigation is ongoing and additional information is forthcoming.
