Nuclear Ship SAVANNAH

Radiological and Non-Radiological Spaces Characterization Survey Report

**Revision 1
February 2, 2006**

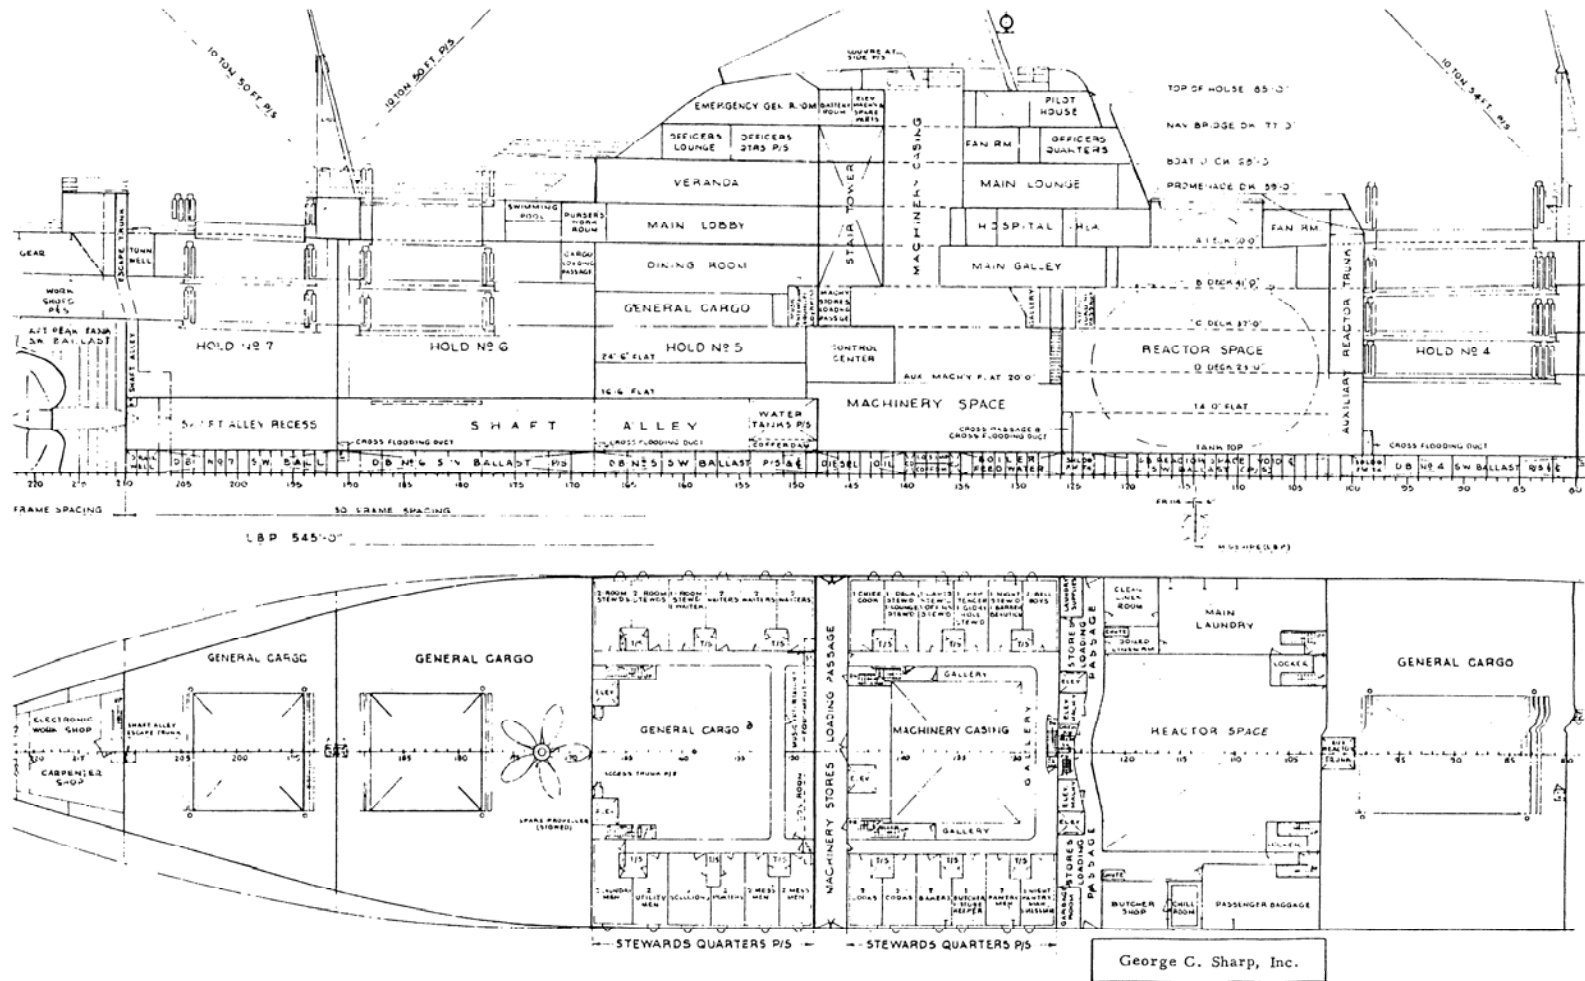
Figure 5A.4-1
N/S SAVANNAH Cross Section, Frames 80-270

Table 5A.4-1 provides a summary of radiological condition found during the evaluation of radiological areas excluding containment. The values listed are maximums. Figure 5A.4-1 provides a cross-sectional view of the NSS radiological area. Brief summaries are provided below with detailed information on the Survey Sheets in Appendix C.

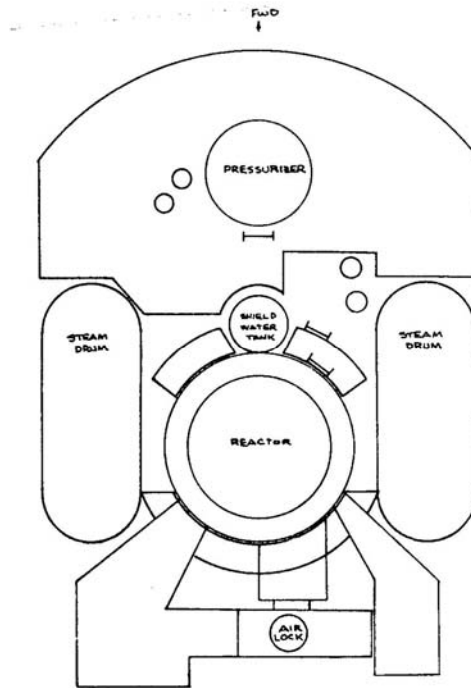
Figure 5A.6-2
Primary Containment Level 1 (Top)

The aft area of 1st level general area dose rate is 0.1–0.5 mR/hour. Next to and forward of the reactor, dose rates vary, with the highest being on the starboard side of the pressurizer at 0.7 mR/hour. Radiological contamination found in several locations <1000 dpm/100cm². One location to right of pressurizer has radiological contamination at 1200 dpm/100cm². See survey numbers NSS-0087, NSS-0079, and NSS-0083.

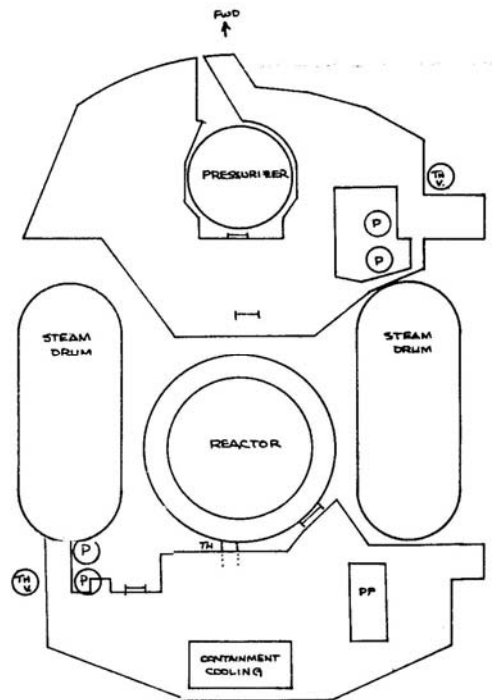
Figure 5A.6-3
Primary Containment Level 2

Dose rates on Level 2 vary 0.1–3 mR/hour. Highest reading is forward starboard near steam drum. No radiological contamination was found. See survey number NSS-0084.
