UNITED STATES AIR FORCE
AIRCRAFT ACCIDENT INVESTIGATION
BOARD REPORT

CV-22B, T/N 06-0032

LOCATION: Near Hurlburt Field, Florida

DATE OF ACCIDENT: 13 June 2012

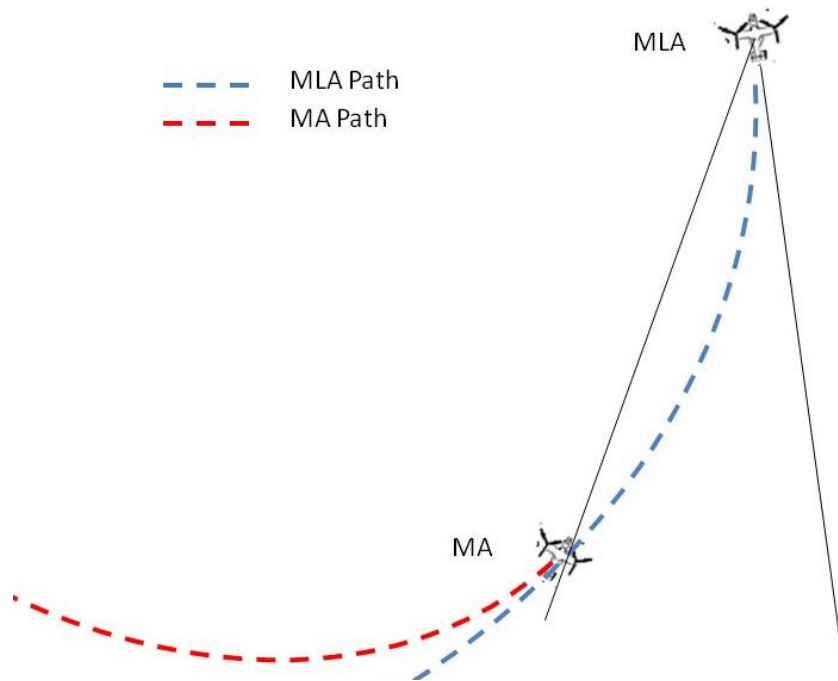
Figure 10. Turning Flightpath Versus Clock Position

MA did cross the MLA's turning flight path and the MLA's wake (See Figures 10 and 11) (Tab AA-15 to AA-16).

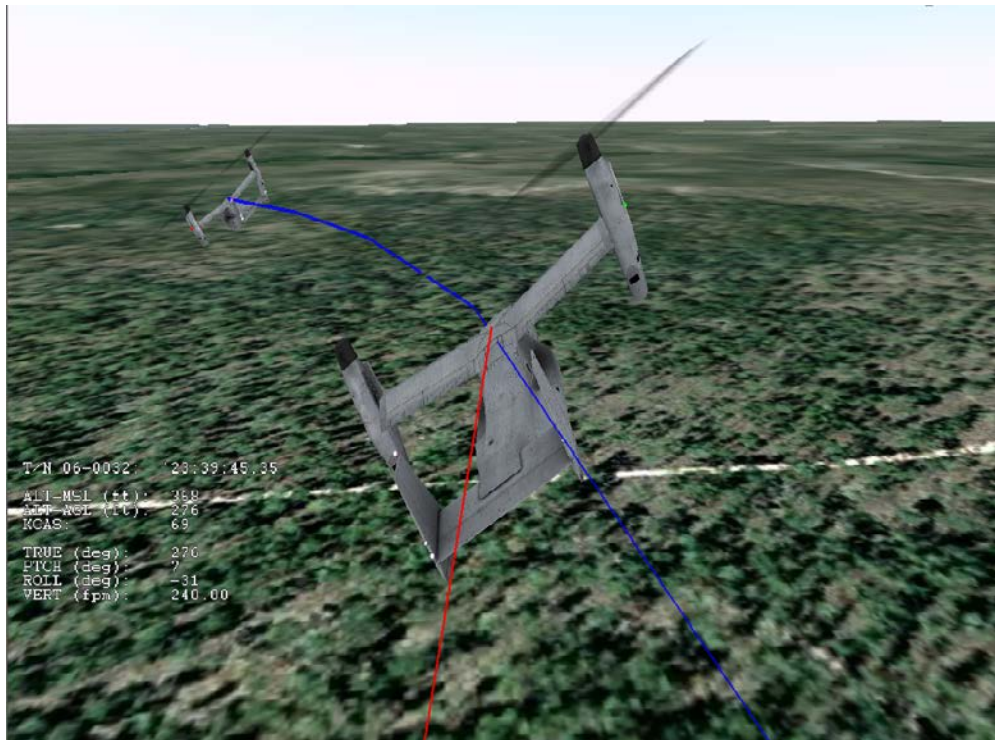
Figure 11. MA Crosses MLA's Turning Flightpath

At 2339:38Z, as the MLA began the left turn, the MLA was at 366 feet MSL and the MA was at 354 feet MSL (Tab AA-15 and AA-25). During the turn, the MLA descended slightly from 366 to 336 feet MSL, while the MA made a level turn (Tab AA-25). The change in the MLA's altitude gave the MCP a false impression that he had adequate vertical separation from MLA's wake (Tab V-2.7). Because the MLA was in a left bank, the MLA's right propotor was raised above the MLA's fuselage, raising the elevation of the MLA's wake. Because the MA was also in a left bank, the MA's left propotor dipped below the level of the MA's fuselage. As the MA crossed the MLA's flight path, the combination of the MLA's bank angle and the MA's bank angle caused the MA's left propotor to enter the MLA's wake (See Figure 12) (Tab AA-16).

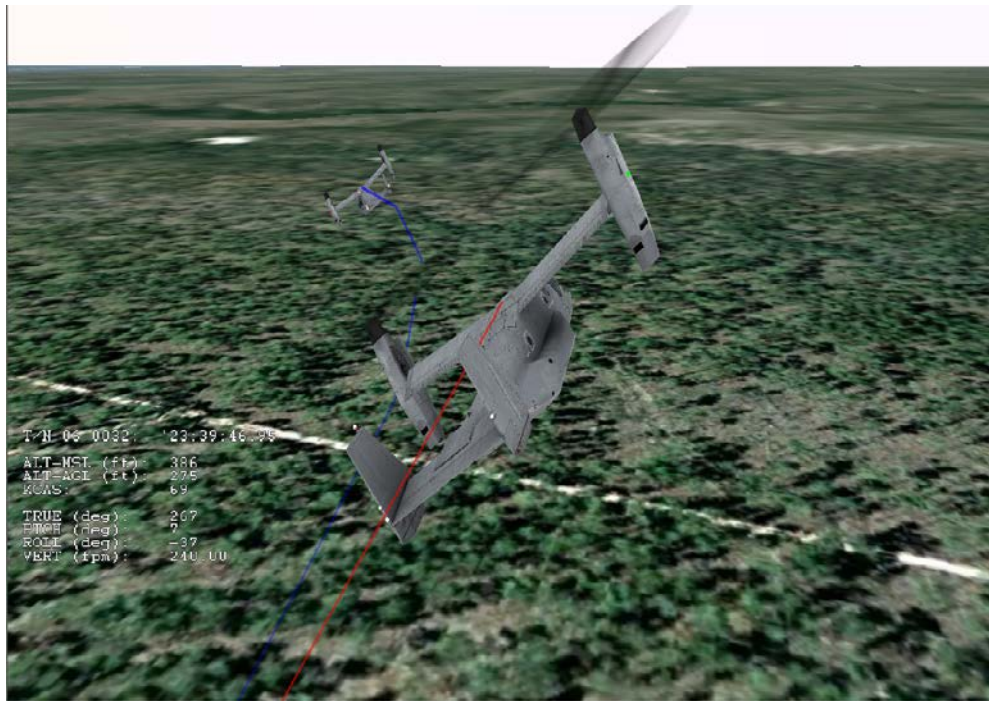
Figure 12. MA's Left Proprotor Enters MLA's Wake

Once the MA's left proprotor entered the MLA's wake, the MA immediately began an uncommanded roll to the left reaching a maximum of 63 degrees left bank, 23 degrees nose-low attitude and 2,880 feet per minute descent (See Figures 13 and 14) (Tab AA-21 to AA-22). The MP placed his hands on the flight controls and both he and the MCP attempted to recover the MA by immediately applying full right cyclic and then full thrust control lever (TCL) (Tabs V-1.6, V-2.7 and AA-26). The MC began to regain lateral control authority of the MA after they were clear of the MLA's flight path; however, the MA was still descending at a rate of 2,600 feet per minute (Tabs V-1.6, V-2.7 and AA-22). The MC stabilized the MA in a wings-level flight condition prior to impact but was unable to arrest the descent rate before the MA entered the 80- to 100-foot trees on the range (Tabs S-6 to S-7, V-1.6 and V-2.7).

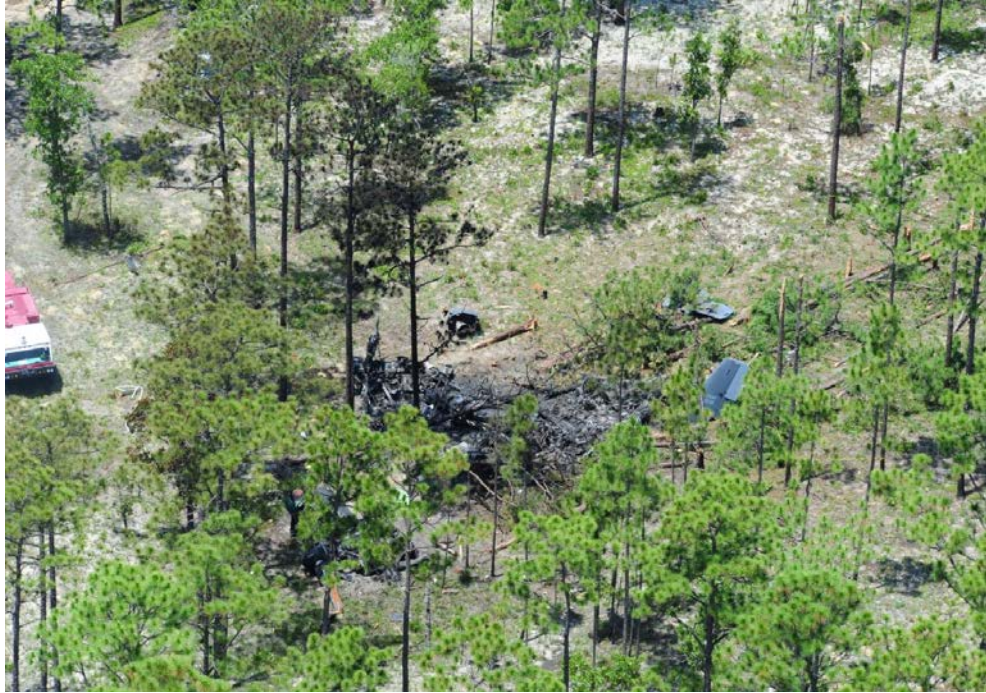
Figure 15. Crash Site from the North (Aerial View)

The MA impacted the terrain at approximately 2339:55Z just north of A-78 in the Eglin Range (Tabs M-3 and S-3). The impact location was a sandy area, covered by 80- to 100-foot pine trees (See Figures 15 and 16) (Tab S-6 to S-7). The MA impacted the ground with the nacelles at 80 degrees and in a near wings-level and slight nose-up attitude (Tabs H-3, V-1.6 to V-1.7, V-1.9 and V-2.7). All the major components remained close to their intact/original positions on the MA (Tab H-3).

that the presence of cut tree tops at the mishap site indicated the proprotors were being driven by the engines at the time of the mishap (See Figure 15) (Tab H-3). No components of the MA were suspected of failure (Tabs U-17 to U-18, V-1.15, V-2.9, V-2.14, V-4.4, V-4.6 and V-5.13).
