National Transportation Safety Board

Date: October 16, 1987

In reply refer to: H-87-50 through -54

PHOTOGRAPHS OF ACCIDENT SITE

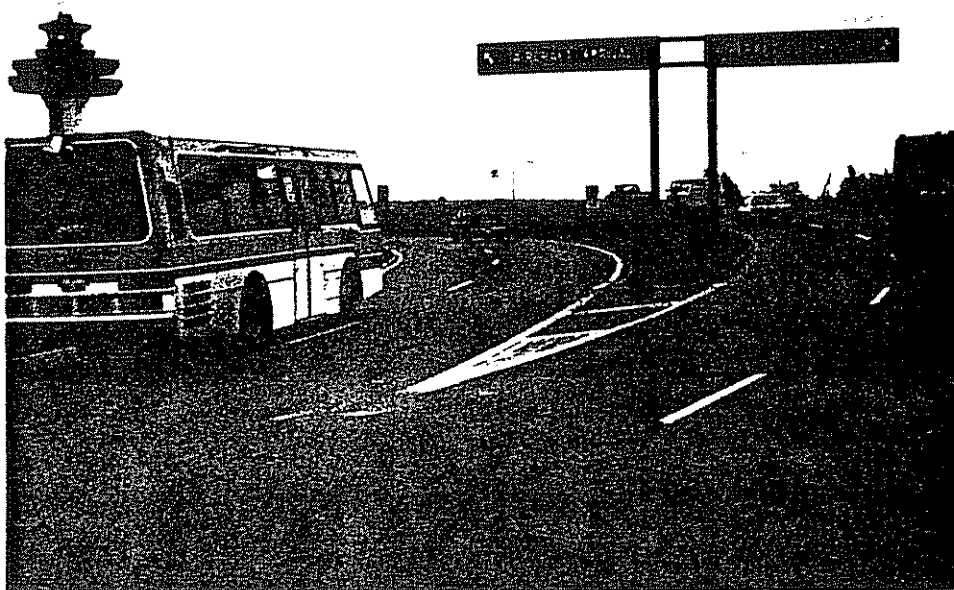
The signpost struck by the bus was located 25 feet from the tip of the approach nose of the gore area. Supported by two 8-inch tubular steel posts, the sign was imbedded in concrete below ground level. Each post was less than 2 feet from the edge of the nearest pavement. The curbing, which delineated the gore, was 2 to 3 inches high and easily mountable by a vehicle. White demarcation lines extended 28 feet from the tip of the approach nose. There was no crash cushion or attenuator in front of the posts. Since the accident, a Fitch Inertial Barrier System (free standing sand-filled plastic containers) has been installed.

The signposts were nonbreakaway and nonfrangible; i.e., when hit by a vehicle the posts would remain standing and the vehicle probably would be severely deformed. There were other signposts similarly located in gore areas and embankments in the airport roadway system. At one location the signpost was "protected" by large truck tires. 1/ At another location, an additional sign had been installed on the original signpost severely limiting the safety effectiveness of the frangible supports. Still another sign had a multiple support system with outdated safety features. None of the single post-mounted signs were of the

ACCIDENT SITE SHOWING SIGNING AND LACK OF CRASH CUSHIONS

Review all existing highway appurtenances such as signs and sign supports, guardrails, and crash attenuators to determine if they meet Federal current standards, and take immediate action to upgrade those appurtenances to comply with such standards. (Class II, Priority Action) (H-87-50)

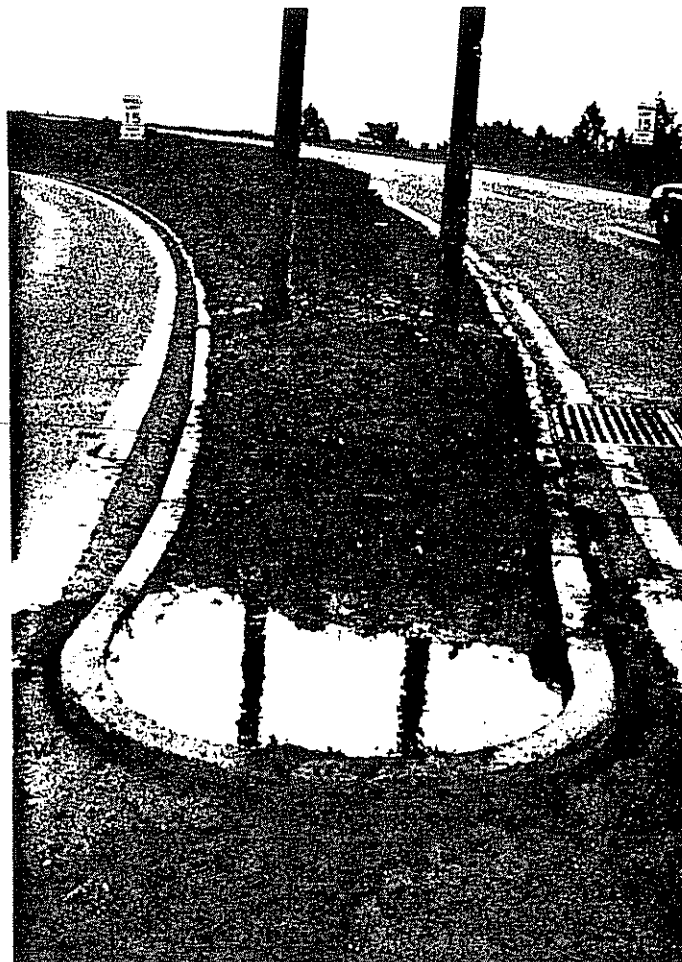
SIGN SUPPORTS SHOWING PREVIOUS IMPACT MARKS
