NTSB/SIR-12/01
PB2012-917003

Highway Special Investigation Report

Wrong-Way Driving

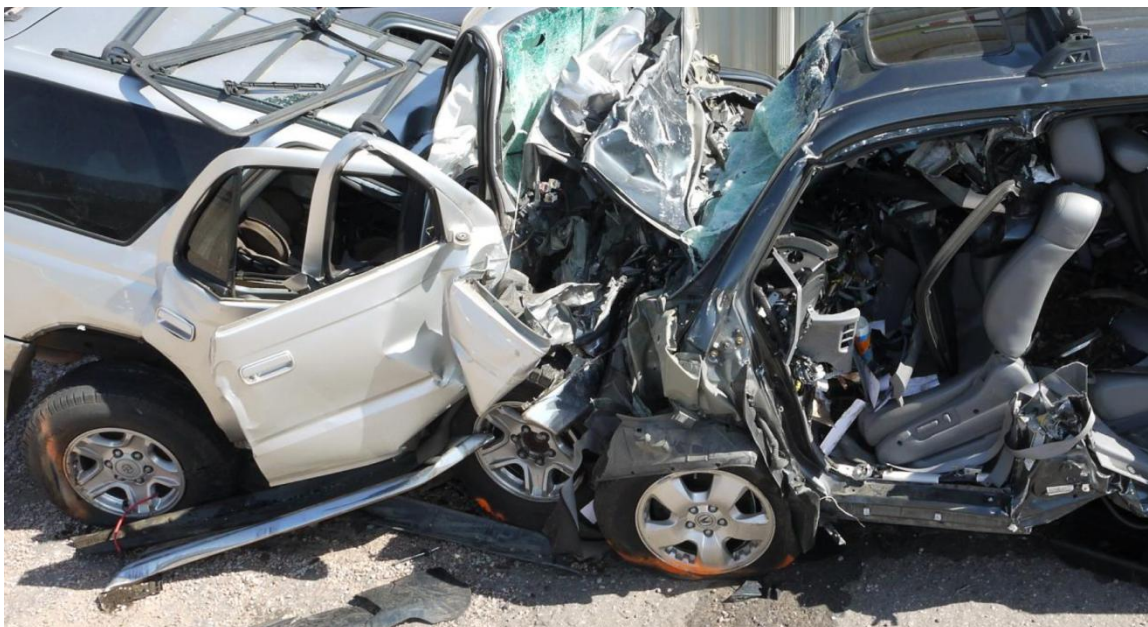
Figure 1. Postaccident view of the vehicles from the Fountain, Colorado, wrong-way collision.

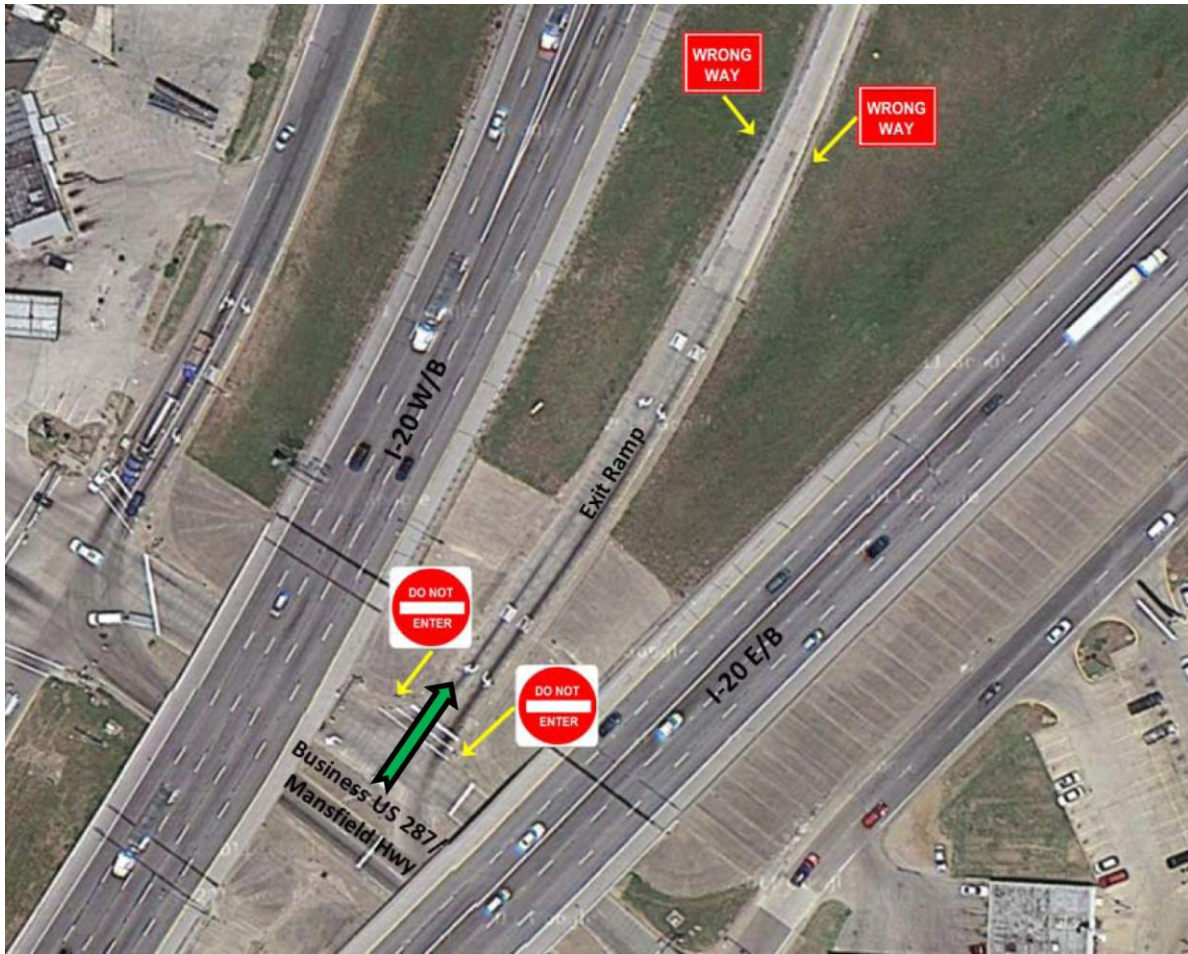
NTSB investigators reviewed witness statements and examined ramps in the vicinity of the collision to determine the location where the SUV driver most likely began to travel the wrong way on I-20. Based on the configuration of the exit, the wrong-way entry point was probably the Business US 287/Mansfield Highway exit for westbound I-20 motorists. The ramp has overhead roadway illumination. The SUV driver would have merged into the travel lane going the wrong way from the exit ramp onto I-20 and traveled in the number three lane for about 2.5 miles before striking the Toyota and the combination vehicle.

The Business US 287/Mansfield Highway exit is equipped with two 48- by 48-inch “Do Not Enter” signs posted about 90 inches above the ground at the crossroad; one “Do Not Enter” sign is oriented southwest to increase its visibility to motorists traveling north on the crossroad, and the other sign faces west. The exit also has two 24- by 36-inch “Wrong Way” signs positioned about 93 inches above the ground and 404 feet east of the crossroad. The ramp has no wrong-way arrow pavement markings and no “One-Way” arrow, “No Right Turn,” or “No Left Turn” signs at the crossroad. (See figure 5.)

Figure 5. Likely wrong-way driver entry point for the Arlington, Texas, collision, with signage locations marked. Green arrow indicates direction of the wrong-way vehicle's travel.

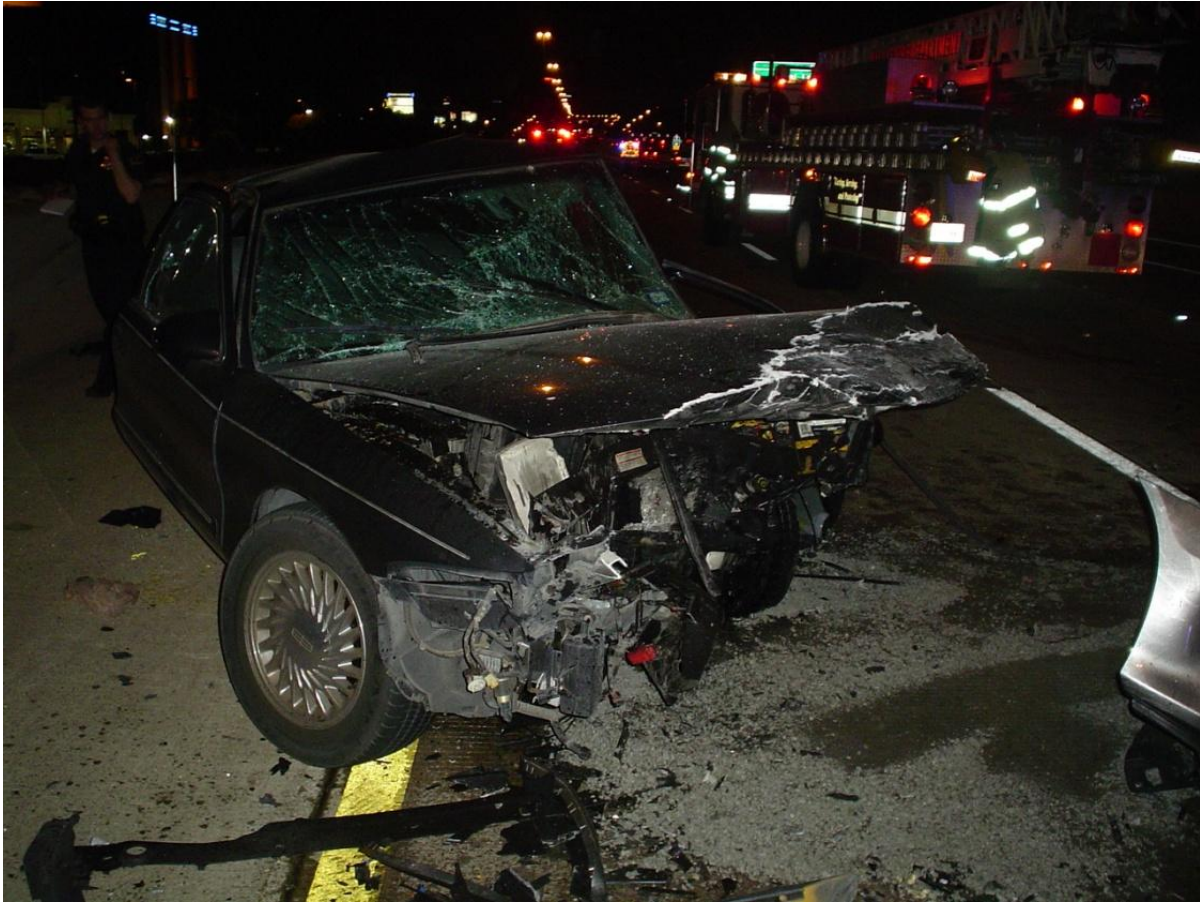
On Friday, August 12, 2011, about 2:00 a.m. central daylight time, a 1994 Lincoln Mark VIII coupe driven by a 31-year-old man was involved in a frontal offset collision while traveling the wrong way (northbound in the southbound lanes) in the number one lane on US Highway 75 in Dallas, Texas. Southbound witnesses indicated that the Lincoln was traveling about 80 mph and, despite the darkness, only its parking lights were illuminated. Approximately 600 feet south of the Forest Lane interchange on Highway 75, the left front of the Lincoln struck the left front of a southbound 2005 Honda Civic, which was driven by a 21-year-old woman and traveling at a witness-estimated speed of 60 mph. The impact of the faster, heavier Lincoln reversed the direction of the Honda, and the Honda rotated counterclockwise approximately 90 degrees before coming to rest facing east. The Lincoln rotated counterclockwise approximately 30 degrees and came to rest facing northwest on the median shoulder. Both drivers survived the collision but sustained serious injuries. (See figure 6.)

Figure 6. Damage to wrong-way vehicle from the Dallas, Texas, collision.

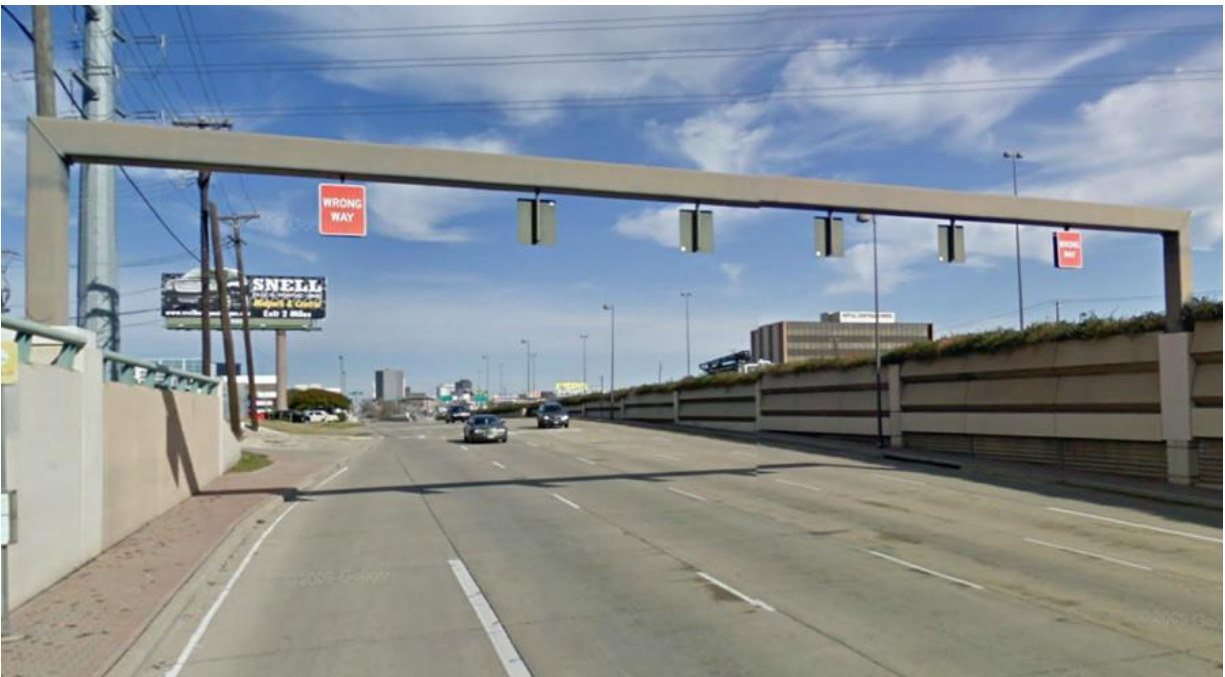
Investigators examined exit ramps in the vicinity of the collision site that channel vehicles from southbound Highway 75 to southbound North Central Expressway. The exit ramps are equipped with four 30- by 30-inch “Do Not Enter” signs positioned approximately 7 feet above the ground, facing south, parallel with the crossroad. The first two “Do Not Enter” signs are located about 25 feet north of the crossroad, and the two additional “Do Not Enter” signs are located about 600 feet farther north. In addition, two 24- by 36-inch “Wrong Way” signs are located 200 feet from the crossroad and elevated about 17 feet above the ground.⁴⁴ (See figure 7.)

Figure 7. Mounting height of wrong-way signs on frontage road adjacent to US Highway 75 in Dallas, Texas.

⁴⁴ Section 2A.18 of the *MUTCD* indicates that 17 feet is the minimum height for overhead signs.

The *MUTCD* stipulates the minimum dimensions for signs posted on the mainline and exit ramps of controlled-access highways. The dimensions of the signs posted at some of the exit ramps associated with NTSB investigations were less than the required 48- by 48-inches for “Do Not Enter” signs and 42- by 30-inches for “Wrong Way” signs. Three exit ramps were not equipped with “One Way” (arrow symbol) signs.¹⁰⁵ The “Do Not Enter” and “Wrong Way” signs associated with the NTSB 2011 investigations were posted between 6 and 7.5 feet above the ground, with the exception two nonilluminated 24- by 36-inch “Wrong Way” overhead signs at the Dallas collision exit ramp that were positioned approximately 17 feet above the ground. (Refer to figure 7.)

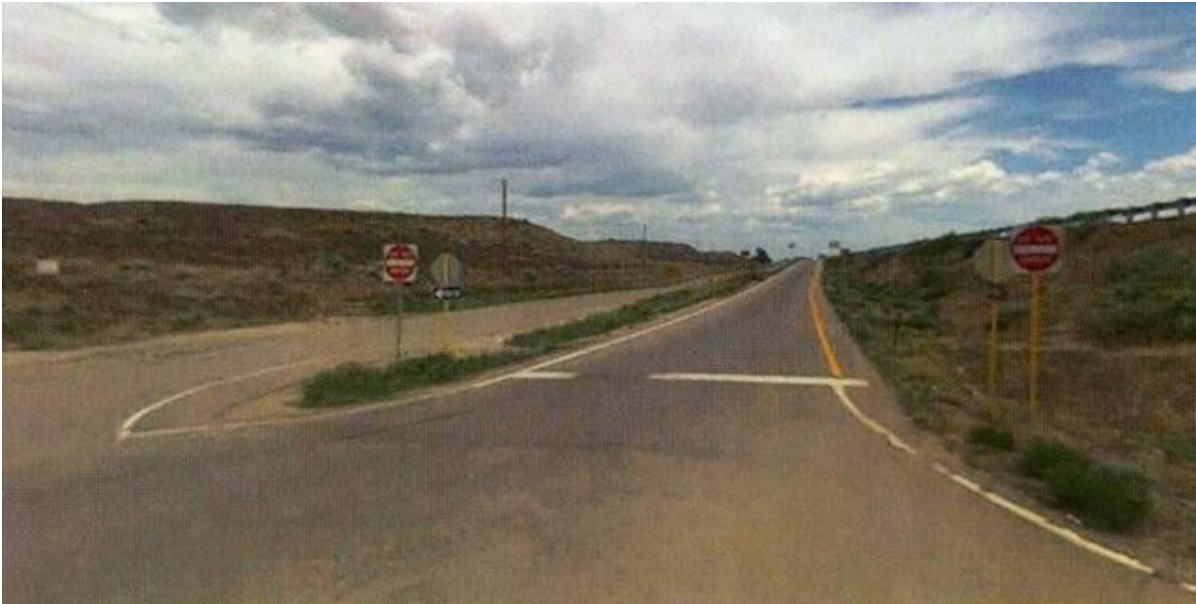
Exit ramps 119 and 122 are equipped with two 30- by 30-inch “Do Not Enter” signs positioned about 7 feet above the ground, facing south, parallel with the crossroad. Additionally, exit 119 has two 24- by 36-inch “Wrong Way” signs located 75 feet from the crossroad; this signage differs from exit 122, which has one 24- by 36-inch “Wrong Way” sign on the left, approximately 37 feet from the crossroad, and a second 24- by 36-inch “Wrong Way” sign on the right, 250 feet from the crossroad. Both ramps also have 12- by 36-inch “One-Way” signs posted about 5 feet above the ground at the crossroad. The ramps have no artificial lighting or wrong-way arrow pavement markings. (See figure 8.)

Figure 8. End of exit ramp 122, possible wrong-way driver entry point for the Fountain, Colorado, collision.

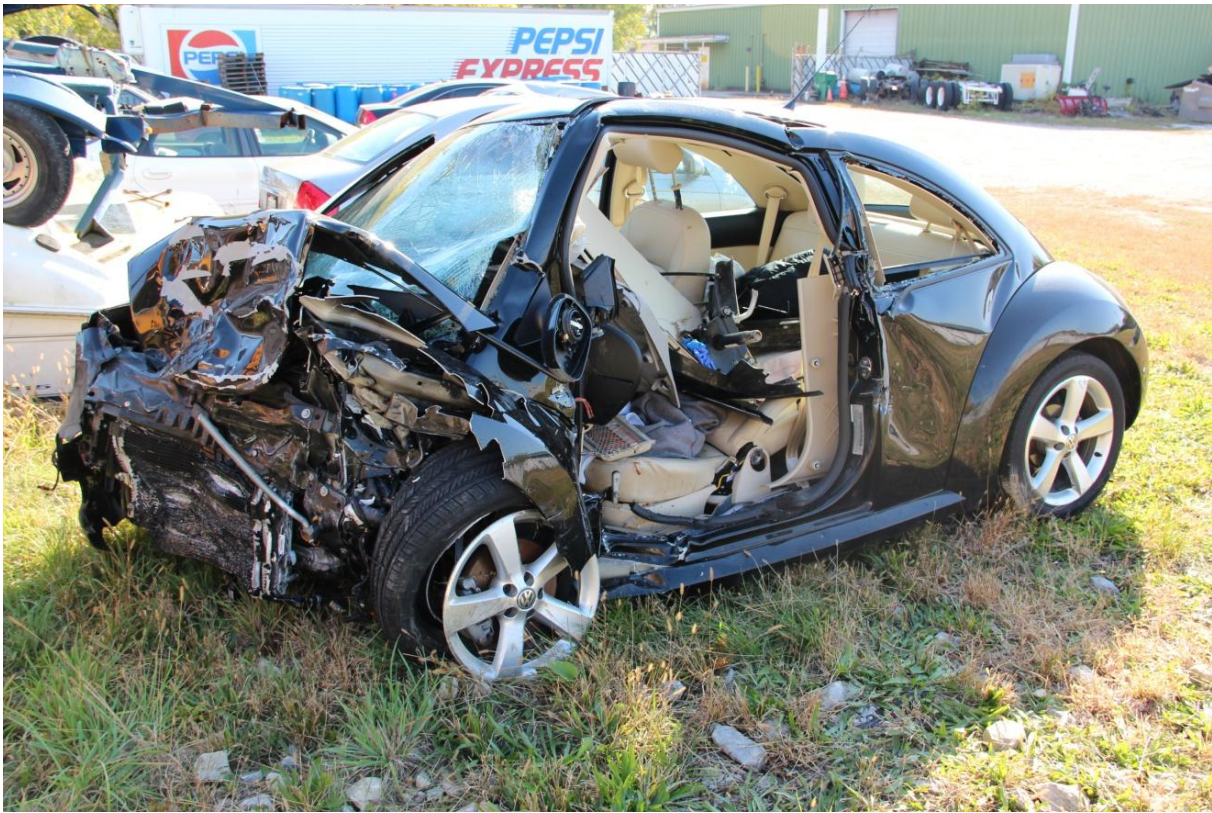
which caused the Chevrolet driver to be ejected. After this impact, the Volkswagen came to rest in the median shoulder, facing the Chevrolet in the number two lane and shoulder. The combination vehicle came to rest in the number two lane.

Figure 9. Damage to the wrong-way vehicle from the Beloit, Wisconsin, collision.

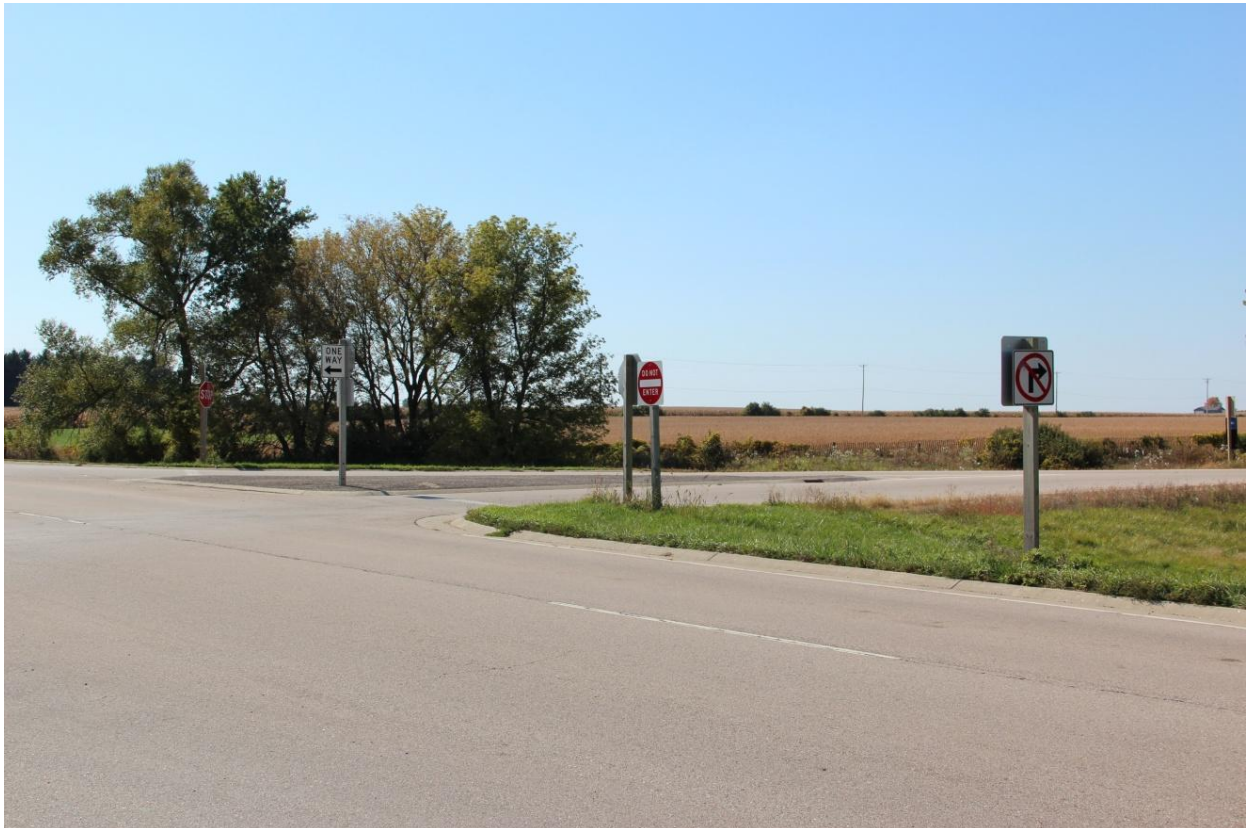
The exit ramp for State Route 140 is equipped with a single “Do Not Enter” sign facing south on the right side of the ramp and two “Wrong Way” signs farther south and on each side of the ramp. There are “No Right Turn” and “No Left Turn” signs posted in each direction on the crossroad to warn drivers on State Route 140 against inadvertently entering the exit ramp. The ramp has no roadway lighting or wrong-way arrow pavement markings. (See figure 10.)

Figure 10. Possible wrong-way driver entry location for the Beloit, Wisconsin, collision.

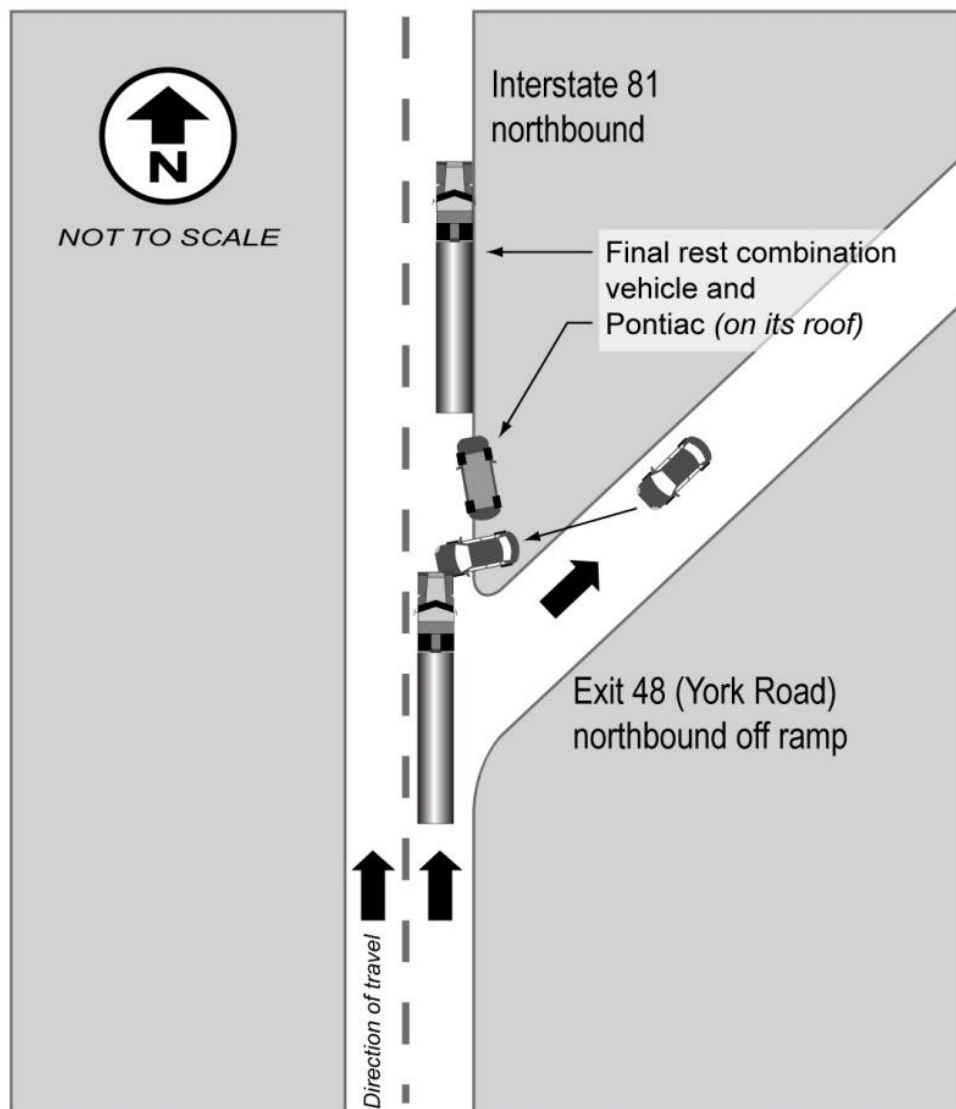
On Thursday, October 6, 2011, about 2:52 p.m. eastern daylight time, an 87-year-old woman driving a 1996 Pontiac Grand Am southeast on York Road in Carlisle, Pennsylvania, turned right one block earlier than intended and entered an exit ramp for vehicles exiting the northbound lanes of I-81. After traveling the full length up the exit ramp, the Pontiac driver made about a 150-degree clockwise turn at its top, attempting to enter northbound I-81 mainline traffic at an oblique angle. Just as the Pontiac began to enter this lane, traveling 10–15 mph, its left front was struck by the right front corner of a northbound 2008 Volvo truck-tractor semitrailer operated by a 30-year-old male driver traveling about 45 mph in the number two lane with vehicle headlamps illuminated. The Pontiac rotated clockwise, overturned, struck a guardrail, and came to rest on its roof facing south. (See figure 11.)

Figure 11. Diagram of Carlisle, Pennsylvania, collision.

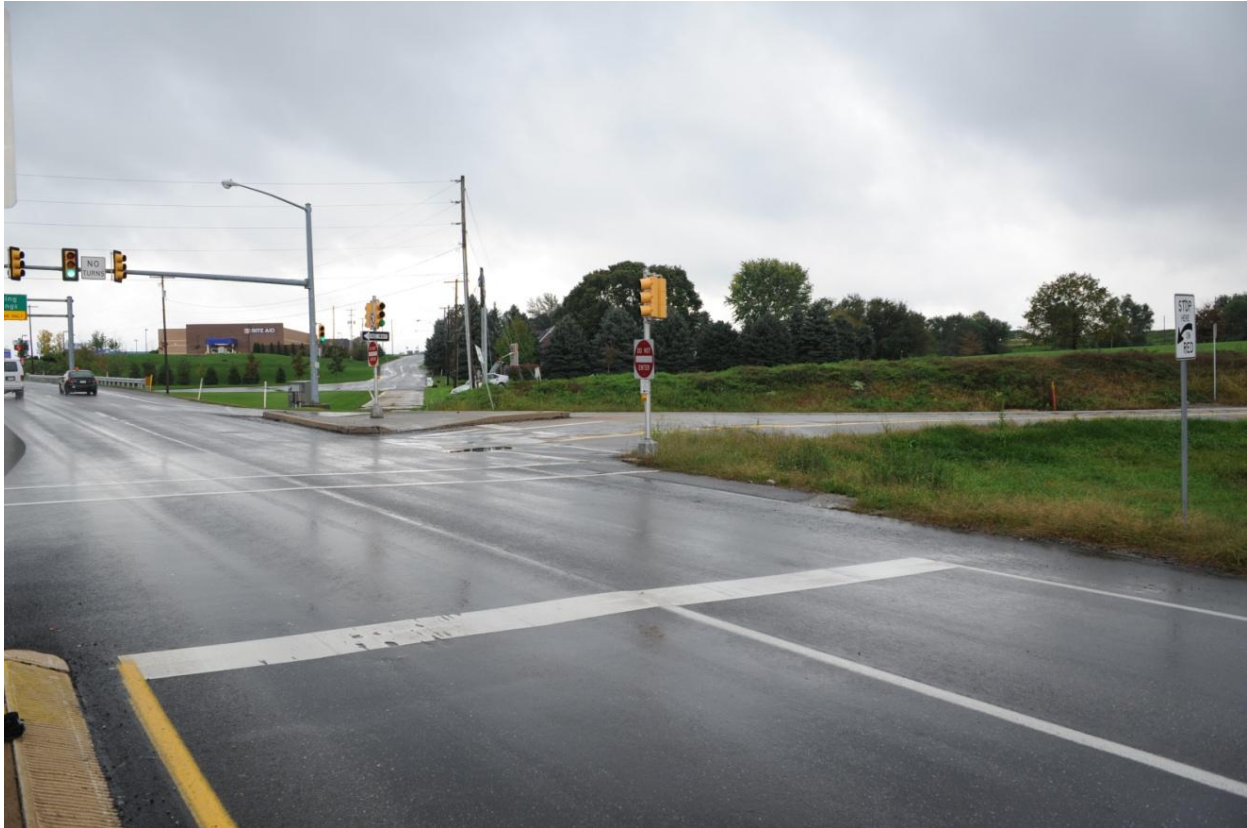
Access from the exit ramp to York Road (crossroad) is controlled by a traffic light. “No Turns” signs are mounted about 14 feet above the ground and adjacent to traffic lights on the crossroad, and a raised center median is present to prevent vehicles from turning left into the exit ramp. At the crossroad, two 30- by 30-inch “Do Not Enter” signs are posted about 5 feet above the ground, and two “One-Way” arrows are posted about 8 feet above the ground. Two 24- by 32-inch “Wrong Way” signs positioned about 8 feet above the ground are located about 65 feet south of the crossroad. Two wrong-way arrow pavement markings, about 12 and 24 feet long, respectively, are located approximately 130 feet south of the crossroad. (See figure 12.)

Figure 12. Approaching the wrong-way driver entry point for the Carlisle, Pennsylvania, collision. (Note: It was not raining when the collision took place.)

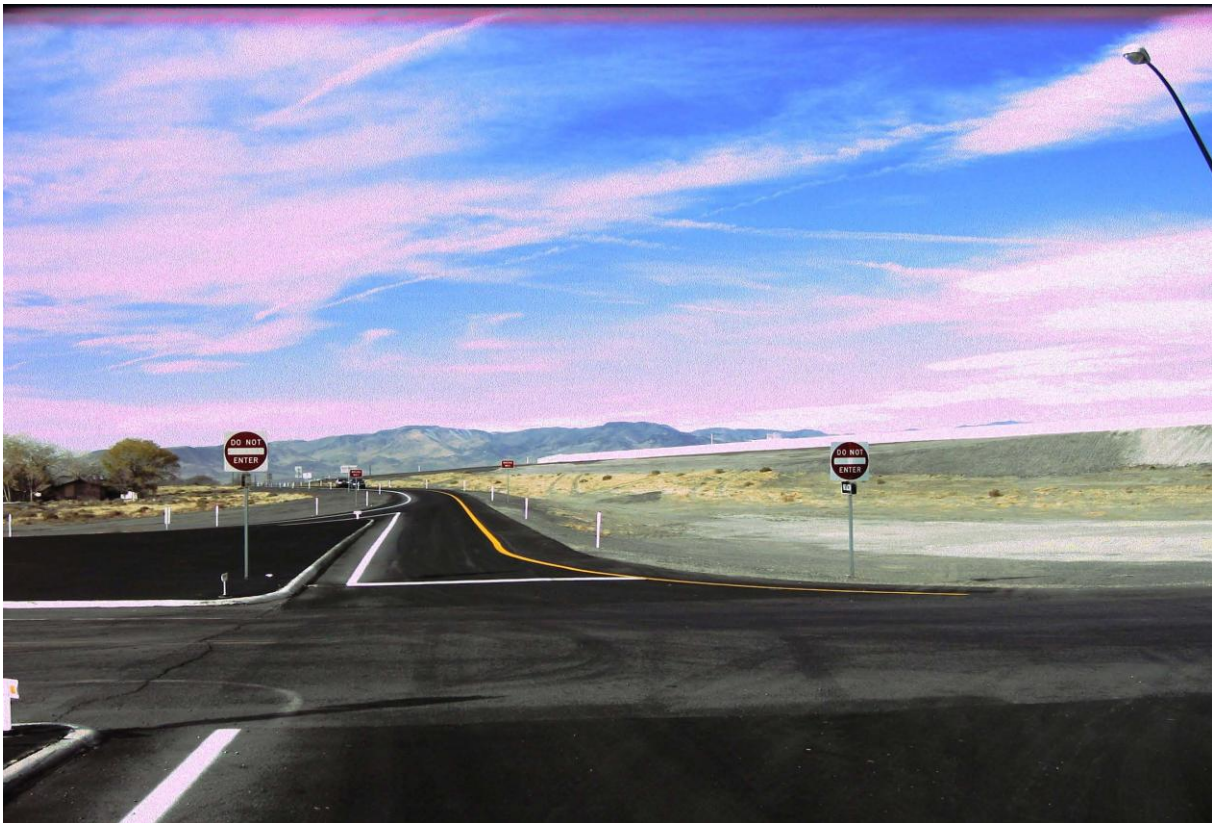
The Nevada State Patrol determined that the Mercedes began to travel the wrong way on I-80 by entering exit 48, about 2 miles east of the collision scene. The ramp intersects with State Route 343 and is equipped with the following warning signage: two 36- by 36-inch “Do Not Enter” signs and “One-Way” arrow signs about 6 feet above the ground; two 42- by 30-inch “Wrong Way” signs about 6 feet above the ground and 100 feet west of the crossroad; and a “No Right Turn” sign on State Route 343 to warn southbound vehicle drivers against inadvertently entering the ramp. (See figure 13 below.)

Figure 13. Likely wrong-way driver entry point for Fernley, Nevada, collision.

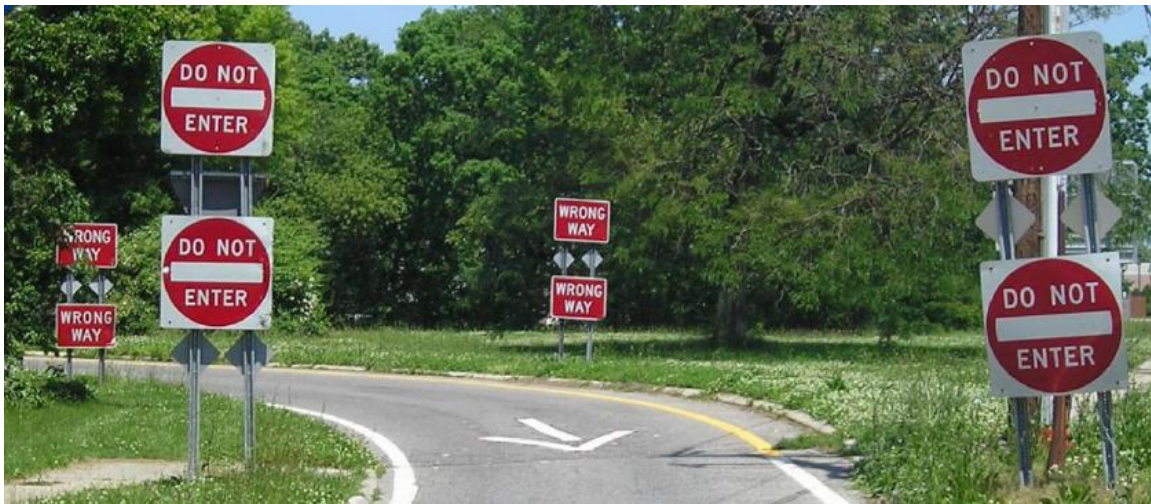
Figure 17. Double-posted “Do Not Enter” and “Wrong Way” signs on an exit ramp. (Courtesy of the New York State Department of Transportation).

- Posting controlled-access highway entrance signs on each side of entrance ramps¹¹²
- Applying red retroreflective tape to the vertical posts of exit ramp signs
- Installing red delineators on each side of exit ramps
- Installing LED-illuminated in-pavement markers or delineators parallel with the stop bar at the crossroad end of exit ramps
- Installing trailblazing lines or reflective markers that channel travel in an arc to guide motorists making a left turn from the crossroad into an entrance ramp, to keep them from inadvertently entering an exit ramp¹¹³
