FREEDOM OF INFORMATION ACT REQUEST (FOI 2010-01517)

**DEPARTMENT OF ENERGY
RICHLAND OPERATIONS OFFICE (RL)
SURVEILLANCE OF
WASHINGTON CLOSURE HANFORD (WCH)
PROCUREMENT PROCESS**

S-09-AMSE-WCH-PRO-002

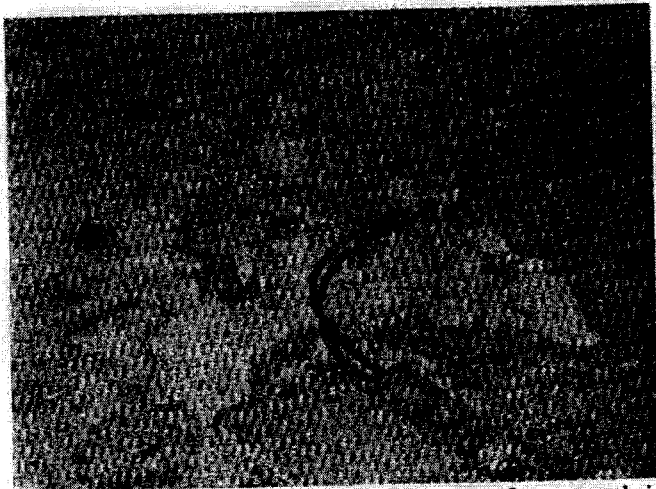
It is understood by the SME that the primary electrical power to Building 272E was isolated (via air gapping) prior to mid January 2010; however, CHPRC D&D project management had not yet verified total isolation of all other possible electrical power sources in accordance with PRC-PROI-DD-40013. This being the case, all workers who enter this building should "consider all electrical conductors are energized and dangerous" based upon their electrical safety training (HAMMER Course # 044480, OSHA Power Tools & Electrical Cord Safety class). Further training of affected field work supervisors and workers will prepare them to effectively recognize and control potential exposure to electrical hazards for D&D work scope. Also, all electrical hazards (including but not limited to those shown below) should have been isolated or barriers installed as to avoid contact with the electrical conductors in accordance with NFPA 70E.

Further, it was apparent based upon the above facts that D&D workers did not adequately maintain a safe distance to potential electrical power sources, which according to Course #044480 is "10 feet". Despite the training and experience that the Field Work Supervisor and D&D workers had, D&D workers cut two electrical conduits, which the supervisor believed was less of a hazard then leaving the conduits there as a tripping hazard.

272E Unguarded Electrical Conductors (from conduit in previous picture on right)
