Department of Energy
Richland Operations Office
P.O. Box 550
Richland, Washington 99352

FREEDOM OF INFORMATION ACT REQUEST (FOI 2010-01517)

CONTRACT NO. DE-AC06-08RL14788 – ENGINEERING PROGRAM/PROCEDURES
(S-09-SED-PRC-004)

The purpose of this letter is to transmit RL Surveillance Report S-09-SED-PRC-004 dealing with a review of the CHPRC contract and the CHPRC Engineering Program/Procedures. The Program/Procedures were evaluated against 10 CFR 830, 10 CFR 835, and DOE Order requirements in the contract. No concerns, findings, or observations resulted from this surveillance activity. Based on the results of this Surveillance Report, there are no actions required on your part. If you have any questions, please contact me, or your staff may contact Pete J. Garcia, Director, Safety and Engineering Division, on (509) 372-1909.

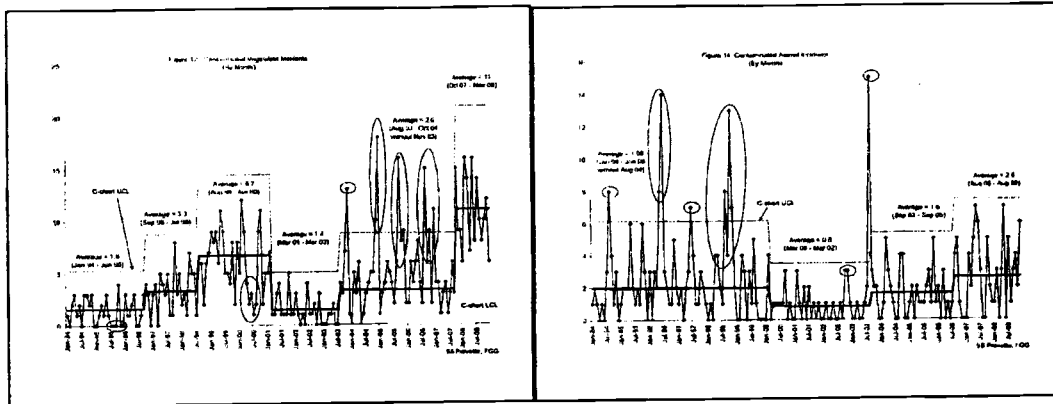
Data shows an adverse trend in the spread of contamination by biological vectors.

- Increases in frequency of contaminated vegetation and contaminated animal incidents have occurred.

Trending has also shown an increase in the contamination levels.

- Less than adequate access to areas for herbicide application in 2005 and 2006 and subsequent inadequate removal of these tumbleweeds resulted in large spreads of contamination.

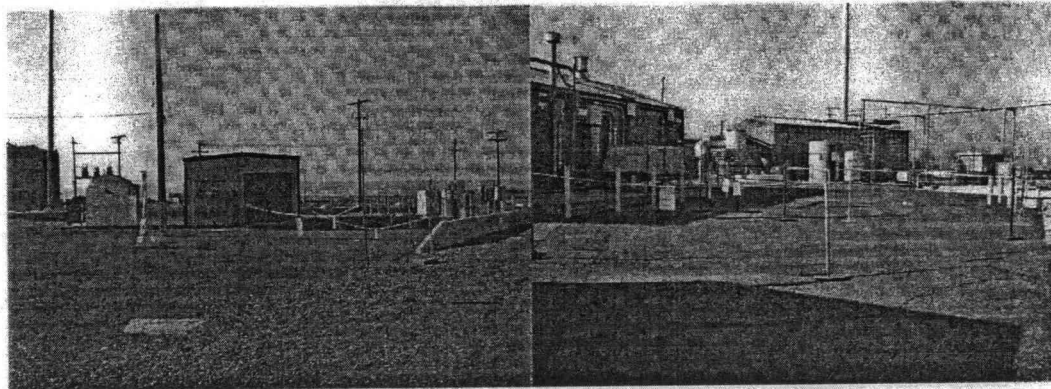
indicated these areas have been expanding over several years due to inadequate control of spread of contamination by biological vectors, but have not all been incorporated into WIDS and thus had not been assigned to a contractor for control and clean-up. Some of the areas have been put into the WRPS monitoring program due to the perseverance of the WRPS (Tank Farms Operations Contractor [TOC]) RCTs.

Examples of these areas are shown below:

SY Farm

241-A

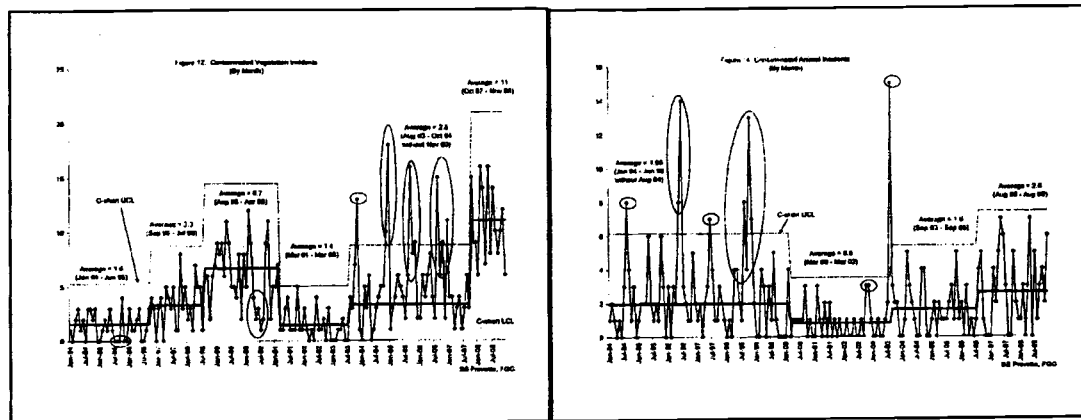
Data shows an adverse trend in the spread of contamination by biological vectors.

- Increases in frequency of contaminated vegetation and contaminated animal incidents have occurred.

Trending has also shown an increase in the contamination levels.

- Less than adequate access to areas for herbicide application in 2005 and 2006 and subsequent inadequate removal of these tumbleweeds resulted in large spreads of contamination.

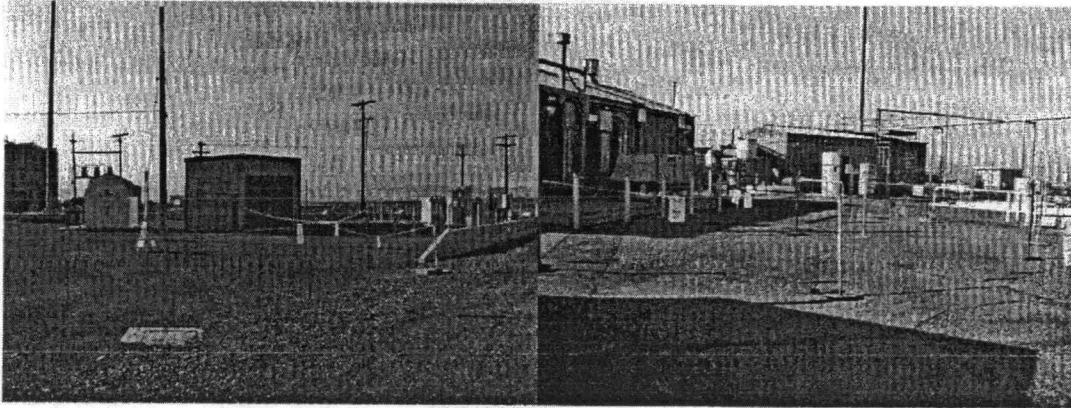
indicated these areas have been expanding over several years due to inadequate control of spread of contamination by biological vectors, but have not all been incorporated into WIDS and thus had not been assigned to a contractor for control and clean-up. Some of the areas have been put into the WRPS monitoring program due to the perseverance of the WRPS (Tank Farms Operations Contractor [TOC]) RCTs.

Examples of these areas are shown below:

SY Farm

241-A

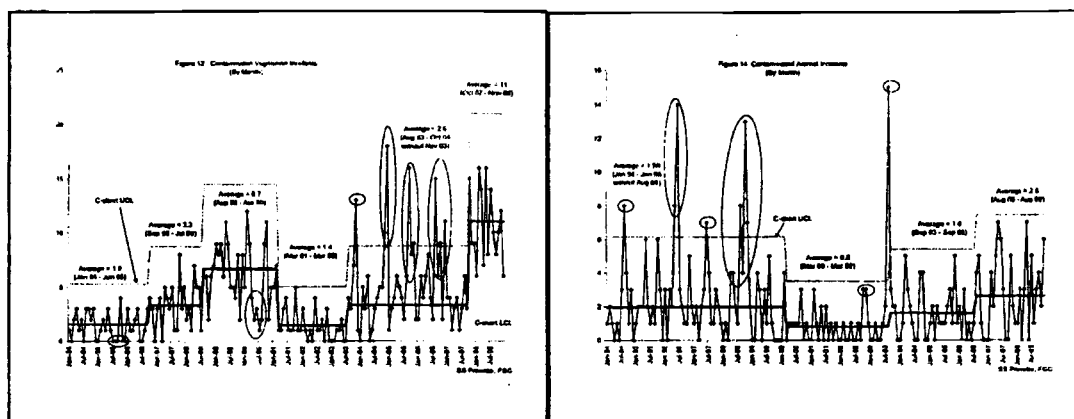
Data shows an adverse trend in the spread of contamination by biological vectors.

- Increases in frequency of contaminated vegetation and contaminated animal incidents have occurred.

Trending has also shown an increase in the contamination levels.

- Less than adequate access to areas for herbicide application in 2005 and 2006 and subsequent inadequate removal of these tumbleweeds resulted in large spreads of contamination.

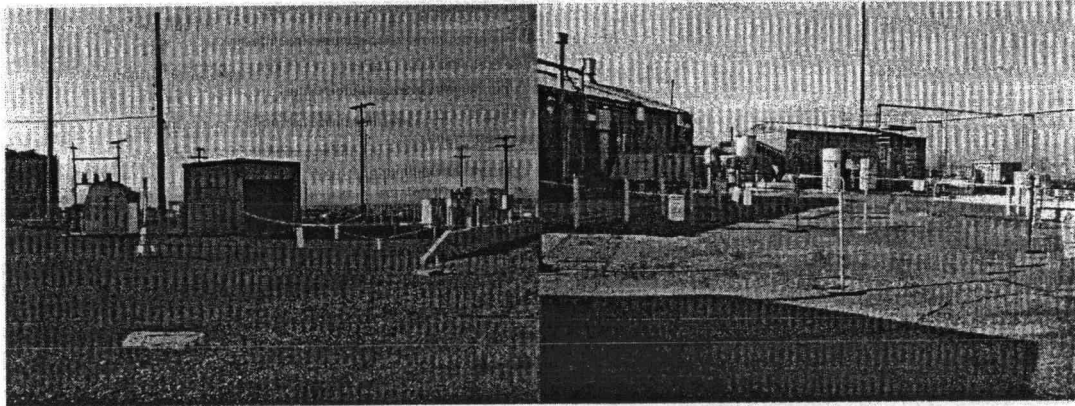
indicated these areas have been expanding over several years due to inadequate control of spread of contamination by biological vectors, but have not all been incorporated into WIDS and thus had not been assigned to a contractor for control and clean-up. Some of the areas have been put into the WRPS monitoring program due to the perseverance of the Washington River Protection Solutions (WRPS) (Tank Farms Operations Contractor [TOC]) RCTs.

Examples of these areas are shown below:

SY Farm

241-A
