SUBJECT : SAFETY BULLETIN : Expanded (72 Hour) Report, Kern Canyon Rollover

Subject: Expanded (72 Hour) Report, Kern Canyon Rollover

Location: Highway 178, in the Kern River Canyon, ¼ mile west of Cow Flat Creek.

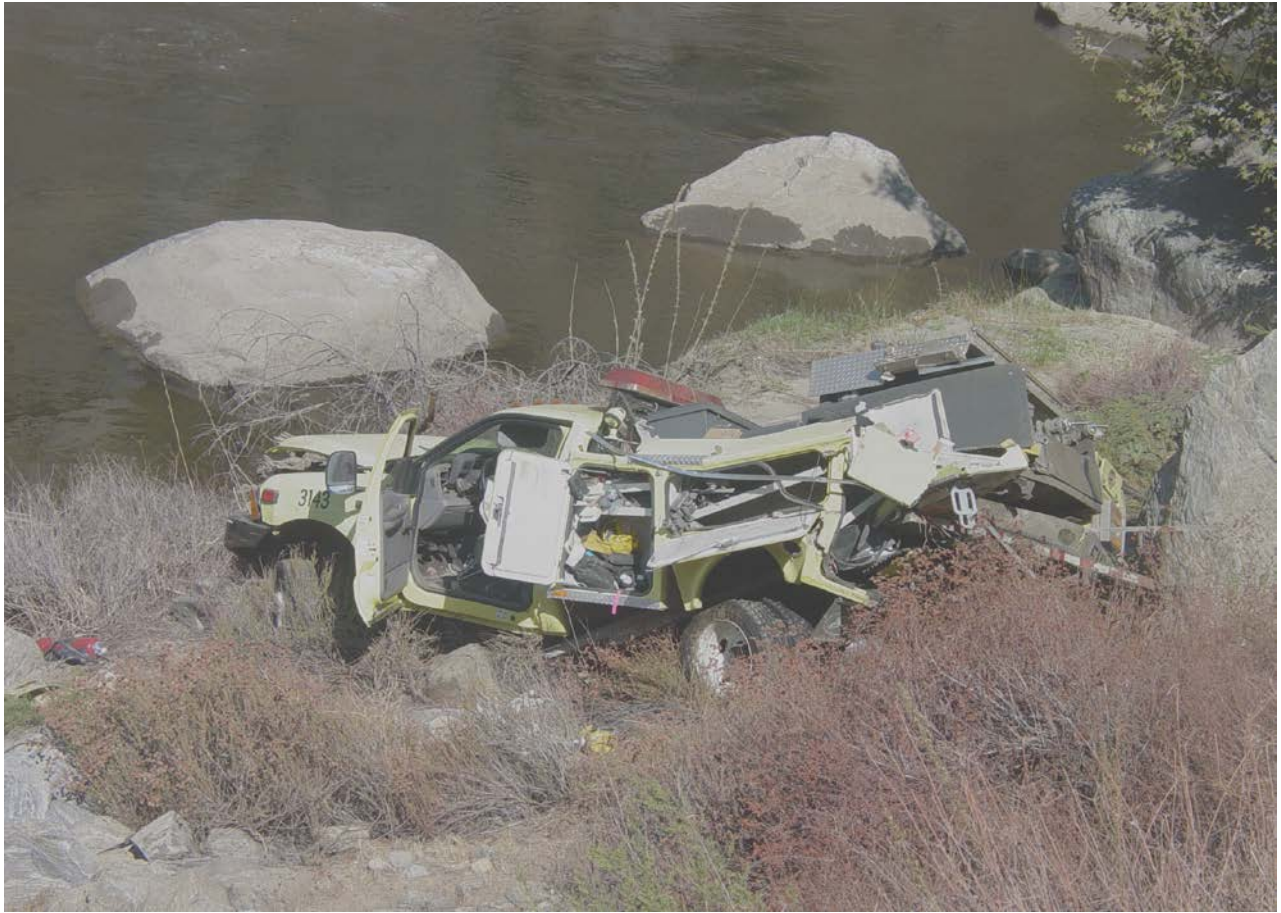
Preliminary Factual Findings: The BLM driver was returning to the Chimney Peak Fire Station traveling eastbound on Hwy 178 when another vehicle approaching from the opposite direction crowded the eastbound lane, forcing the driver of the BLM engine to swerve towards the shoulder of the road. The right front tire left the pavement onto the shoulder, at which time, the tire rolled off the rim, causing the driver to lose control. The engine impacted a concrete culvert, forcing the vehicle into a slide. The vehicle then crossed the westbound lane, sliding off the highway and over the embankment. The Engine rolled several times before coming to rest, right side up at the edge of the Kern River. It was estimated at the accident scene that the vertical distance between the highway and the river is approximately 50ft.

Primary Factor: Loss of air in the right front tire caused the vehicle to pull hard to the right, towards the hillside. The driver then over corrected the vehicle, lost control, and slid off the highway.

Secondary Factor: Narrow canyon road with little or no shoulder and absent of guardrails in accident area.
