# Herbert C. Hoover Building Renovation

## Washington, DC

# What Flooding?

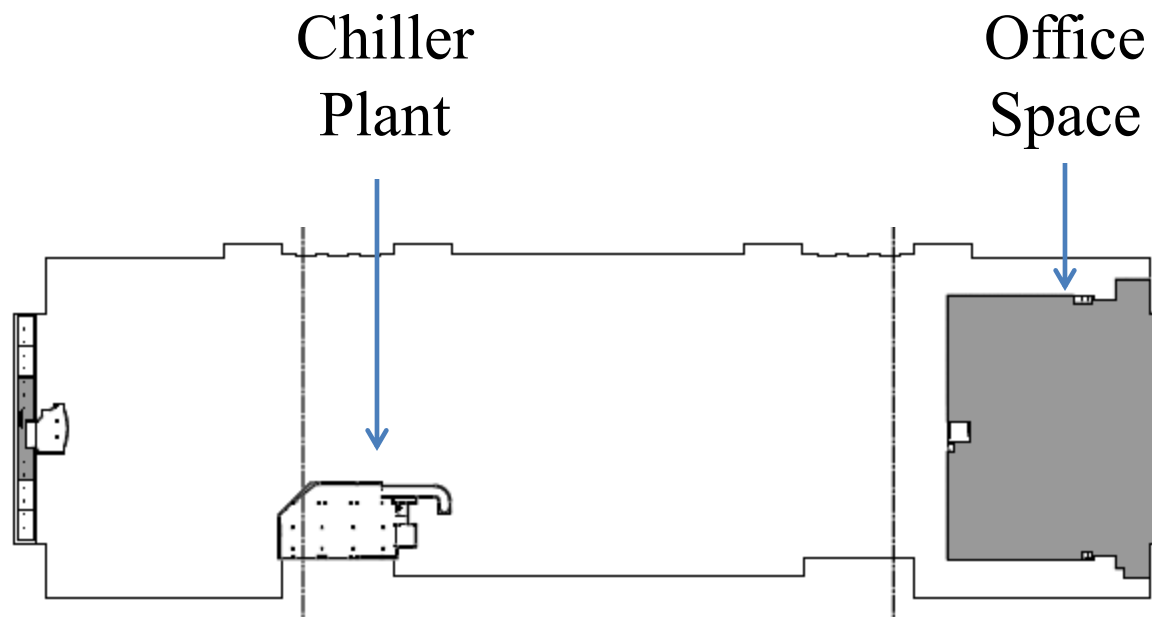
- History of flooding in subbasement areas.

- Flooding into basement areas of the building from the GSA Steam Tunnels.
