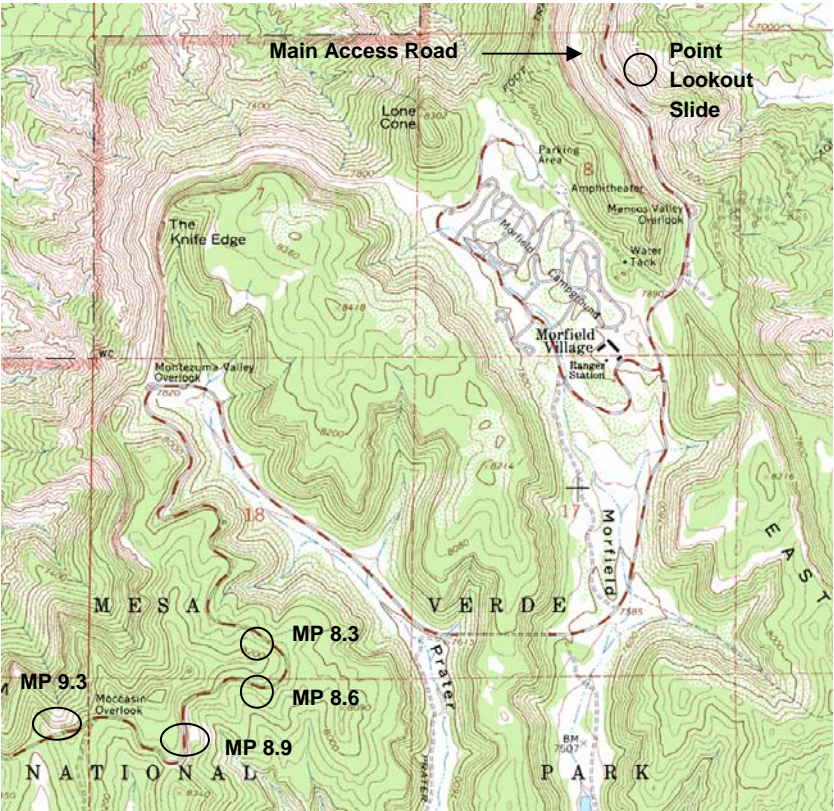
Figure 16. Map. Topographic map showing locations of unstable slopes in Mesa Verde National Park.

- **Slope Alignment:** Of particular interest for the current evaluation were the slopes along the east side of Point Lookout, as indicated Figure 16. Since these slopes generally face an easterly direction, the slope alignment is good for satellite-based InSAR. Other slopes of interest are at MP 8.3, 8.6, 8.9 and 9.3, as also indicated in Figure 16. The slope at MP 8.9 is east facing. The other slopes have less favourable alignment: at MP 8.3 the slope faces northeast, at MP 8.6 the slope faces south, and at MP 9.3 the slope faces north.

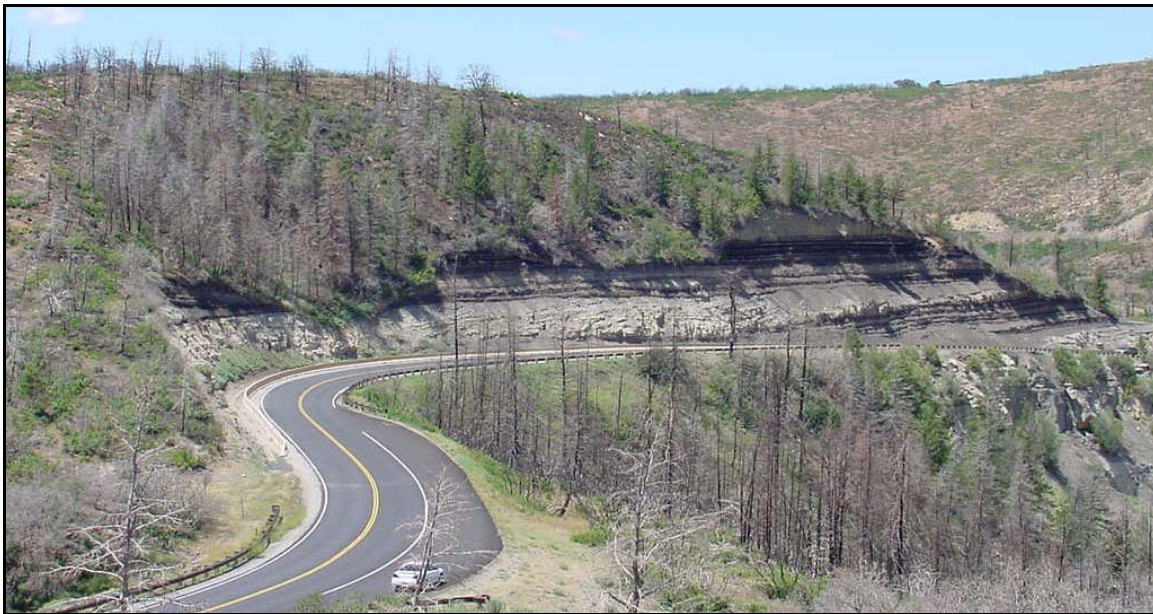
Figure 18. Photo. Unstable slope near Mile Post 9.3 in Mesa Verde National Park, CO.

Figure 18 shows the MP 9.3 site, where a rock fall is occurring in the cut above the road and slumping is occurring below the road. This area was reconstructed in 1985 and there has been movement since; pavement cracking, a settling shoulder, and visible distress in the slope well below the road are evidence of this.

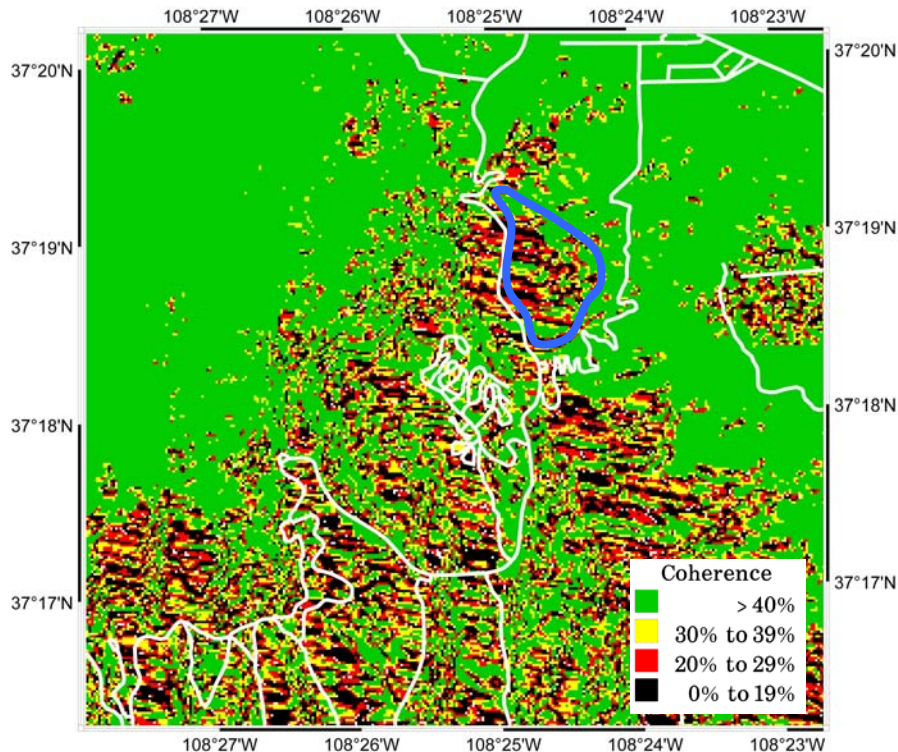
preclude the use of InSAR for measuring ground movement. In particular, the slopes to the east of Point Lookout (encircled in blue in Figure 19) are within the layover regions and cannot be monitored by InSAR. As shown in Figure 19, the areas of more gentle relief generally have quite good coherence, especially outside the mountainous area. The poor coherence within the mountainous areas generally mirrors the topographic relief.

Figure 19. Graph. Coherence of Mesa Verde sites for May 28 – September 10, 1996.
