CHAPTER 5 – EXAMINATION OF FIELD DATA

5.1 STANDARDIZED PRESENTATION OF THE DEFECT CHARACTERIZATION AND IMAGING RESULTS

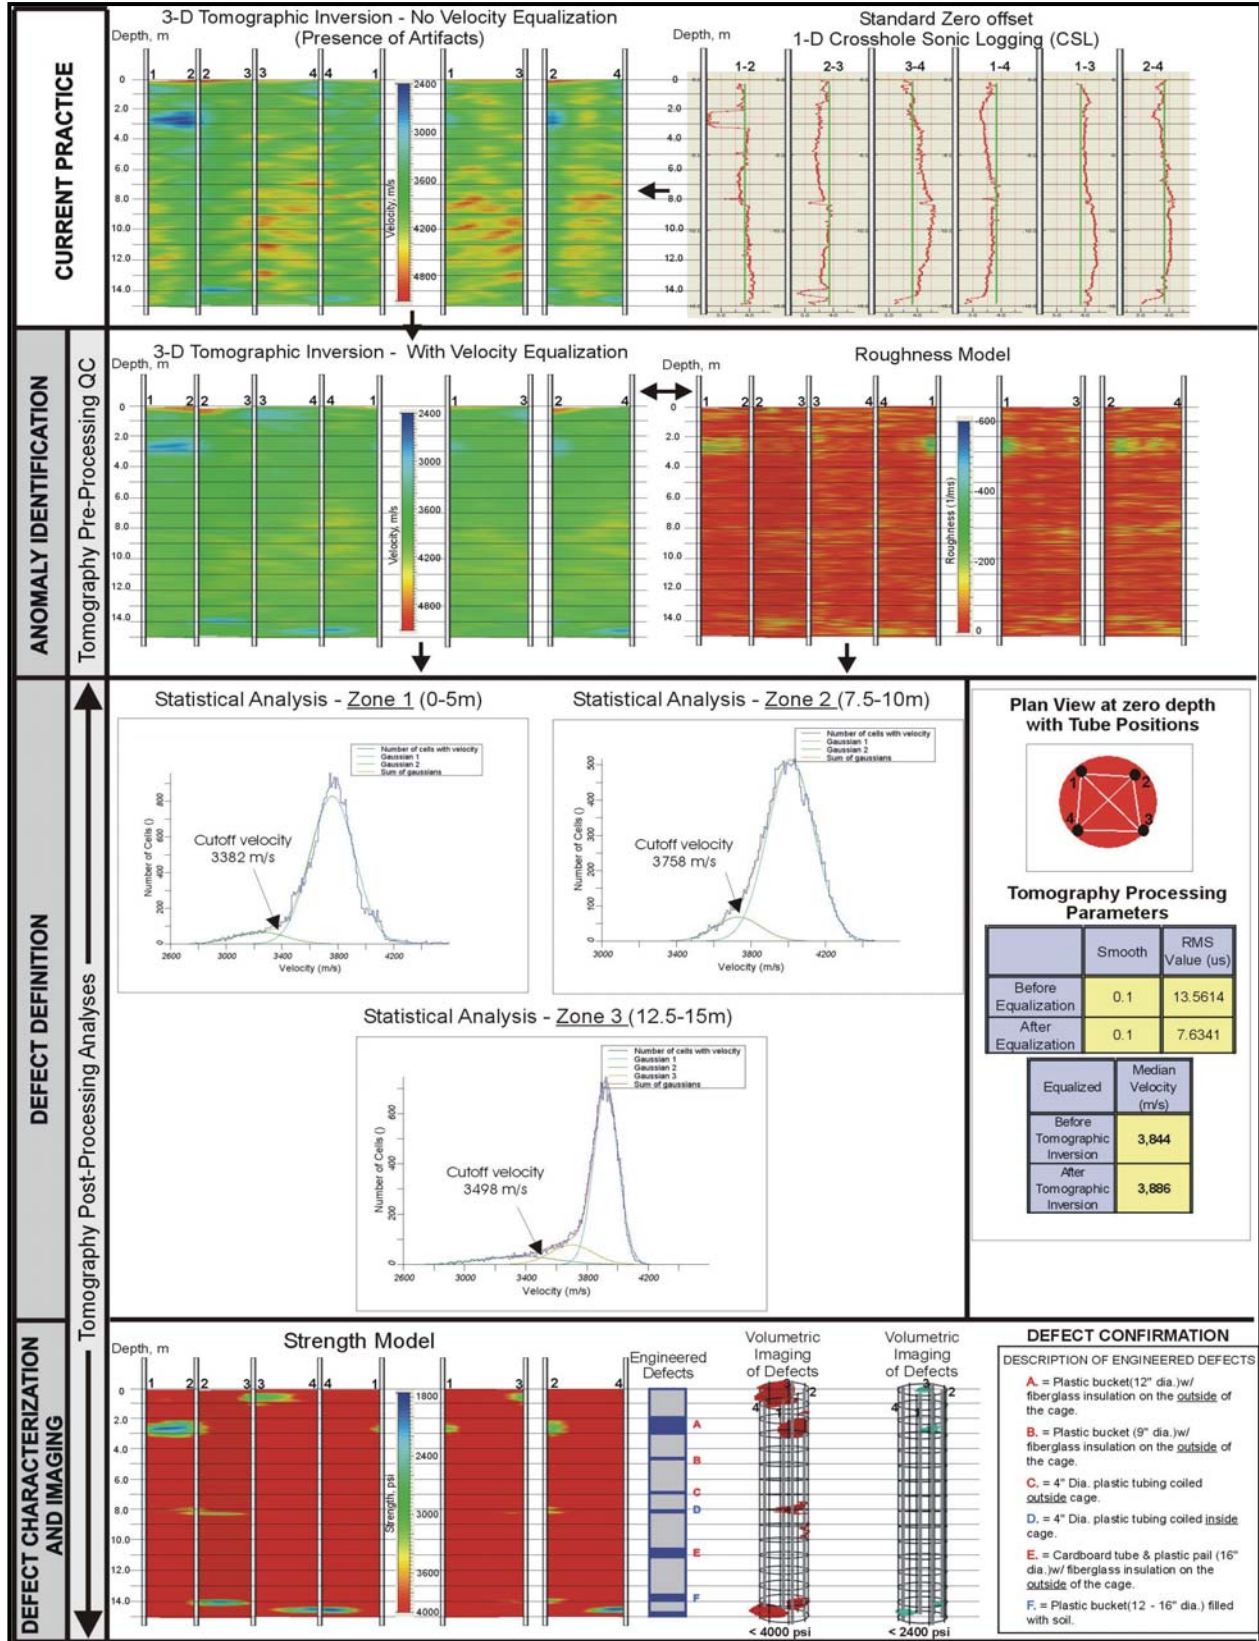
Figure 46. Schematic. Defect Characterization and Imaging Results from Shaft 1, NGES – Amherst.

1. *Current Practice* – Standard CSL (velocity vs. depth) indicates three suspected “anomalies”:
 - Anomaly 1: 2-3 m depth and mostly between Tubes 1 and 2;

- Anomaly 2: 8-8.5 m depth and mostly between Tubes 2 and 3;
 - Anomaly 3: 14-15 m depth and mostly between Tubes 2, 3, and 4.
 Multi-offset (7-offsets) 3-D CSLT tomography, with no velocity equalization, images CSL Anomalies 1 and 3 but not Anomaly 2.

2. *Anomaly Identification* – Multi-offset CSLT with velocity equalization better resolves Anomalies 1 and 3. Slight indication for Anomaly 2 is now indicated in both the CSLT image and the roughness model. Also, a small anomaly (0-0.5 m) near the shaft surface is indicated (Anomaly 0).

3. *Defect Definition* – Three depth zones are selected (to examine the four Anomalies 0-3) and velocity cut-off values are indicated using 2 and 3 Gaussian fits to the velocity histogram.

4. *Defect Characterization and Imaging* – Four blue color “defects” zones are interpreted in the strength model. Volumetric images indicate only Defects 0, 1, and 3 between 0-0.5 m, 2-3 m, and 14-15 m depths, respectively are of low strength (<16,500 kPa (2,400 psi)).

Comments. Next to the strength model, a cross-section is provided indicating actual locations of planned defects and a description of the defects. Six defects were pre-planned with only two defects (planned Defects D and F) were located inside the rebar cage. Tomography clearly imaged the planned defects D and F as well as planned Defect A. The planned Defect A was a plastic bucket located outside the cage which is clearly imaged by CSLT. Again note a slight indication of an unplanned low velocity defect near the surface (0-0.5 m) close to Tube 3.

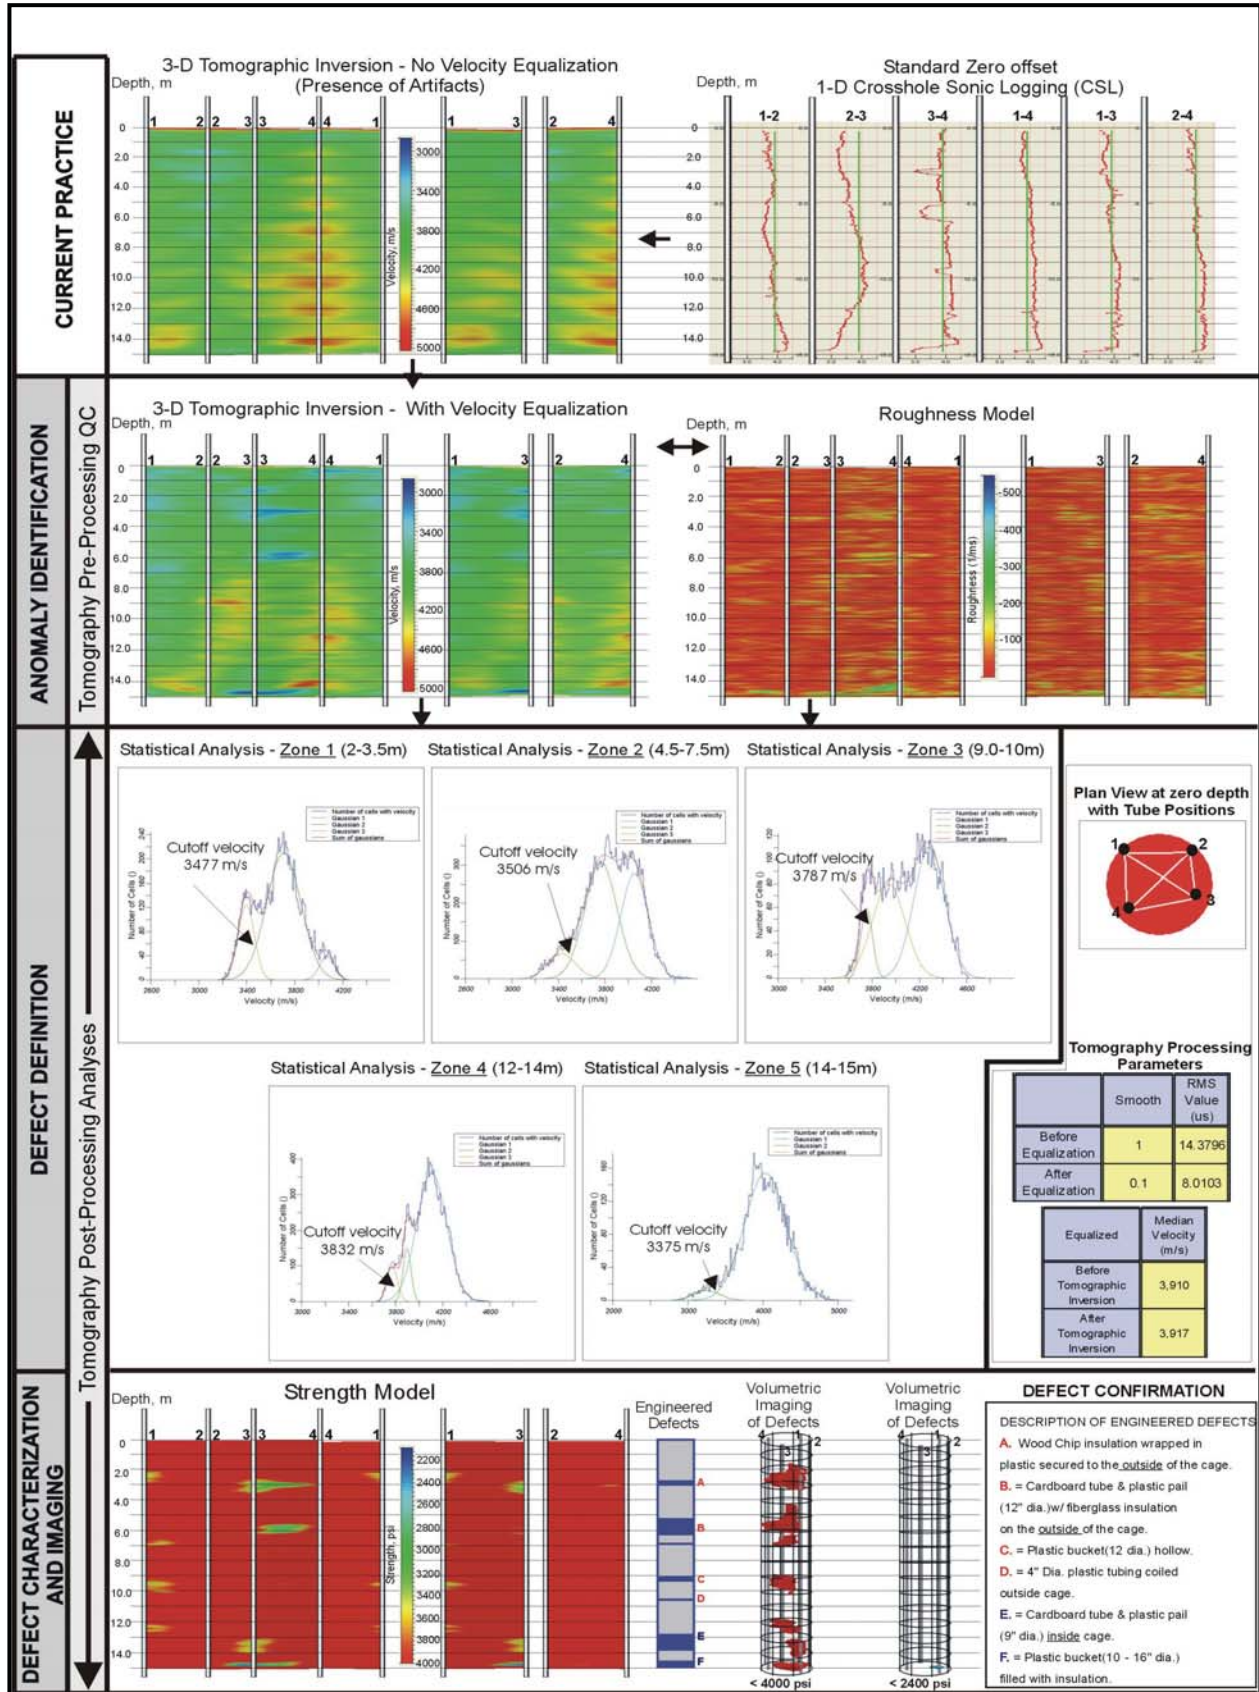
Figure 47. Schematic. Defect Characterization and Imaging Results from Shaft 4, NGES – Amherst.

1. *Current Practice* – Standard CSL indicates four suspected “anomalies”:
 - Anomaly 1: 2.5-3 m depth and mostly between Tubes 3 and 4;
 - Anomaly 2: 5-6 m depth and mostly between Tubes 3 and 4;
 - Anomaly 3: 9.2-9.8 m depth and mostly between Tubes 3 and 4;
 - Anomaly 4: 14.5-15 m depth and mostly between Tubes 2, 3, and 4.
 Multi-offset tomography (CSLT), with no velocity equalization, images Anomalies 1 and 2 but not Anomalies 3 and 4 (only a slight indication is observed).
2. *Anomaly Identification* – Multi-offset CSLT with velocity equalization better resolves Anomalies 1, 2 and 4. Slight indication for Anomaly 3 is indicated in both the CSLT image and the roughness model.

3. *Defect Definition* – Five depth zones are selected and velocity cut-off values are indicated using 2 and 3 Gaussian fits to the velocity histogram. Anomalies 3 and 4 have a cut-off velocities close to median velocity (3,917 m/s) and; therefore, not statistically significant.
4. *Defect Characterization and Imaging* – Three (3) green-blue color “defects” zones are interpreted in the strength model (Defects 1, 2, and 4). Other minor defects are indicated by yellow-orange colors. Volumetric images indicate only Defect 4, between 14.5-15 m depth, is of low strength (<16,500 kPa (2,400 psi)).

Comments. Next to the strength model, a cross-section is provided indicating actual locations of planned defects and a description of the defects. Six defects were pre-planned with only two defects (planned Defects E and F) were located inside the rebar cage. Tomography clearly imaged the planned Defect F as well as exterior planned Defects A and B. Minor indication of exterior planned Defects C and E are also observed (yellow color).

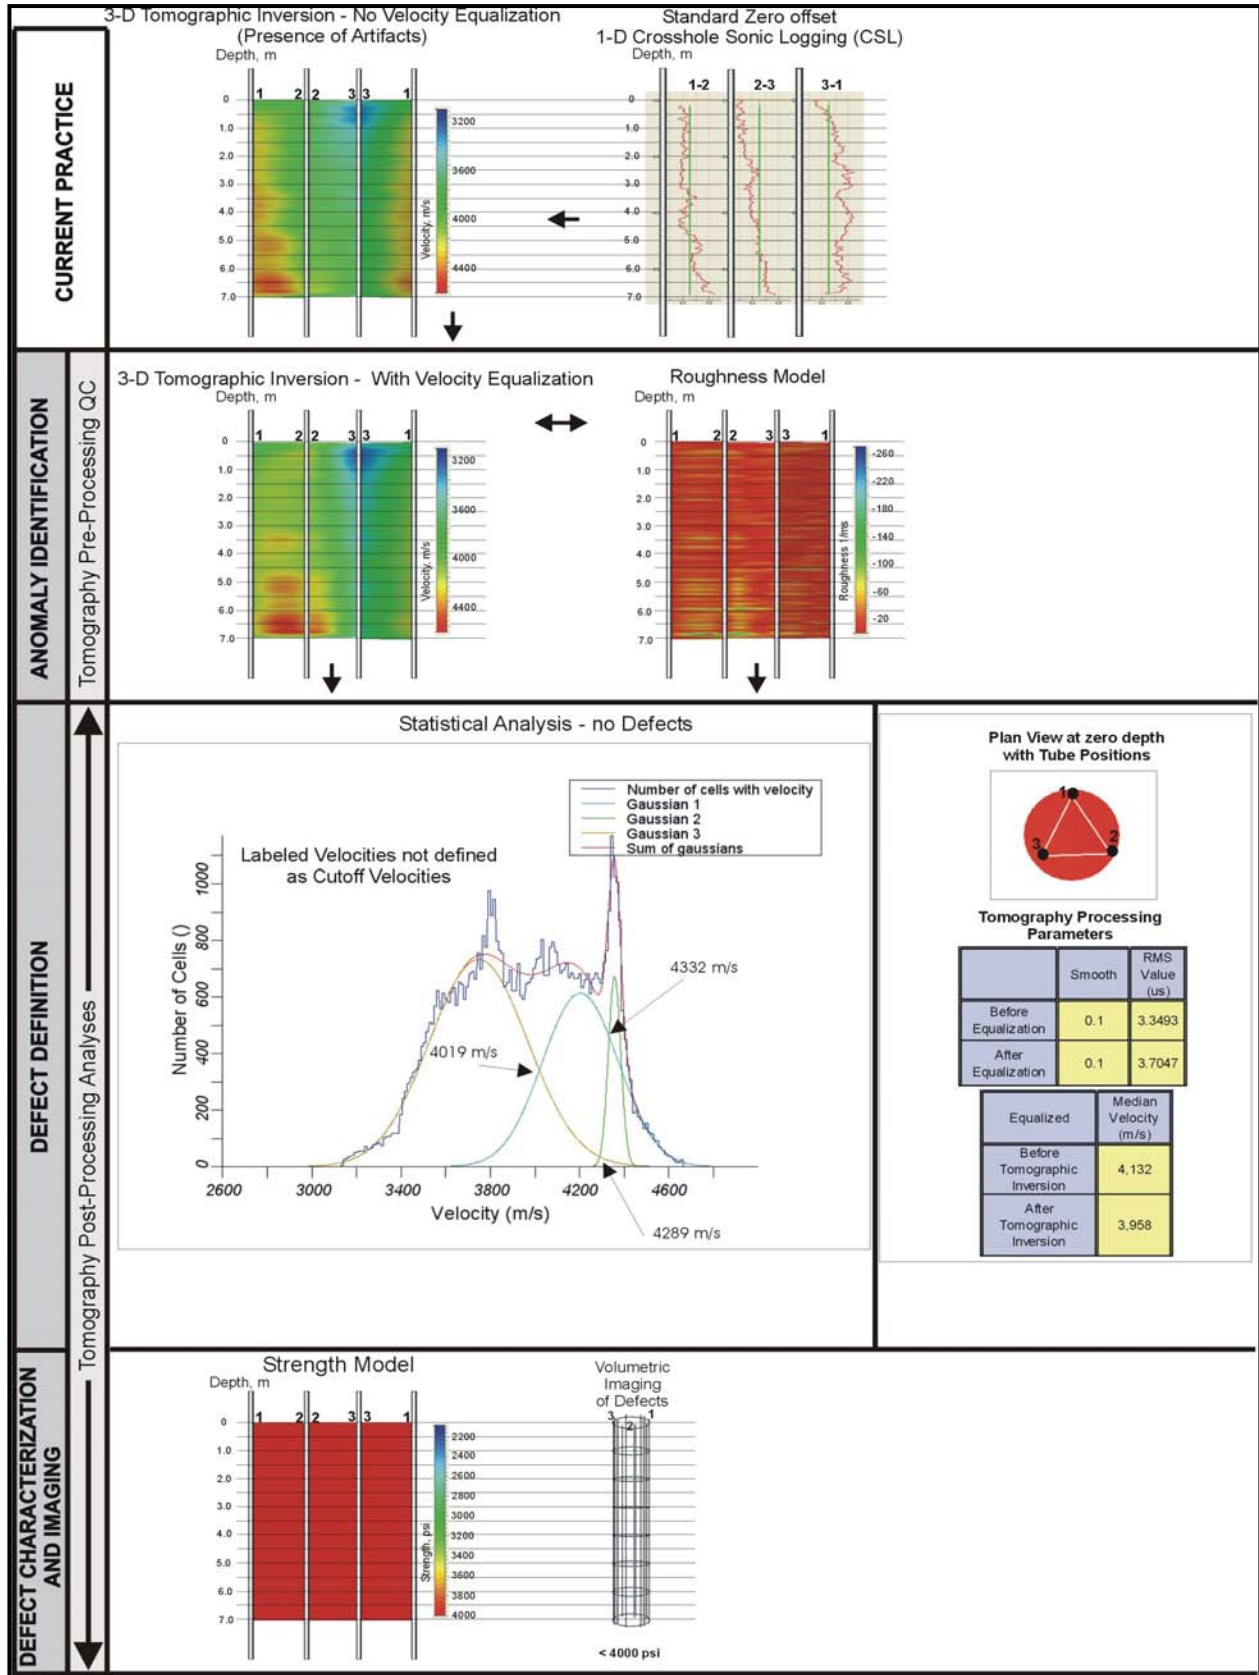
Figure 50. Schematic. Defect Characterization and Imaging Results from Shaft A1A, Jim Camp Bridge.

1. *Current Practice* – Standard CSL indicates no anomalies, just irregular CSL dataset. Zero-offset tomography (CSLT), with no velocity equalization, indicates un-balanced velocity panels with artifacts in the CSLT images, probably due to errors in measuring tube offsets in the field.
2. *Anomaly Identification* – Zero-offset CSLT with velocity equalization balances the velocity panels. A low velocity zone is indicated between 0.2-1 m around Tube 3.
3. *Defect Definition* – No single cut-off velocity can be defined. Shaft is sound.
4. *Defect Characterization and Imaging* – No defects are indicated.

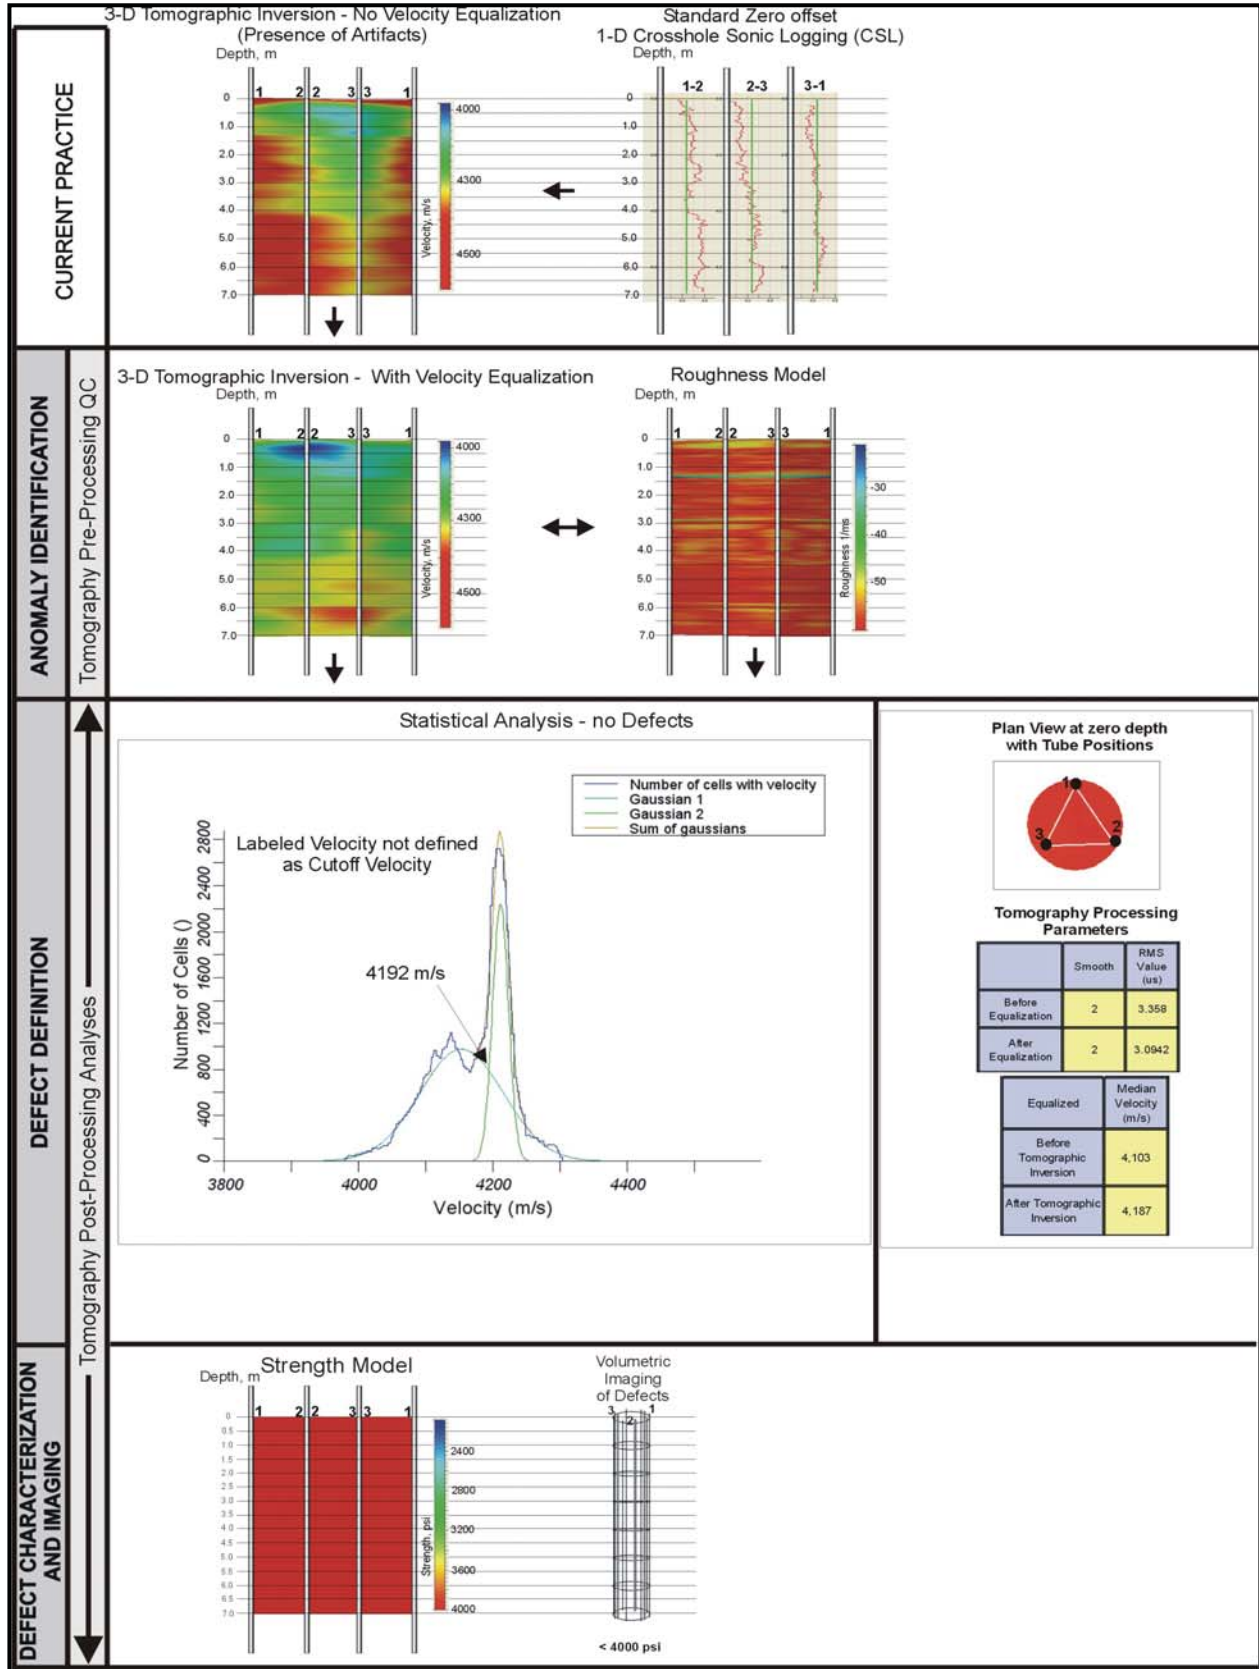
Figure 51. Schematic. Defect Characterization and Imaging Results from Shaft A1B, Jim Camp Bridge.

1. *Current Practice* – Standard CSL indicates no anomalies, just irregular CSL dataset. Zero-offset tomography (CSLT), with no velocity equalization, indicates un-balanced velocity panels with artifacts in the CSLT images, probably due to errors in measuring tube offsets in the field.
2. *Anomaly Identification* – Zero-offset CSLT with velocity equalization balances the velocity panels. A low velocity zone is indicated between 0.2-0.7 m around Tube 2 with slight indication in the roughness model.

3. *Defect Definition* – A single cut-off velocity of 4,192 m/s is obtained for the whole shaft which is close to the shaft median velocity (4,187 m/s).
4. *Defect Characterization and Imaging* – No defects are indicated.

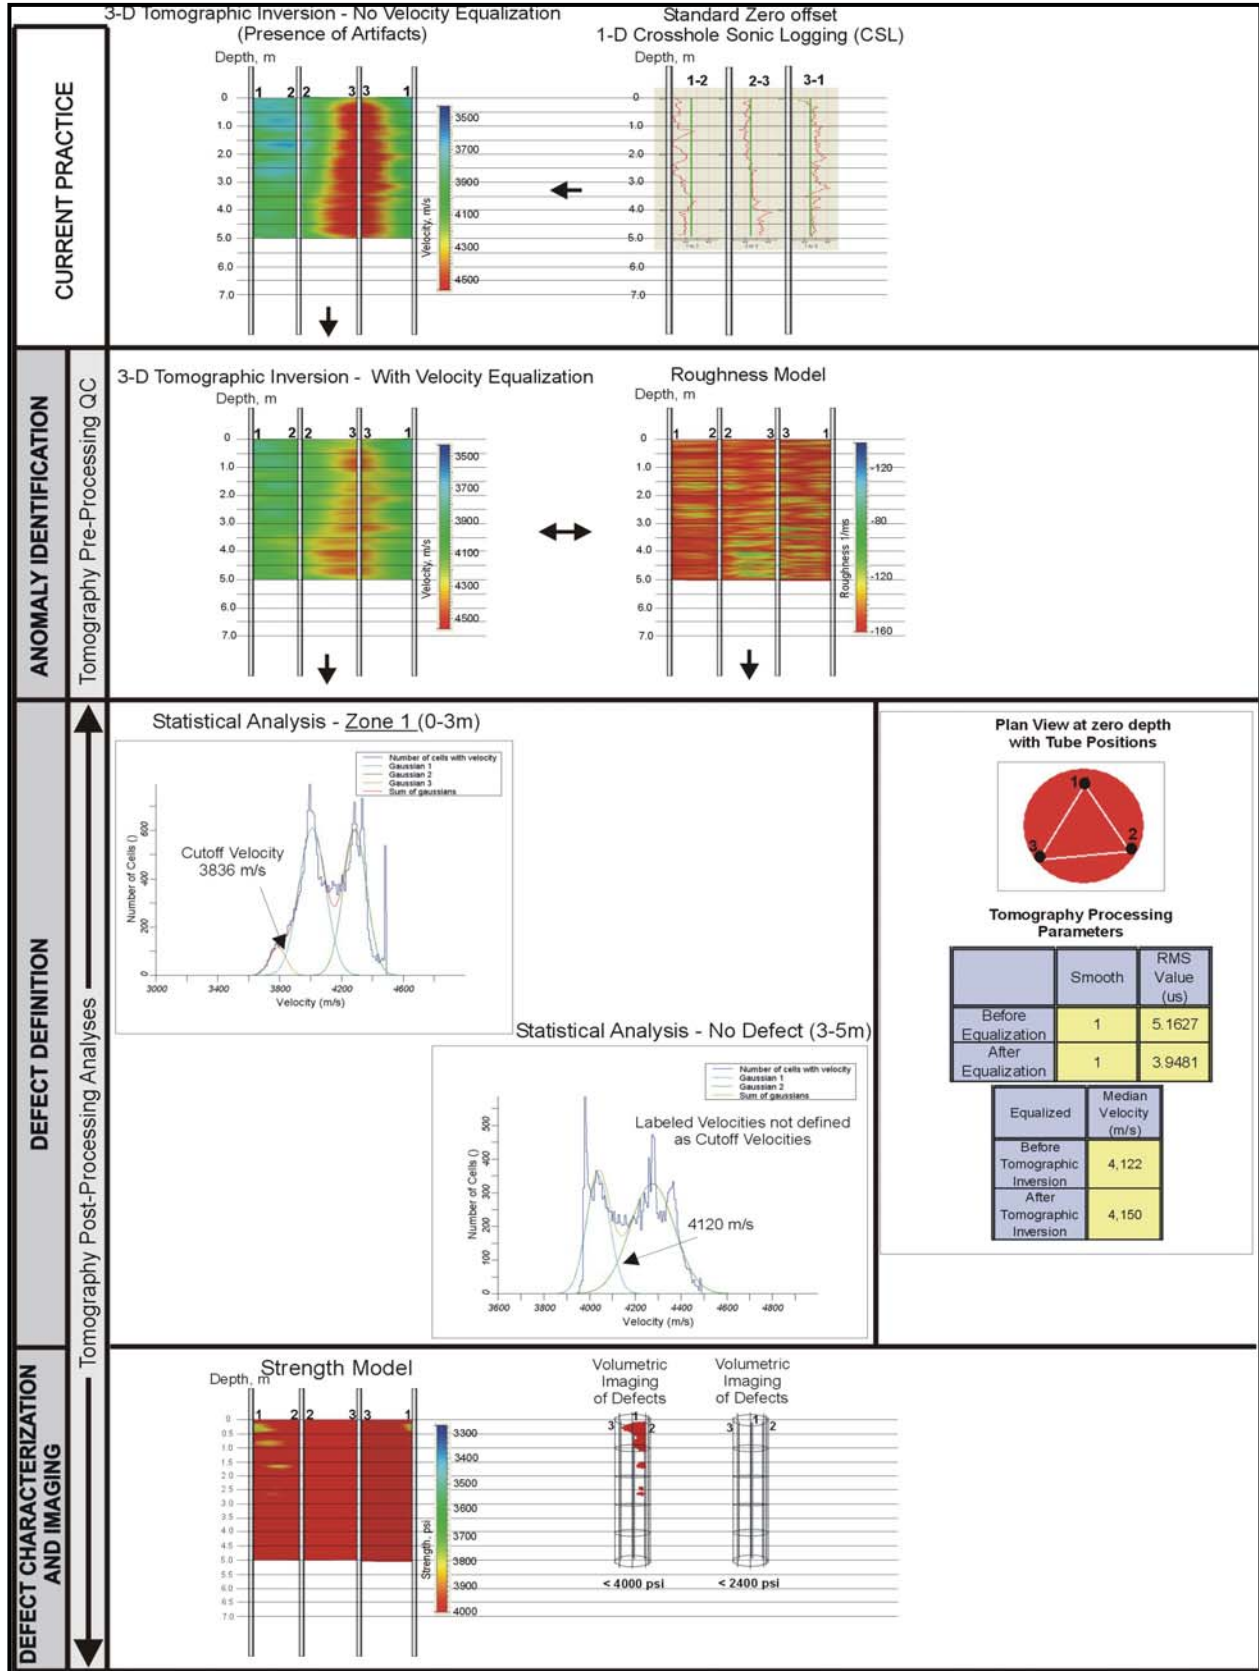
Figure 52. Schematic. Defect Characterization and Imaging Results from Shaft A2A, Jim Camp Bridge.

1. *Current Practice* – Standard CSL indicates no anomalies, just irregular CSL dataset. Zero-offset tomography (CSLT), with no velocity equalization, indicates un-balanced velocity panels with artifacts in the CSLT images, probably due to errors in measuring tube offsets in the field.
2. *Anomaly Identification* – Zero-offset CSLT with velocity equalization balances the velocity panels.
3. *Defect Definition* – Two zones are selected and velocity cut-off values are indicated using 2 and 3 Gaussian fits to the velocity histogram. One anomaly between 0-3 m in depth has a cut-off velocity 3,836 m/s close to median velocity of 4,150 m/s, and; therefore, may not be statistically significant.
4. *Defect Characterization and Imaging* – One small defect between 0.2-0.5 m near Tube 1 is indicated. Volumetric images indicate that this defect is of high relative strength (>16,500 kPa (2,400 psi)).

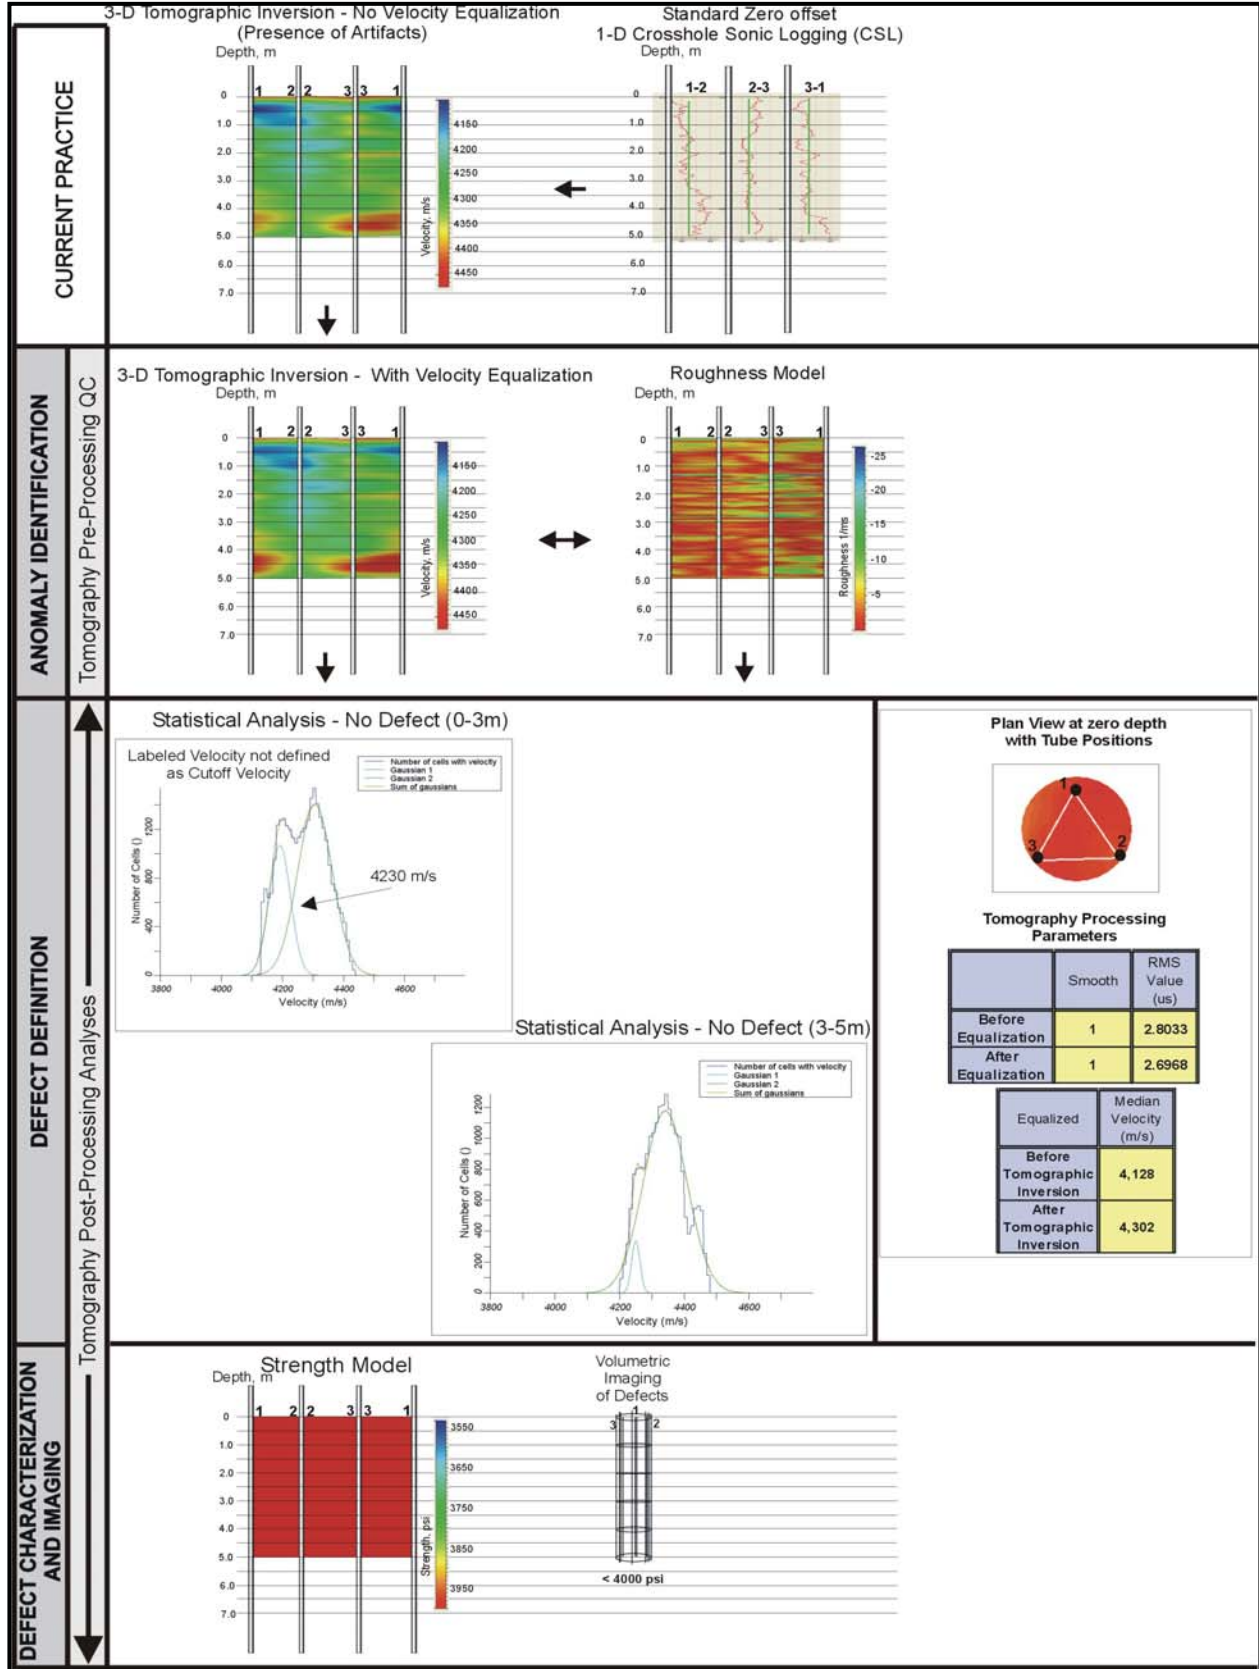
Figure 53. Schematic. Defect Characterization and Imaging Results from Shaft A2B, Jim Camp Bridge.

1. *Current Practice* – Standard CSL indicates no anomalies, just irregular CSL dataset. Zero-offset tomography (CSLT), with no velocity equalization, indicates a low velocity zone between Tubes 1 and 2.
2. *Anomaly Identification* – Zero-offset CSLT with velocity equalization balances the velocity panels and also confirms the low velocity zone between 0.2-1 m with slight indication in the roughness model.
3. *Defect Definition* – Two zones are selected and velocity cut-off values are obtained close to median velocity using 2 and 3 Gaussian fits to the velocity histogram.
4. *Defect Characterization and Imaging* – No defects are indicated.

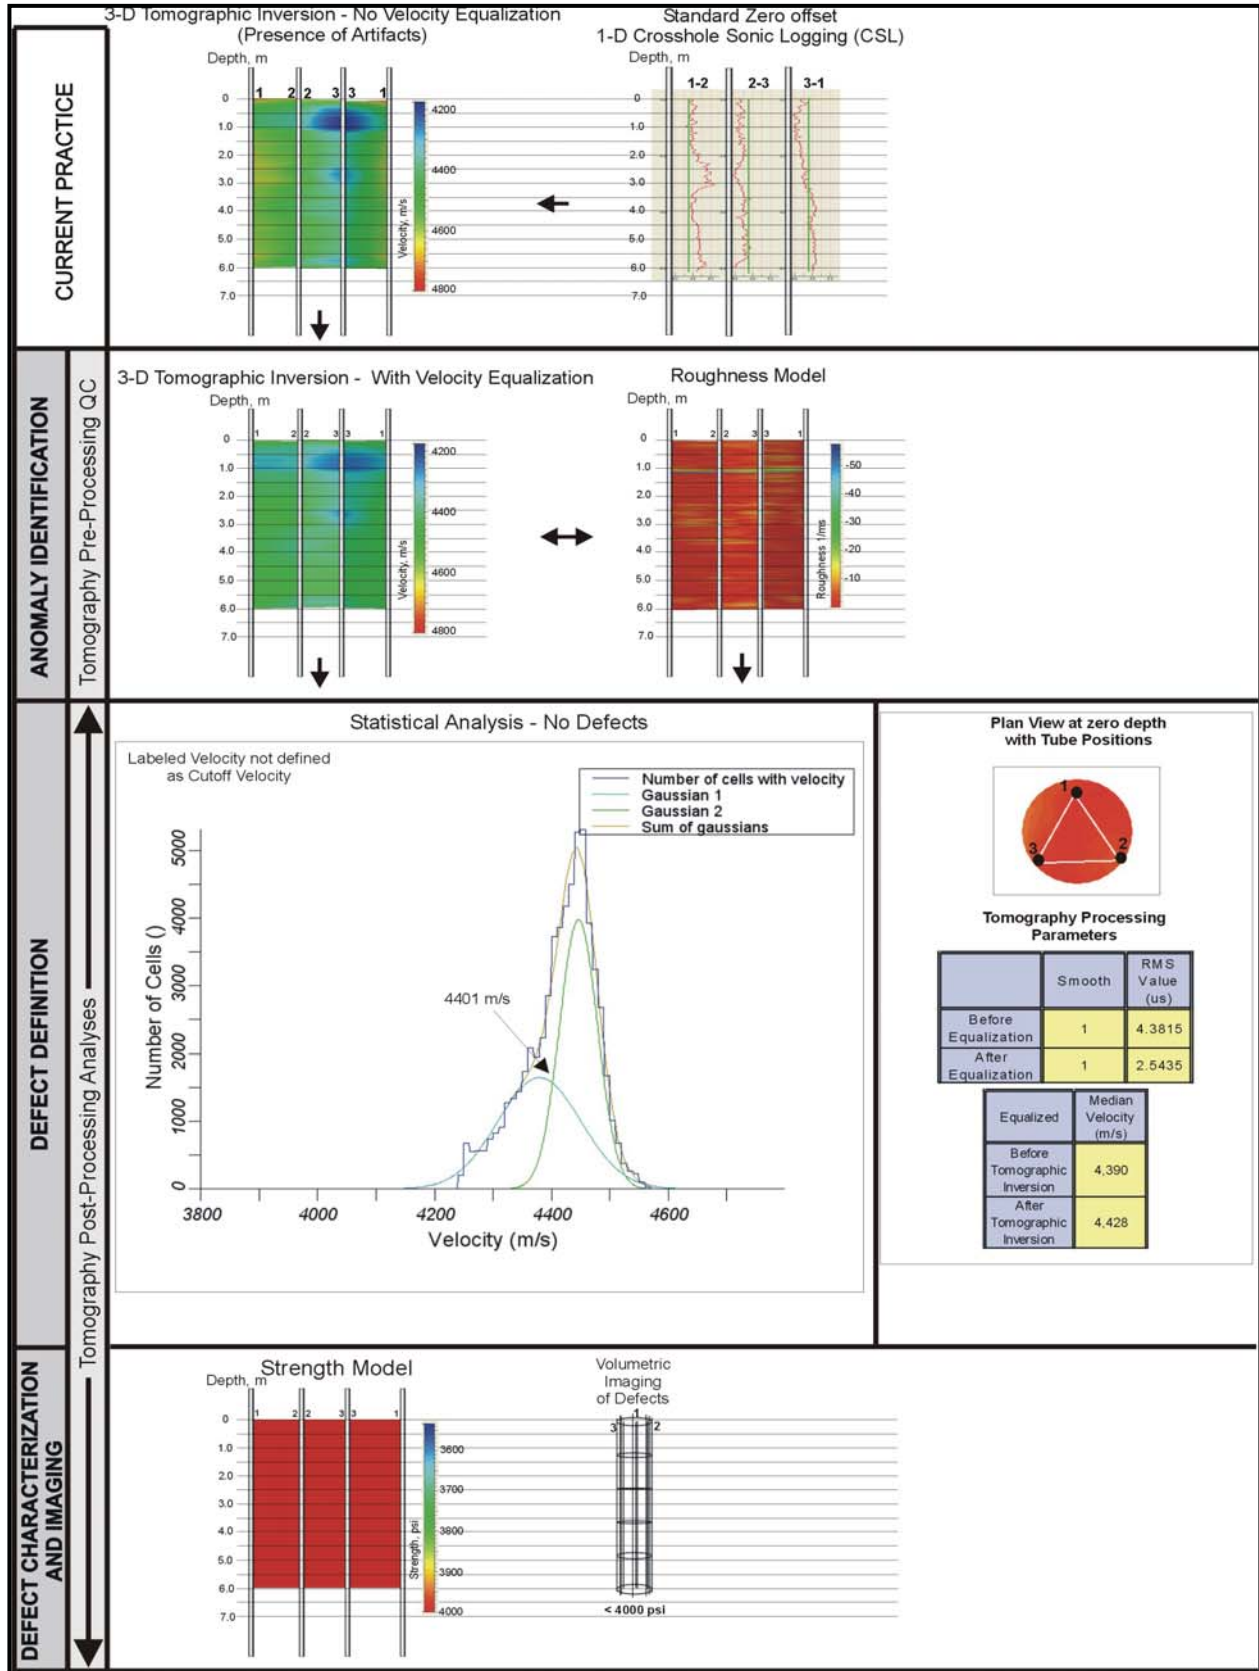
Figure 54. Schematic. Defect Characterization and Imaging Results from Shaft P1A, Jim Camp Bridge.

1. *Current Practice* – Standard CSL indicates no anomalies, just irregular CSL dataset. Zero-offset tomography (CSLT), with no velocity equalization, indicates a low velocity zone between Tubes 2 and 3.
2. *Anomaly Identification* – Zero-offset CSLT with velocity equalization balances the velocity panels also confirms the low velocity zone between 0.5-1 m with slight indication in the roughness model.
3. *Defect Definition* – A single cut-off velocity of 4,401 m/s is obtained for the whole shaft which is close to shaft median velocity (4,428 m/s).
4. *Defect Characterization and Imaging* – No defects are indicated.

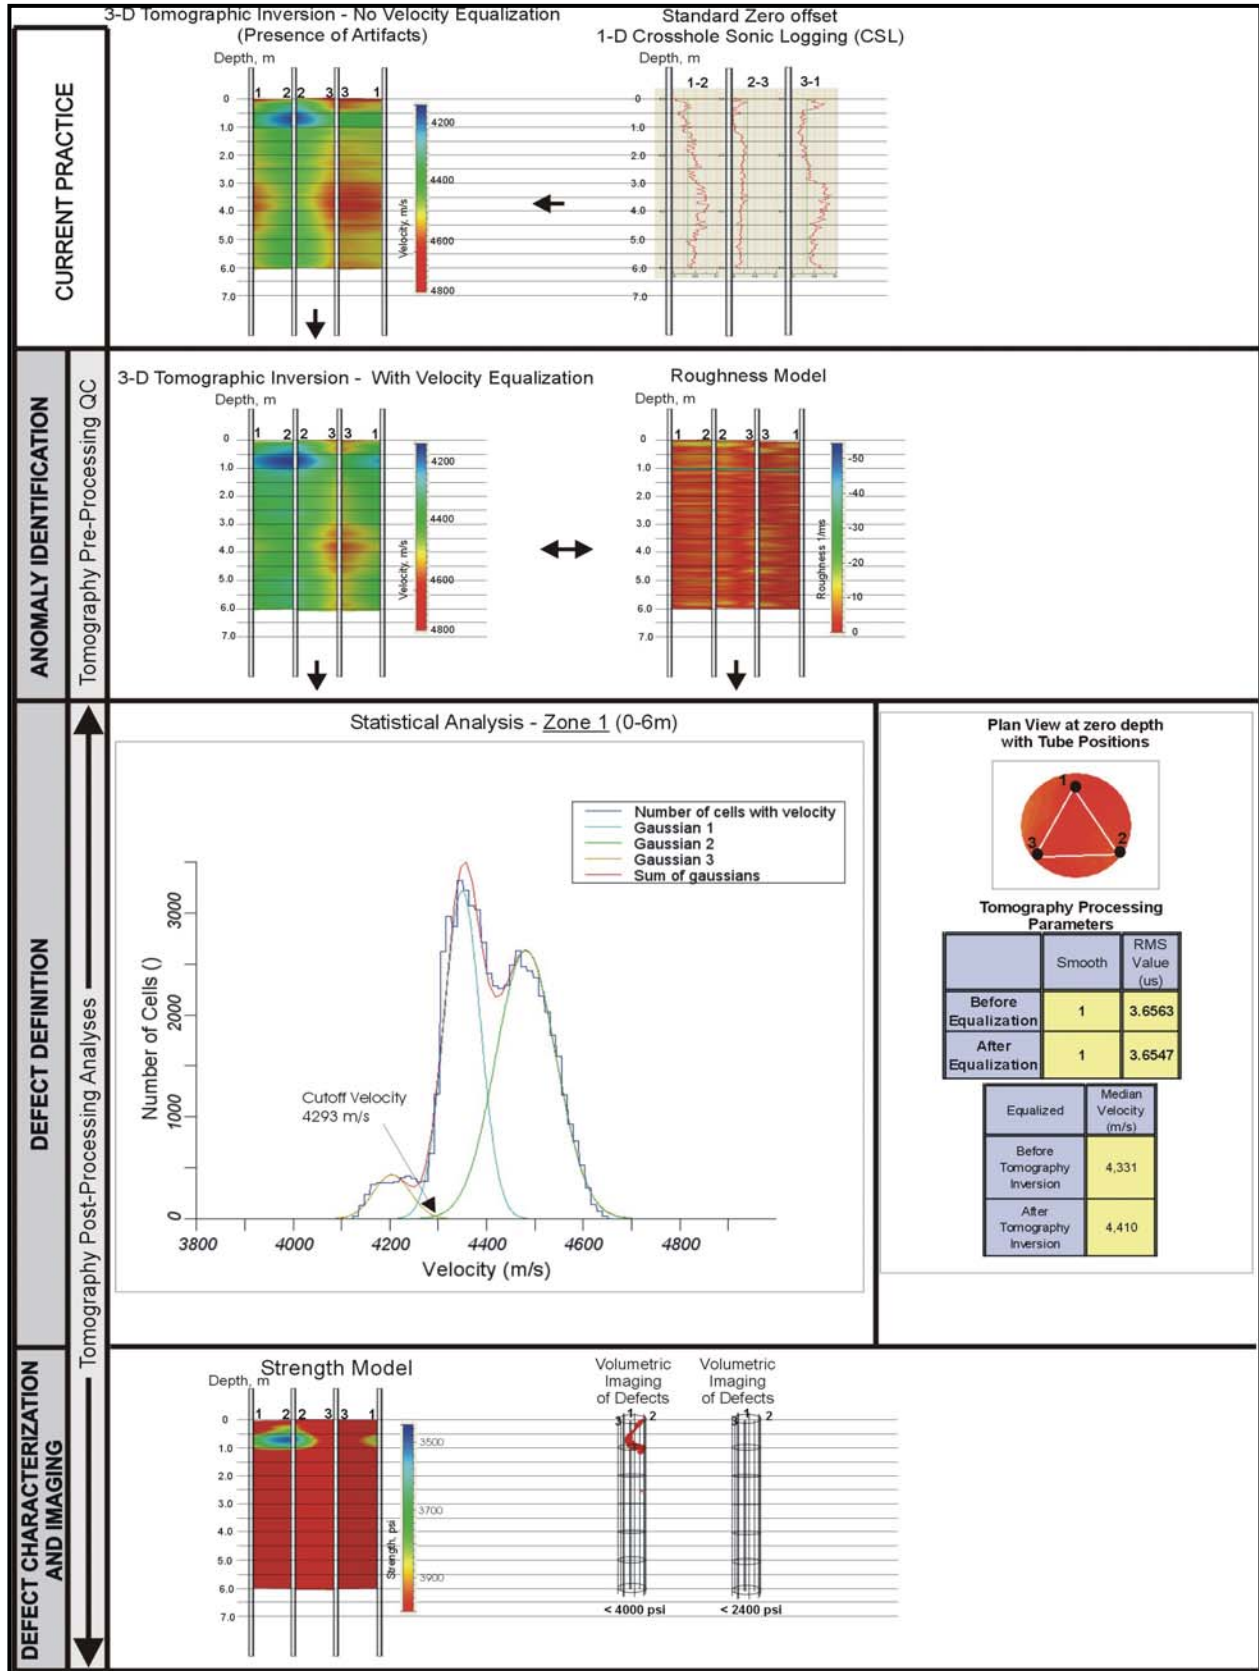
Figure 55. Schematic. Defect Characterization and Imaging Results from Shaft P1B, Jim Camp Bridge.

1. *Current Practice* – Standard CSL indicates no anomalies, just irregular CSL dataset. Zero-offset tomography (CSLT), with no velocity equalization, indicates a low velocity zone near Tube 2.
2. *Anomaly Identification* – Zero-offset CSLT with velocity equalization balances the velocity panels also confirms the low velocity zone between 0.5-1 m with slight indication in the roughness model.
3. *Defect Definition* – A single cut-off velocity of 4,293 m/s is obtained for the whole shaft which is close to shaft median velocity (4,410 m/s).
4. *Defect Characterization and Imaging* – One small defect between 0.2-1 m near Tube 2 is indicated. Volumetric images indicate that this defect is of high relative strength (>16,500 kPa (2,400 psi)).

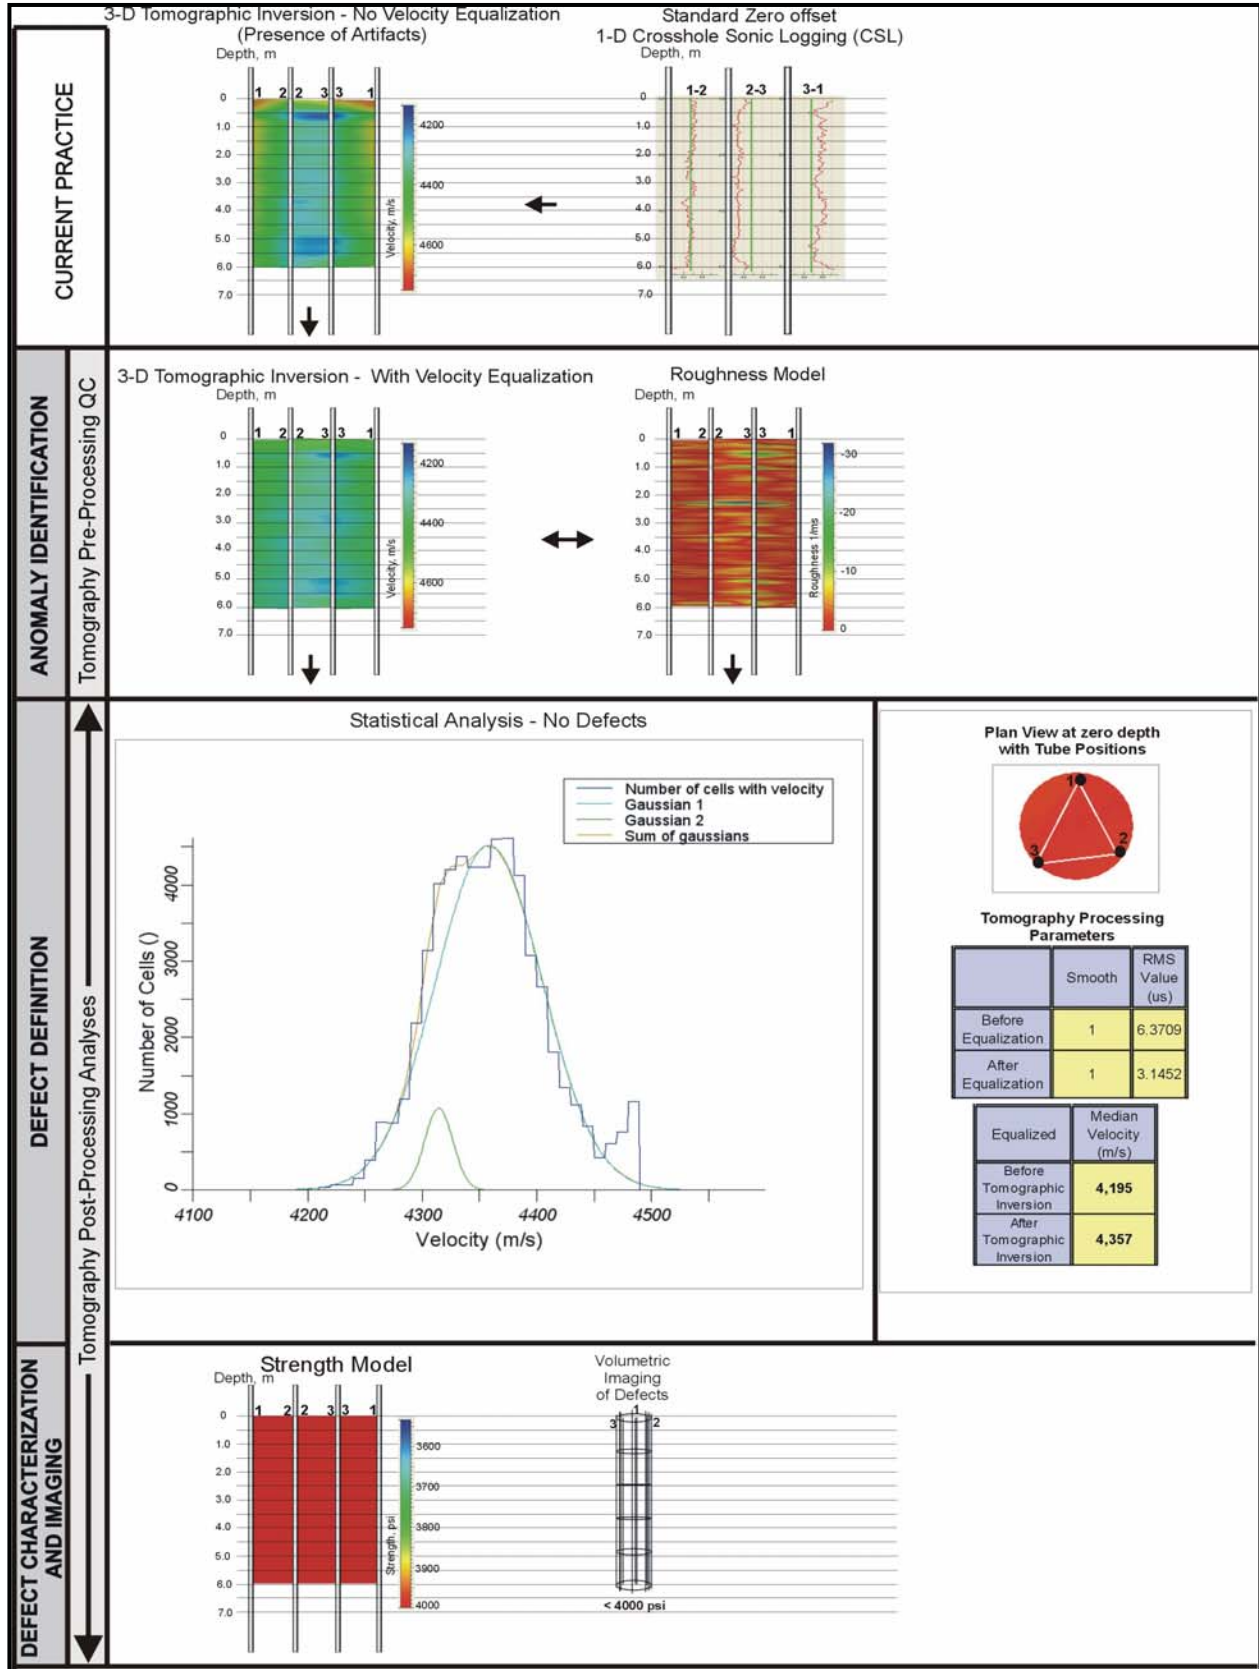
Figure 56. Schematic. Defect Characterization and Imaging Results from Shaft P2A, Jim Camp Bridge.

1. *Current Practice* – Standard CSL indicates no anomalies. Zero-offset tomography (CSLT), with no velocity equalization, indicates two low velocity zones between Tubes 2 and 3 between 0.5-0.8 m and 5-5.5 m.
2. *Anomaly Identification* – Zero-offset CSLT with velocity equalization balances the velocity panels and the apparent low velocity zones.
3. *Defect Definition* – No single cut-off velocity could be obtained for the whole shaft.
4. *Defect Characterization and Imaging* – No defects are indicated.
