CHAPTER 5 – EXAMINATION OF FIELD DATA

5.1 STANDARDIZED PRESENTATION OF THE DEFECT CHARACTERIZATION AND IMAGING RESULTS

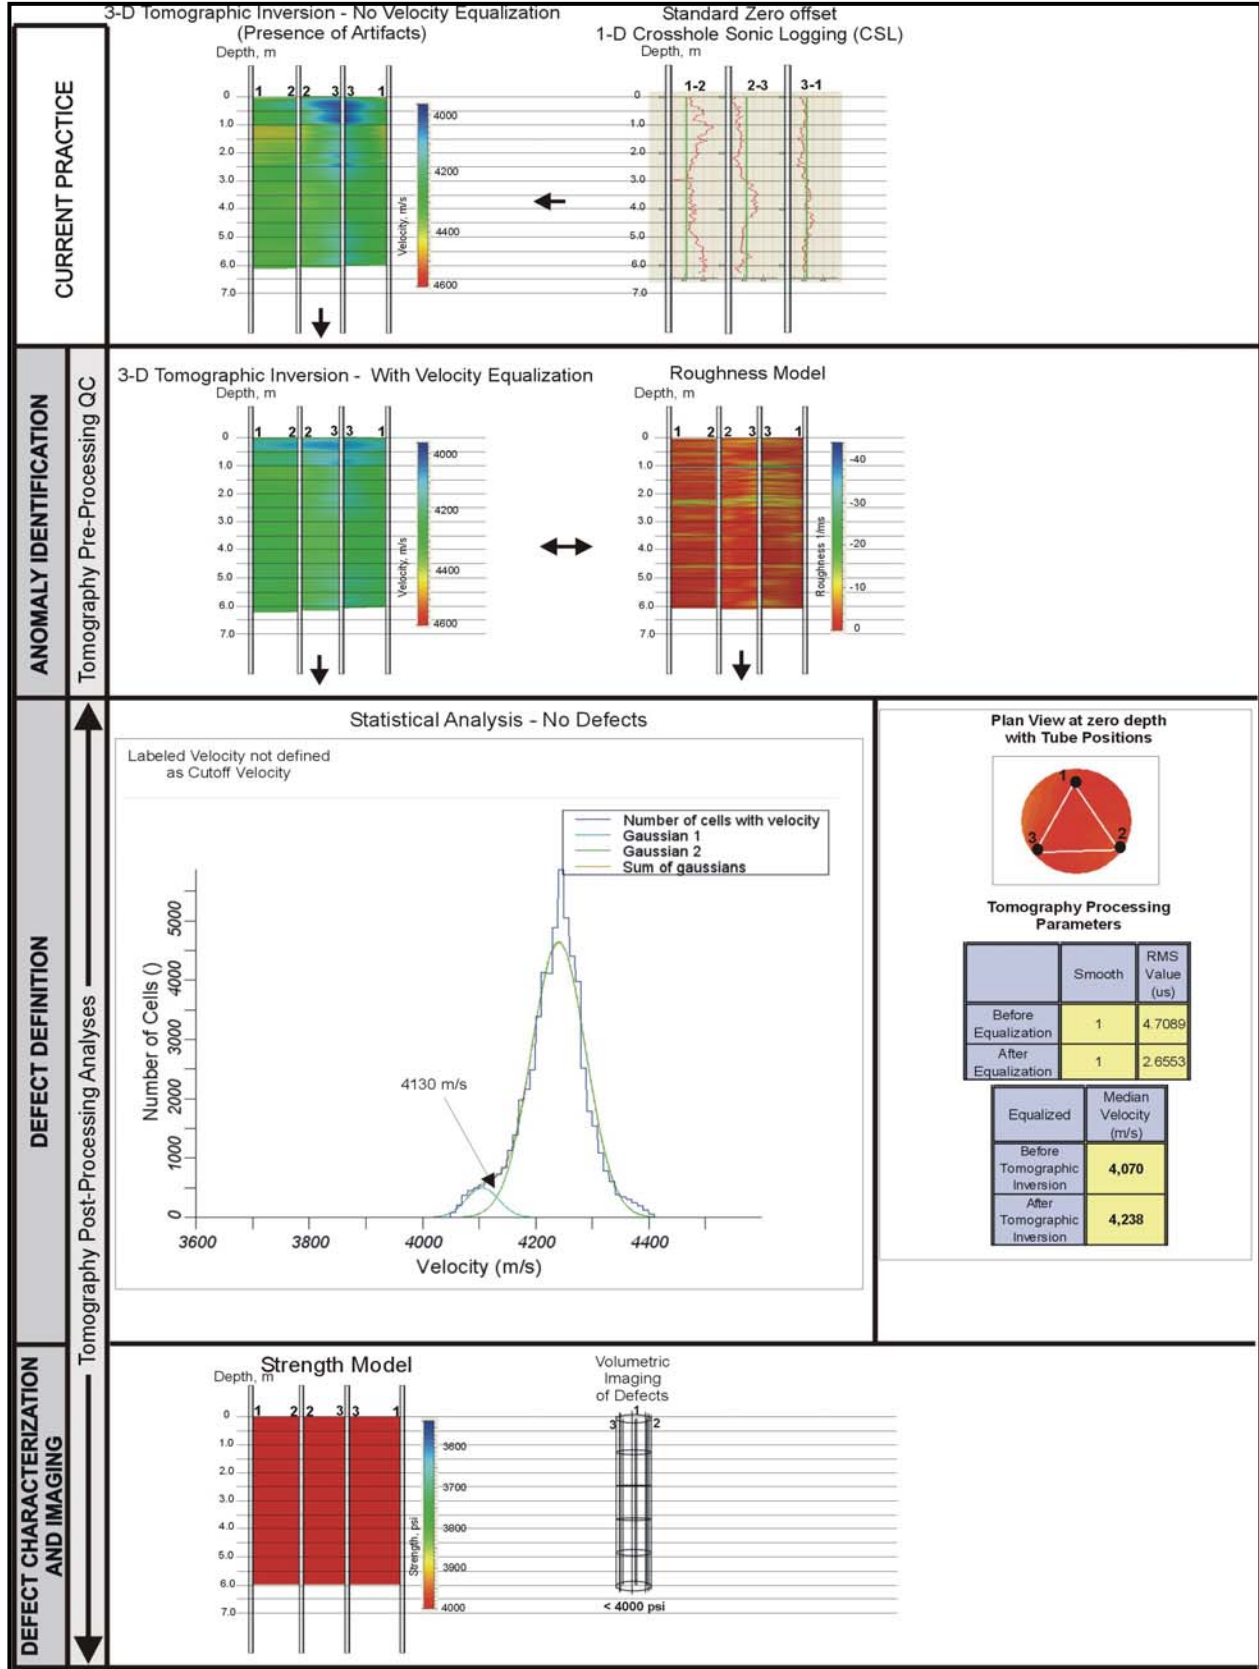
Figure 57. Schematic. Defect Characterization and Imaging Results from Shaft P2B, Jim Camp Bridge.

1. *Current Practice* – Standard CSL indicates no anomalies. Zero-offset tomography (CSLT), with no velocity equalization, indicates a low velocity zone near Tube 3 between 0-1 m.
2. *Anomaly Identification* – Zero-offset CSLT with velocity equalization balances the velocity panels and the apparent low velocity zone.
3. *Defect Definition* – A single cut-off velocity of 4,130 m/s is obtained for the whole shaft which is close to the shaft median velocity (4,238 m/s).
4. *Defect Characterization and Imaging* – No defects are indicated.

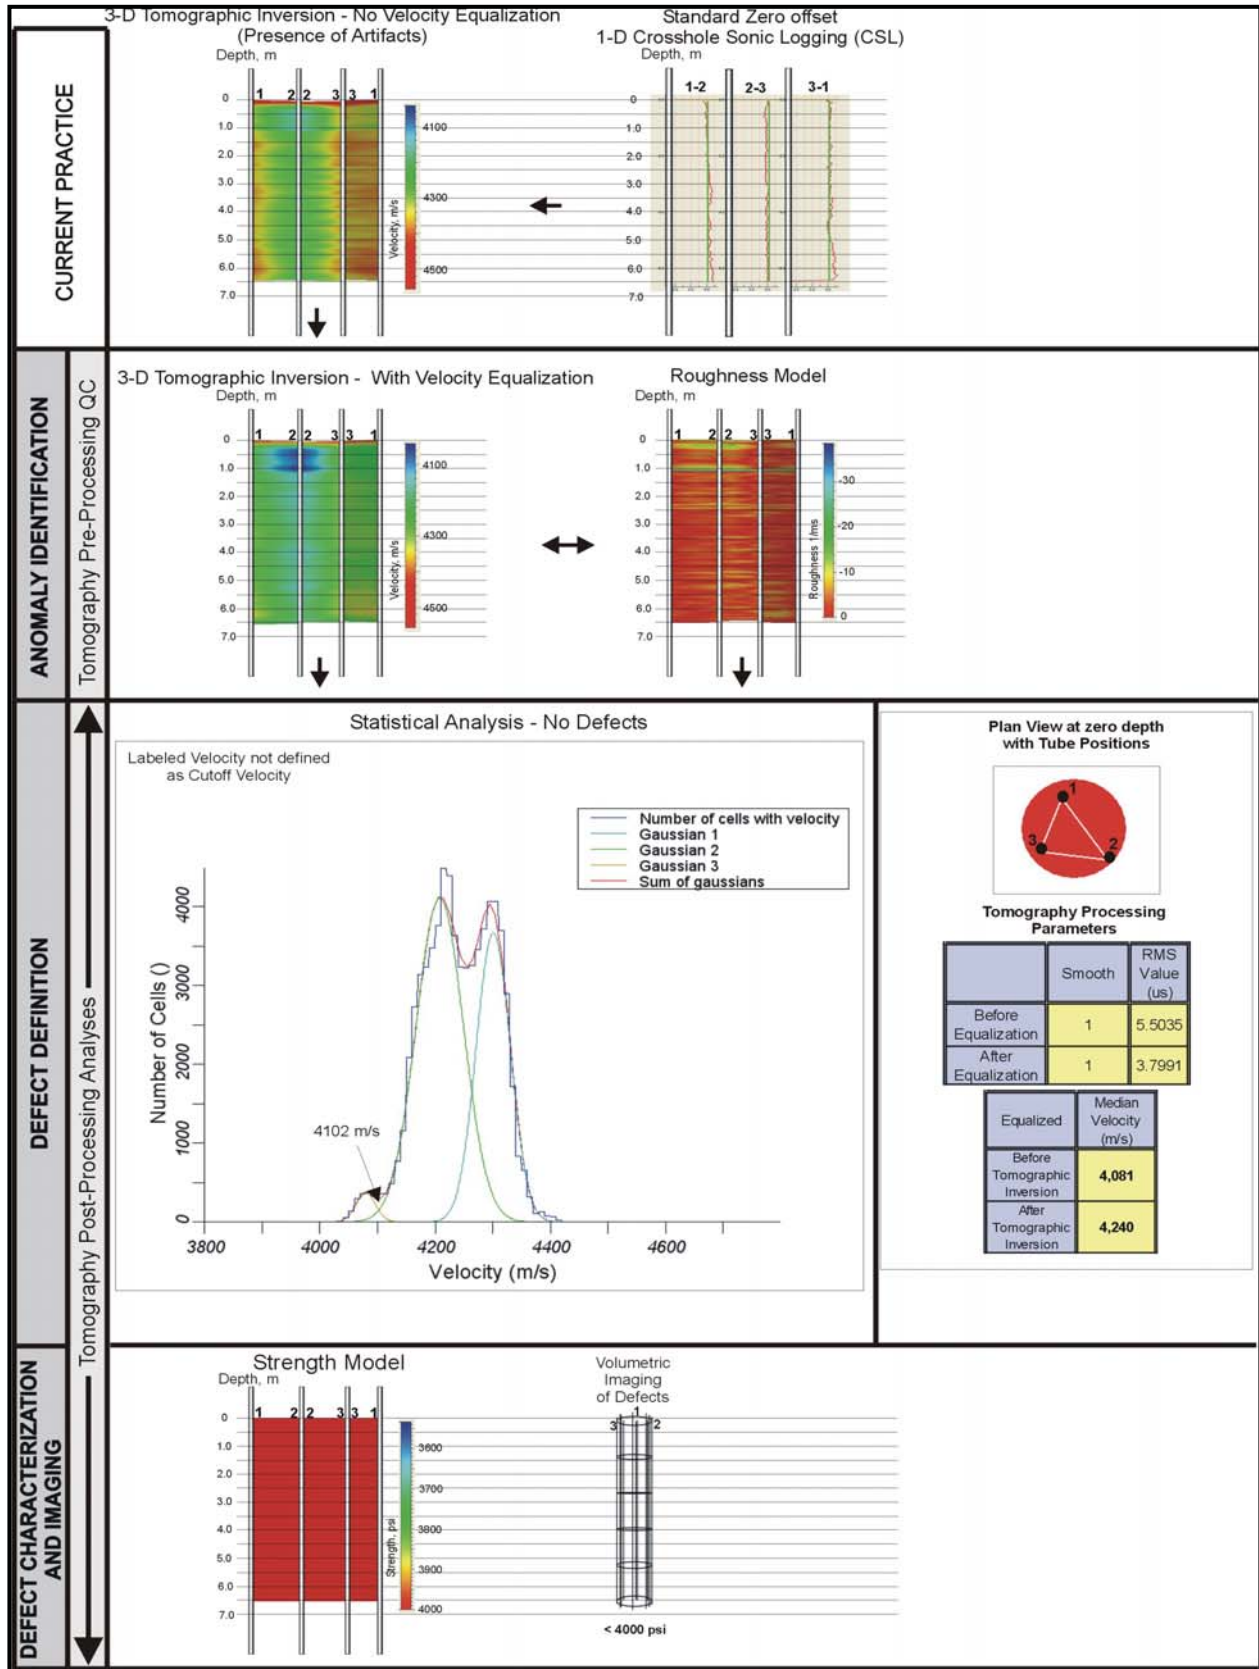
Figure 58. Schematic. Defect Characterization and Imaging Results from Shaft P3A, Jim Camp Bridge.

1. *Current Practice* – Standard CSL indicates no anomalies. Zero-offset tomography (CSLT), with no velocity equalization, indicates un-balanced velocity panels in the CSLT images, probably due to the tube positioning errors.
2. *Anomaly Identification* – Zero-offset CSLT with velocity equalization balances the velocity panels and an apparent low velocity anomaly is indicated between 0.2-1.0 m depths.
3. *Defect Definition* – A single cut-off velocity of 4,102 m/s is obtained for the whole shaft which is close to the shaft median velocity (4,240 m/s).
4. *Defect Characterization and Imaging* – No defects are indicated.

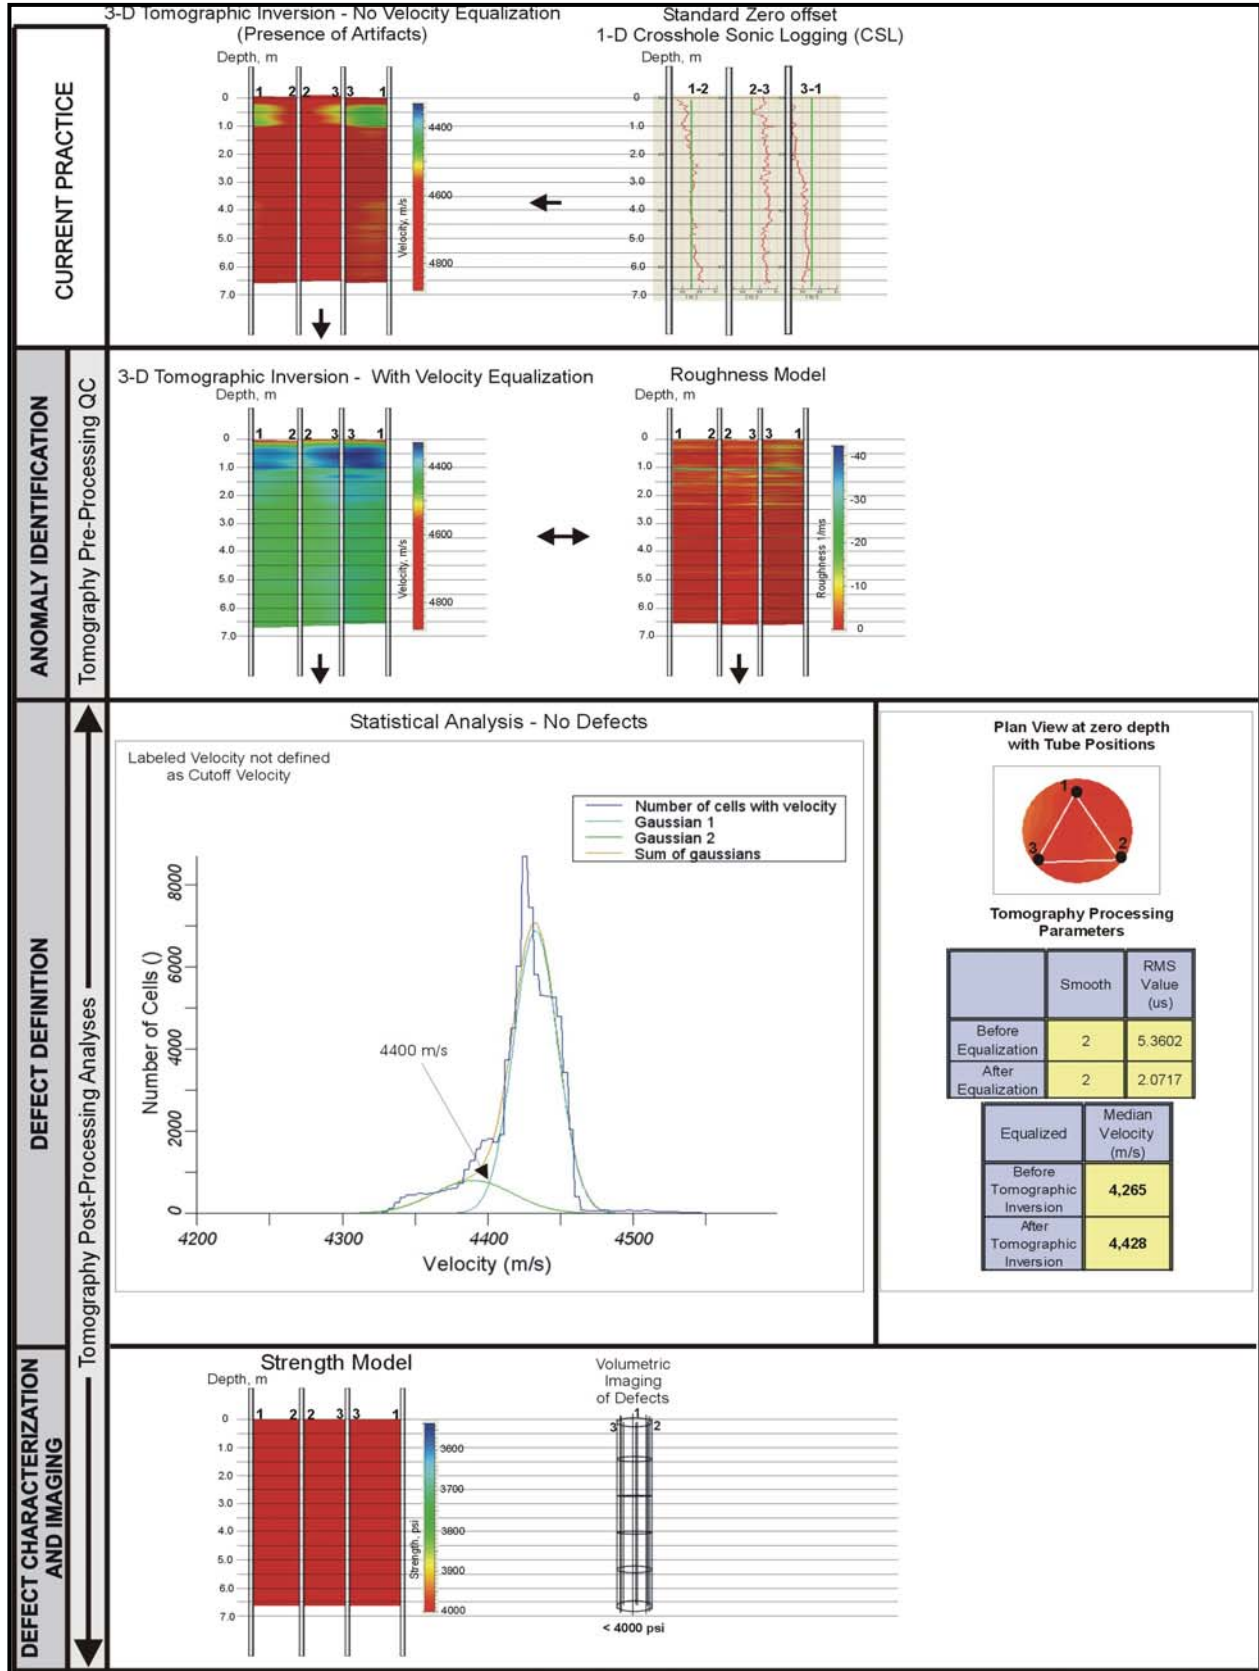
Figure 59. Schematic. Defect Characterization and Imaging Results from Shaft P3B, Jim Camp Bridge.

1. *Current Practice* – Standard CSL indicates no anomalies. Zero-offset tomography (CSLT), with no velocity equalization, indicates slightly un-balanced velocity panels in the CSLT images.
2. *Anomaly Identification* – Zero-offset CSLT with velocity equalization balances the velocity panels and an apparent low velocity zone indicated between 0.3-1.0 m depths.
3. *Defect Definition* – A single cut-off velocity of 4,400 m/s is obtained for the whole shaft which is about equal to the shaft median velocity (4,428 m/s).
4. *Defect Characterization and Imaging* – No defects are indicated.

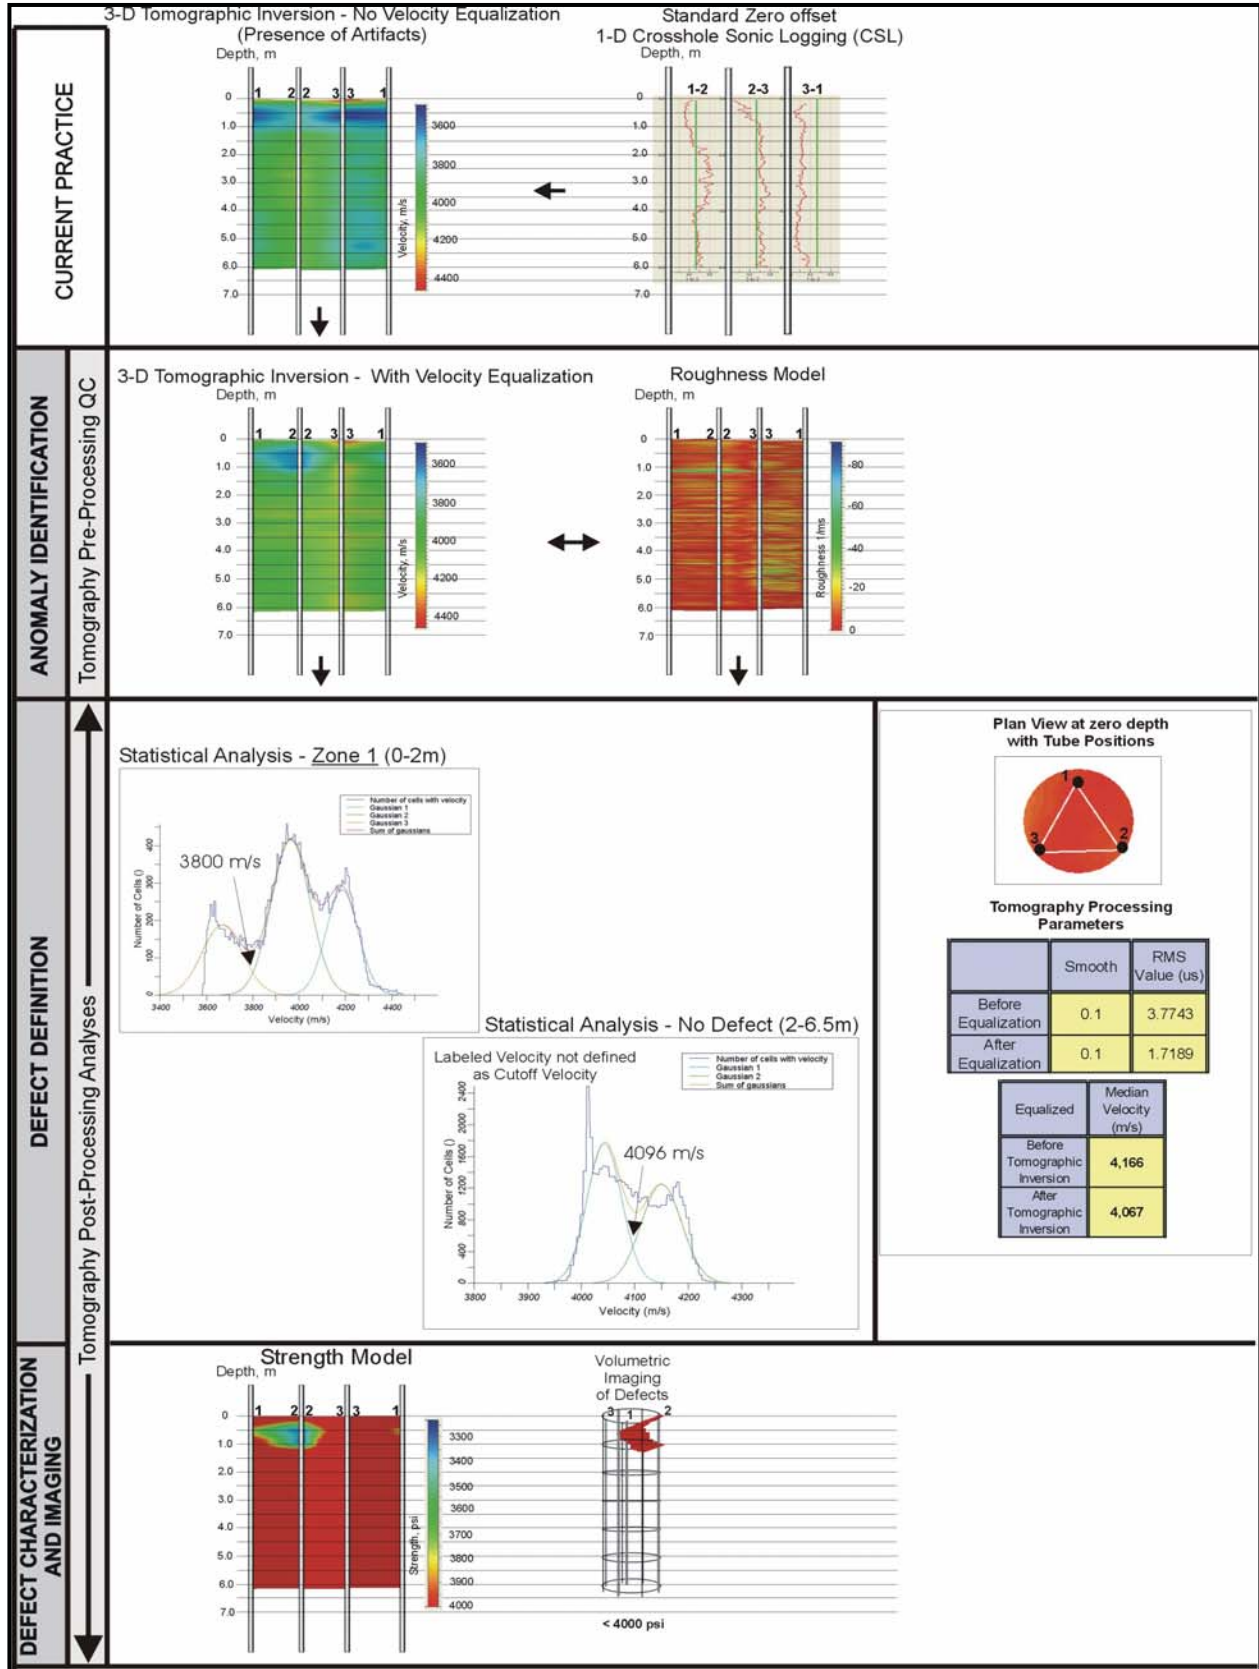
Figure 60. Schematic. Defect Characterization and Imaging Results from Shaft P4A, Jim Camp Bridge.

1. *Current Practice* – Standard CSL indicates no anomalies, just irregular CSL dataset. Zero-offset tomography (CSLT), with no velocity equalization, indicates a low velocity zone between 0.5-1 m.
2. *Anomaly Identification* – Zero-offset CSLT with velocity equalization balances the velocity panels also confirms the low velocity zone near Tube 2 with slight indication in the roughness model.
3. *Defect Definition* – Two zones are selected and velocity cut-off values are indicated using 2 and 3 Gaussian fits to the velocity histogram. Anomaly 1 (0-2 m) has a cut-off velocity of 3,800 m/s, which is close to shaft median velocity of 4,067 m/s.
4. *Defect Characterization and Imaging* – One small defect between 0.2-1 m near Tube 2 is indicated. Volumetric images indicate that this defect is of high relative strength (~27,600 kPa (4,000 psi)).

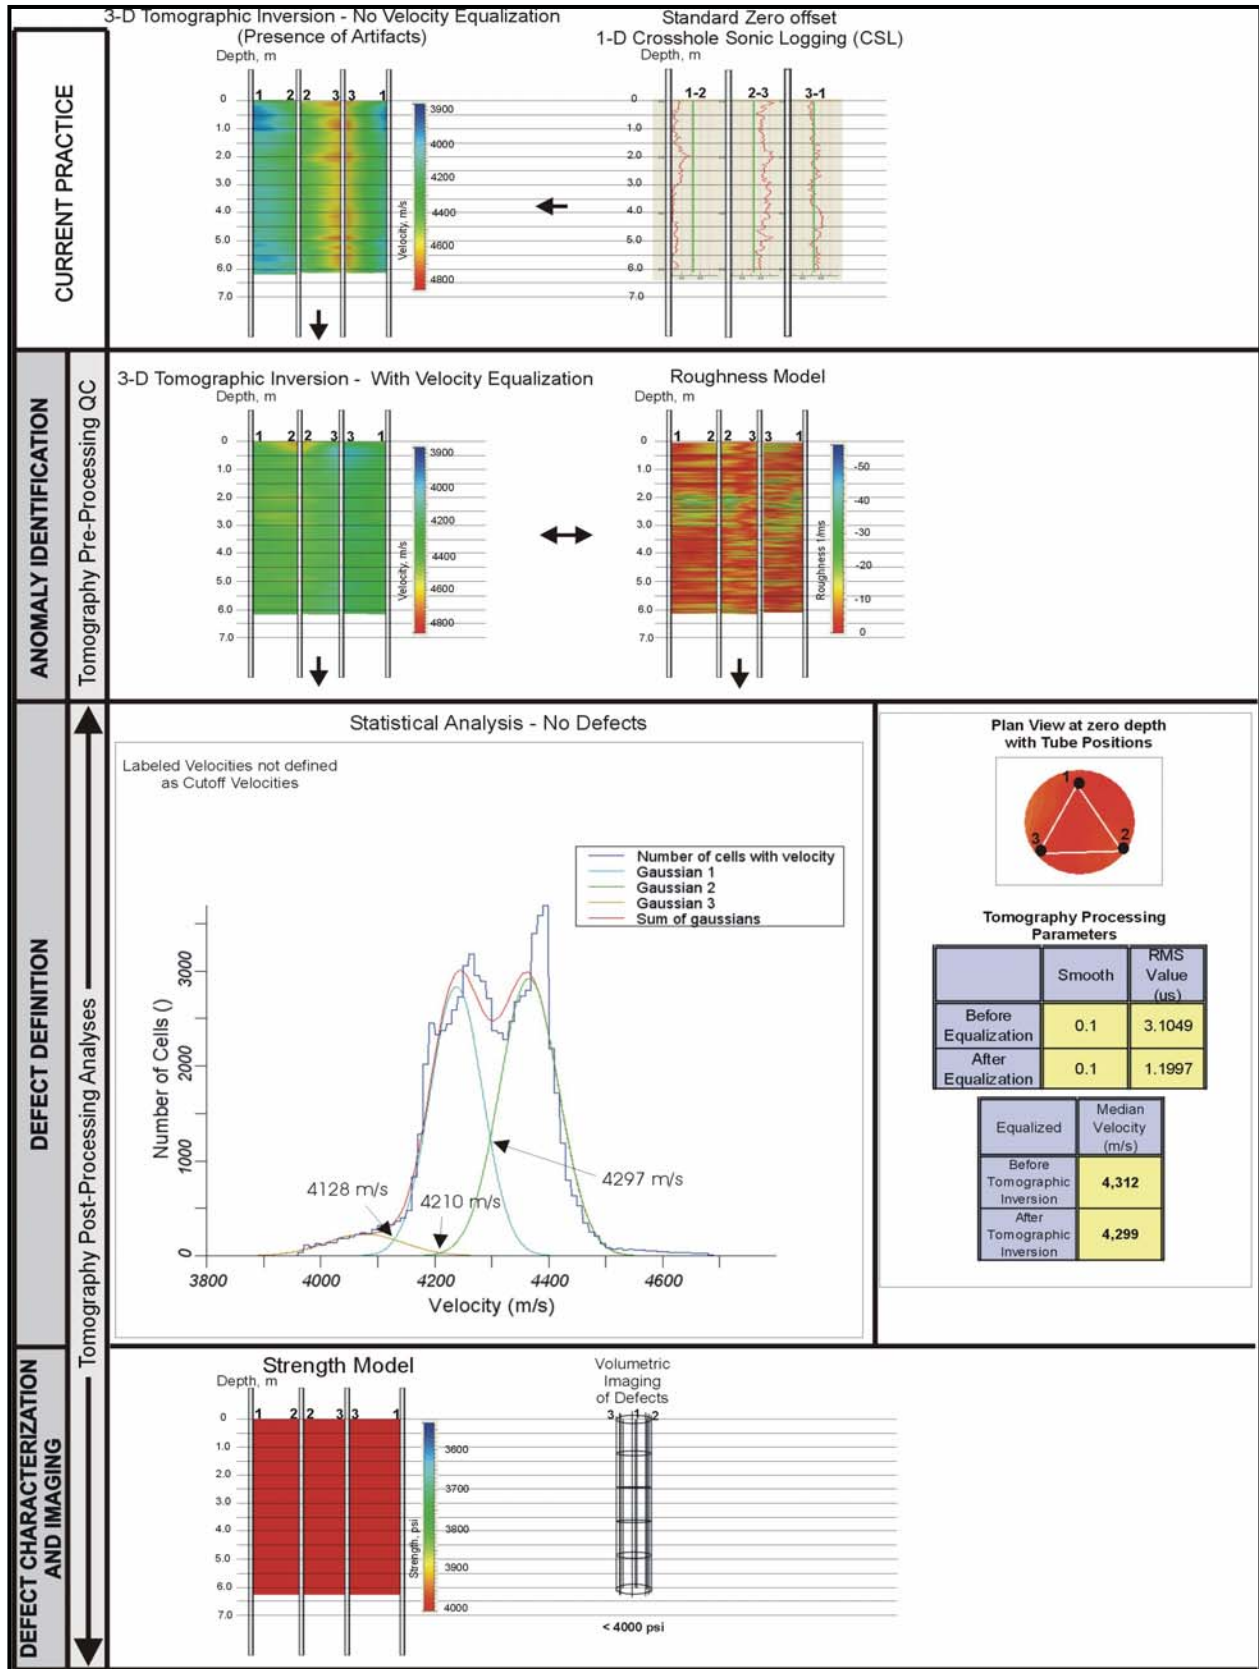
Figure 61. Schematic. Defect Characterization and Imaging Results from Shaft P4B, Jim Camp Bridge.

1. *Current Practice* – Standard CSL indicates no anomalies. Zero-offset tomography (CSLT), with no velocity equalization, indicates un-balanced velocity panels in the CSLT images.
2. *Anomaly Identification* – Zero-offset CSLT with velocity equalization balances the velocity panels.
3. *Defect Definition* – A single cut-off velocity of 4,128 m/s is obtained for the whole shaft which is close to the shaft median velocity (4,299 m/s).
4. *Defect Characterization and Imaging* – No defects are indicated.

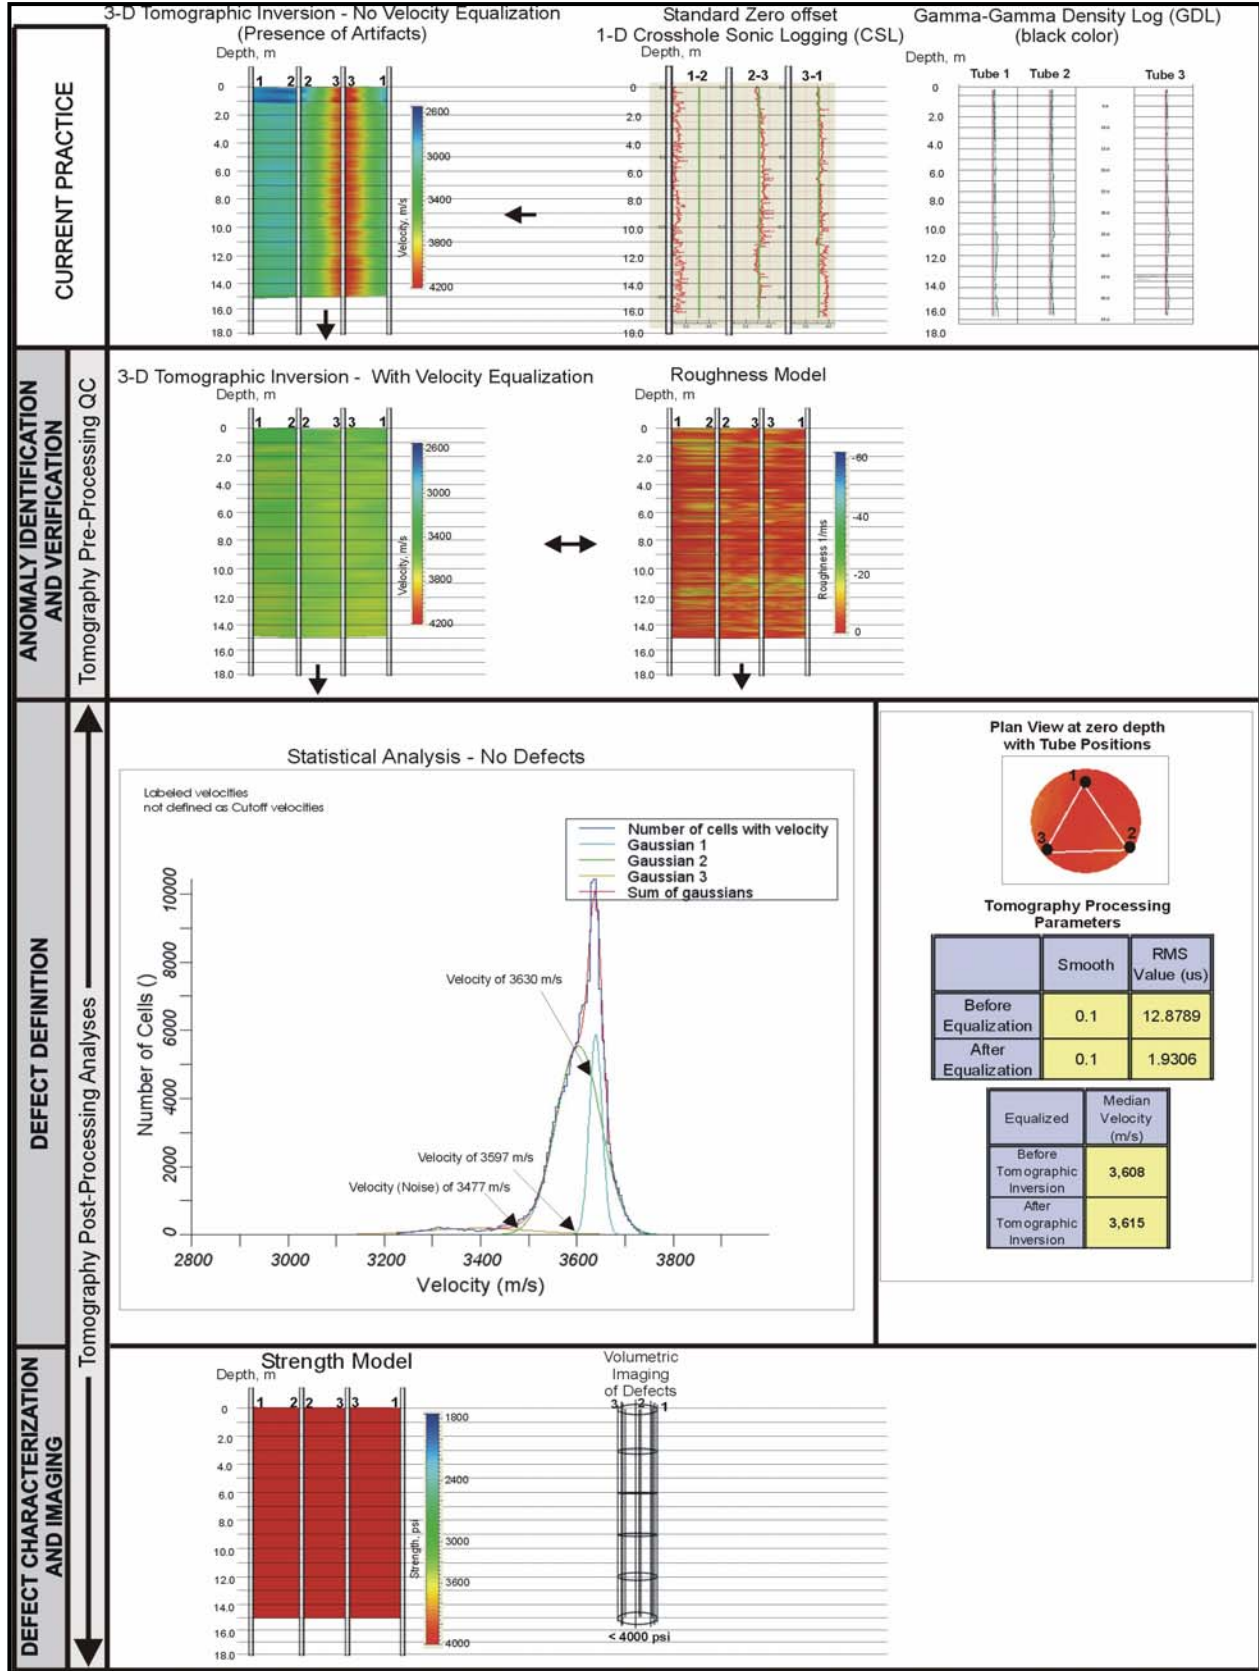
Figure 62. Schematic. Defect Characterization and Imaging Results from Shaft 7, Sevenmile-Gooseberry Bridge.

1. *Current Practice* – Standard CSL indicates no anomalies. Zero-offset tomography (CSLT), with no velocity equalization, is highly un-balanced, probably due to the tube positioning errors in the field.
2. *Anomaly Identification and Verification* – Zero-offset CSLT with velocity equalization indicates no anomalies. GDL data indicates no anomalies. (In our presentation format, GDL data is shown along with mean, 2, and 3 standard deviations from mean indicated in green, blue, and red vertical lines, respectively).
3. *Defect Definition* – No single low cut-off velocity can be determined for the sound shaft.
4. *Defect Characterization and Imaging* – No anomalies are detected in the shaft.

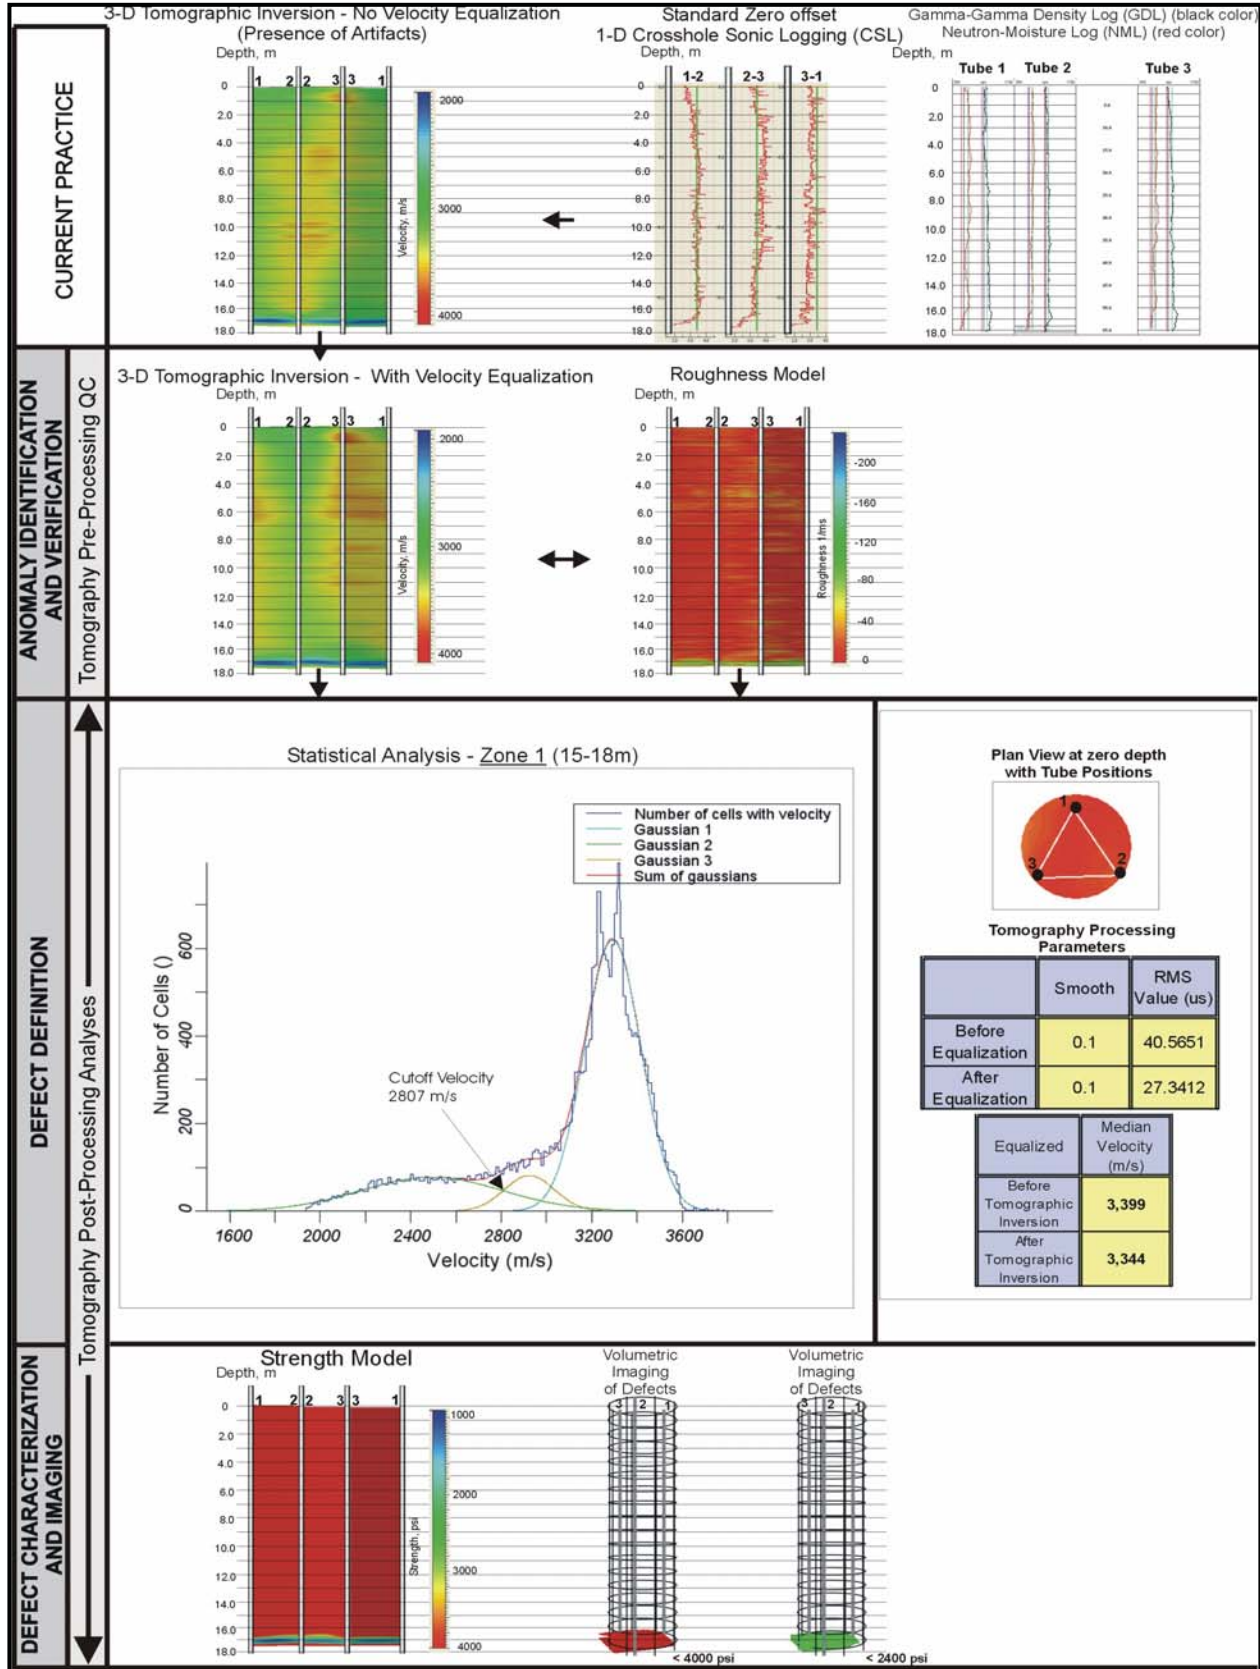
Figure 63. Schematic. Defect Characterization and Imaging Results from Shaft 8, Sevenmile-Gooseberry Bridge.

1. *Current Practice* – Standard CSL indicates a soft bottom between 17-17.5 m. Zero-offset tomography (CSLT), with no velocity equalization, images the soft bottom.

2. *Anomaly Identification and Verification* – Zero-offset CSLT with velocity equalization better resolves the soft bottom with slight indication in the roughness model. GDL (shown in black) indicates no anomalies; therefore, the anomaly is located in the interior portion of the shaft. Note, however, that NML (shown in red) indicates that a high moisture zone exists in the bottom of the shaft.

3. *Defect Definition* – A single low cut-off velocity of 2,807 m/s is obtained for the whole shaft, which is less than the shaft median velocity (3,344 m/s).

4. *Defect Characterization and Imaging* – The soft bottom is clearly imaged in the strength model. Volumetric imaging indicates the soft bottom to be structurally significant (<16,500 kPa (2,400 psi)).

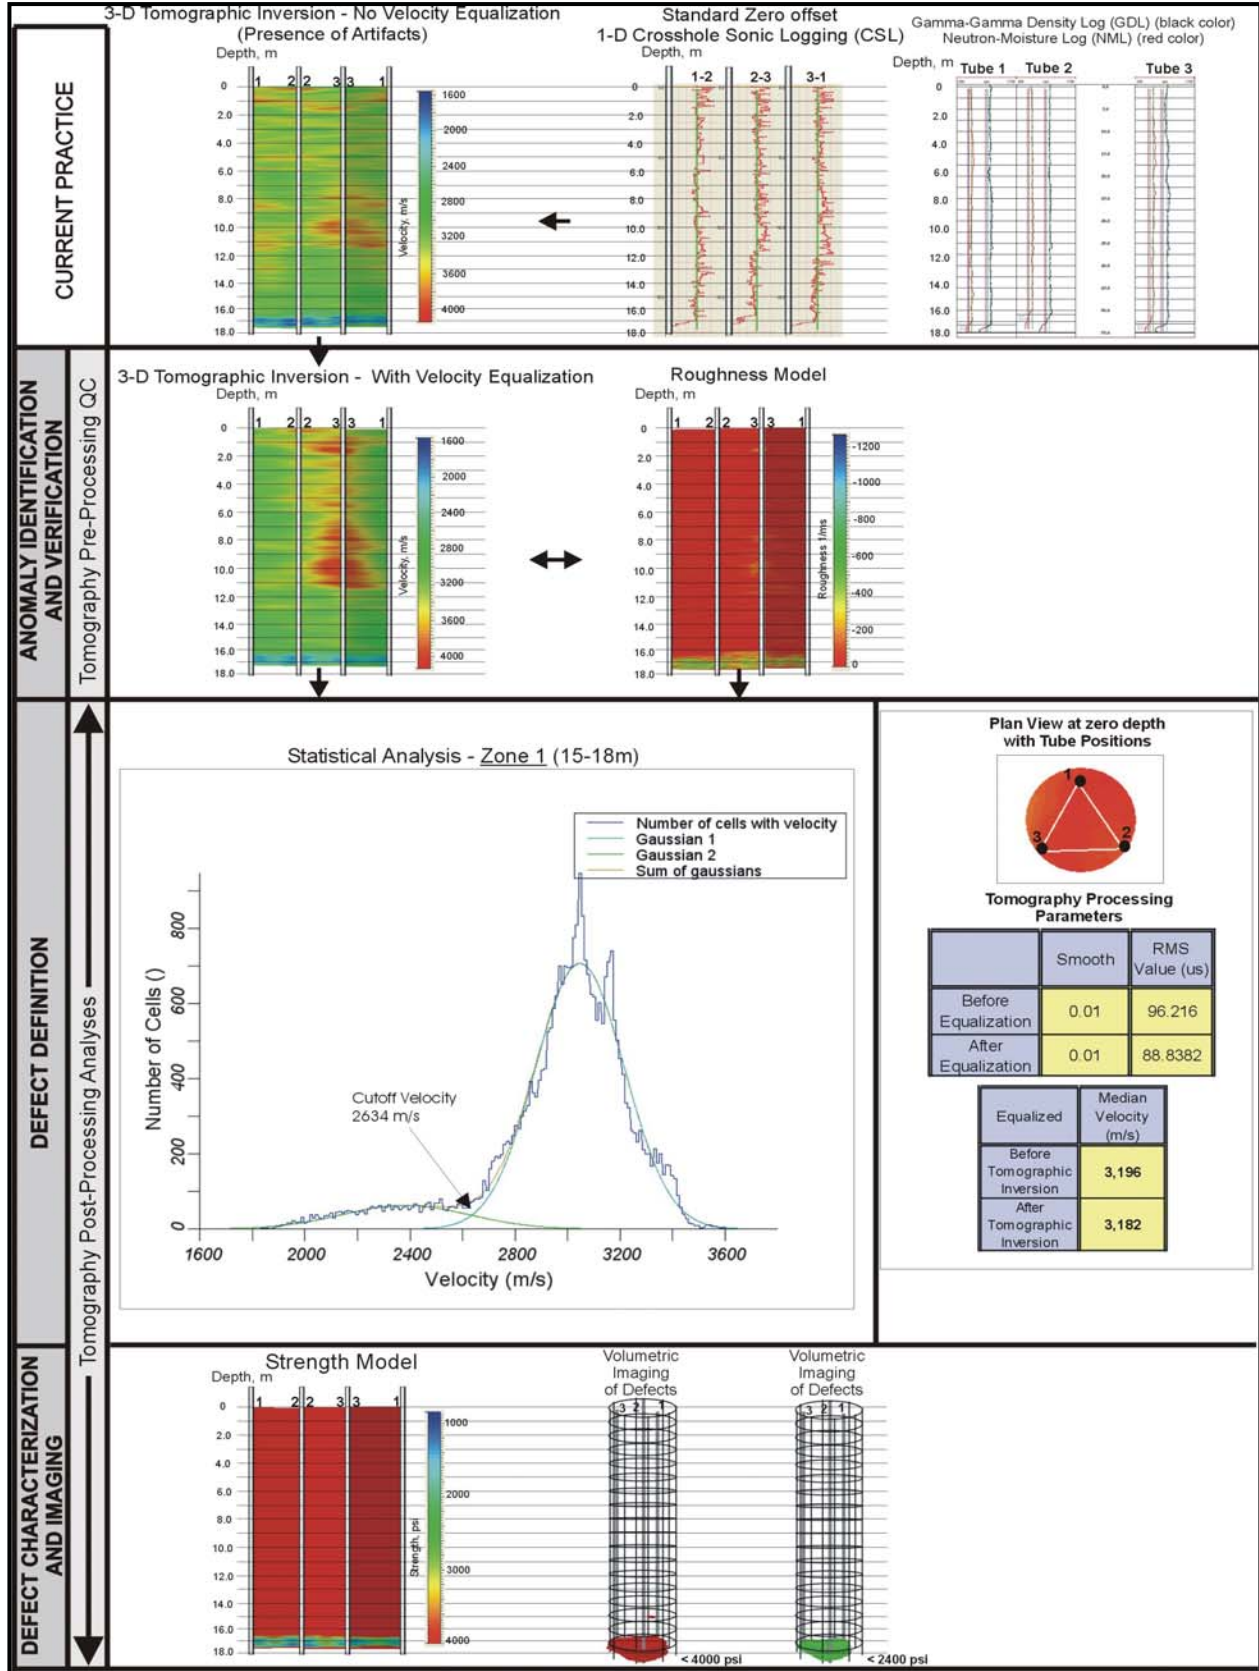
Figure 64. Schematic. Defect Characterization and Imaging Results from Shaft 9, Sevenmile-Gooseberry Bridge.

1. *Current Practice* – Standard CSL indicates a soft bottom between 17-17.5 m. Zero-offset tomography (CSLT), with no velocity equalization, images the soft bottom.
2. *Anomaly Identification and Verification* – Zero-offset CSLT with velocity equalization slightly better resolves the soft bottom with slight indication in the roughness model. GDL (shown in black) and NML (shown in red) confirm the soft bottom anomaly.
3. *Defect Definition* – A single low cut-off velocity of 2,634 m/s is obtained for the whole shaft.
4. *Defect Characterization and Imaging* – The soft bottom is clearly imaged in the strength model. Volumetric imaging indicates the soft bottom to be structurally significant.

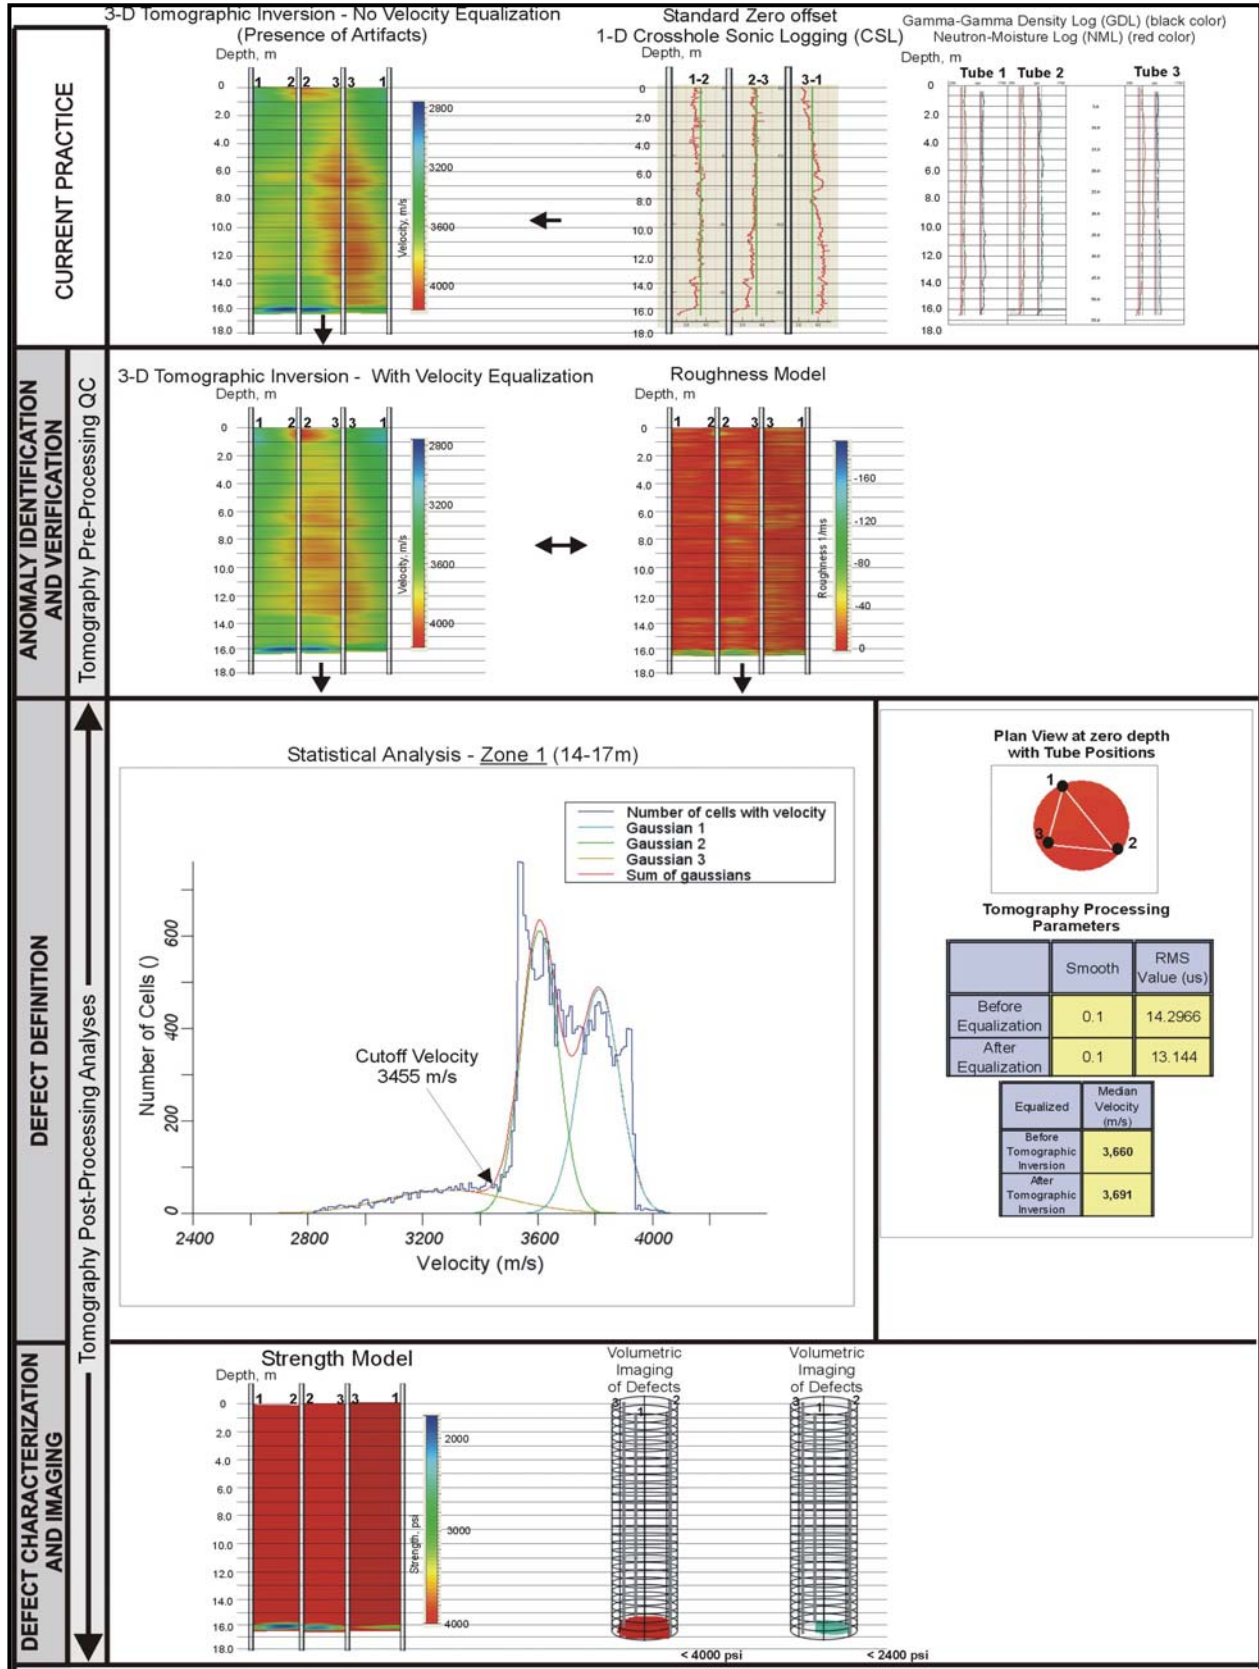
Figure 65. Schematic. Defect Characterization and Imaging Results from Shaft 10, Sevenmile-Gooseberry Bridge.

1. *Current Practice* – Standard CSL indicates a soft bottom between 16-16.5 m near Tube 2. Zero-offset tomography (CSLT), with no velocity equalization, images the soft bottom.
2. *Anomaly Identification and Verification* – Zero-offset CSLT with velocity equalization better resolves the soft bottom with good indication in the roughness model. GDL indicates only a small drop in density in Tube 2; therefore, the anomaly is situated in the inside of the shaft just missing Tubes 1 and 3.
3. *Defect Definition* – A single low cut-off velocity of 3,455 m/s is obtained for the whole shaft.
4. *Defect Characterization and Imaging* – The soft bottom is clearly imaged in the strength model. Volumetric imaging indicates the soft bottom to be structurally significant (<16,500 kPa (2,400 psi)).
