CHAPTER 5 – EXAMINATION OF FIELD DATA

5.1 STANDARDIZED PRESENTATION OF THE DEFECT CHARACTERIZATION AND IMAGING RESULTS

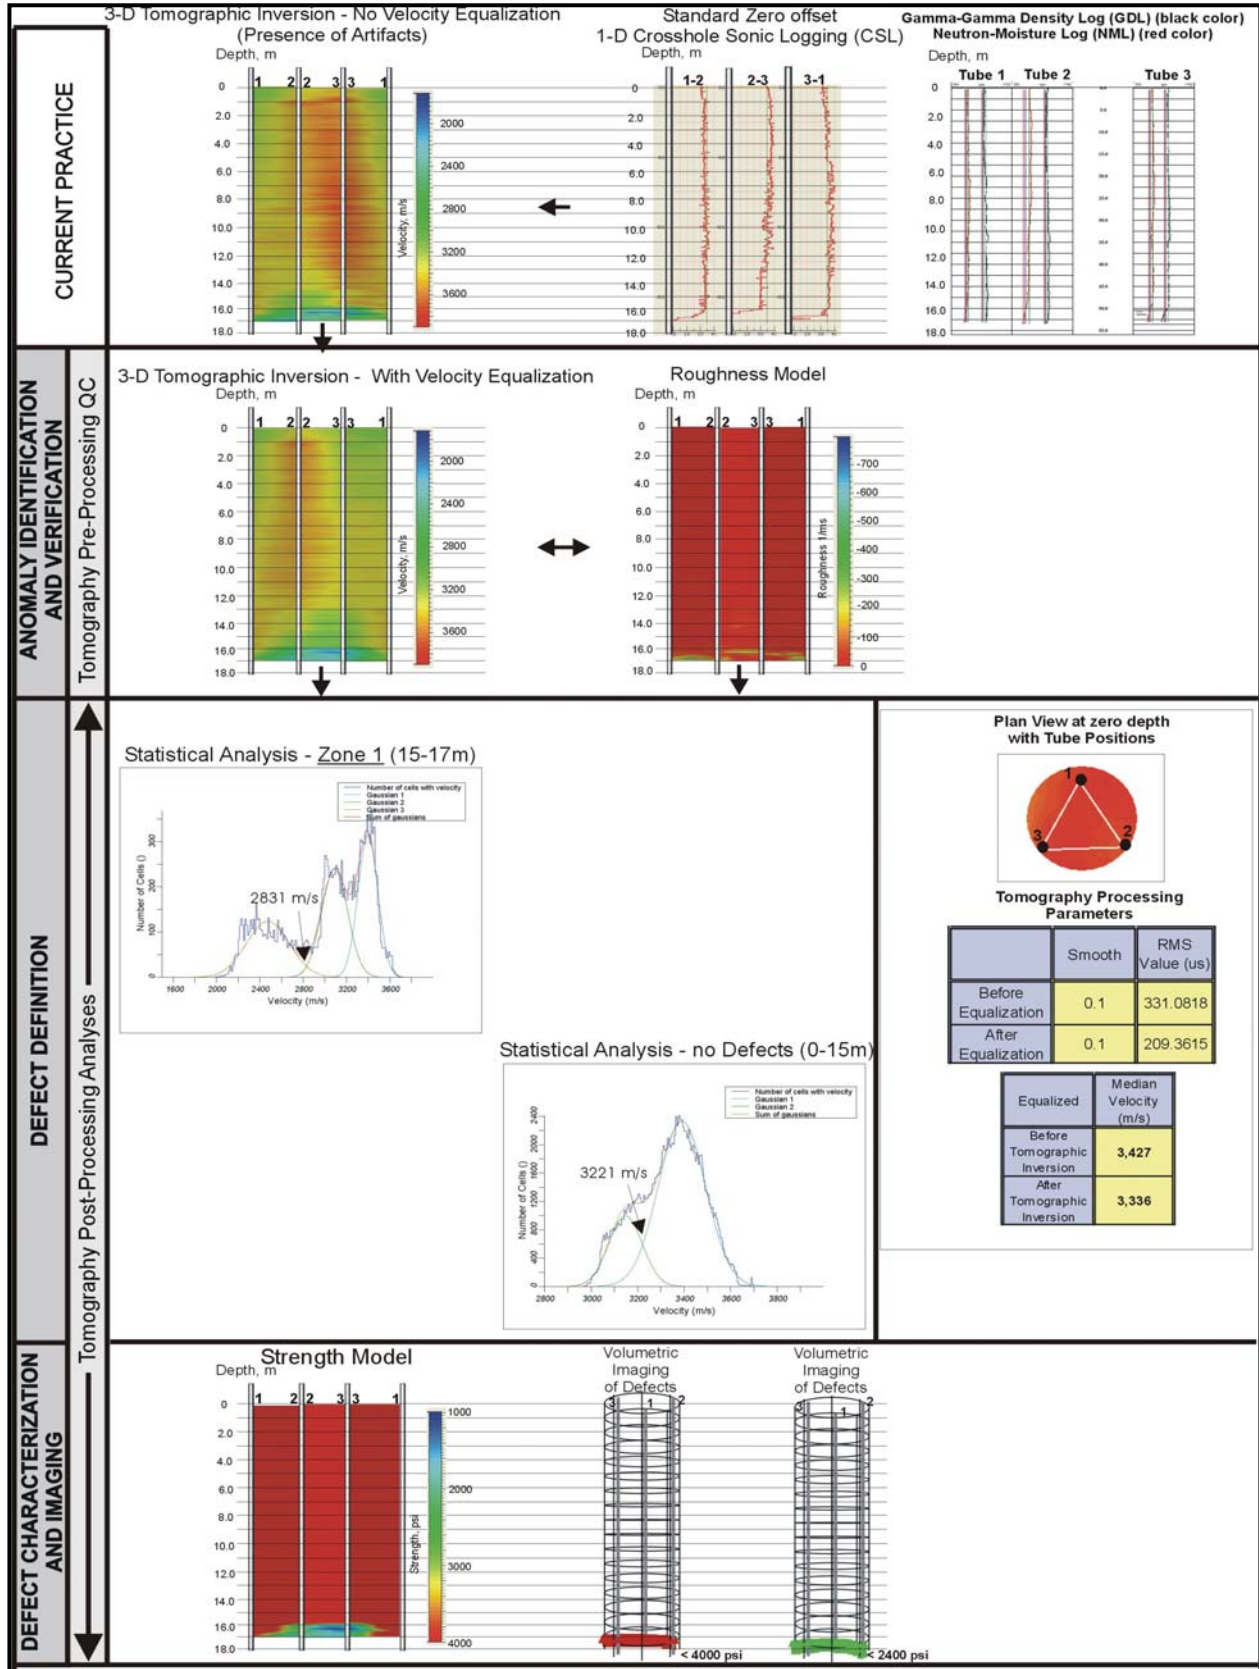
Figure 66. Schematic. Characterization and Imaging Results from Shaft 11, Sevenmile-Gooseberry Bridge.

1. *Current Practice* – Standard CSL indicates a soft bottom between 17-17.5 m. Zero-offset tomography (CSLT), with no velocity equalization, images the soft bottom.
2. *Anomaly Identification and Verification* – Zero-offset CSLT with velocity equalization better resolves the soft bottom with slight indication in the roughness model. GDL indicates an anomaly only in Tube 3; therefore, the anomaly extends to the interior portion of the shaft just missing Tubes 1 and 2.
3. *Defect Definition* – A single low cut-off velocity of 2,831 m/s is obtained for the whole shaft.
4. *Defect Characterization and Imaging* – The soft bottom is clearly imaged in the strength model. Volumetric imaging indicates the soft bottom to be structurally significant (<16,500 kPa (2,400 psi)).

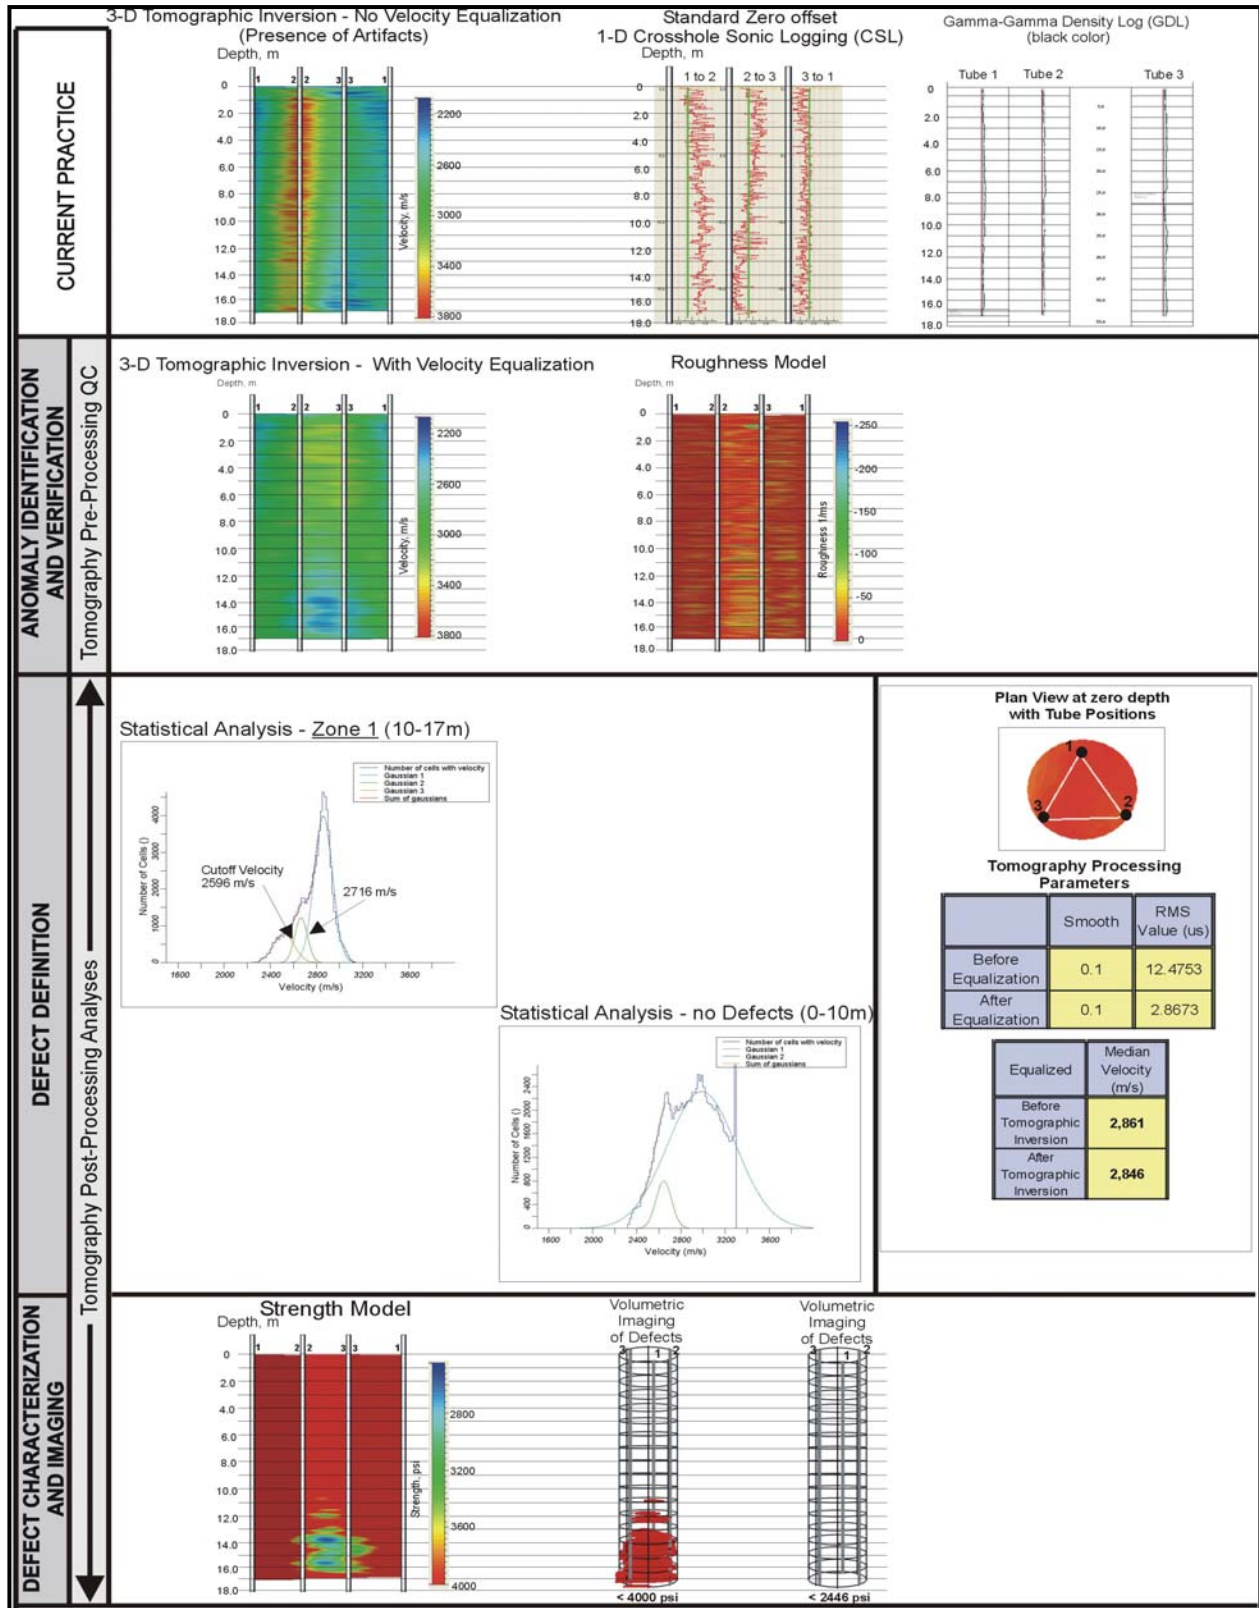
Figure 67. Schematic. Characterization and Imaging Results from Shaft 12, Sevenmile-Gooseberry Bridge.

1. *Current Practice* – Standard CSL indicates no anomalies. Zero-offset tomography (CSLT), with no velocity equalization, is highly un-balanced, probably due to the tube positioning errors in the field.
2. *Anomaly Identification and Verification* – Zero-offset CSLT with velocity equalization indicates a small anomaly between 14-16 m. GDL also indicates no anomalies.
3. *Defect Definition* – A single low cut-off velocity of 2,596 m/s is obtained for the whole shaft.
4. *Defect Characterization and Imaging* – One small defect between 13-16 m near Tubes 2 and 3 is indicated. Volumetric images indicate that this defect is not structurally significant ($>16,500$ kPa (2,400 psi)).
