APPENDIX A – DUAL CROSSHOLE SONIC LOGGING (CSL) AND GAMMA-
GAMMA DENSITY LOGGING (GDL) - CASE HISTORIES

In this appendix, seven (7) case histories are presented to outline the benefits of **dual** logging for accurate interpretation of anomalies in drilled shafts both inside and outside the rebar cage (including rebar exposure to soil). Dual logging is performed using both crosshole sonic logging (CSL) and gamma-gamma density logging (GDL) methods. Dual logging provides with independent verification of anomalies and provides a better picture for the possible causes for the observed anomalies. It also helps eliminate false positives or false negatives in the data that results in costly construction delays. The seven (7) case histories are all from the Arizona Department of Transportation (ADOT) project sites where dual logging was performed:

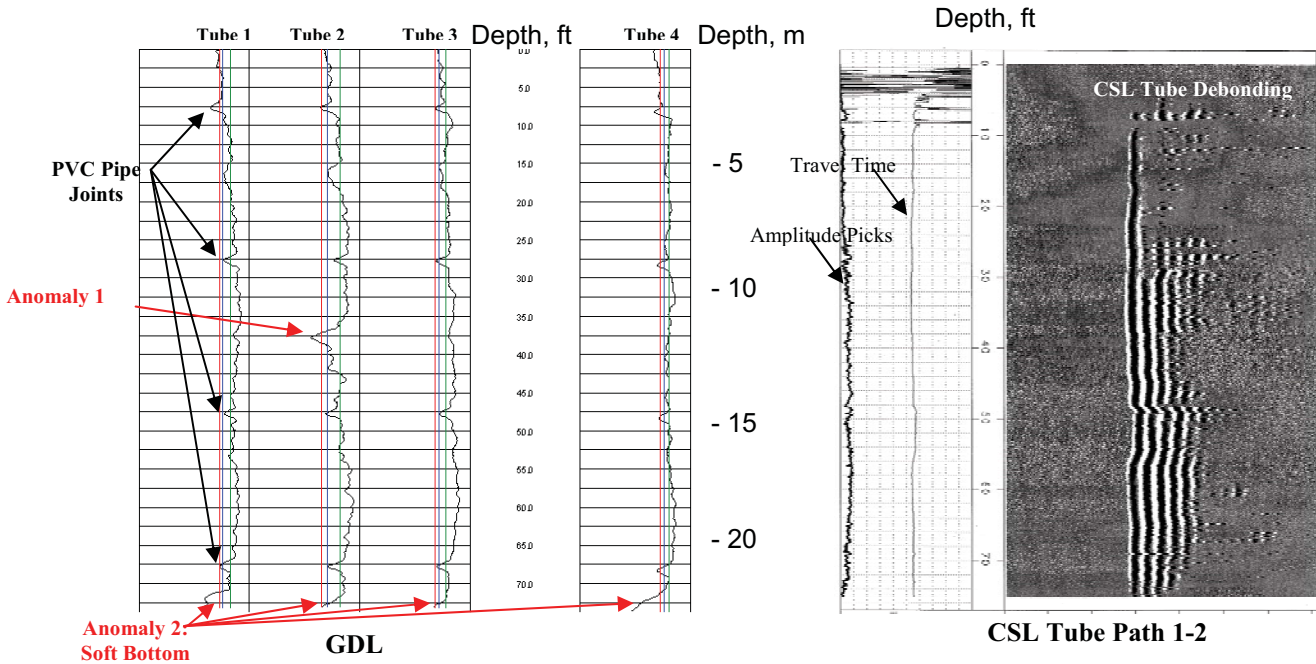
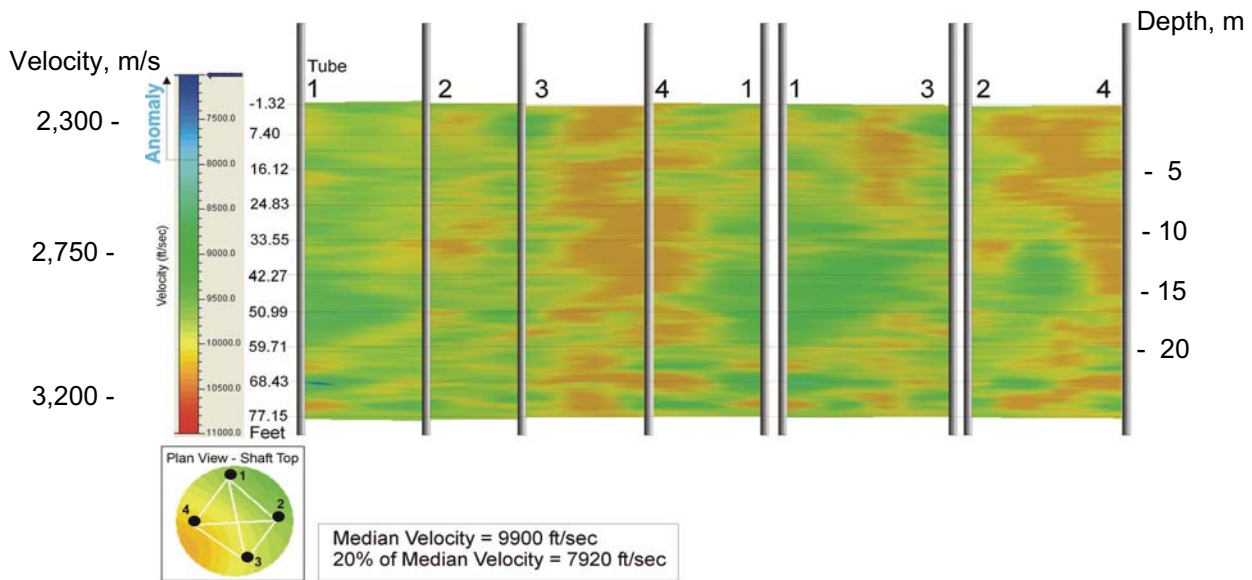
Case History	Inspection Tubes	Testing Age (Days)		GDL Anomalies	CSL/T Anomalies	
		CSL	GDL		Travel Time	Amplitude
5' Dia. Shaft	4 PVC	17	7	YES	NO	NO

GDL test was performed first which indicated a soft bottom condition and a poor quality density zone at Tube 2 between 11.3-11.8 m (37-39 ft). CSL and CSLT did not indicate velocity anomalies (just PVC tube debonding for 17-days old shaft).

Density anomalies were located outside the rebar cage.

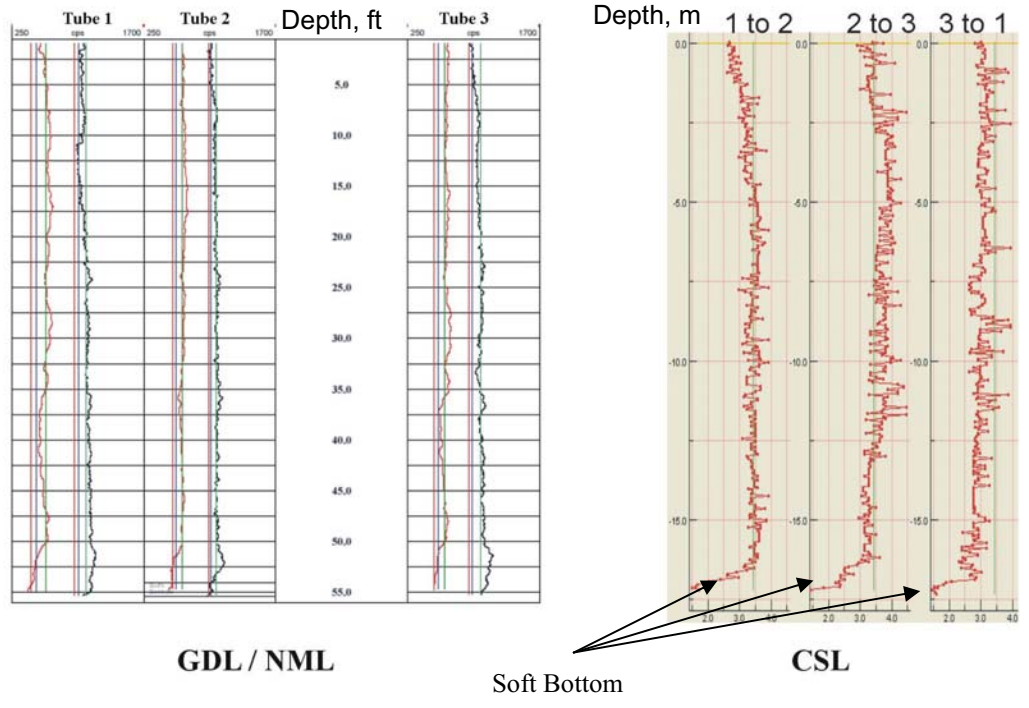
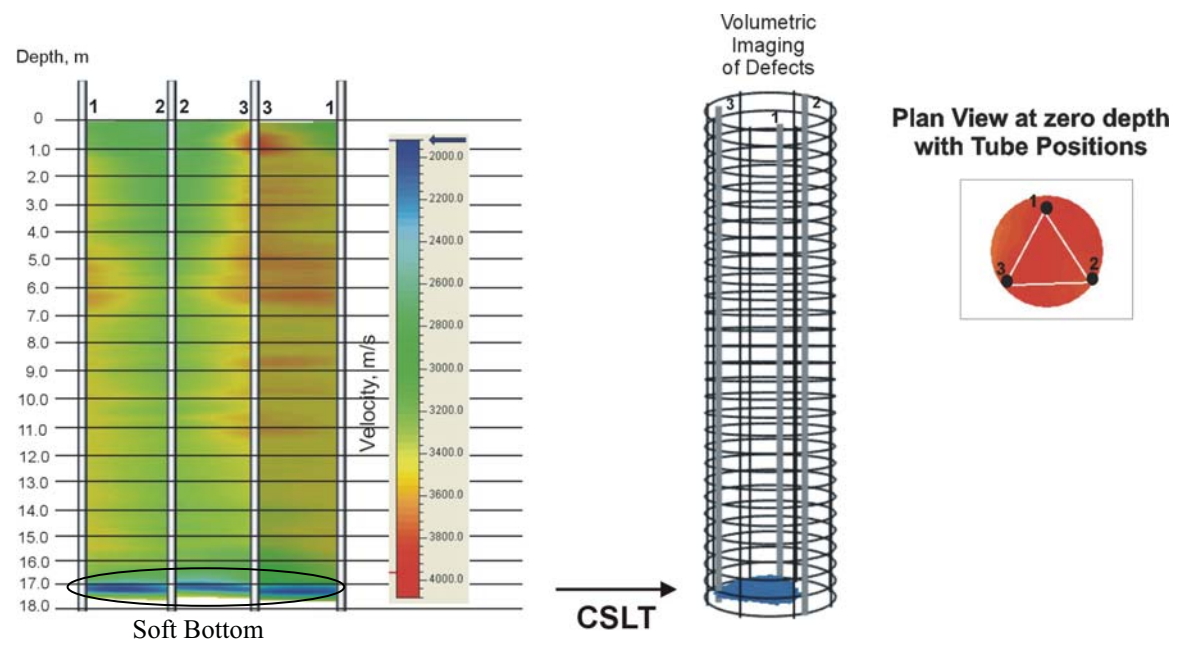
Case History 2	Inspection Tubes	Testing Age (Days)		GDL Anomalies	CSL/T Anomalies	
		CSL	GDL		Travel Time	Amplitude
3' Dia. Shaft	3 STEEL	6	18	NO	YES	YES

Analysis: ALL three (3) CSL logs indicated a soft bottom. However, GDL, shown in black, indicated no major density anomaly. NML (red), indicated a high moisture zone.

Interpretation: “Soft bottom” condition located in the interior portion of the shaft just missing the tubes.

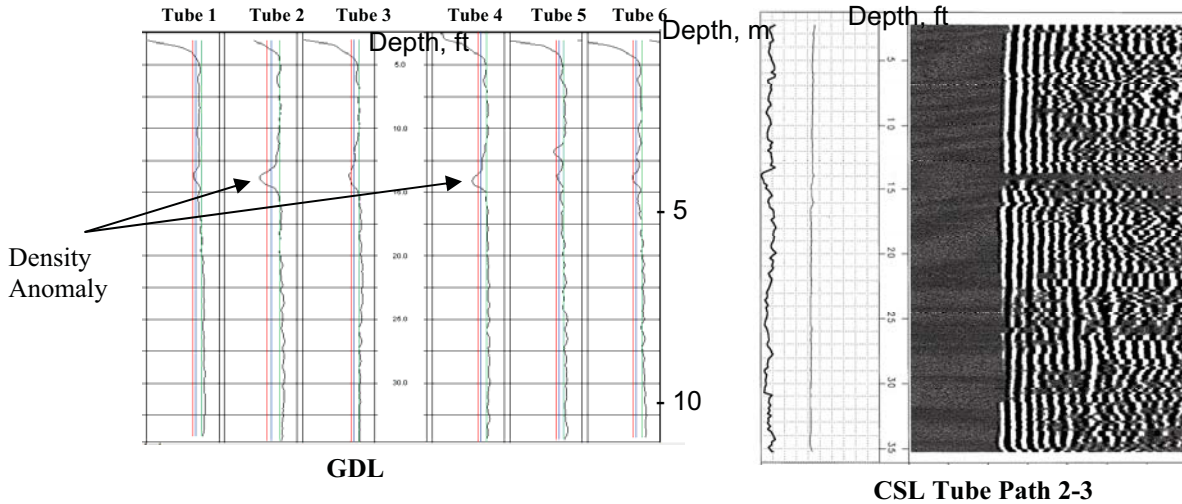
Case History 3	Inspection Tubes	Testing Age (Days)		GDL Anomalies	CSL/T Anomalies	
		CSL	GDL		Travel Time	Amplitude
6' Dia. Shaft	6 PVC	6	6	YES	NO	YES

Analysis: CSL and GDL performed at the same time. GDL indicates a density anomaly at 4.1-4.4 m (13.5-14.5 ft). CSL indicates low amplitude (reduced signal energy) at the same depth; but no velocity anomaly.

Interpretation: Density anomalies outside rebar cage and is intruding in just touching the tubes. Therefore, the rebar cage is probably exposed to the density anomaly.

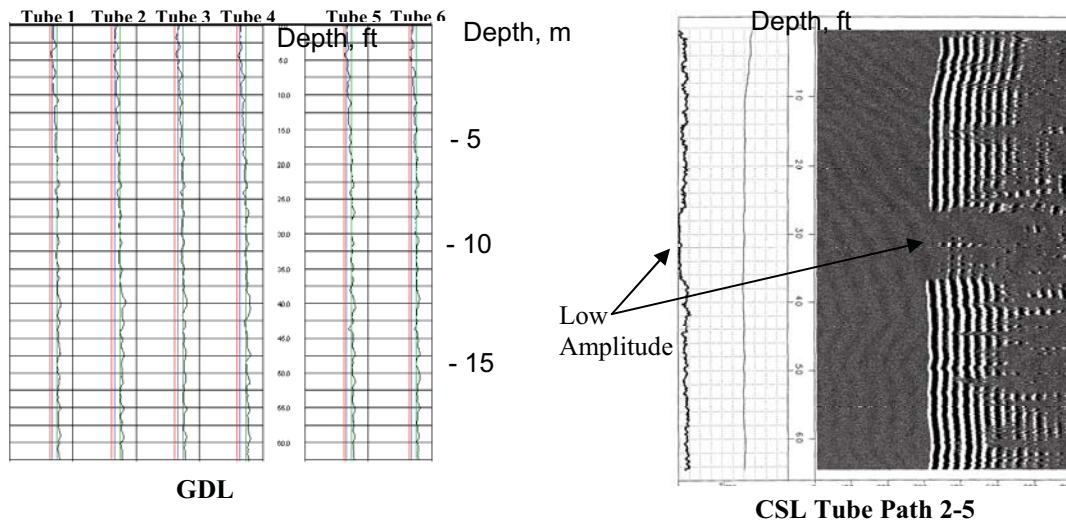
Case History 4	Inspection Tubes	Testing Age (Days)		GDL Anomalies	CSL/T Anomalies	
		CSL	GDL		Travel Time	Amplitude
6' Dia. Shaft	6 PVC	4	22	NO	NO	YES

Analysis: CSL test was performed first which indicated low amplitude (reduced signal energy) near Tubes 2 and 3 between 8.3-11.3 m (27-37 ft); but no velocity anomaly. GDL indicates no density anomalies.

Interpretation: Tube bonding problem, possibly due to excessive vibration during instillation.

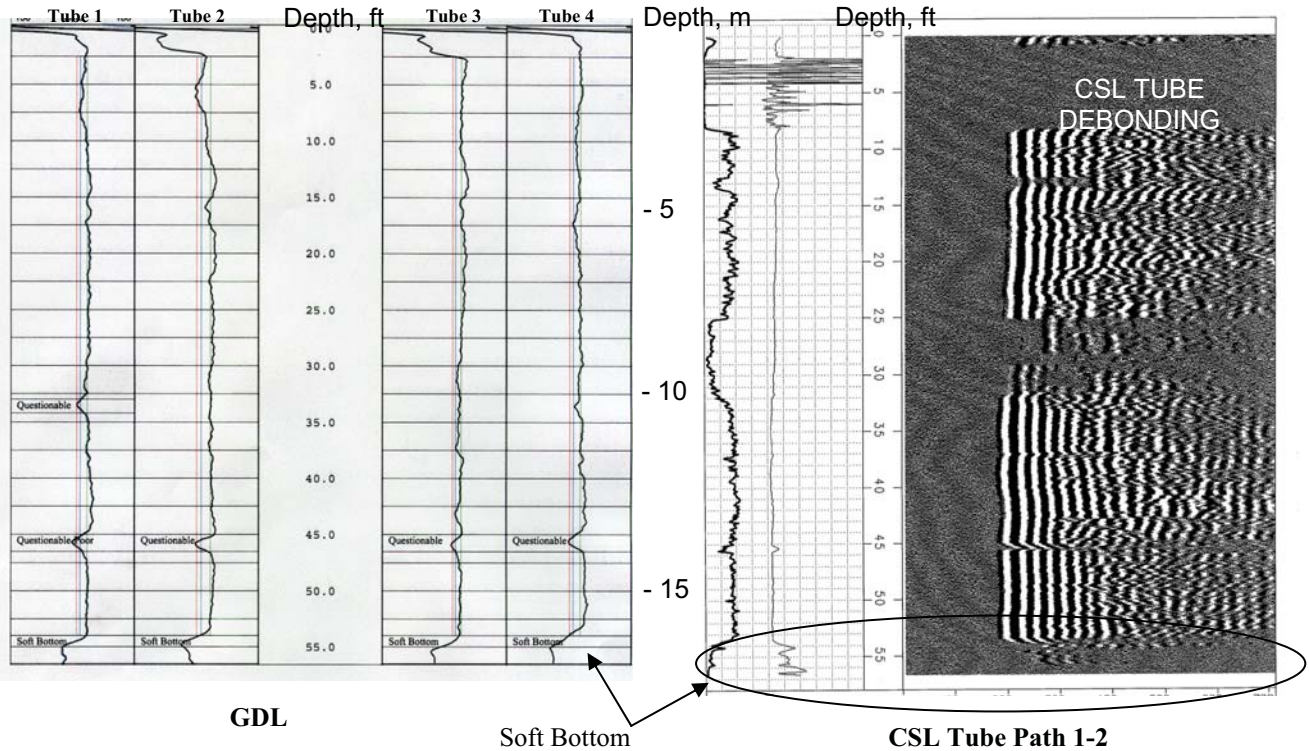
Case History 5	Inspection Tubes	Testing Age (Days)		GDL Anomalies	CSL/T Anomalies	
		CSL	GDL		Travel Time	Amplitude
4' Dia. Shaft	4 PVC	43	7	YES	NO/YES	YES

GDL test was performed first which indicated three zones of density anomalies. CSL was performed next with severe PVC tube debonding observed in the 43-days old shaft.

- Anomaly 1:** GDL indicated a questionable density zones near Tube 1 between 10-10.4 m (33-34.2 ft). CSL testing does not indicate a significant velocity anomaly.

- Interpretation:** Density anomaly is located outside the rebar cage.
- Anomaly 2:** GDL indicated a questionable-poor density anomaly in all four tubes between 13.7-14.2 m (45-46.5 ft). CSL data indicate only a drop in signal amplitudes in all four tubes without a significant reduction in velocity (<10%).

- Interpretation:** Density anomalies outside rebar cage and is intruding in just touching the tubes. Therefore, the rebar cage is probably exposed to the density anomaly.

- Anomaly 3:** GDL indicated a soft bottom condition in all tubes at the bottom 0.76 m (2.5 ft). CSL testing also confirms the soft bottom condition (>20% drop in velocity).

- Interpretation:** The soft bottom condition is located both inside and outside the rebar cage.

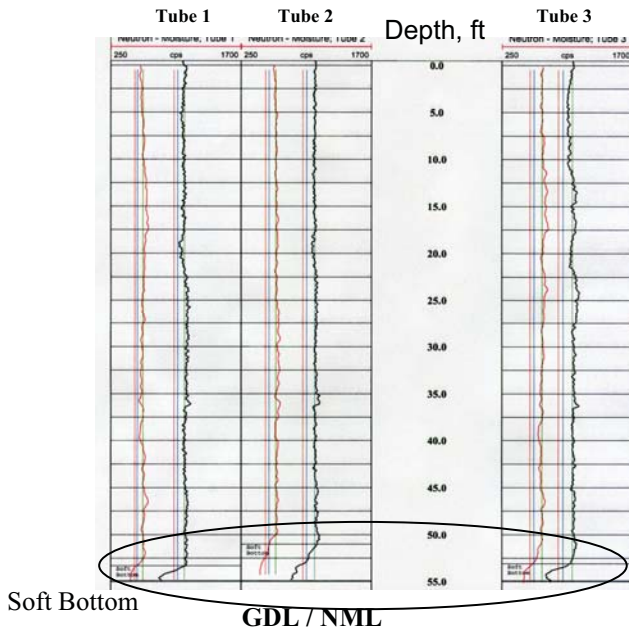
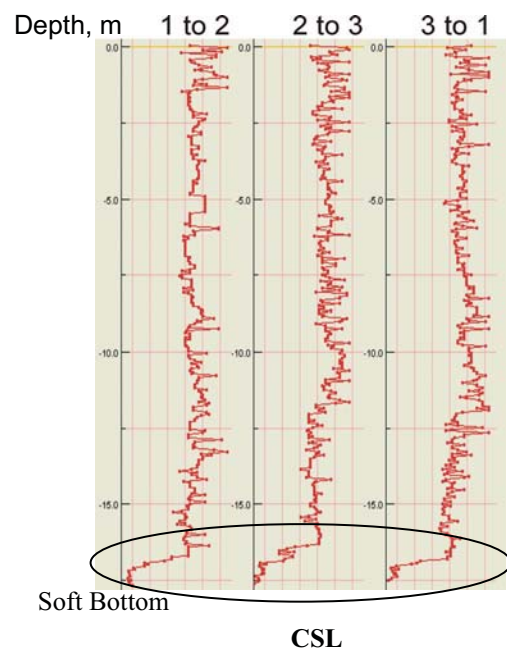
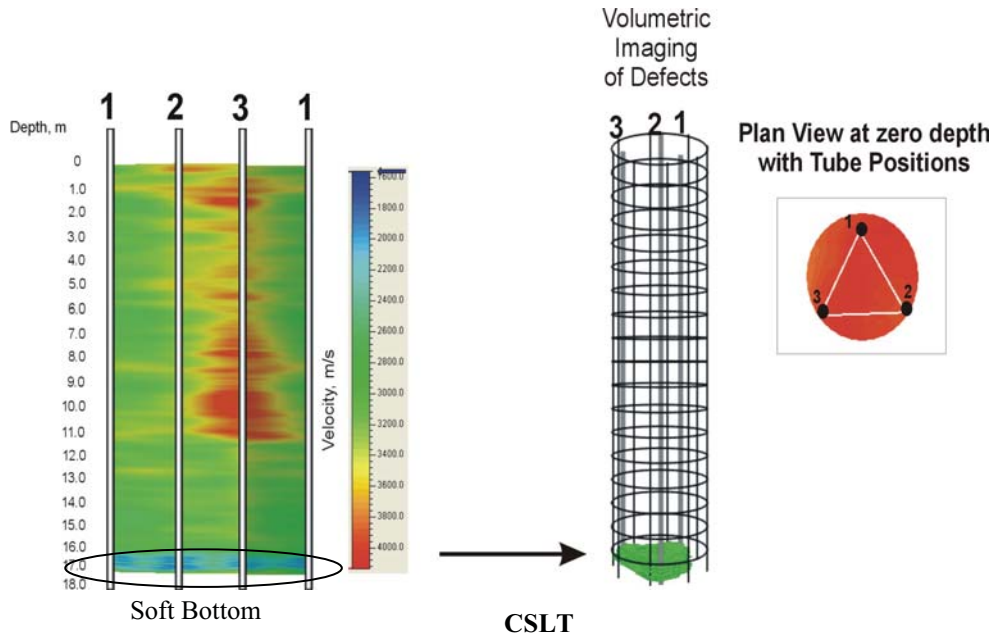
Case History 6	Inspection Tubes	Testing Age (Days)		GDL Anomalies	CSL/T Anomalies	
		CSL	GDL		Travel Time	Amplitude
3' Dia. Shaft	3 STEEL	6	18	YES	YES	YES

Analysis: ALL three (3) CSL, GDL, and NML logs indicated a soft bottom condition. Therefore, complementary results were indicated; however, note for Tube 3, neutron-moisture (NML) indicates higher extent of high-moisture anomaly.

Interpretation: “Soft bottom” condition which extends to the interior of the shaft.

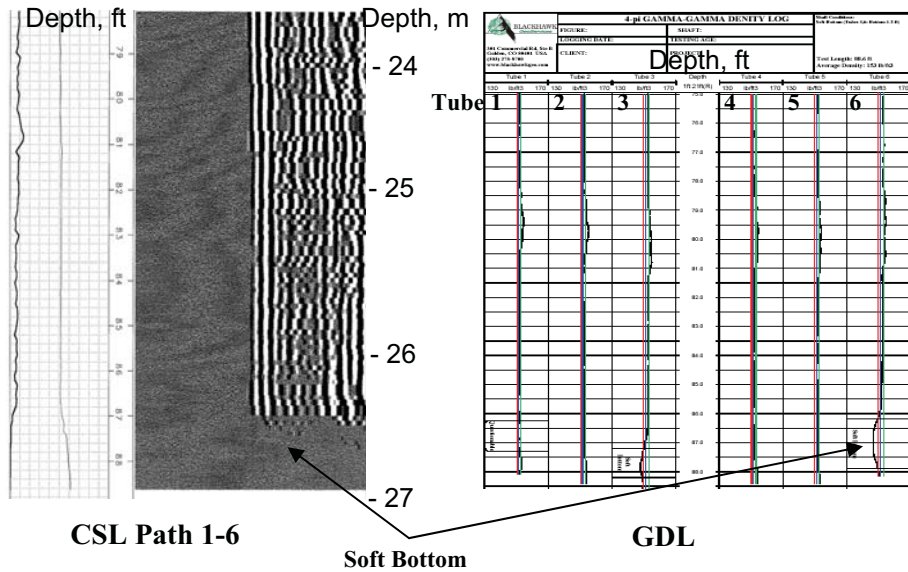
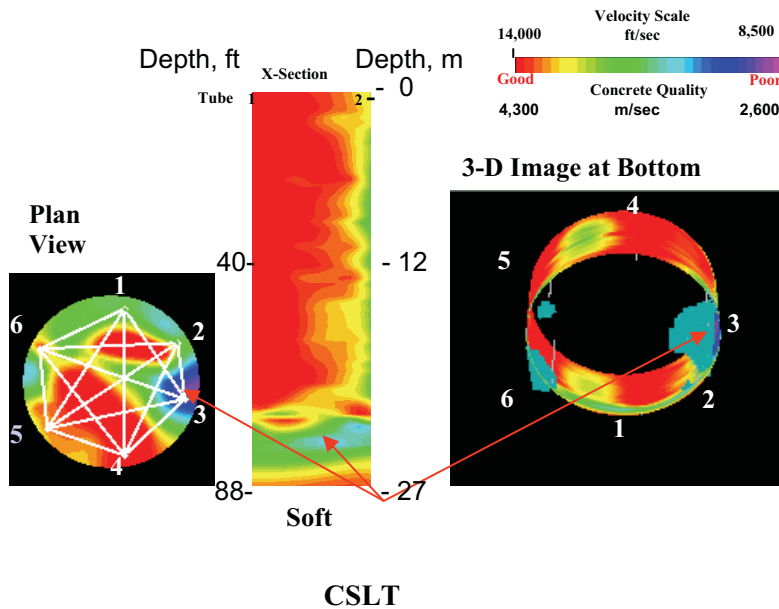
Case History 7	Inspection Tubes	Testing Age (Days)		GDL Anomalies	CSL/T Anomalies	
		CSL	GDL		Travel Time	Amplitude
6' Dia. Shaft	6 STEEL	5	5	YES	YES	YES

Analysis: CSL and GDL data indicated 0.3-0.6 m (1-2 ft) “soft bottom” condition. Three-dimensional tomographic imaging (CSLT) was performed for coring followed by remediation.

Interpretation: Soft bottom condition which extends to the interior of the shaft. 3-D images defined poor quality concrete zones shown in green, blue, and purple colors. Good quality concrete is shown in red. The defect zones are shown at the bottom of the shaft primarily around Tubes 6, 5, and 3.
