**Loss of Control and Impact With Terrain
Aviation Charter, Inc.
Raytheon (Beechcraft) King Air A100, N41BE
Eveleth, Minnesota
October 25, 2002**

NTSB/AAR-03/03

**National
Transportation
Safety Board**

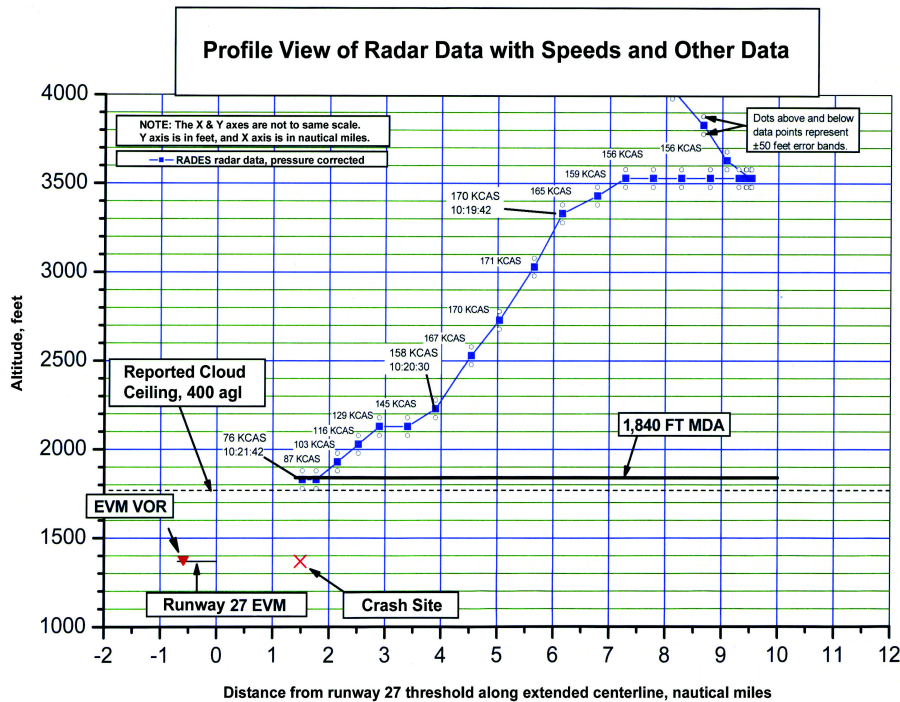
Figure 3. Profile view of the accident flight.
