**Collision with Trees and Crash Short of the  
Runway, Corporate Airlines Flight 5966  
BAE Systems BAE-J3201, N875JX  
Kirksville, Missouri  
October 19, 2004**

**Aircraft Accident Report**

**NTSB/AAR-06/01**

**NTSB/AAR-06/01  
PB2006-910401  
Notation 7694A  
Adopted January 24, 2006**

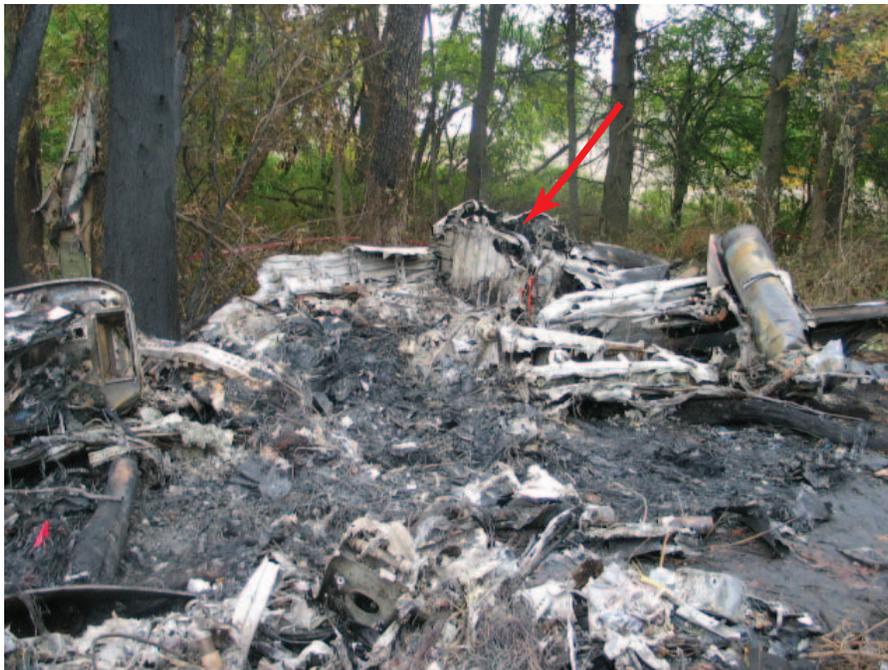
The main wreckage (which included the remains of the fuselage and the empennage, the right wing, the inboard portion of the left wing, and the remains of the right engine and propeller and the left propeller) was located in an almost circular area about 30 feet in diameter and exhibited extensive fire damage. Most of the main wreckage and the surrounding vegetation were consumed by fire. Figure 5 is a photograph of the main wreckage area.

**Figure 5.** Photograph of the main wreckage area.

The forward section of the airplane is in the foreground, and the tail section is in the background (the aft pressure bulkhead is indicated by the red arrow).

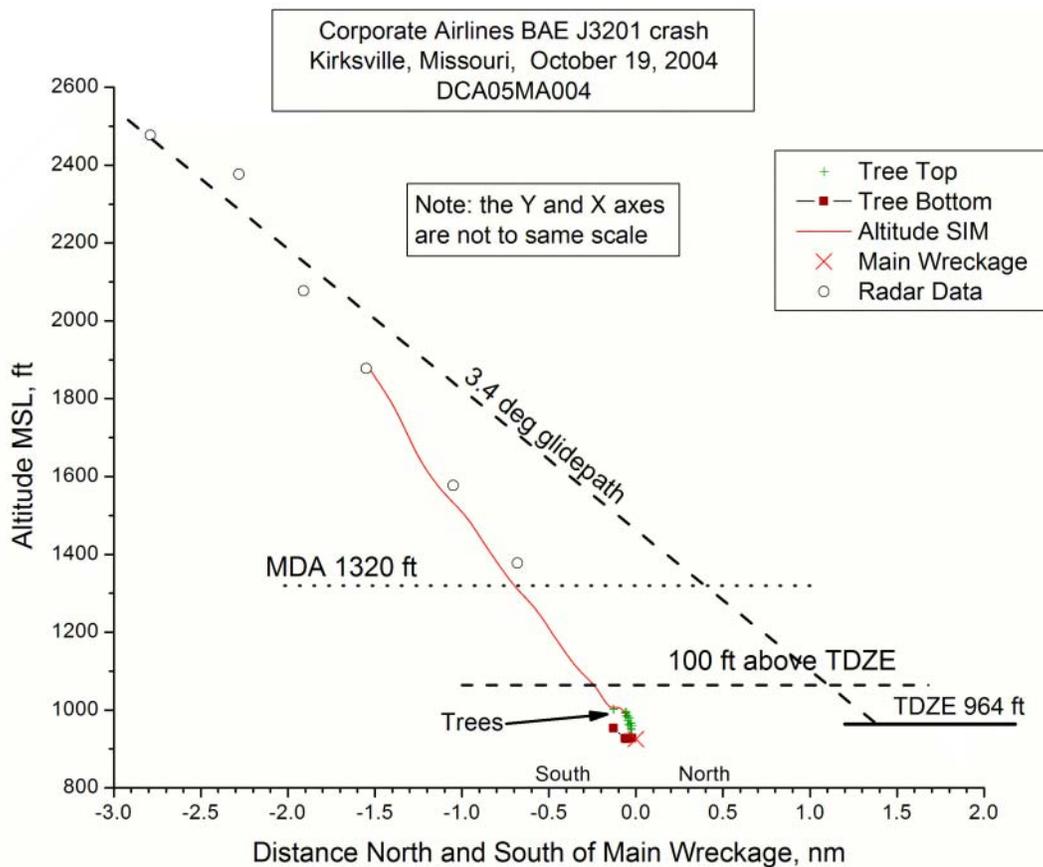
**Figure 6.** The accident airplane’s descent profile during the accident approach with the airport/runway location shown.

The following altitudes are also shown: MDA, 100 feet above the TDZE, and the TDZE. Additionally, a 3.4° visual glidepath to the airport is shown for reference purposes only.
