Crash After Encounter with Instrument Meteorological Conditions During Takeoff from Remote Landing Site

New Mexico State Police
Agusta S.p.A. A-109E, N606SP
Near Santa Fe, New Mexico
June 9, 2009

NTSB/AAR-11/04
PB2011-910404

Aircraft Accident Report

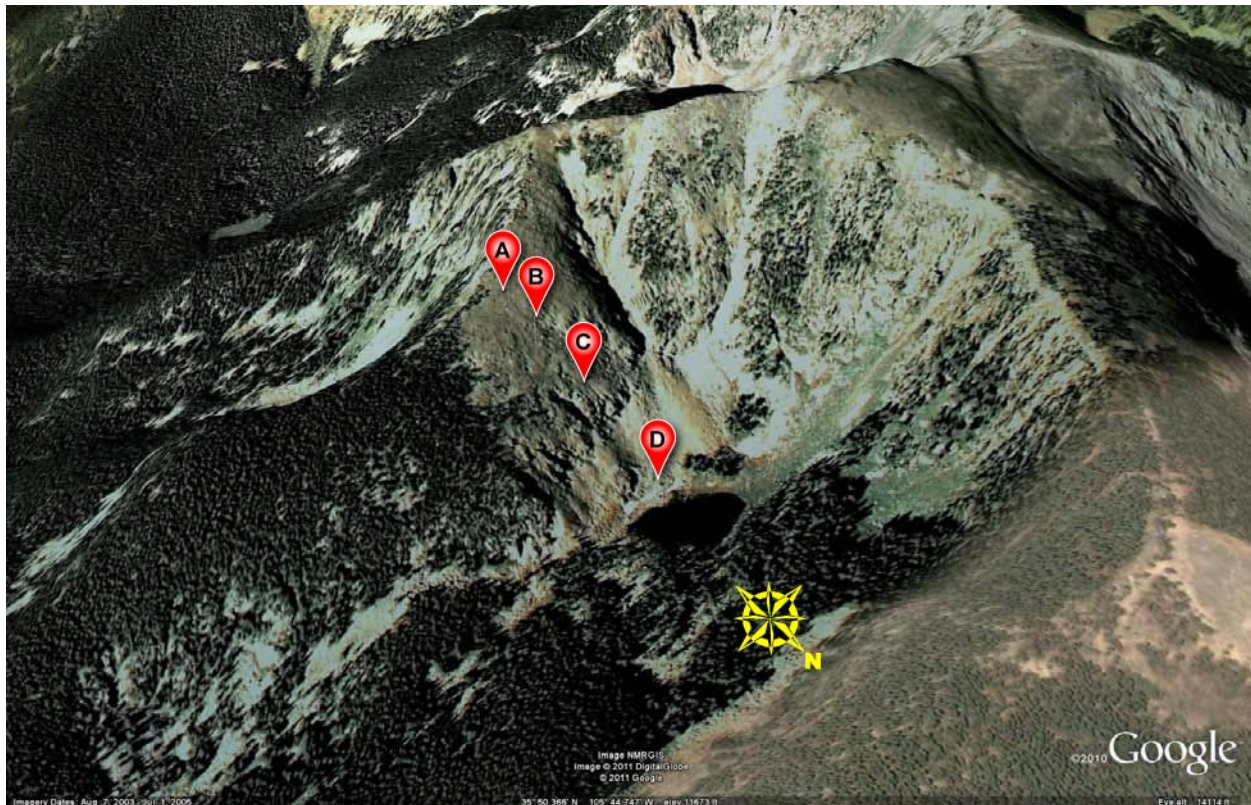
Figure 2. View of the accident location.

Examination of the accident site showed that the helicopter impacted terrain for the second time point at an elevation of 11,970 feet,¹⁹ about 1 nm north-northeast of the hiker's location and about 21 nm northeast of SAF, near the top of a steep ridgeline. Investigators were unable to identify the exact location of the helicopter's first impact with terrain, which the pilot referenced in his radio transmission. After the second impact, the helicopter rolled down a steep, rock-covered slope.²⁰ During this descent, components of the helicopter separated from the fuselage, and the pilot and hiker were ejected. The separated portion of the tailboom was located at an elevation of about 11,780 feet, and the main fuselage was located at an elevation of about 11,490 feet (see figure 2).

Note: The map shows the locations of the highest piece of wreckage debris (A), highest impact marks (B), tailboom (C), main fuselage wreckage (D), and a compass showing north.

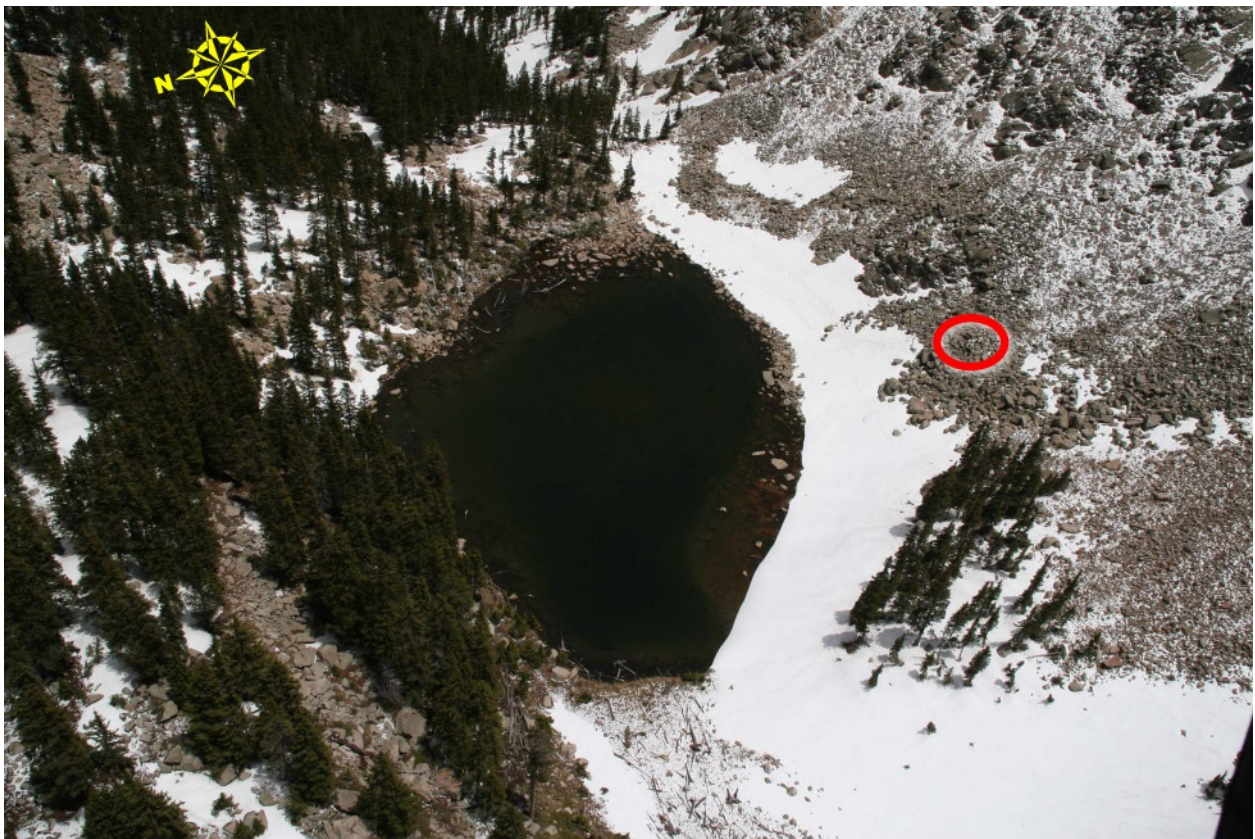
Figure 3. Aerial photograph showing the main fuselage wreckage location, circled in red, on the west side of the lake.

SAR ground teams did not locate the helicopter's wreckage until 1816. The SAR ground teams described the accident site as dangerously steep, rocky, and covered with snow and ice (see figures 3, 4, and 5).

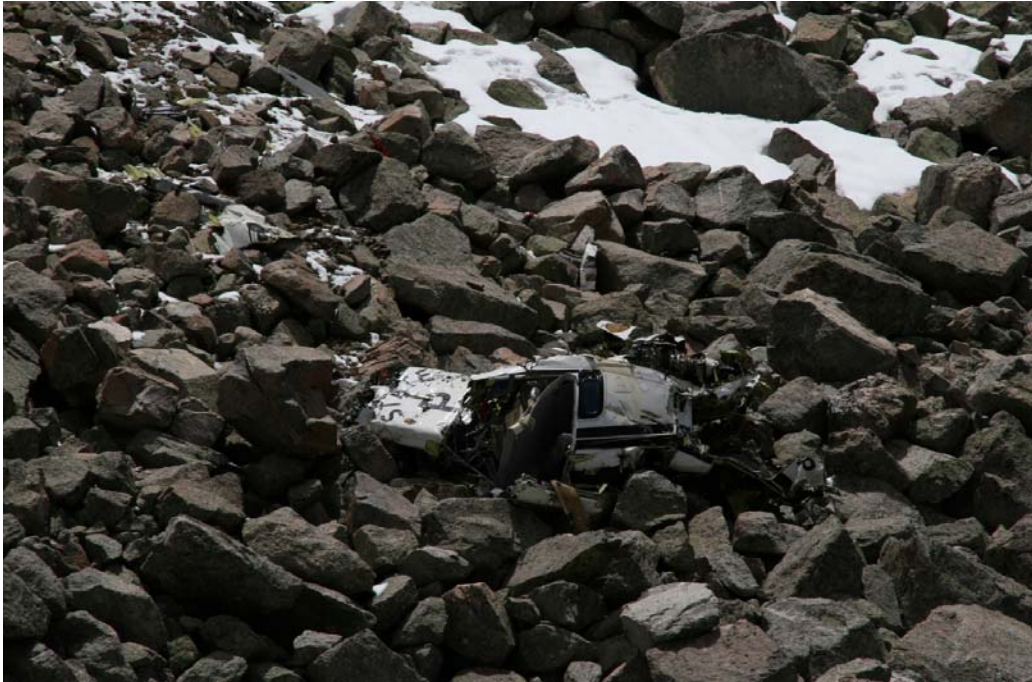
Figure 4. Photograph showing the helicopter main fuselage wreckage.

The helicopter was substantially damaged by impact forces as a result of damage to the fuselage, main and tail rotors, and tailboom.

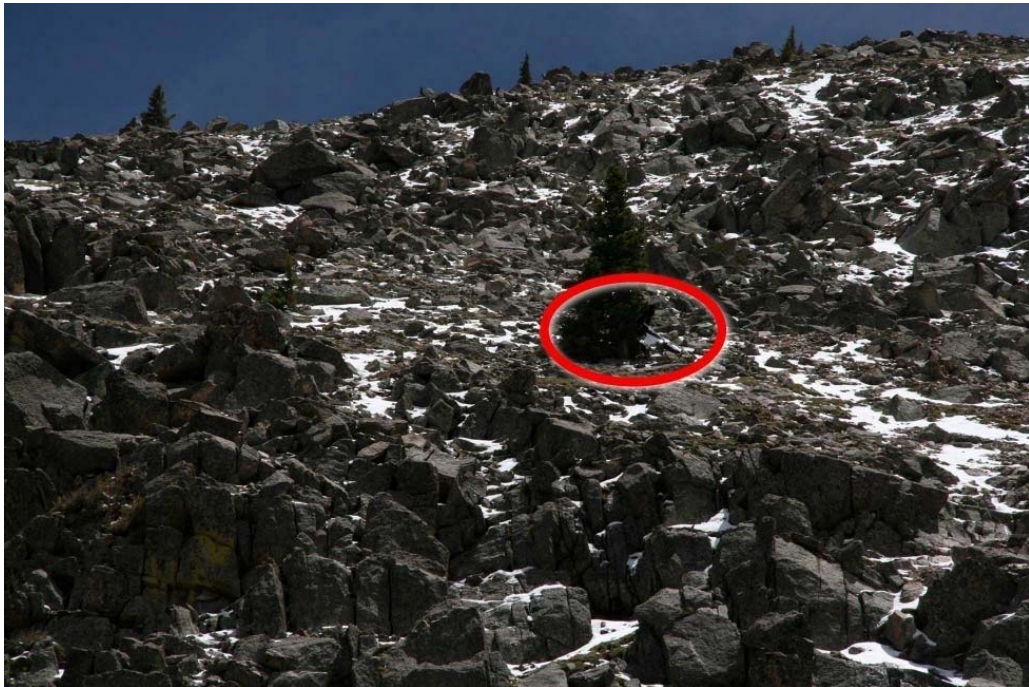
Figure 5. Photograph at ground view looking from the helicopter main fuselage wreckage location in a southerly direction up the ridge that the accident helicopter rolled down.

Note: The location of the separated portion of the tailboom is indicated by the red circle at the base of the tree.
