**HIGHWAY ACCIDENT REPORT  
MULTIPLE- VEHICLE COLLISIONS  
UNDER FOG CONDITIONS, FOLLOWED BY  
FIRES, NEW JERSEY TURNPIKE,  
NORTH OF GATE 2  
NOVEMBER 29, 1969**

**REPORT NUMBER: NTSB-HAR-71-3**

ADOPTED: JANUARY 20, 1971

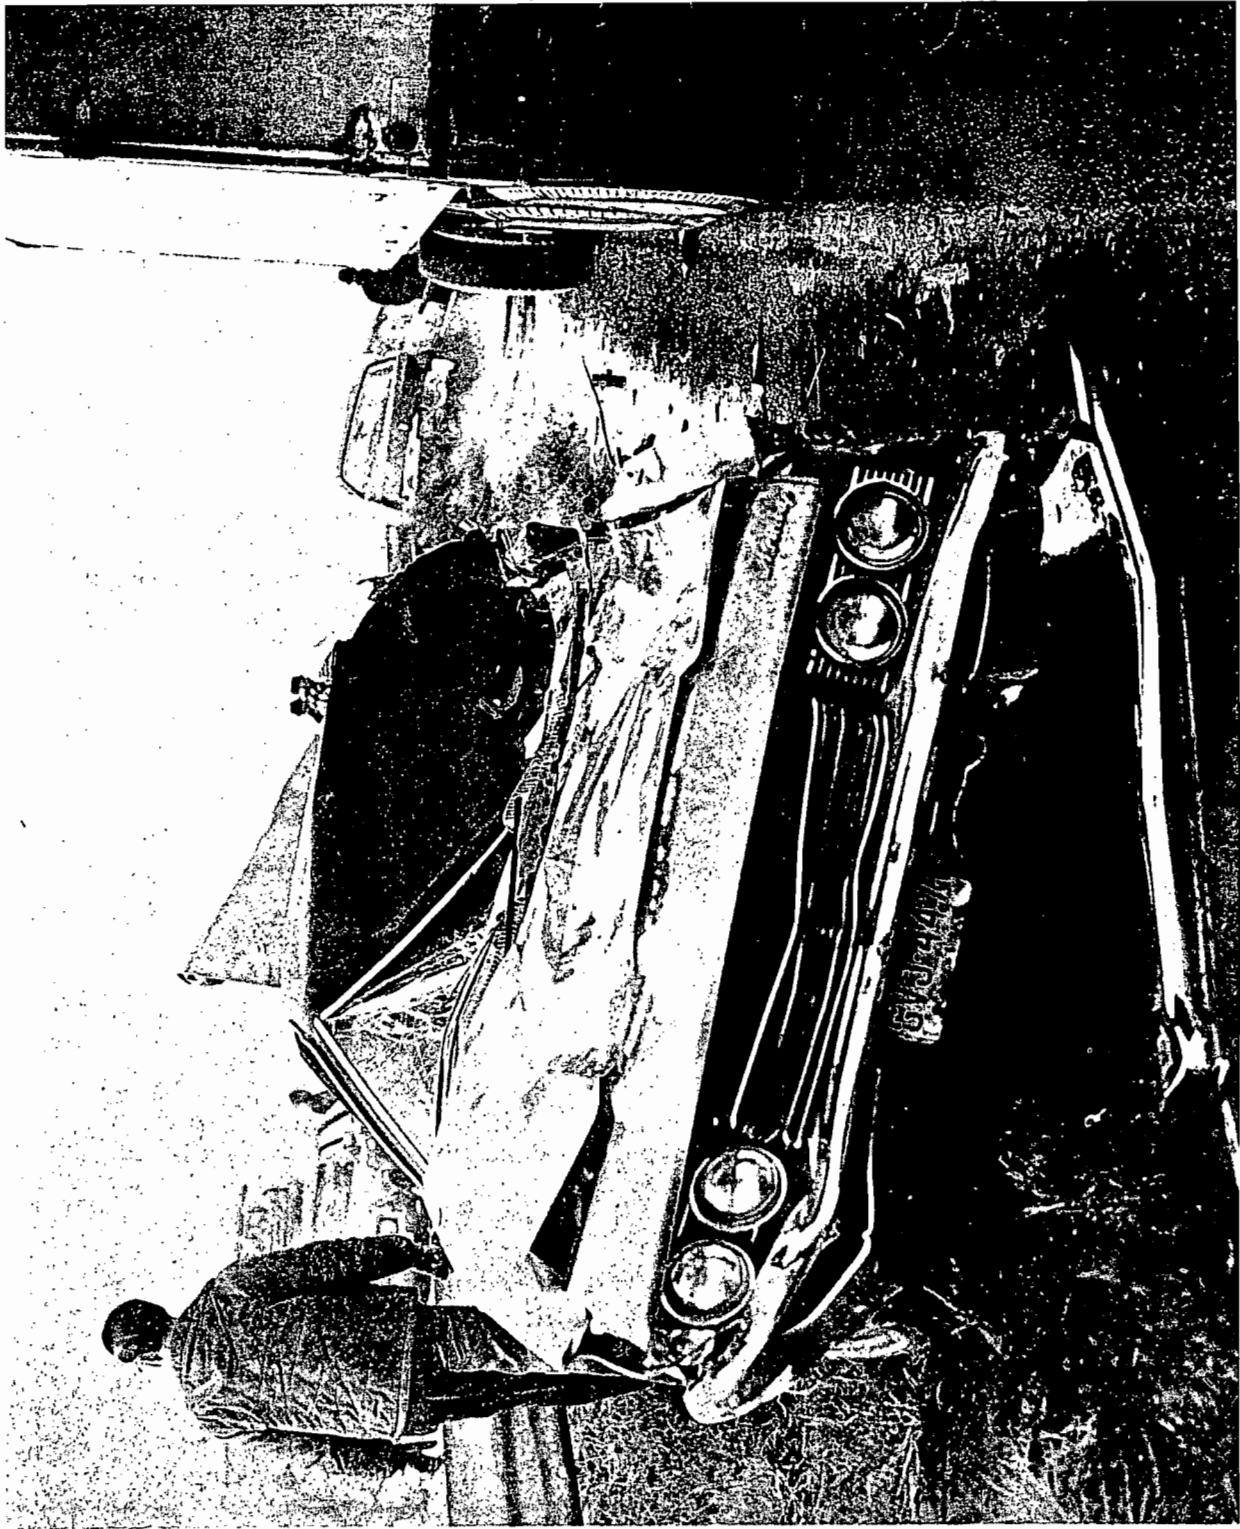
contacted a second time by Vehicle 1, which partially overran Vehicle 17. Vehicle 17 was found on the median berm and shoulder, having rotated some 180° from its original line of travel in a counterclockwise direction. (See Figure 2.)

Figure 2. Mercury Monterey (Vehicle 17) facing north alongside median guardrail.

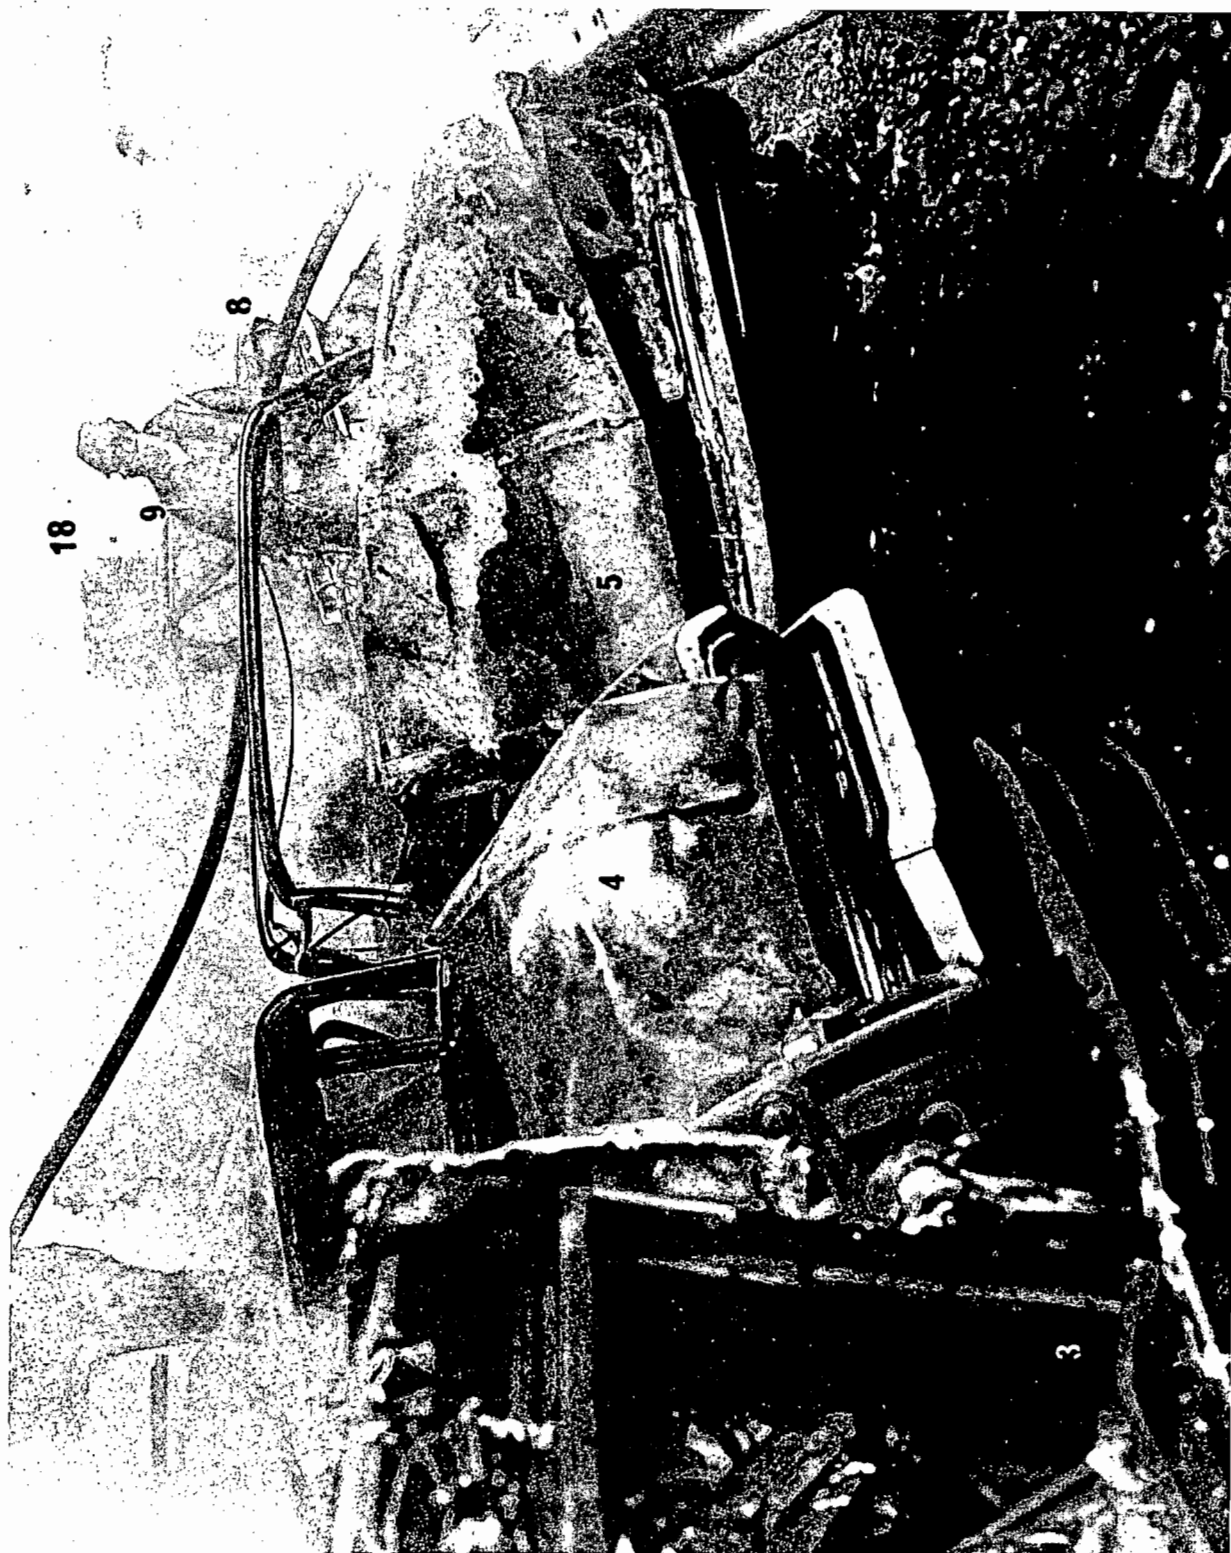
Figure 3. Vehicles 3, 4, and 5, looking north.

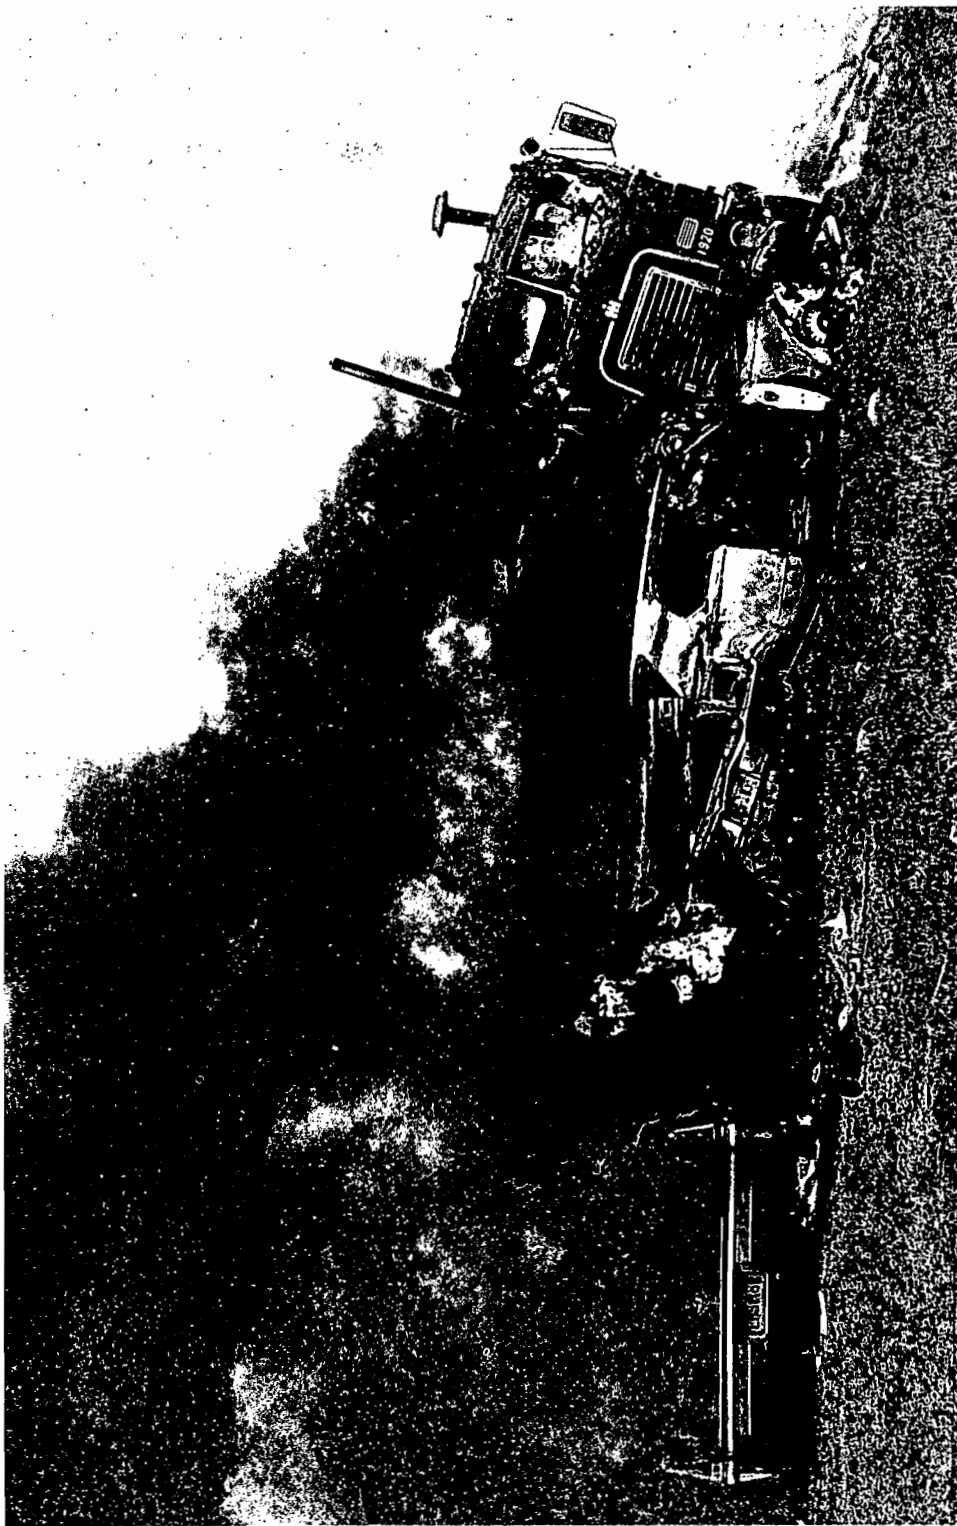
Figure 4. Vehicles 1, 10, 11, and 12, looking south.

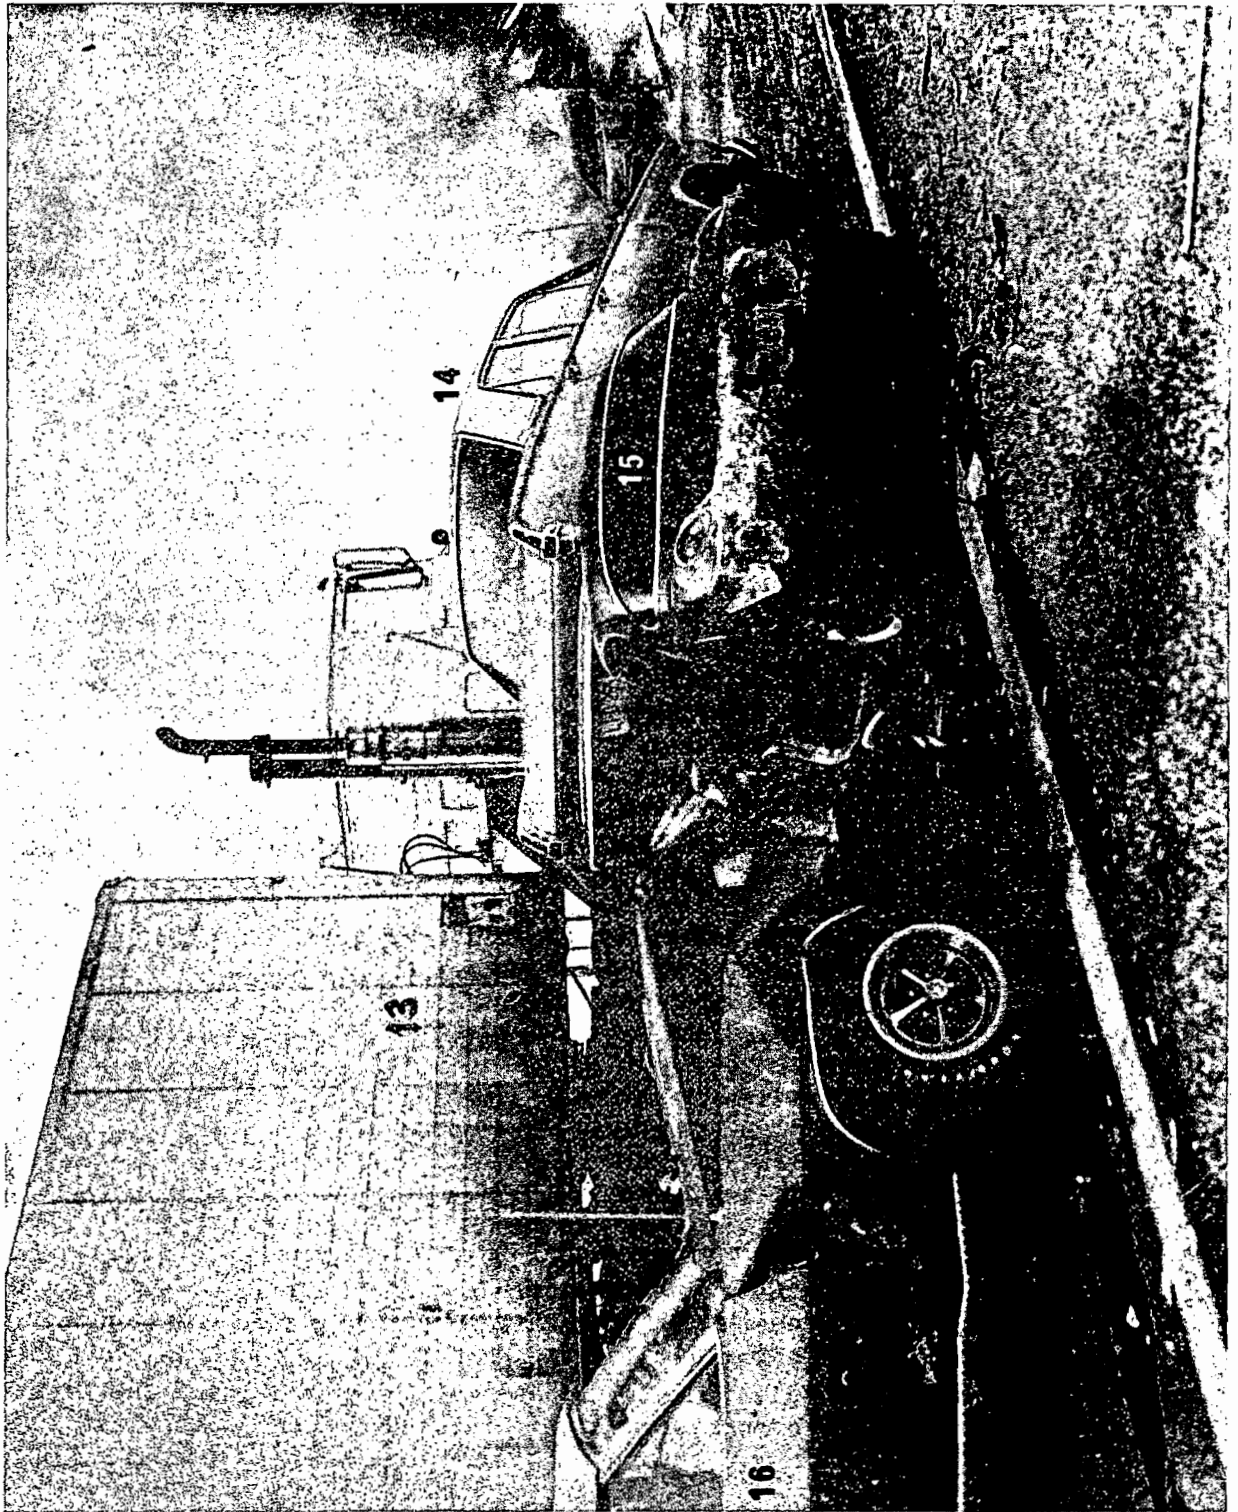
Figure 5. Vehicles 14, 15, and 16, looking south.

Vehicle 14, a 1966 Plymouth sedan, stopped in the right lane when the driver saw fire and wrecked cars ahead. While backing away from the fire, Vehicle 14 was struck in the rear by Vehicle 15, a 1967 Jaguar coupe. Vehicle 16, a 1970 Plymouth Barracuda, traveling in the left lane, swerved to the right to avoid striking Semitrailer 13, but struck Vehicle 15, ramming it forward and partially under Vehicle 14. No one was injured in this sequence. (See Figure 5.)

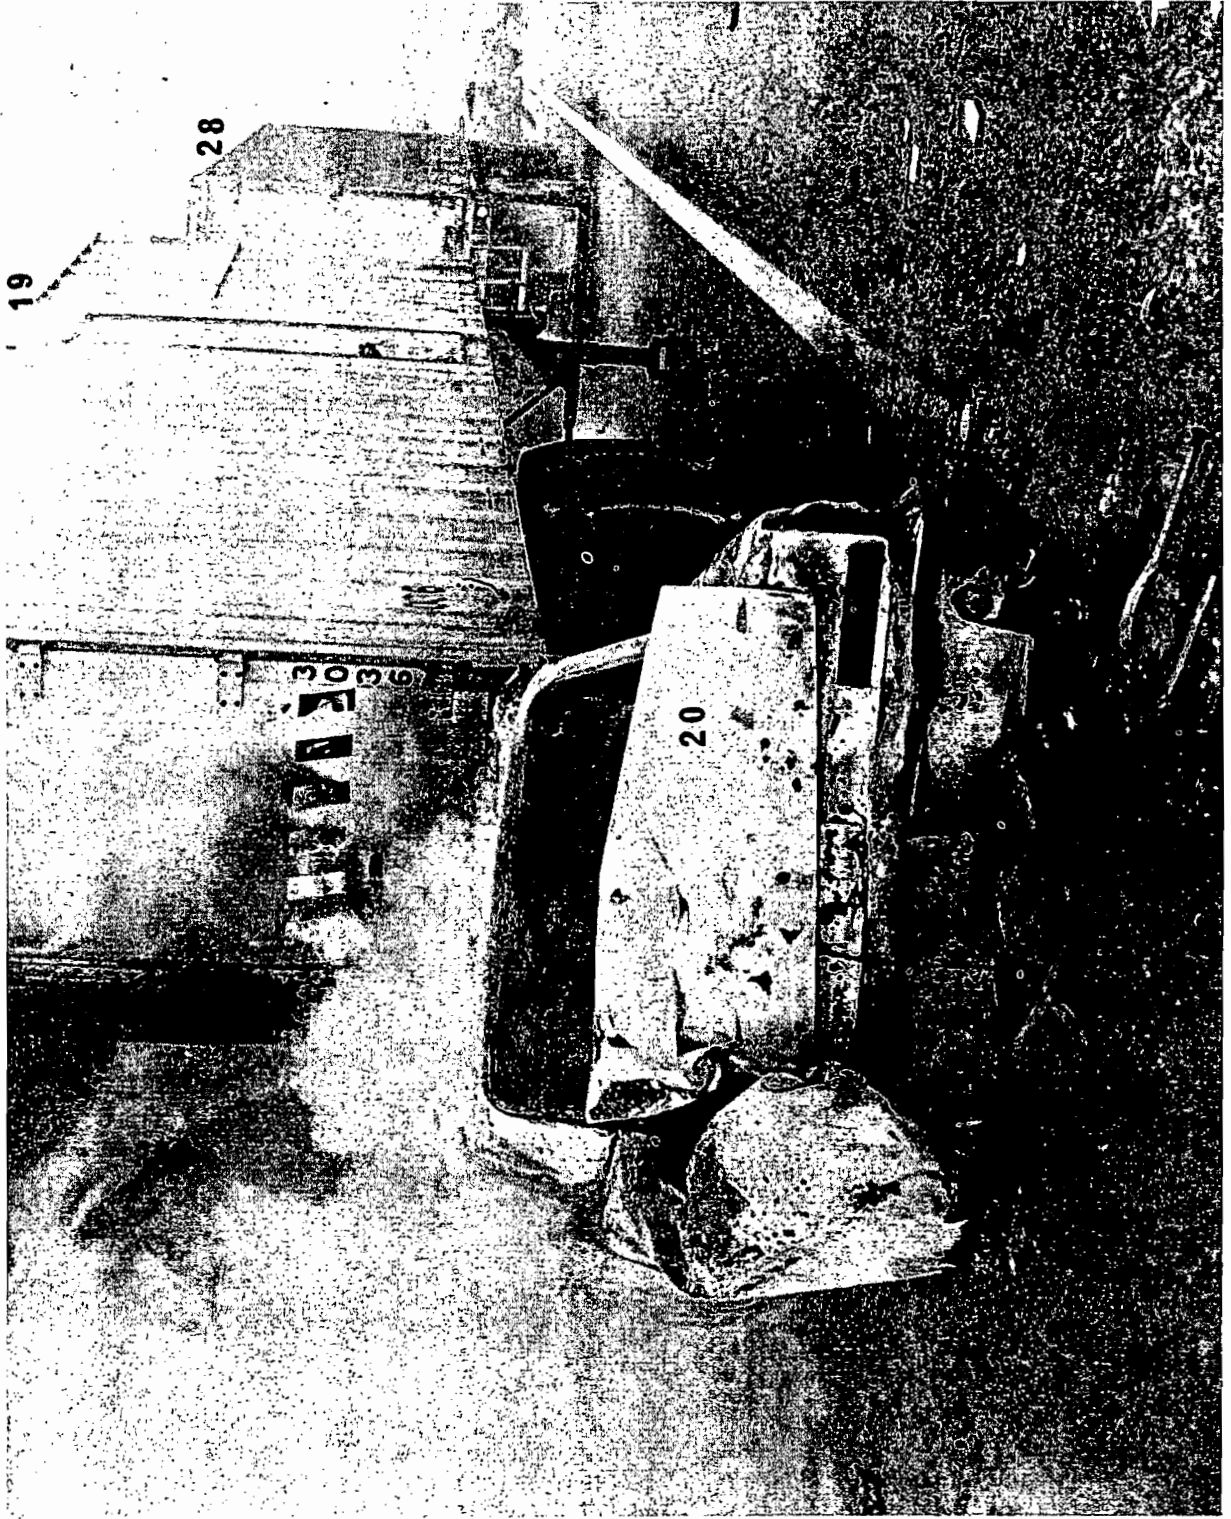
Figure 6. Vehicle 20 in rear of Vehicle 19 Semitrailer.

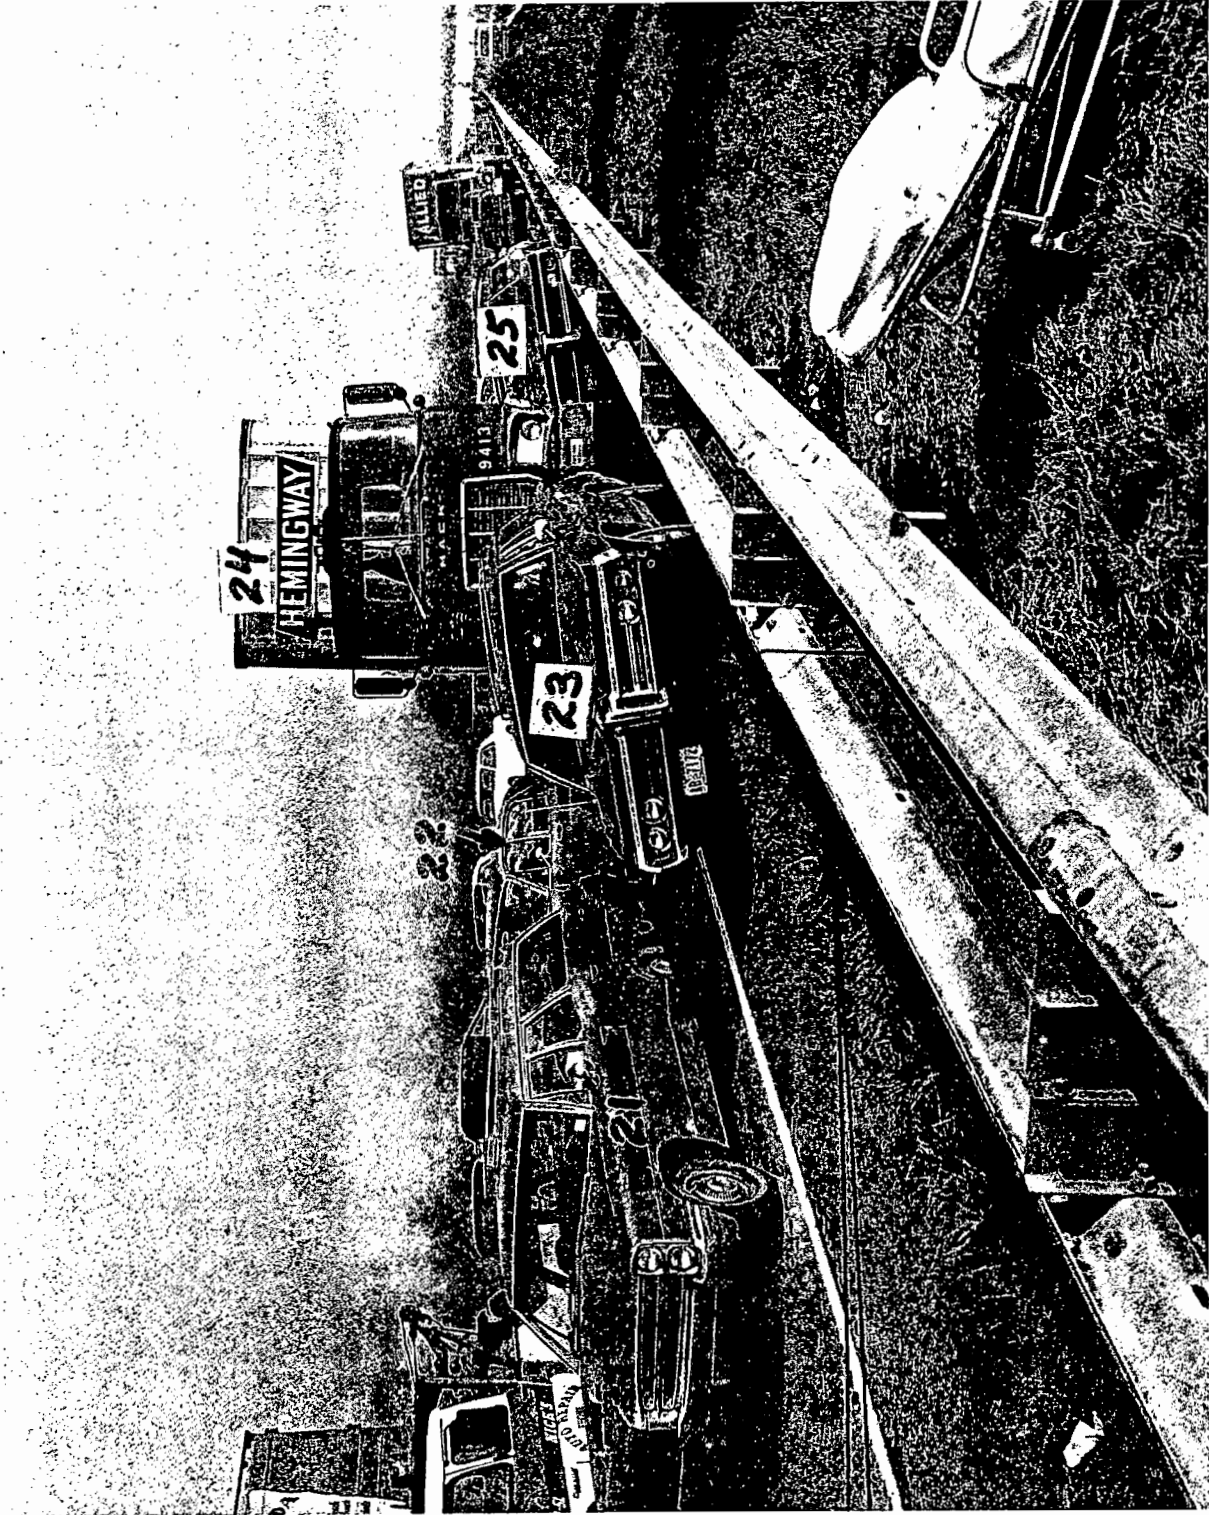
Figure 7. Vehicles 21 through 25, looking north.

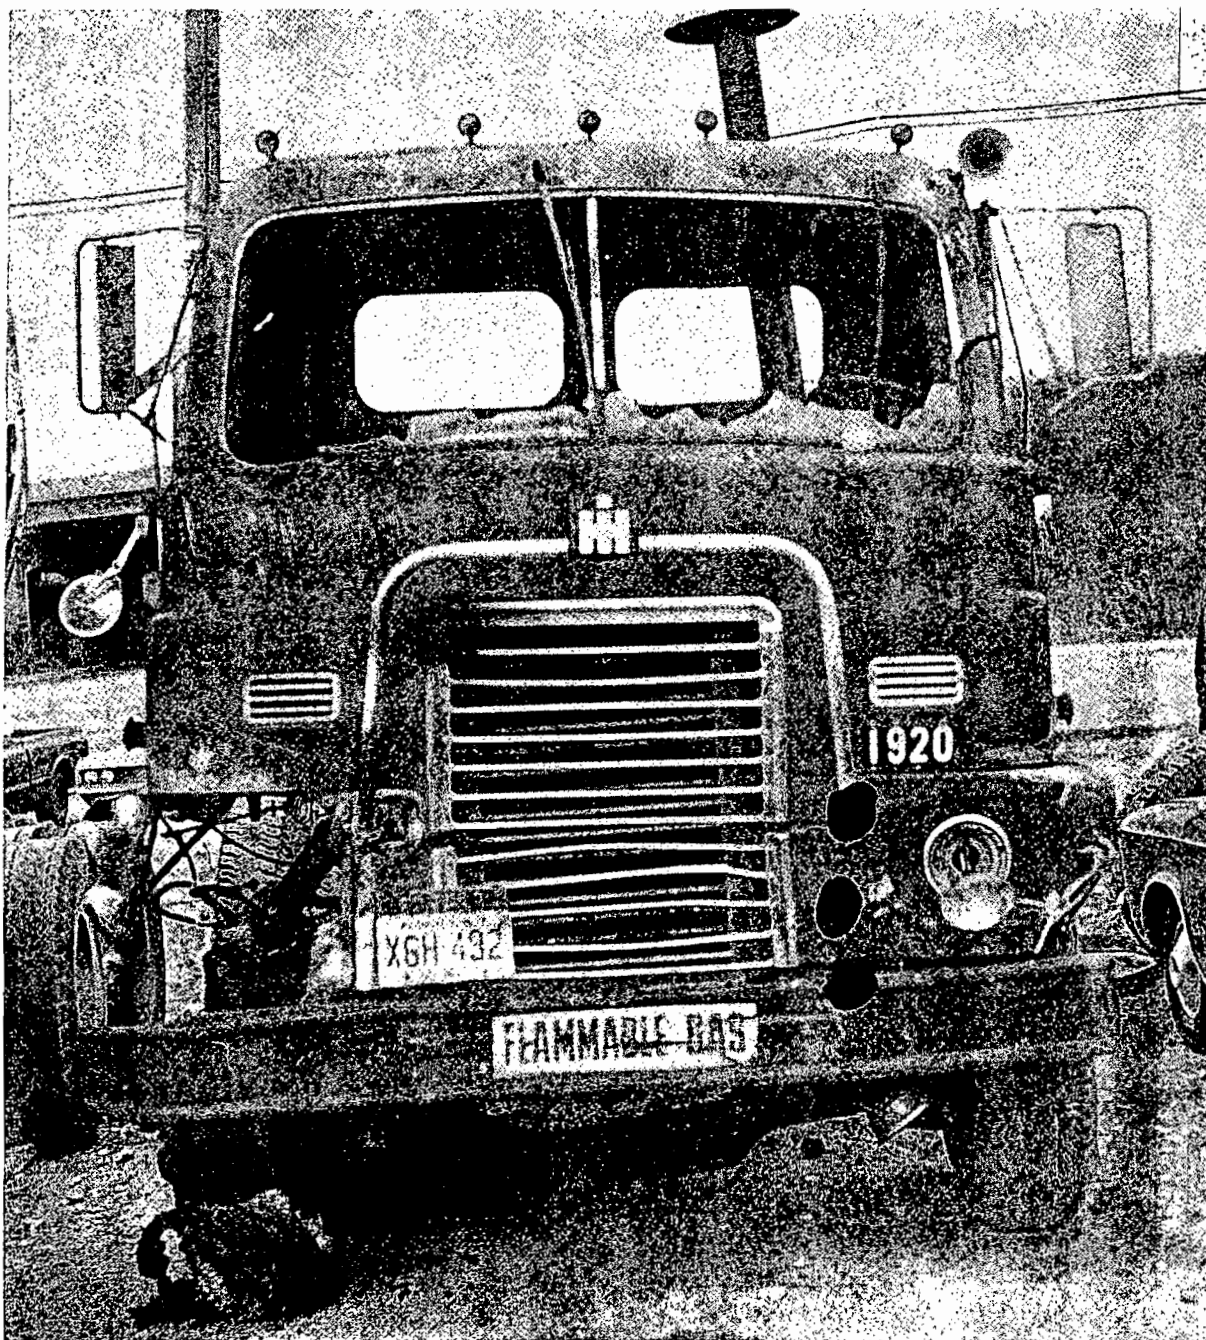
Figure 8. Front of Vehicle 1 tractor. (The three spots on the left front, near the grille, were the points where blue paint chips were found, identified as from Vehicle 17.)

Blue paint transfers were found on several places on the Vehicle 1 tractor: (1) left front tractor bumper; (2) front panel behind the bumper on the left side, just below the outer chrome strip, approximately halfway down into the left of the cab center line; and (3) the outside of both front and rear left drive-axle tires. (See Figure 8.)

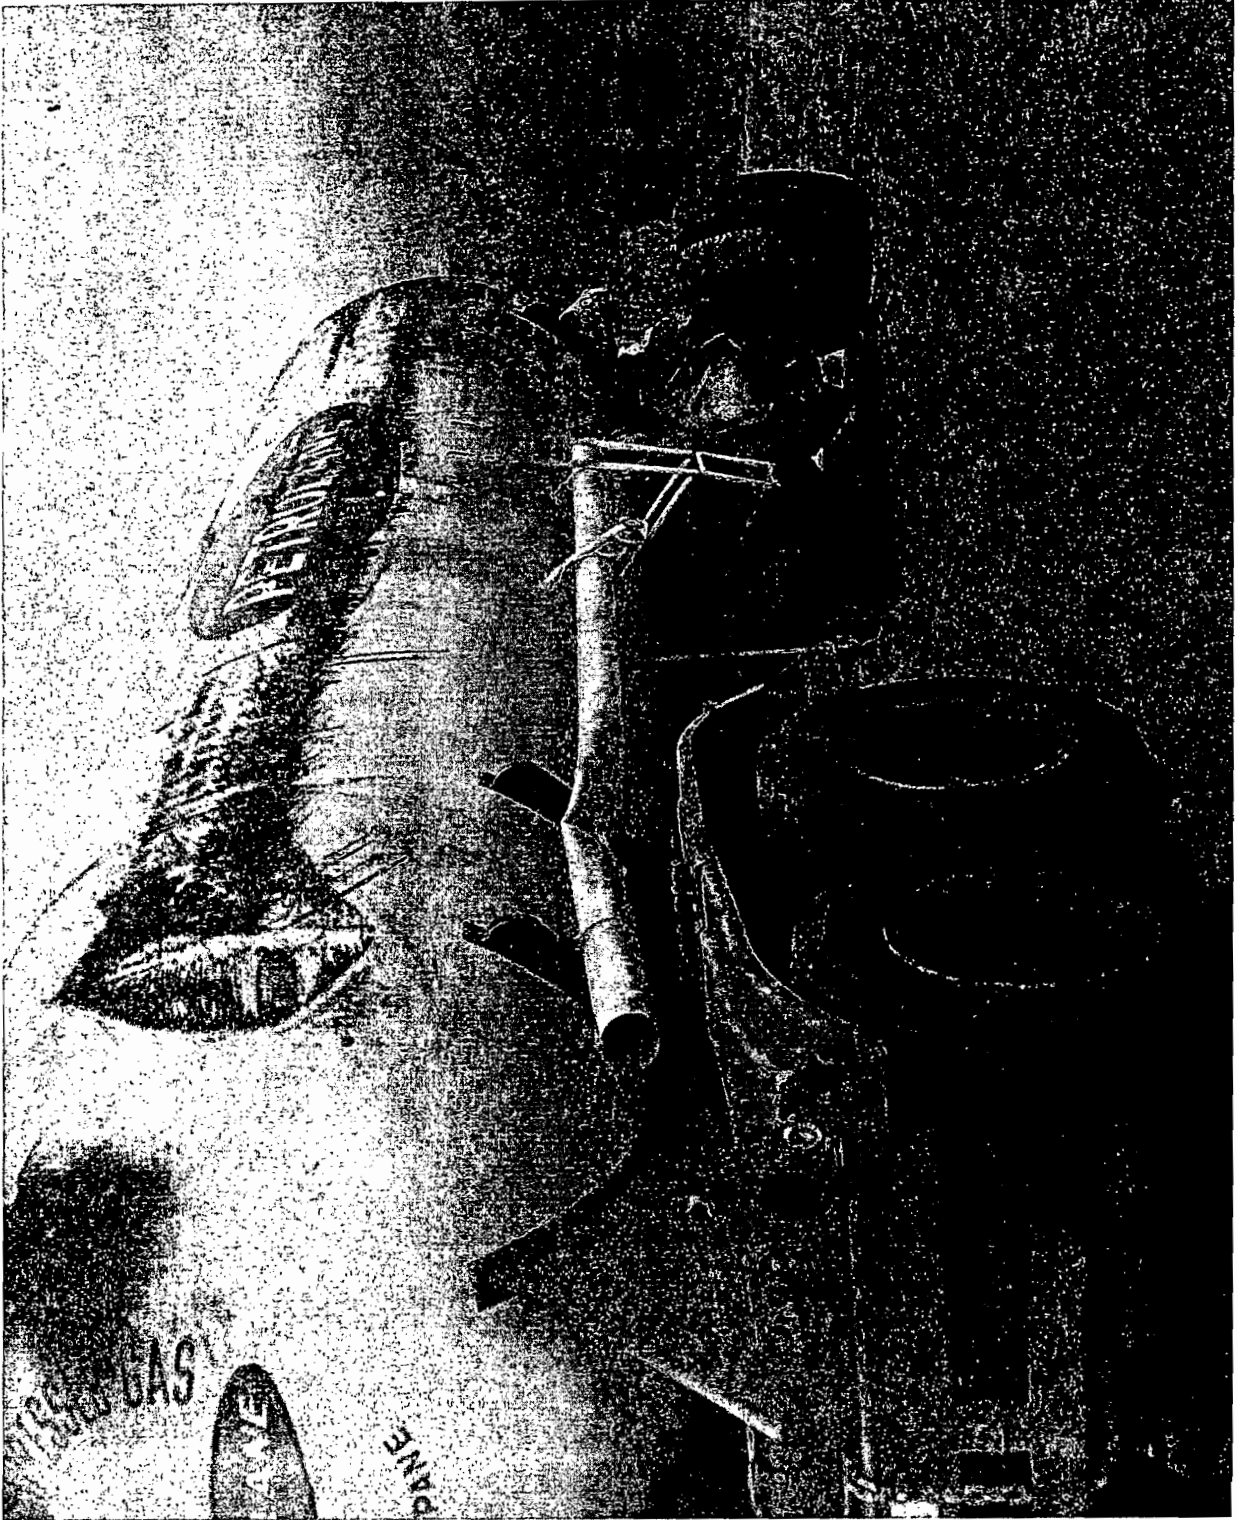
Figure 9. Right side of Vehicle 1 Semitrailer.

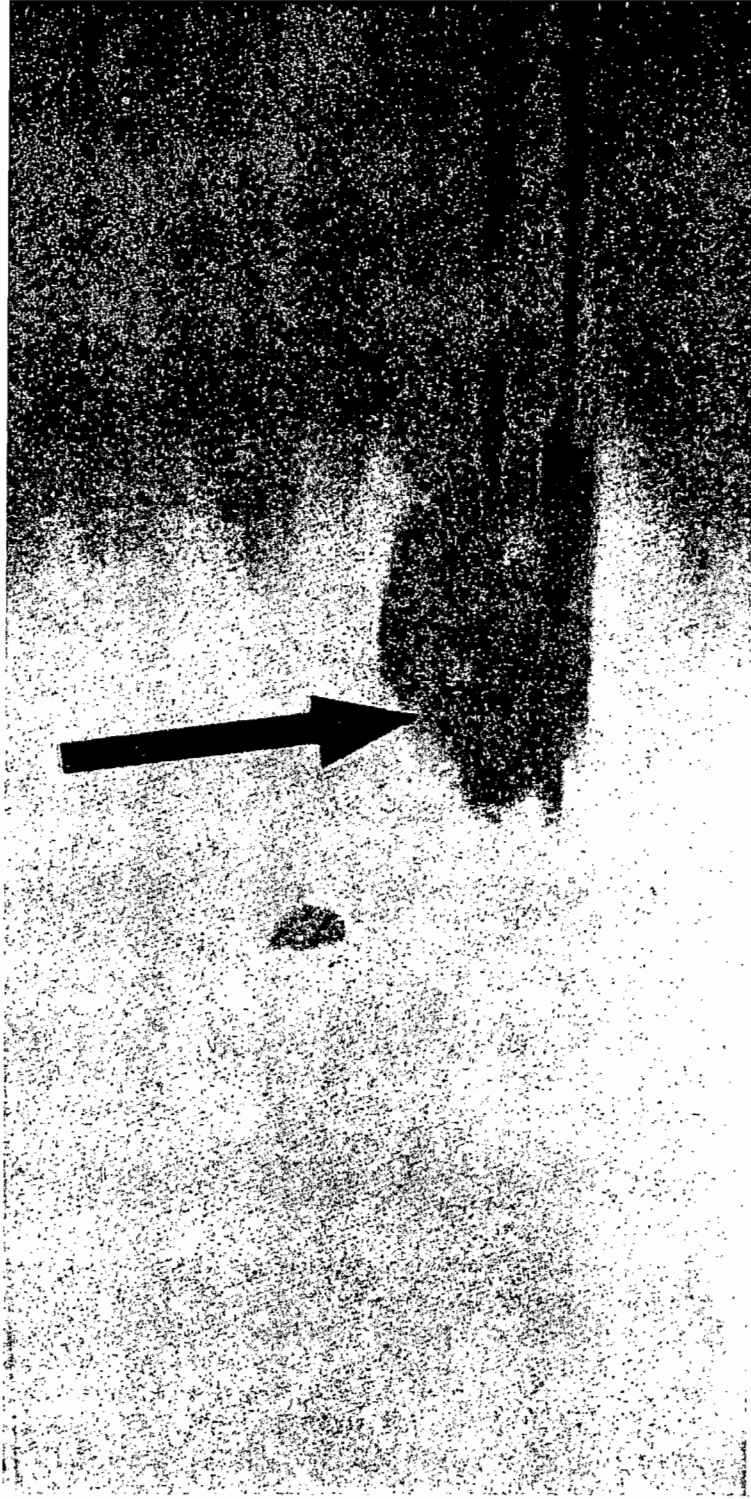
A semicircular crack approximately 7 1/2 inches long was found in the top of the tank, approximately one-third of the distance back from the forward head. The crack was directly adjacent to an internal baffle circular mounting-clip pad, 5 inches in diameter, and followed the perimeter of the clip pad for about 180° at the toe of the pad-to-shell weld.

The tank shell surrounding the crack was dented (shell out of round) for fore-and-aft distance of 10 feet and transversely about 2 feet. The deepest indentation was three-quarters of an inch at the crack.

Figure 10. Crack in propane tank, Vehicle 1.

Based on internal baffle distortion (buckling) the tank shell appeared to have been pushed inward more than three quarters of an inch and then sprung back partially to its original configuration.

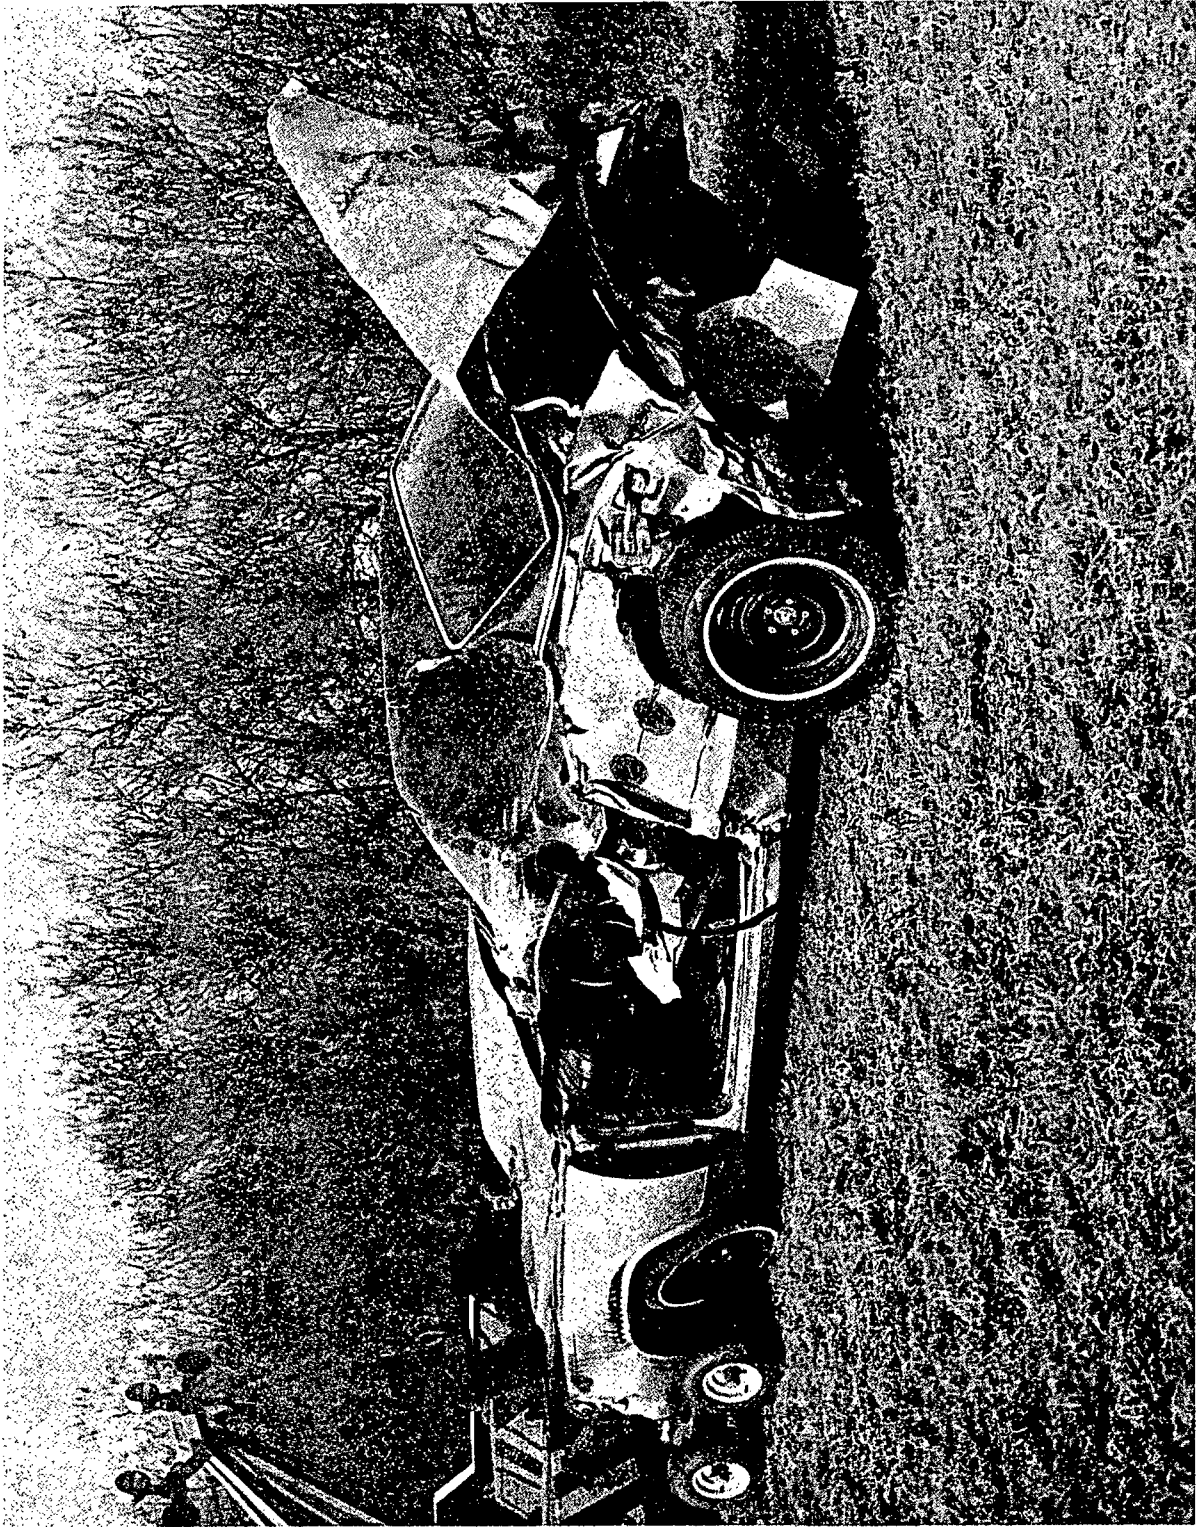
Rear Body: Severe impact damage the full width of the rear of this vehicle was evident, with the greater forward distortion evident on the left rear. The trunk lid was buckled upward and distorted forward. Rear body components were peeled upward and forward away from the side rails (frame). The rear bumper had been torn off and was missing.

Figure 11. Left side of Vehicle 17. (Two spots on left rear fender, ahead of wheel, mark the places where green paint was found, and which matched paint from Vehicle 1.)

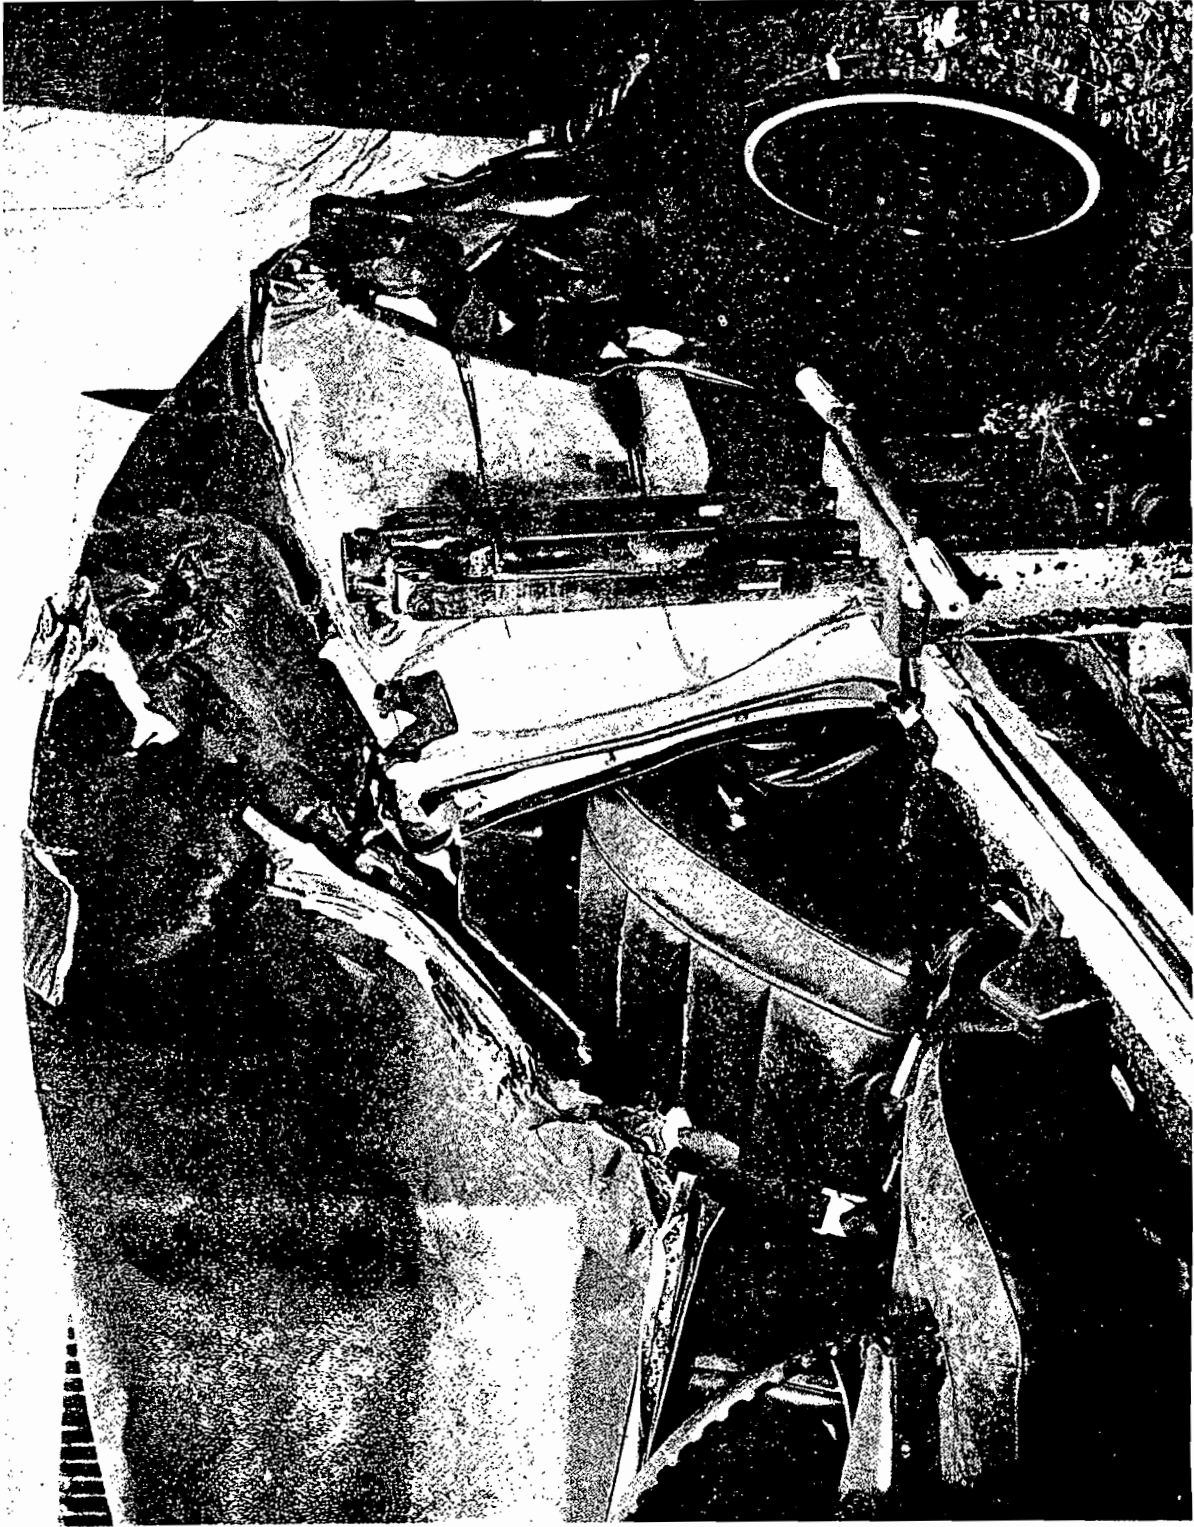
Figure 13. Driver's seat of Vehicle 17.

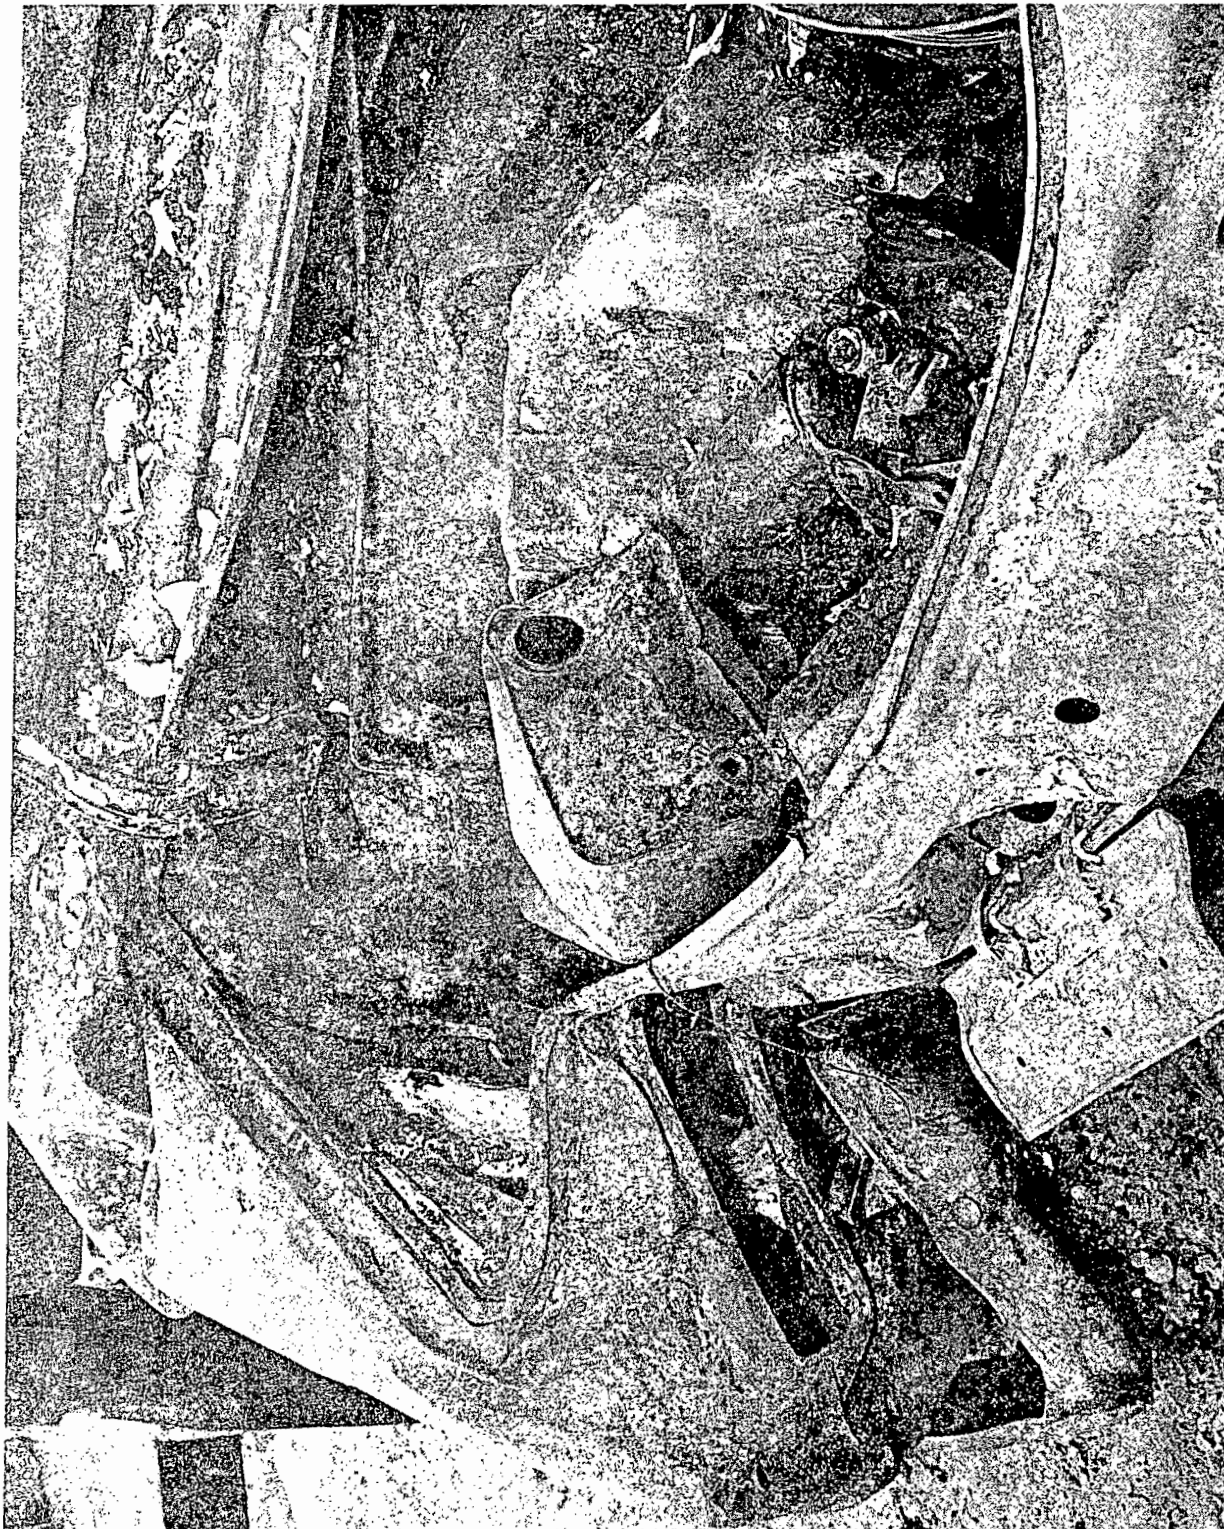
Figure 14 shows part of the contents of Vehicle 20's trunk compartment, including a number of aerosol-type containers and a large rectangular can of the type commonly used to carry engine oil. The smaller cans indicated no mechanical damage, and the rectangular can showed signs of distention. Its spout fittings appeared to have been melted away by heat. There was no indication of what any of these containers might have held.

Figure 14. Part of contents of Vehicle 20, in trunk compartment.
