**HIGHWAY ACCIDENT REPORT  
MULTIPLE- VEHICLE COLLISIONS  
UNDER FOG CONDITIONS, FOLLOWED BY  
FIRES, NEW JERSEY TURNPIKE,  
NORTH OF GATE 2  
NOVEMBER 29, 1969**

**REPORT NUMBER: NTSB-HAR-71-3**

ADOPTED: JANUARY 20, 1971

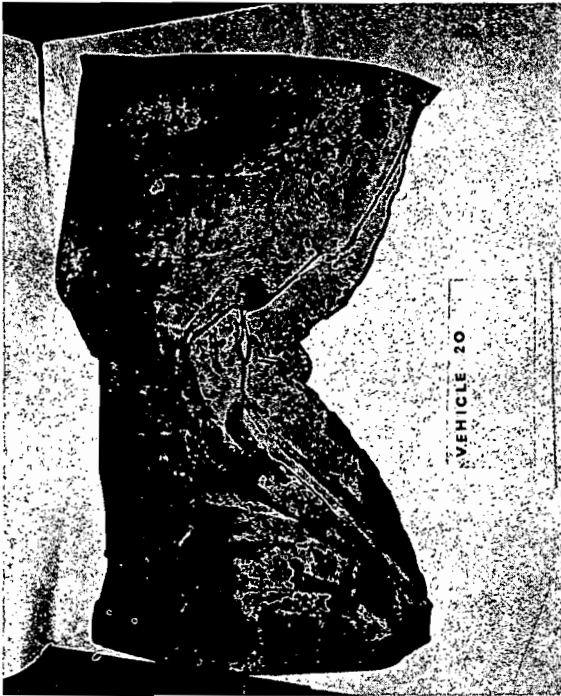
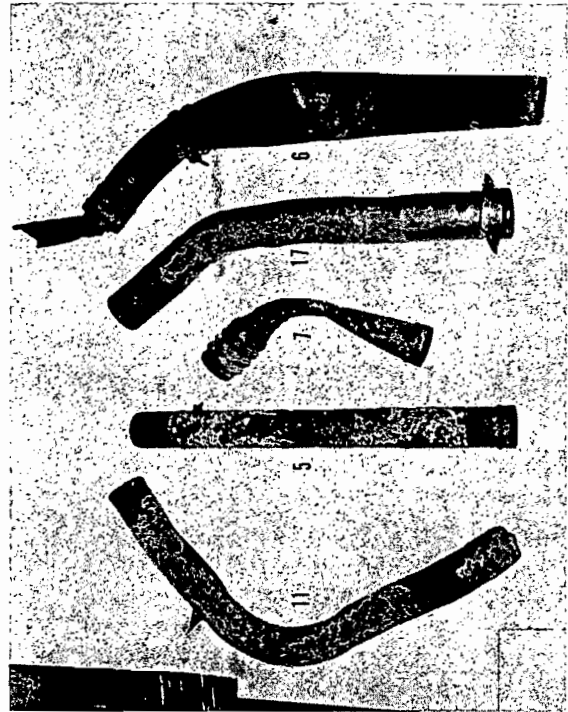
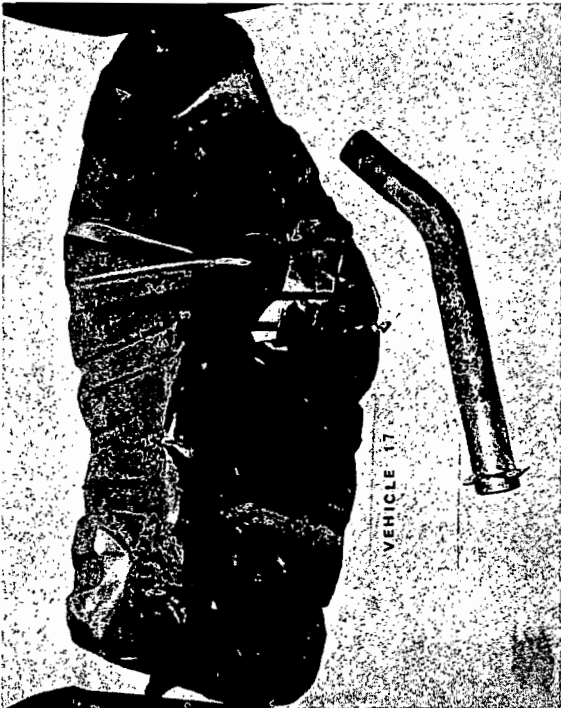
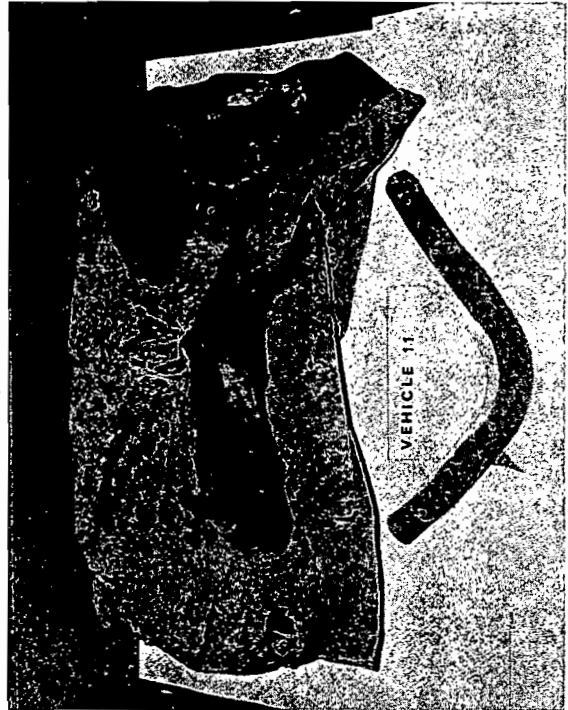
Vehicle 20 -- fuel tank damaged, hanger straps broken or loosened so that tank was not retained on vehicle, and filler pipe separated from tank. (See Figure 15 for examples of fuel-tank and filler-pipe damage.)

Figure 15. Various fuel tanks and filler spouts.
