Hazardous Materials Accident Report - Overturn of a
Tractor-Semitrailer (Cargo Tank) with the Release of Automotive
Gasoline and Fire, Carmichael, California, February 13, 1991

HAZARDOUS MATERIALS ACCIDENT REPORT

OVERTURN OF A TRACTOR-SEMITRAILER
(CARGO TANK) WITH THE RELEASE OF
AUTOMOTIVE GASOLINE AND FIRE
CARMICHAEL, CALIFORNIA
FEBRUARY 13, 1991

**ADOPTED: September 4, 1991
NOTATION 5471A**

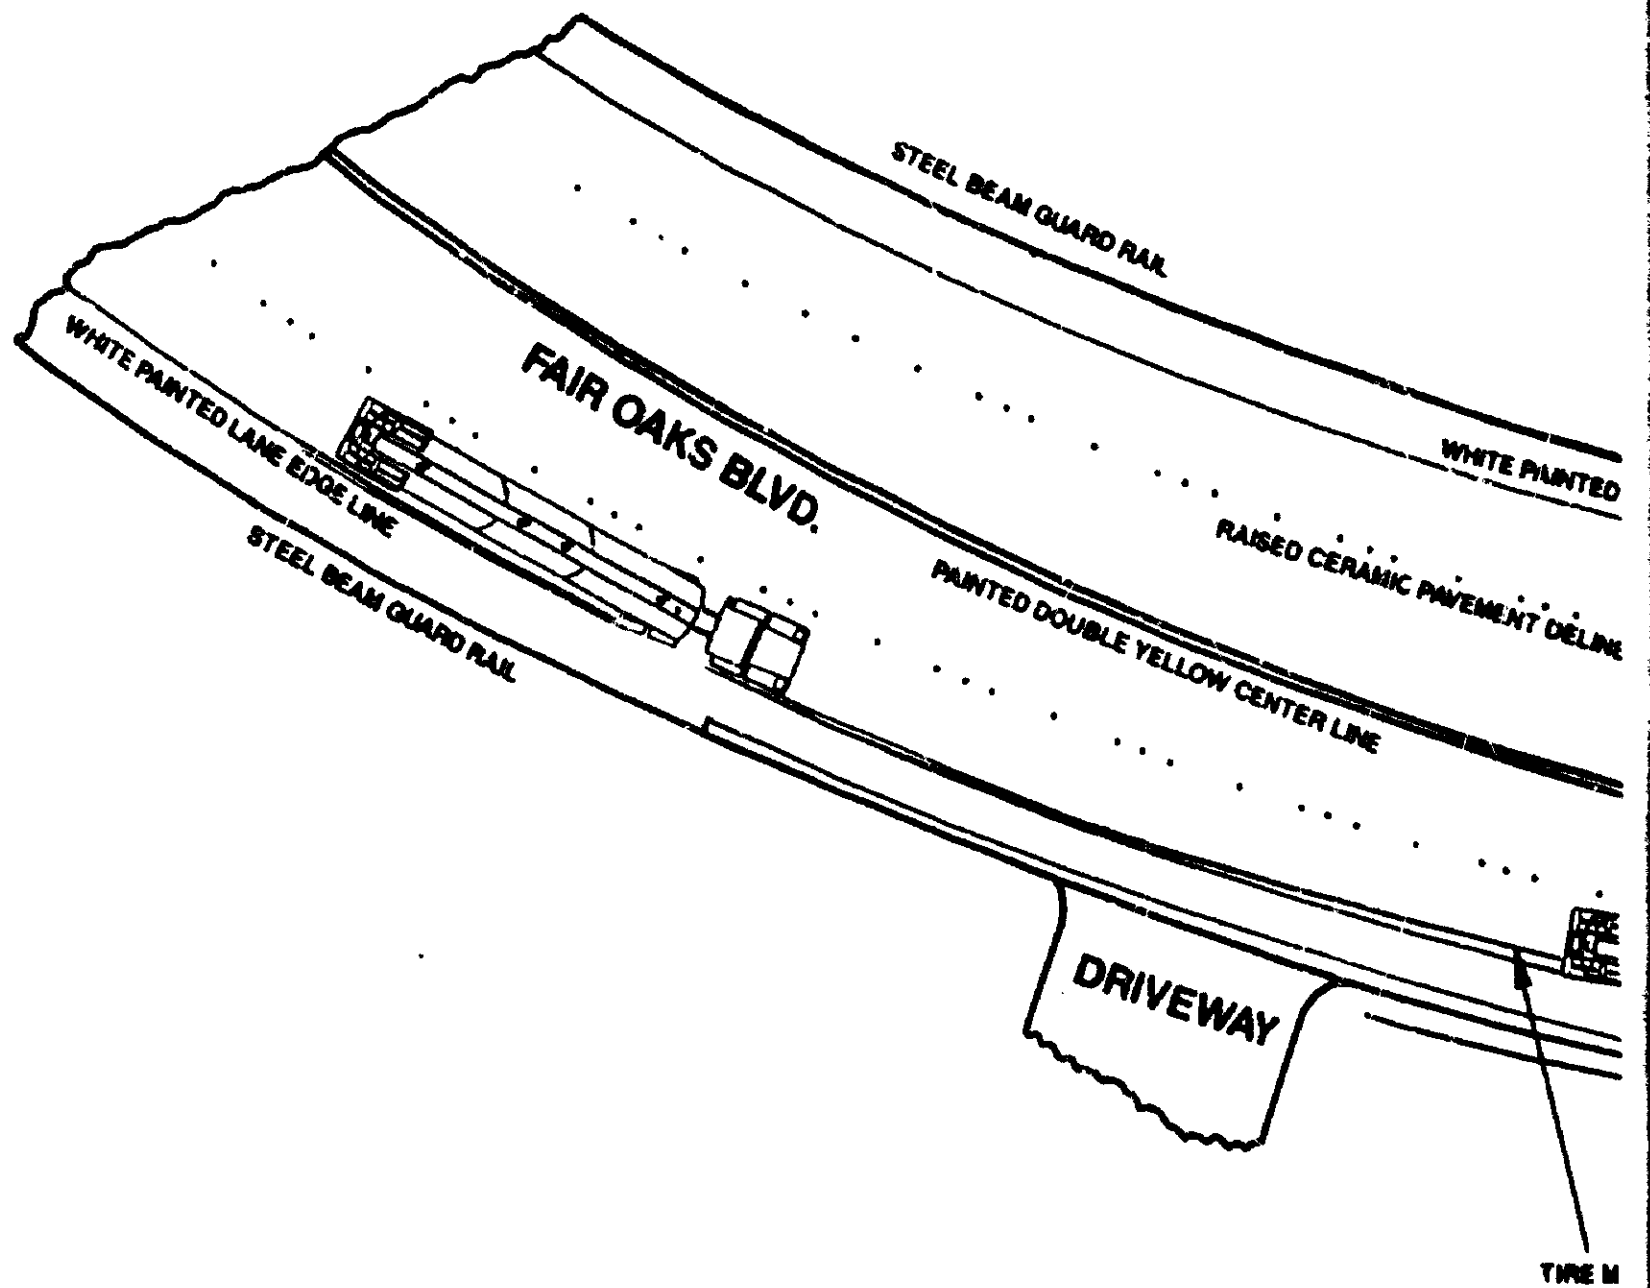
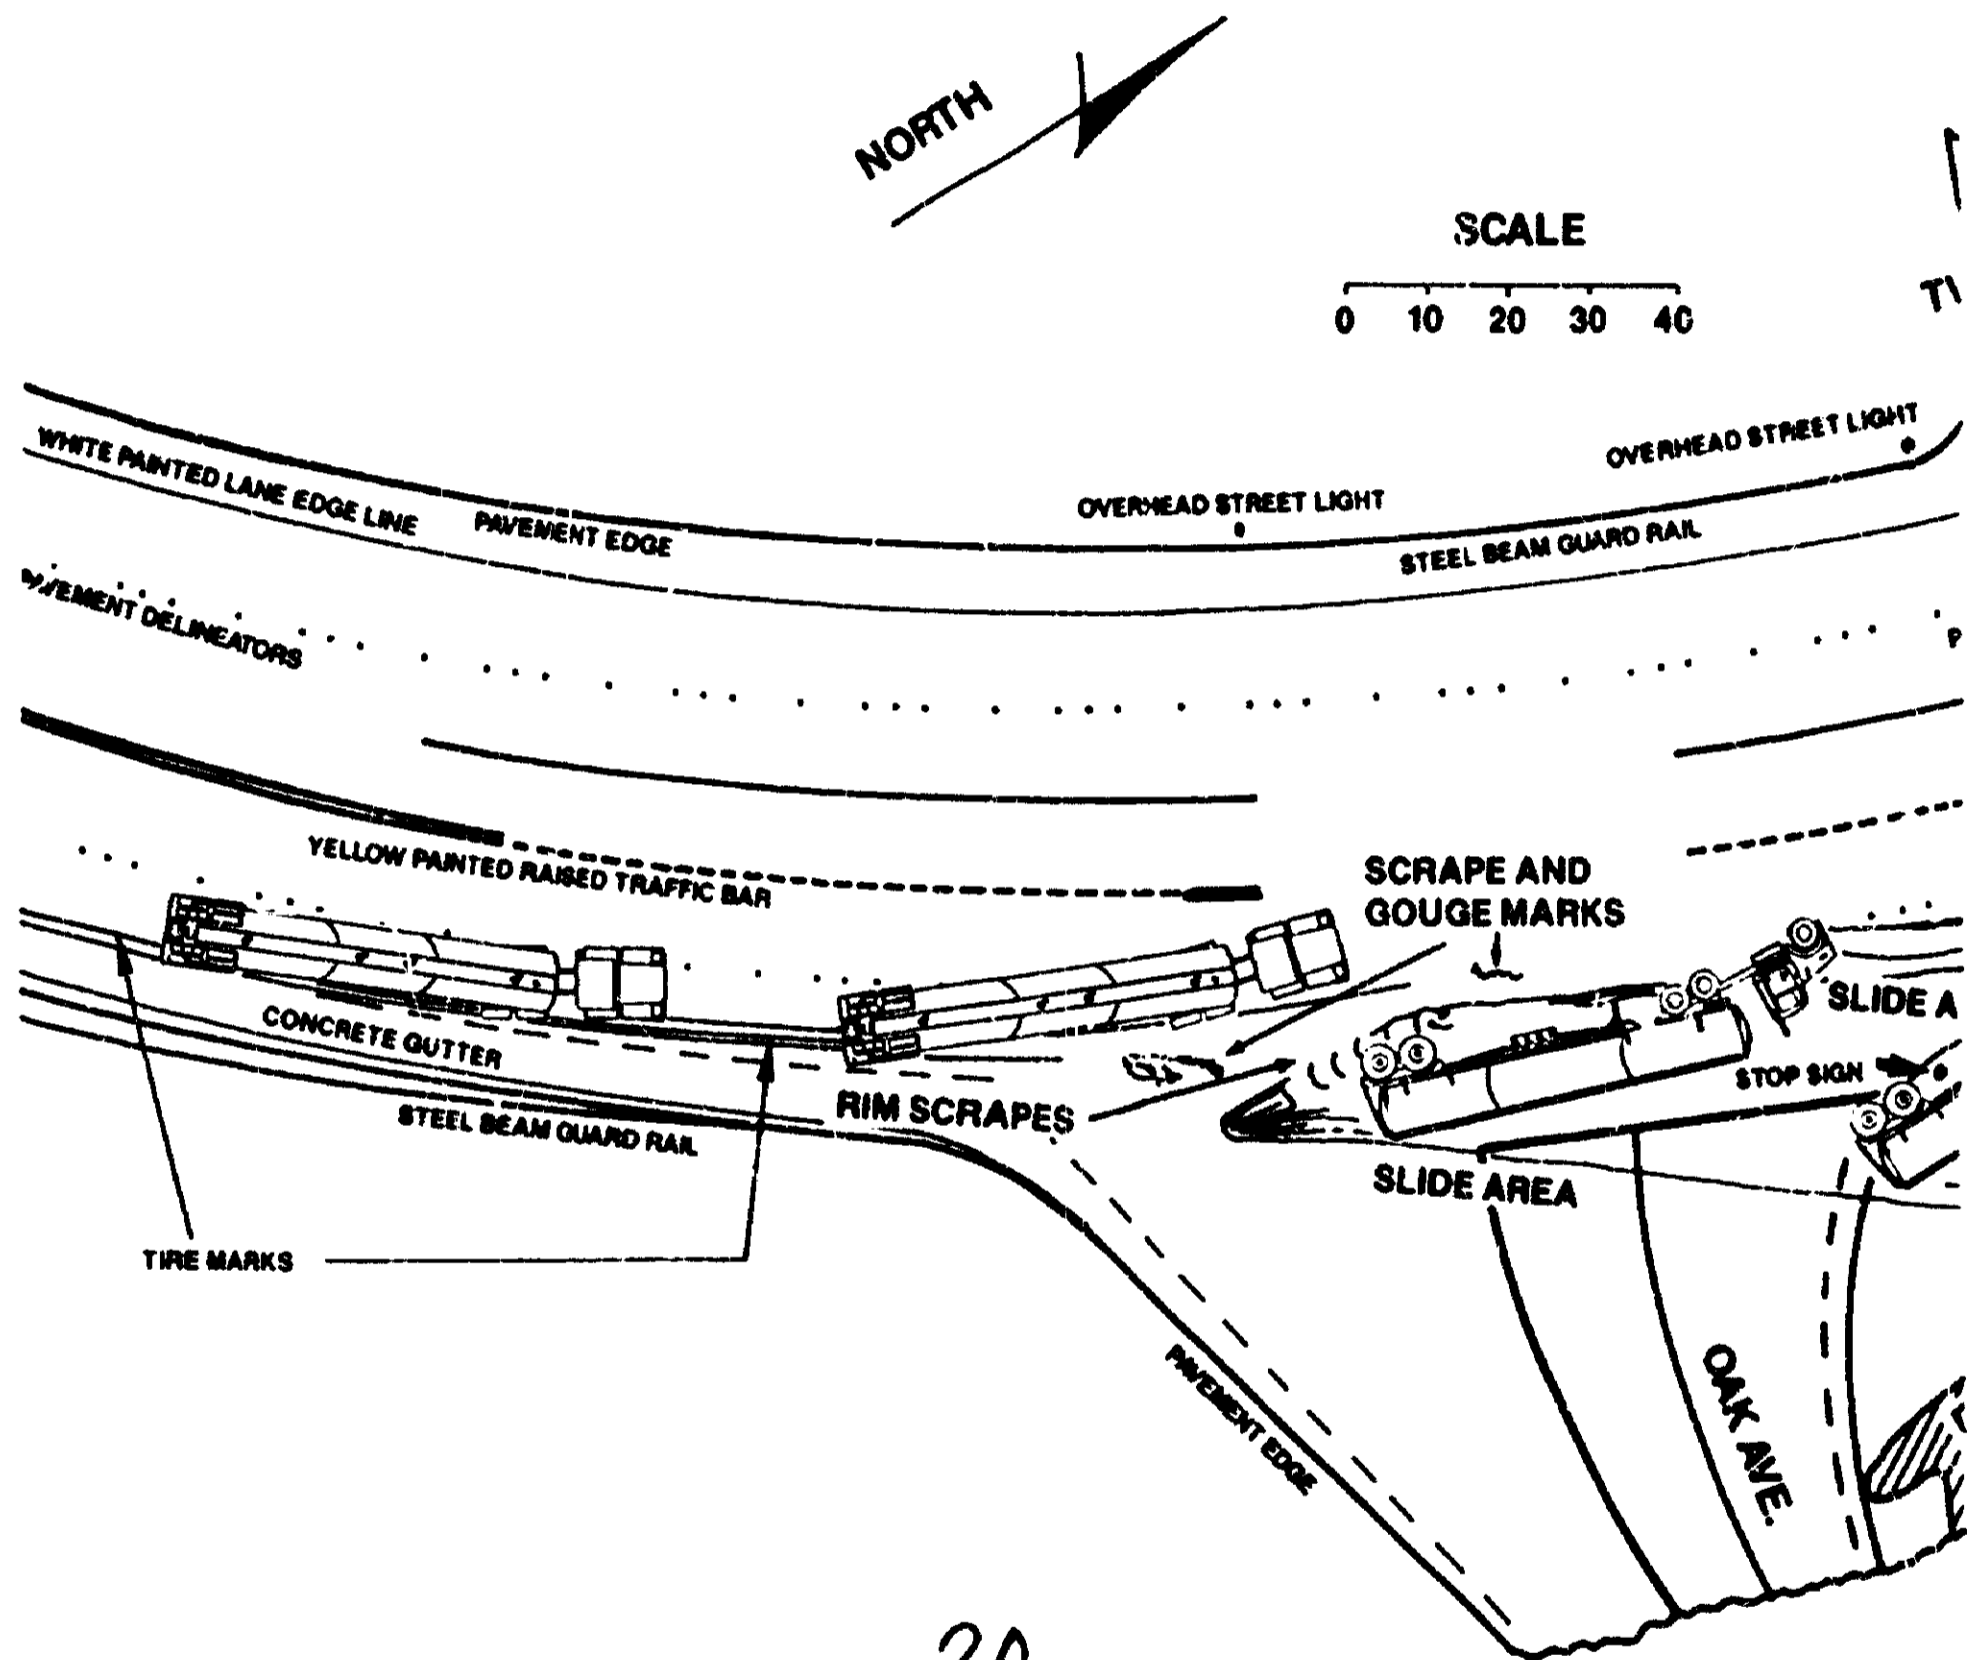
**Figure 8. Intersection and accident dynamics diagram.
(Courtesy of the California Highway Patrol.)**

Physical Evidence.--The CHP documented the location and type of marks and scrapes on the roadway, including the tire marks. From these marks, the CHP developed an accident dynamics diagram (see fig. 8) that depicts the path and orientation of the tank truck from the point the rollover began to its location at final rest. According to the dynamics diagram, the top of the cargo tank was approximately aligned with the drainage ditch when the vehicle struck the embankment of the ditch. The dynamics diagram also indicates that the final location of the cargo tank was at an angle to the ditch, with the front-end of the tank on the embankment and the rear-end of the cargo tank between 10 and 20 feet east of the embankment.

There were about 400 feet of marks on the pavement and dirt of the accident site. Tire marks in the outside traffic lane started about 150 feet into the horizontal curve to the left (see fig. 8). The marks, which were

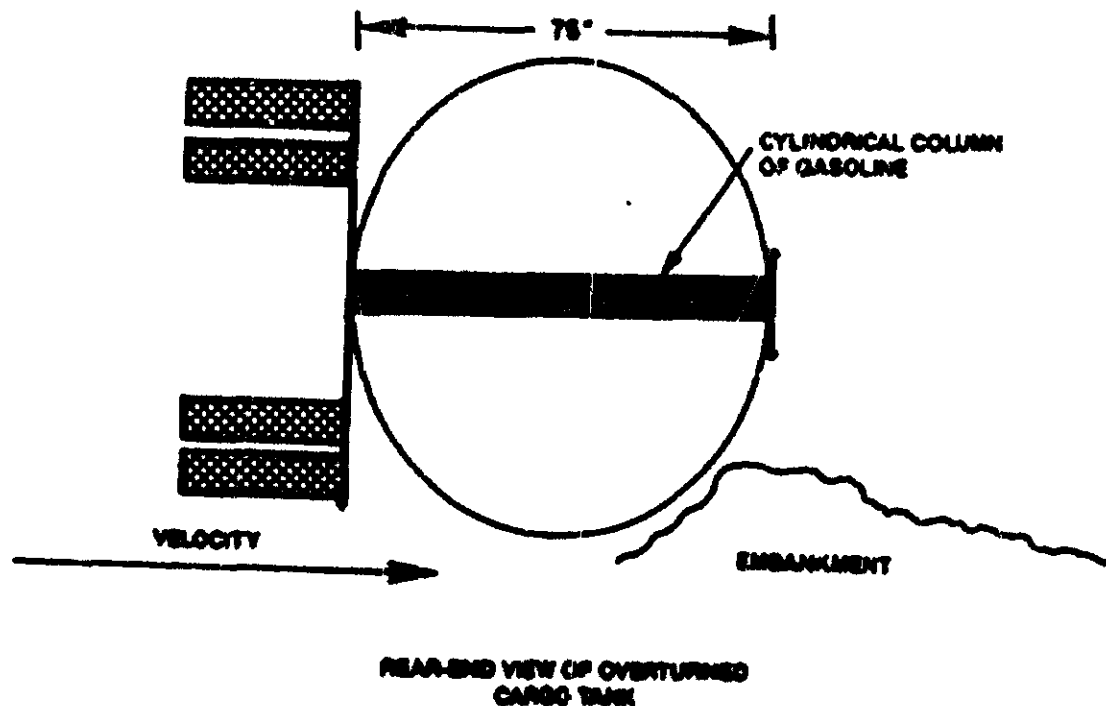
1. The cargo tank was 90° from the vertical when it struck the embankment of the drainage ditch.
2. Dynamic surge forces on the manhole cover for compartment 1 at the front of the cargo tank were generated by a cylindrical column of gasoline as shown in the figure below.

3. The cargo tank struck the embankment on the right front side of the tank shell, with the force distributed along the length of the front cargo compartment.
4. Based on the dynamics diagram provided by the California Highway Patrol, the tank truck slid about 110 feet after overturning.
