National Transportation Safety Board  
Washington, D.C. 20594

Highway Accident Brief

**Accident No.:** HWY-98-SH-039  
**Accident Type:** Loss of control on downgrade  
**Location:** Dunlap, Tennessee  
**Date and Time:** August 13, 1998; 7:13 p.m.  
**Vehicle 1 (V1):** 1994 Peterbilt tractor-semitrailer hauling wood chips  
**Vehicles 2–10 (V2–V10):** 4 passenger cars, 1 sport utility vehicle, 3 pickup trucks, and 1 panel truck  
**Fatalities/Injuries:** 2 fatalities, 17 minor to moderate injuries

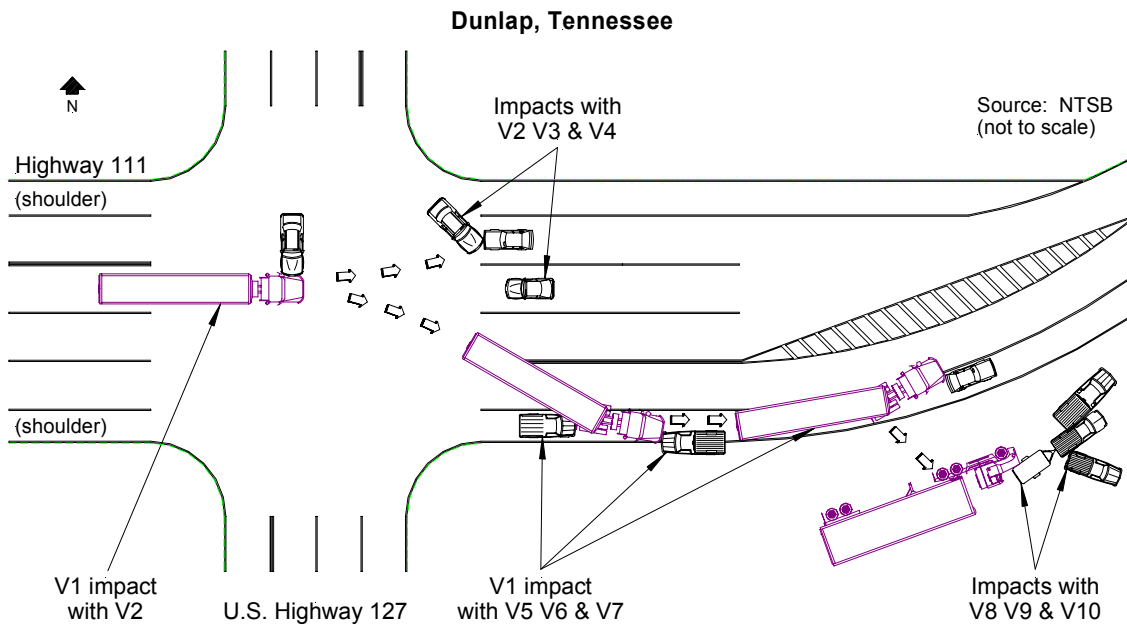
**Figure 1.** Accident diagram.

The truckdriver was unable to control the vehicle's speed traveling down a steep, 4-mile downgrade toward a signalized intersection at State Highway 111 and U.S. Highway 127. (See figure 1.) She stated that she attempted to downshift into a lower gear. The driver failed to put the transmission back into gear, thereby descending the hill with only air mechanical brakes to control the speed. She lost control of the truck, traveled into the intersection, and struck several parked and moving vehicles and pedestrians. Two occupants of a car were killed; four other vehicle occupants and 13 pedestrians were injured.
