**Rear-End Collision and Subsequent Vehicle Intrusion
Into Pedestrian Space at Certified Farmers' Market
Santa Monica, California
July 16, 2003**

NTSB/HAR-04/04

**National
Transportation
Safety Board**

Abstract: On July 16, 2003, a 1992 Buick LeSabre was westbound on Arizona Avenue, approaching the intersection of Fourth Street, in Santa Monica, California. A 2003 Mercedes Benz S430 sedan was stopped on Arizona Avenue at the intersection for pedestrians in a crosswalk on Fourth Street. The Buick struck the Mercedes, continued through the intersection, and drove through a farmers' market, striking pedestrians and vendor displays before coming to rest. As a result of the accident, 10 people were fatally injured, and 63 people received injuries ranging from minor to serious. The Buick driver and both Mercedes occupants were uninjured.

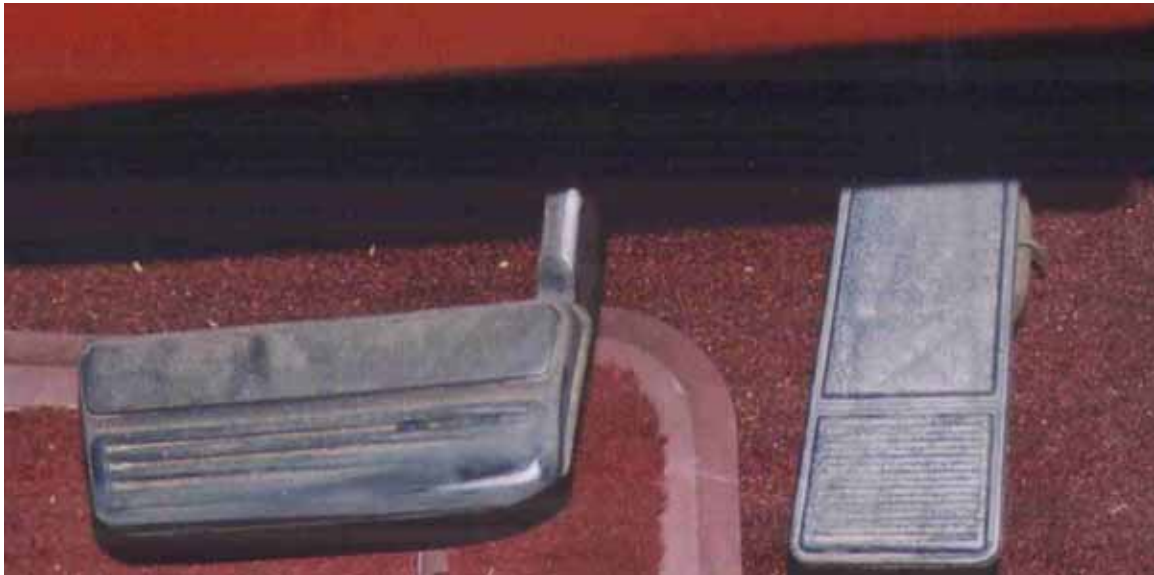
The Buick was equipped with a power-assisted, dual-circuit hydraulic brake system configured with front disc brakes and rear drum brakes. The master cylinder was adequately filled with fluid and the power booster supply check valve functioned properly. All wheel hubs rotated freely and without indications of drag or out-of-round conditions. Examination of each brake assembly and associated hydraulic lines revealed no leaks, restrictions, or operational defects. The brake pedal was intact and functional, offering consistent resistance and approximately 2 1/2 inches of nonpower-assisted travel. The rubber cover on the brake pedal was worn on the lower right edge, revealing the metal beneath (see figure 3). Separation between the brake pedal and the accelerator at the closest point was 2 inches.

Figure 3. Accident vehicle's brake pedal.

The primary concern about pedal placement is dual activation, that is, the driver depressing both the accelerator and the brake when he or she only intends to depress one or the other. The pedal separation in the accident vehicle was at the recommended minimum,³² and two factors suggest that dual activation did not occur in this accident. First, witnesses reported they did not see the vehicle's brake lights illuminate, which would have occurred if the brake pedal had been depressed, even in conjunction with the accelerator. Second, witness descriptions of the vehicle's motion and the physical evidence indicated significant increases in acceleration and speed during the accident sequence and did not indicate a retarding force, which would be expected if the brake pedal had been depressed.

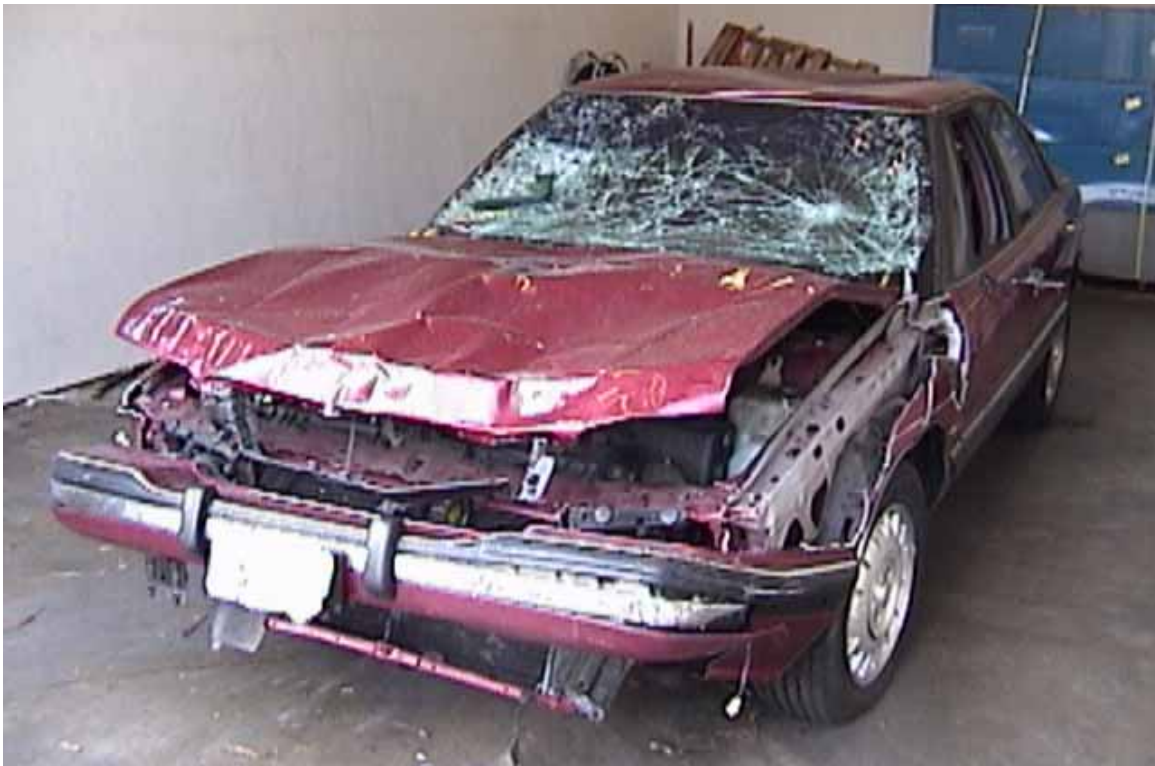
The Buick sustained frontal damage encompassing the front bumper, forward light fixtures, radiator grill, radiator and support, left front quarter panel, windshield, roof, both side mirrors, and rear antenna. (See figure 4.) The two side-view mirrors were missing, and the shattered windshield had two distinct impact or indentation locations; remnants and debris from items struck were found embedded in the windshield. The right side of the front bumper had light blue paint transfer, and the rubber portion of the right rear bumper had white paint transfer. The left bumper quarter panel was missing and exhibited exposed, jagged edges. The bumper was angled upward from the frame, consistent with accident damage. The Buick's airbag had deployed.

Figure 4. Postaccident damage to 1992 Buick LeSabre.

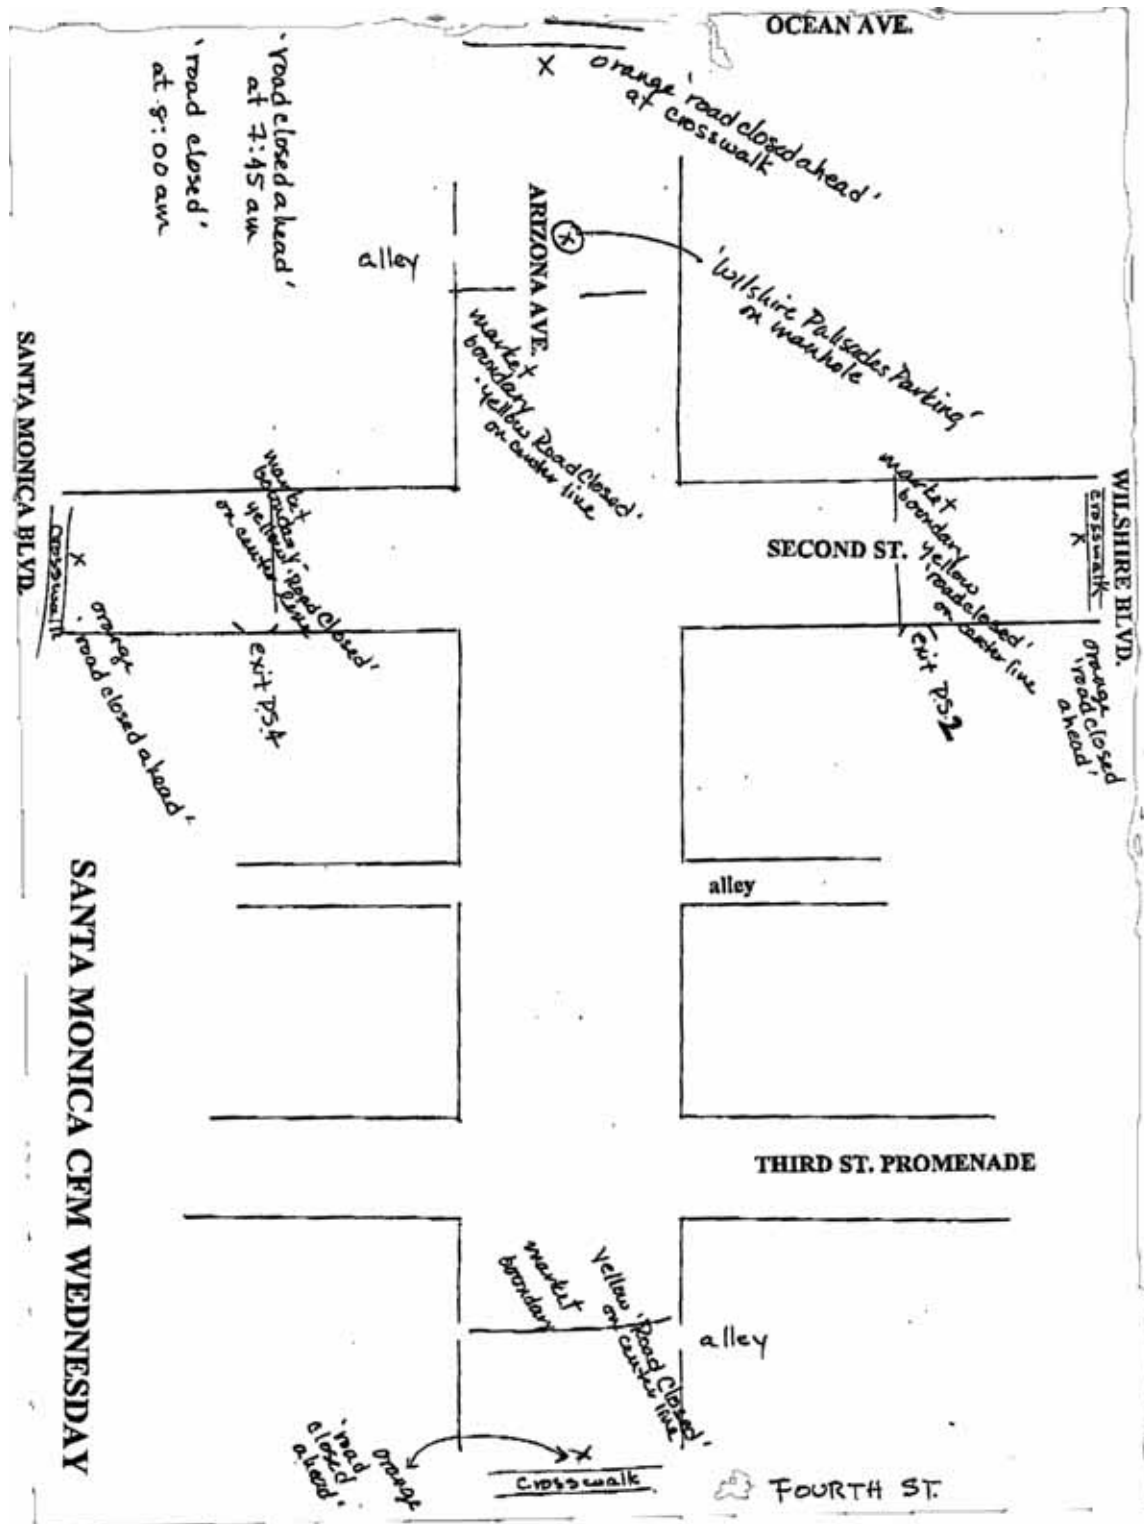
Santa Monica provided a temporary traffic plan for the SMC FM to Safety Board investigators. The undated and unsigned temporary traffic plan consisted of a single sheet of paper (8 1/2 x 11 inches) on which a roadway diagram was hand-drawn (see figure 6); the diagram indicated where barricades should be placed in the roadway. The plan did not cite any specific *Manual on Uniform Traffic Control Devices* (MUTCD) or *Caltrans* [California Department of Transportation] *Traffic Manual* (CTM) barricade types or traffic channelization devices⁸ to be used. According to the director of the SMC FM, the traffic plan had been developed in 1981 when the market opened and revised in 1986 when the market expanded onto Second Street. It had not been revised, reevaluated, or updated since then.

Figure 6. Temporary traffic plan (1986 version).

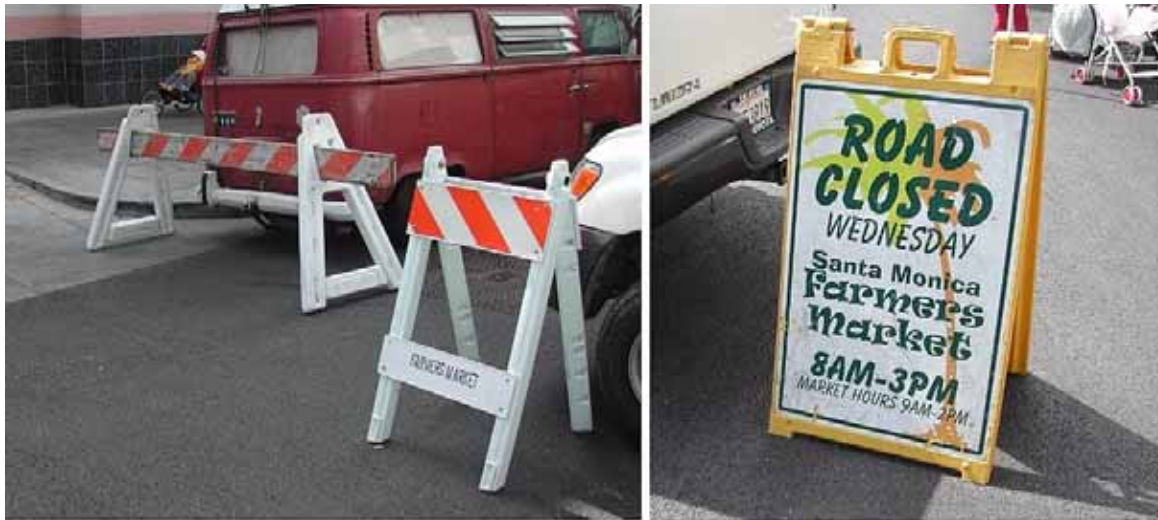
According to the SMC FM director, Arizona Avenue was blocked at the entrances to the market by two MUTCD type I barricades,⁹ supplemented by two A-frame plastic barricades (see figure 7). The barricades were placed in the roadway about 7:00 a.m. every Wednesday, remained in place during the event, and removed about 3:00 p.m. Orange, diamond-shaped ROAD CLOSED AHEAD warning signs (designated “W-20” signs in the MUTCD and “C-19” in the CTM), attached to temporary fixtures, were placed on the centerlines of Arizona Avenue and Second Street (see figure 8),¹⁰ about 1/2 block before the road closure. No other advance warning signs were used. When Safety Board investigators observed the SMC FM in operation on July 23, 2003, barricades were in place at those locations indicated in the temporary traffic plan. Contract personnel, hired by the city’s Office of Economic Development, placed and removed the barricades and warning signs.

Figure 7. Market barricades.

⁹ The CTM, Chapter 5, Section 5-05.6, “Channelizing Devices, F. Barricade Application,” recommends the use of type III barricades for full road closures, as shown in Typical Application 5-8 on page 5-99, “Road Closed with Off-Site Detour.”

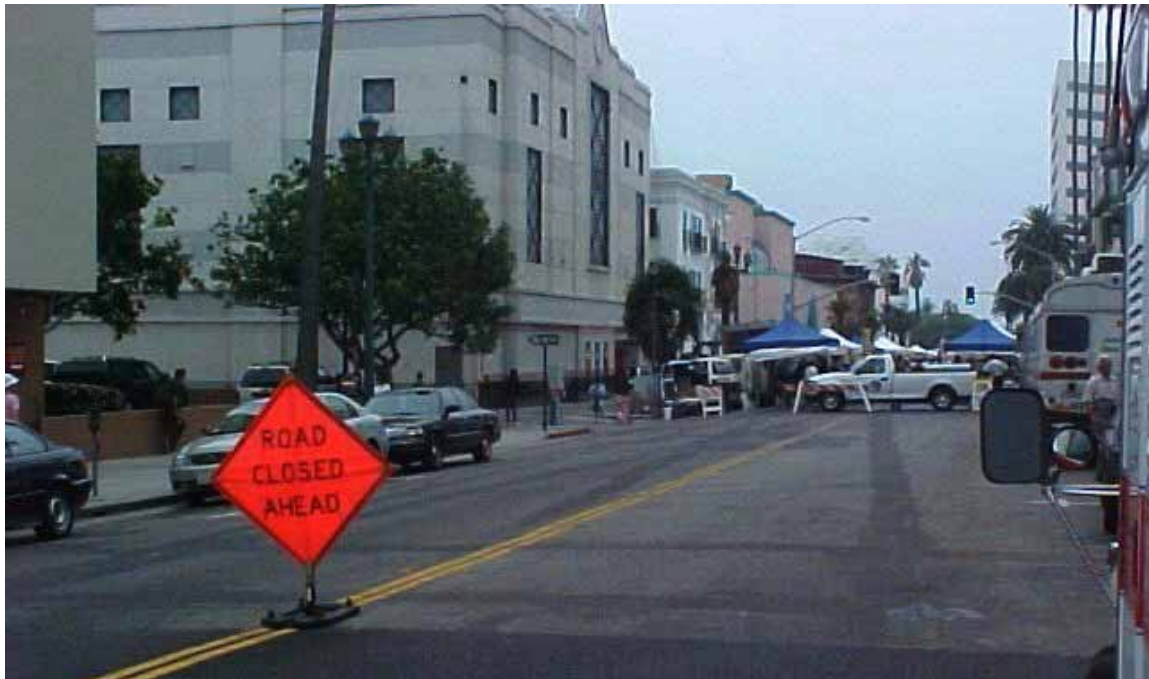
¹⁰ In this photograph, taken a week after the accident, a small pickup truck is parked in the middle of the street. No vehicles were parked in the middle of the street on the day of the accident.

Figure 8. Advance warning sign on Arizona Avenue, just west of Fourth Street (postaccident).

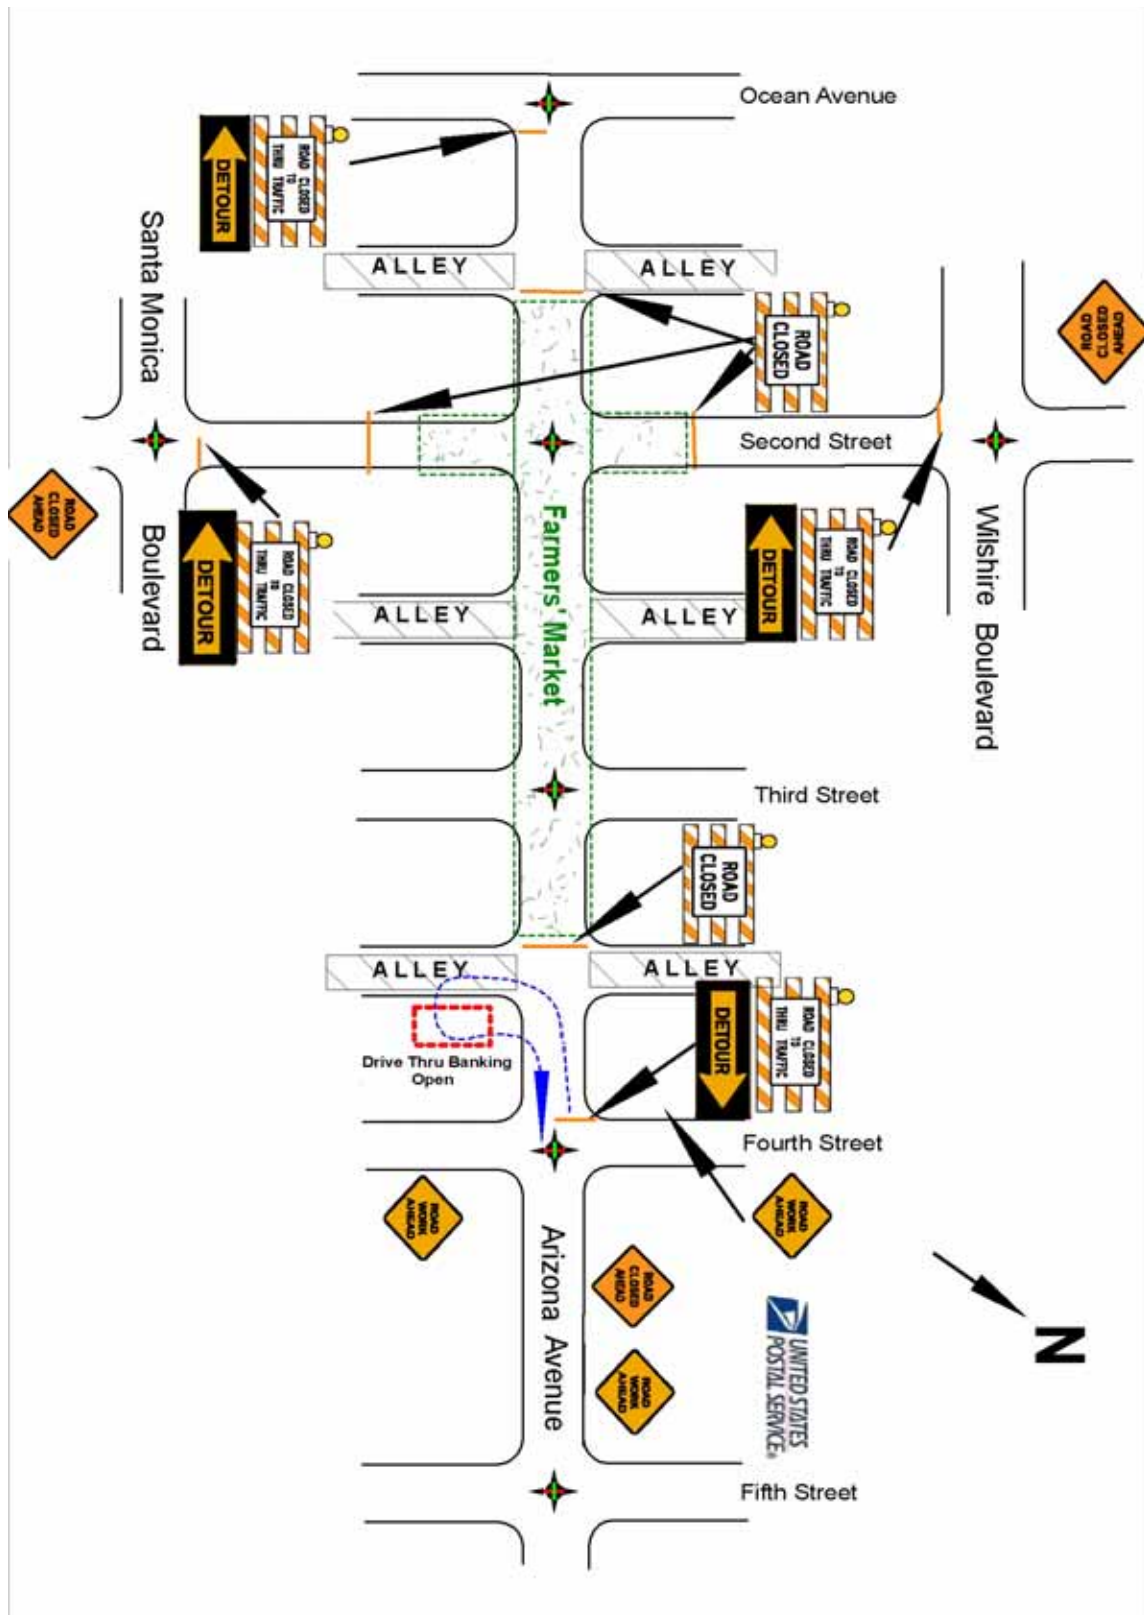
Thus, Santa Monica failed to comply not only with its own guidance, but also with State and Federal guidelines regarding temporary road closures for the SMC FM. As a result, the temporary traffic control devices erected along Arizona Avenue at the time of the accident did not provide the more robust barricades recommended in city, State, and Federal manuals and sent conflicting messages to motorists by, for example, allowing traffic signals at Second and Third Streets to function, even though the road was not open to through traffic. While the signage is unlikely to have affected the accident driver's actions, it could be critical in another situation in which a driver is impaired or distracted and does not understand that Arizona Avenue is closed to vehicular traffic.

Figure 13. SMCFM traffic control measures that comply with city guidelines.

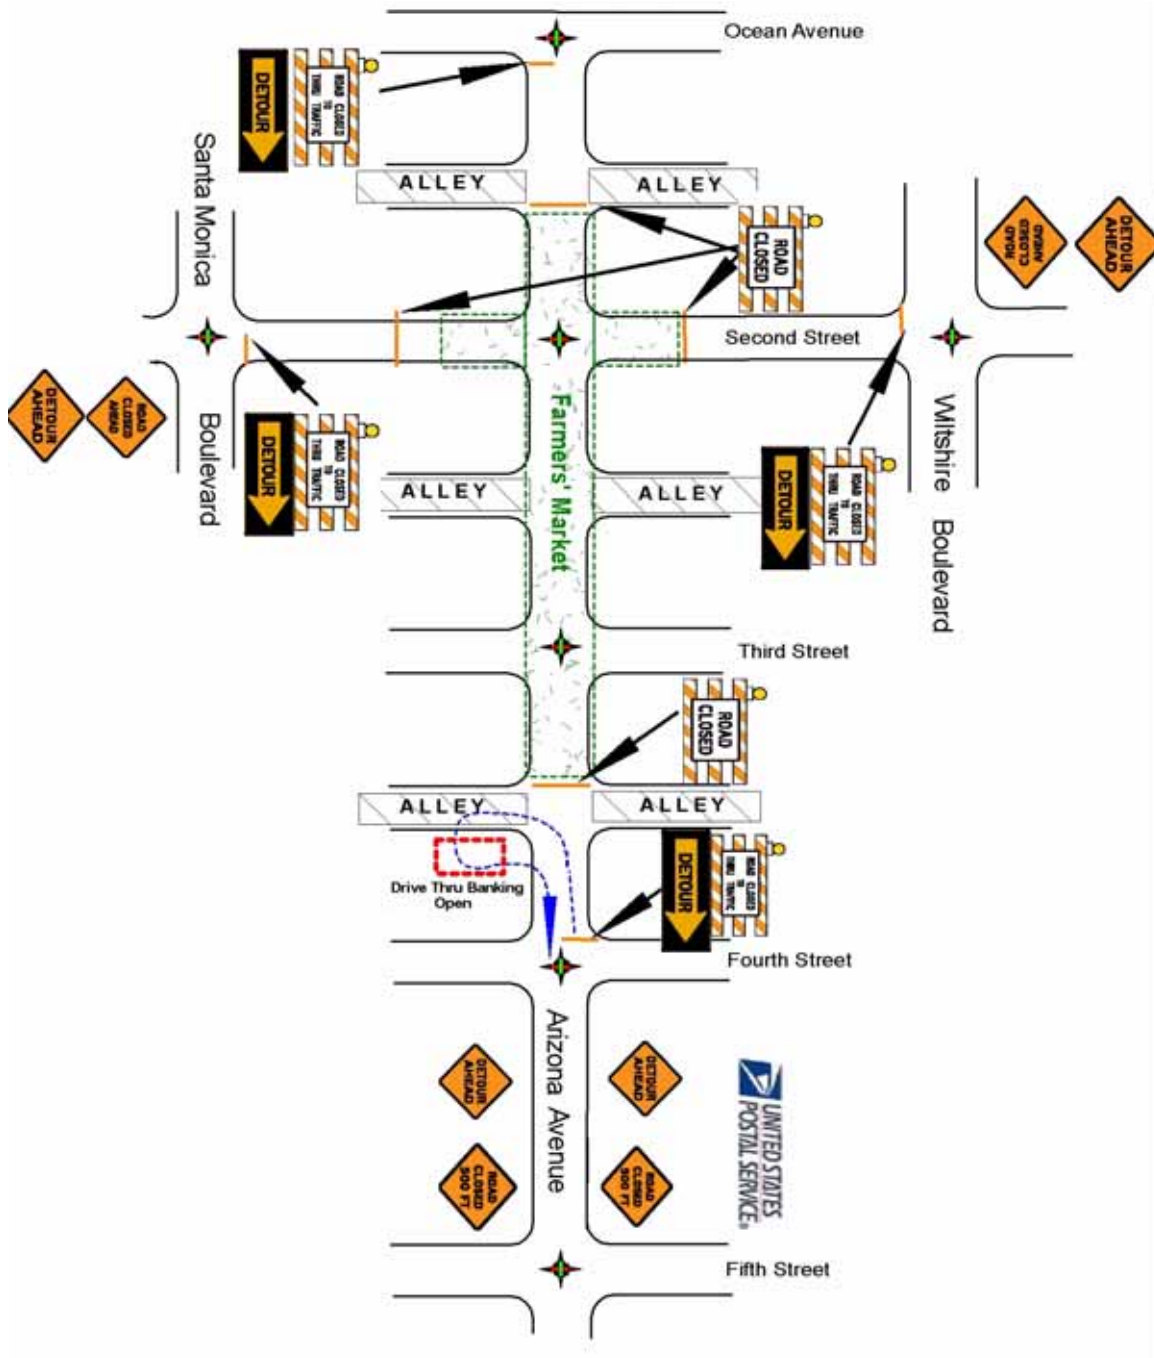
Figure 14. SMCFM traffic control measures that comply with CTM and MUTCD guidelines.

The Safety Board therefore concludes that the city’s temporary traffic plan for closure of Arizona Avenue to accommodate the SMCFM was not consistent with established local, State, or national guidelines and was inadequate to ensure the safe flow of vehicular and pedestrian traffic in the area. The temporary traffic control plan for the market had been developed more than 2 decades ago and revised only once 5 years later. Since the 1986 revision, both the CTM and the MUTCD were updated several times.
