# National Transportation Safety Board

## Highway Accident Brief

**Accident No.:** HWY-05-MH-023  
**Accident Type:** Frontal and sideswipe collision between a school bus and a trash truck  
**Location:** Columbia Pike near the intersection with Courthouse Road; Arlington, Virginia  
**Date and Time:** April 18, 2005; 8:40 a.m.  
**Vehicle 1:** 1999 Thomas Built 52-passenger school bus  
**Operator 1:** Arlington County, Virginia, School District  
**Vehicle 2:** 2003 Mack 4-axle truck with a Heil trash body  
**Operator 2:** AAA Recycling and Trash Removal Services  
**Injuries:** 2 fatal, 3 serious, and 4 minor

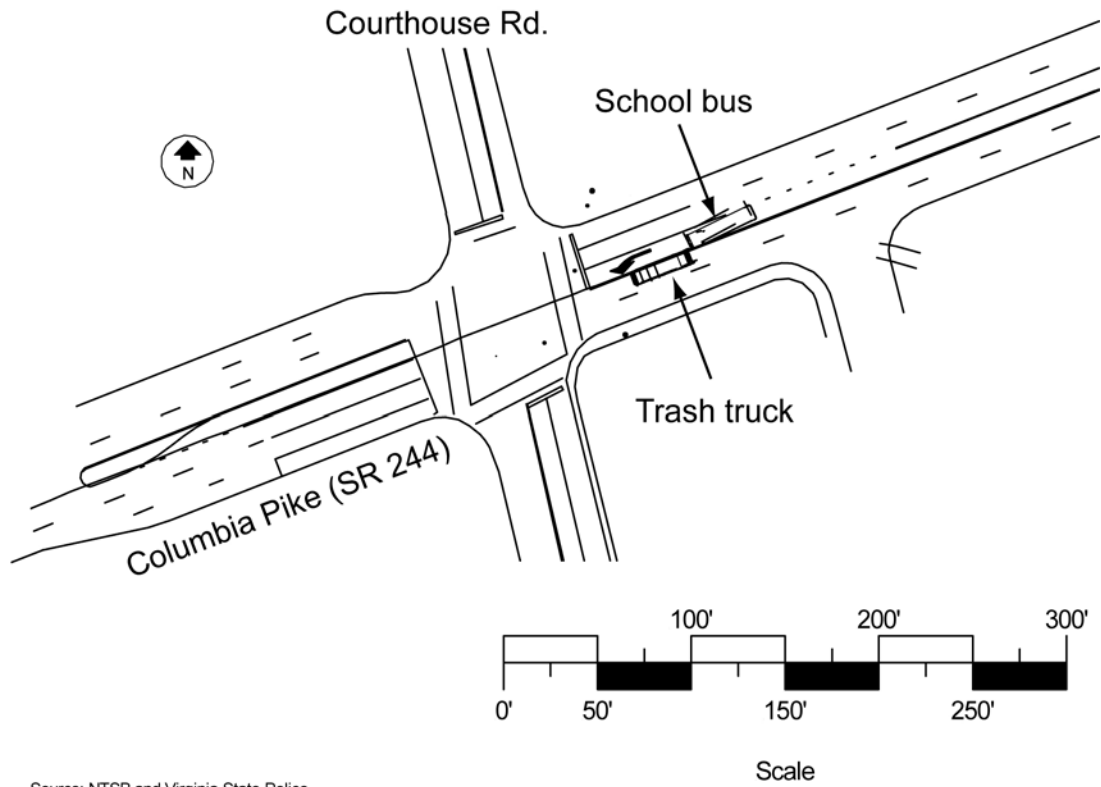
corners of both vehicles and a sideswipe. (See figures 1 and 2 for a map of the accident location area and a diagram representing the vehicles at the point of impact.)

**Figure 2.** Diagram showing the estimated positions of the school bus and the trash truck at the point of impact.

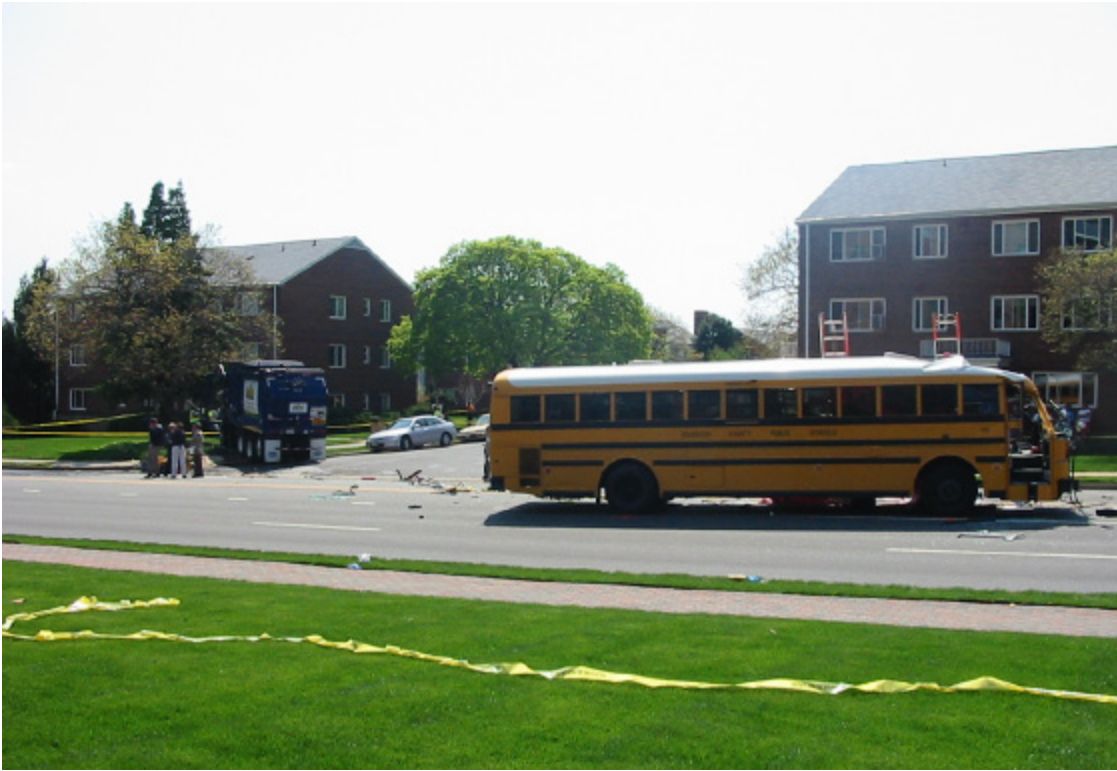
During the collision, the school bus was pushed backward, but it remained in the left turn lane following the accident. The trash truck continued eastbound about 200 feet, crossed the right eastbound lane, jumped the right curb of Columbia Pike, and came to rest. (See figure 3.)

**Figure 3.** Vehicles at rest postaccident.

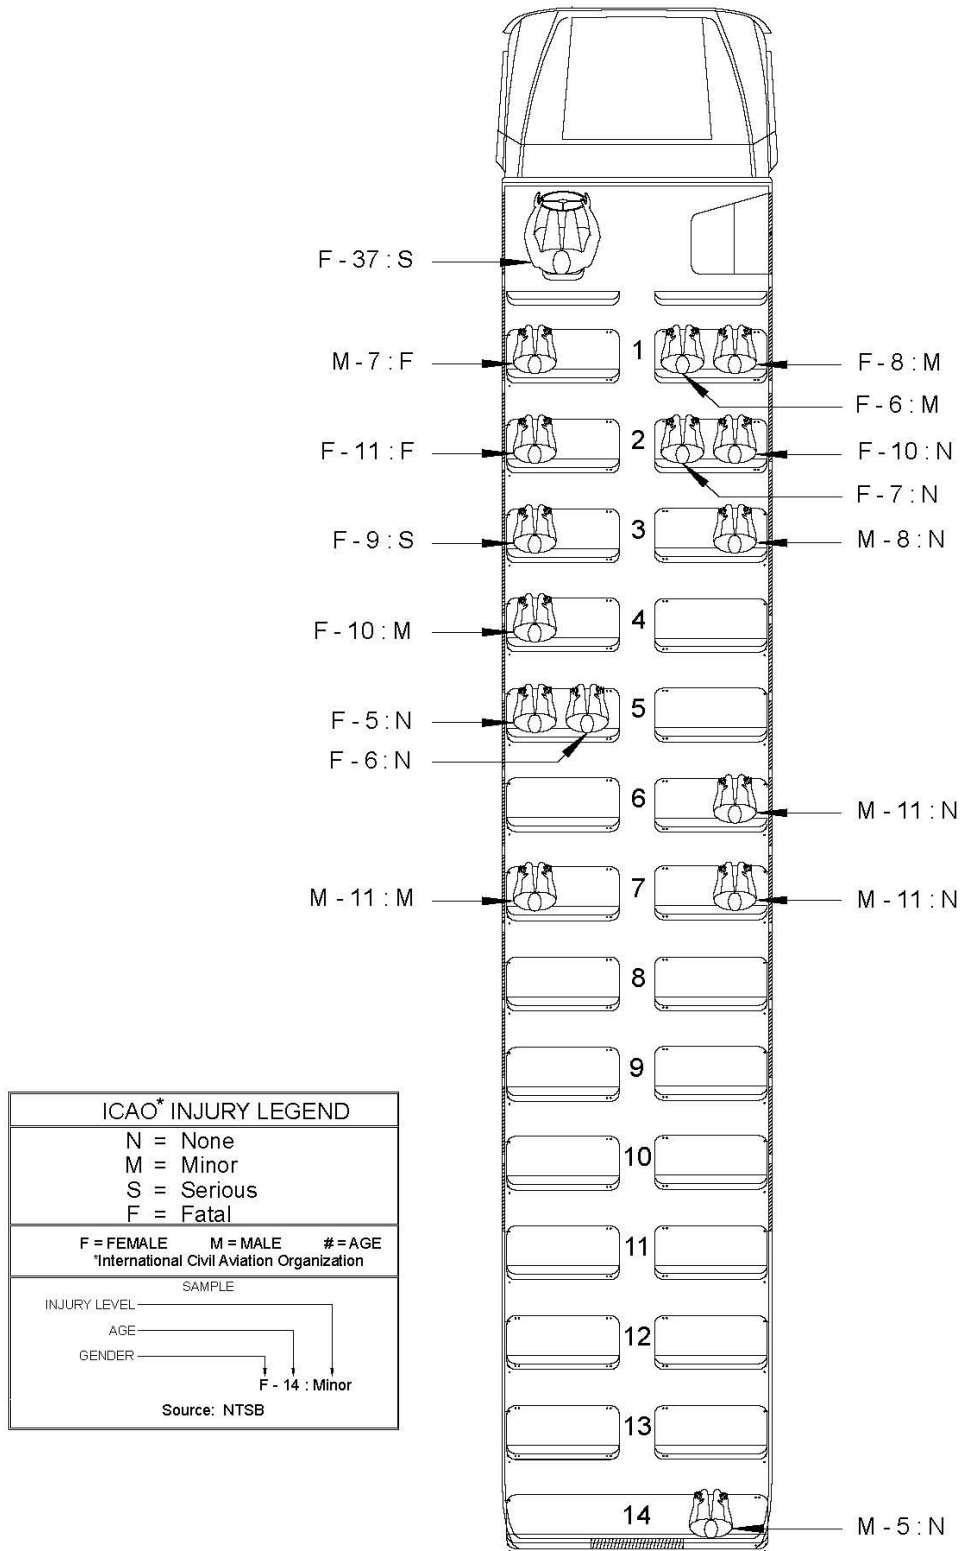
One student died at the scene and one student died 3 days later in the hospital. The truck driver, school bus driver, and one student on the bus sustained serious injuries; four students sustained minor injuries; and the remaining eight students were uninjured. The bus driver, who had been wearing her seat belt, was ejected through the broken windshield when the shoulder portion of the belt was sheared in half. Emergency responders needed approximately 1 hour to extricate the trash truck driver from the truck cab because of his legs being trapped in the wreckage. The students who suffered the most severe injuries were seated behind the driver on the left side, near the front, of the bus. (See figure 4.)

Figure 4. School bus seating and injury chart.

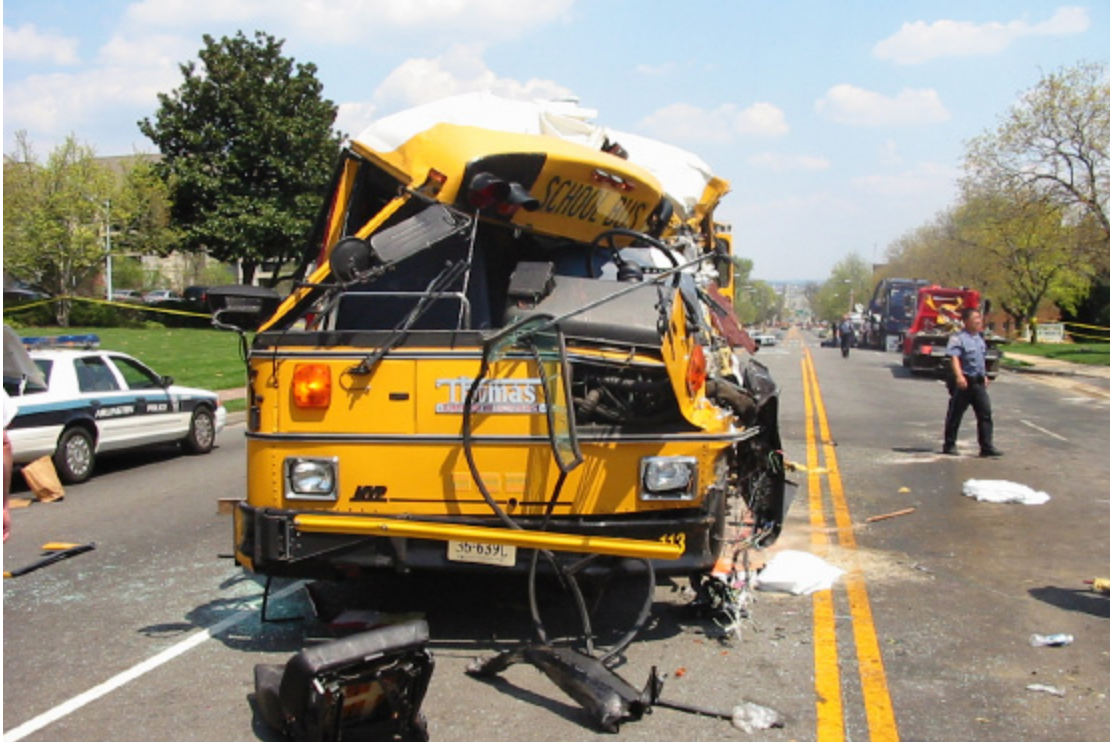
The school bus sustained impact damage to its front and left side. (See figure 5.) The damage continued along the left side of the bus to near the sixth passenger row behind the driver's seat, approximately 20 feet rearward from the front bumper. Intrusion into the occupant compartment extended inboard to a depth of about 6 1/2 inches.

**Figure 5.** Damage to the school bus.

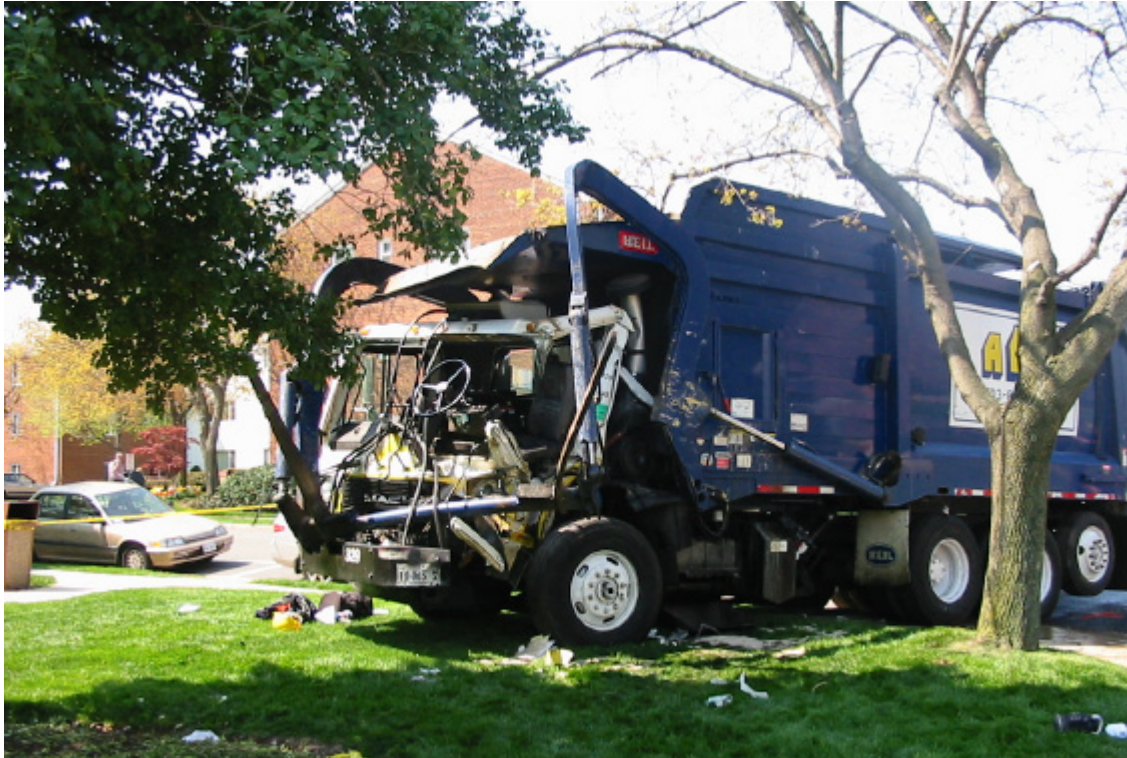
The trash truck sustained damage to its left-front corner and its hydraulic front loader arm assembly. The left fork of the trash truck's hydraulic arm was bent outward and protruded to the left of the truck's left side. (See figure 6.)

**Figure 6.** Damage to the trash truck.

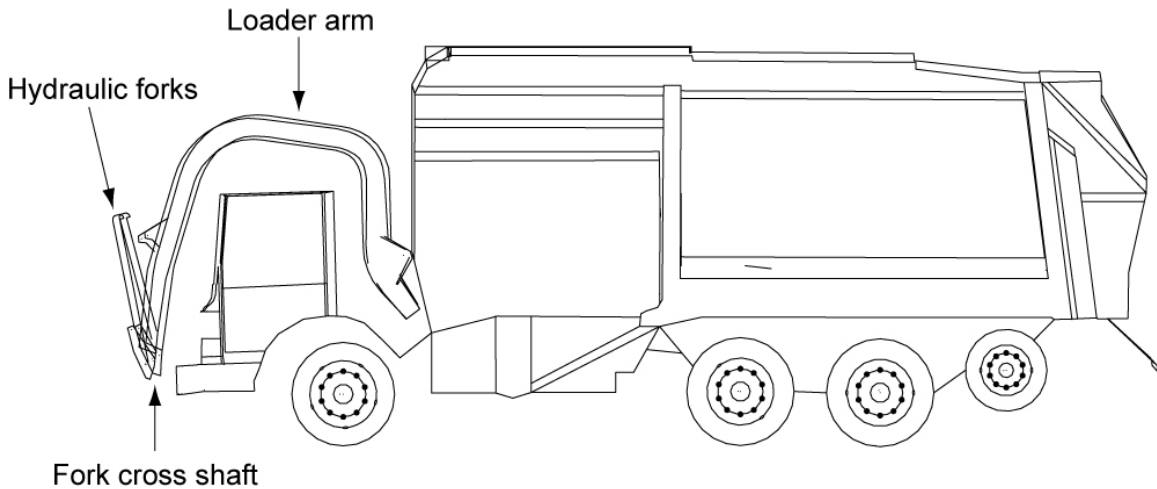
The vehicle's hydraulic front-loading arm assembly was designed to pick up dumpsters, raise them above the truck, and empty their contents into the back of the truck. According to Heil, the recommended in-transit position for this assembly was with the fork cross shaft (bottom) of the arm "slightly below cab windshield"<sup>5</sup> to ensure visibility through the windshield and enable the vehicle to meet road height restrictions. The recommended in-transit position for the forks (which retract down from the two sides of the arm) was that they be folded up into the arm. (See figure 7.)

**Figure 7.** Diagram of an exemplar trash truck with loader arm positioned below cab windshield, as recommended by Heil for transit. The forks in this diagram are approximately halfway between being folded into the arm and being fully extended.

The truck driver stated that he had positioned the truck's arm above the headlights, which would put it forward of the bumper and a little below the windshield. Postaccident examination indicated that the forks were neither fully folded nor fully extended. (Damage to the forks made it difficult to determine their preaccident position.)

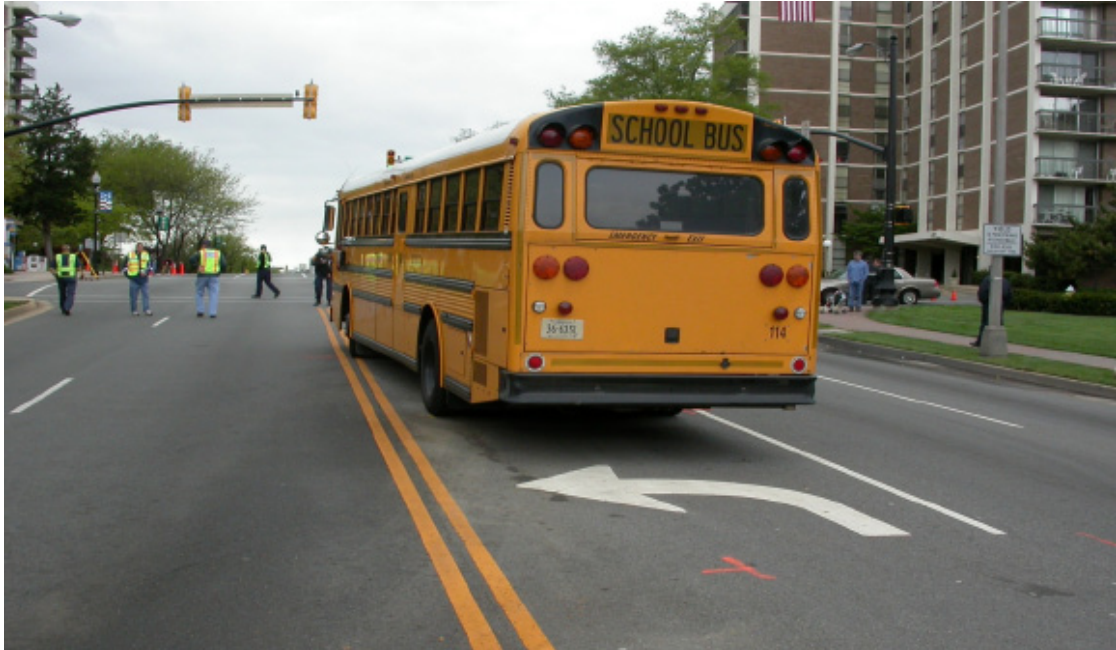
At the time of the accident, the bus was entering the center left turn lane. A tire mark on the edge of the centerline closest to the bus indicated that the bus's left front tire was touching this line, suggesting that the bus had initiated the movement into the turn lane but had not yet "straightened" the full body of the bus into and within it. If this movement were made later than would be optimal,<sup>12</sup> a portion of the bus's left front overhang might angle briefly over the centerline and into the eastbound lane. The incursion would last only until the sharp leftward movement was completed and the vehicle had fully readjusted its position back into and within the 10-foot-wide turn lane. (See figures 8 and 9.)

**Figure 8.** View from the rear of an exemplar school bus positioned as the accident bus is likely to have been immediately preceding the accident. (Photograph taken during postaccident reconstruction.)

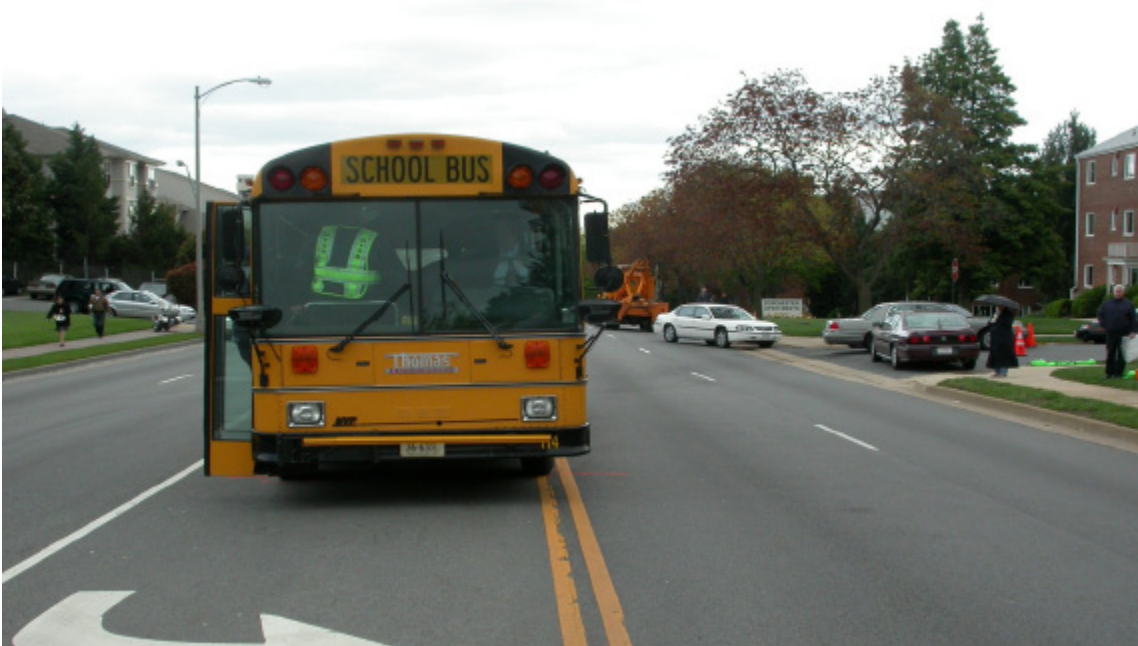
**Figure 9.** View from the front of an exemplar school bus positioned as the accident bus is likely to have been immediately preceding the accident. Note that the bus's left-front corner is encroaching upon the eastbound lane. (Photograph taken during postaccident reconstruction.)

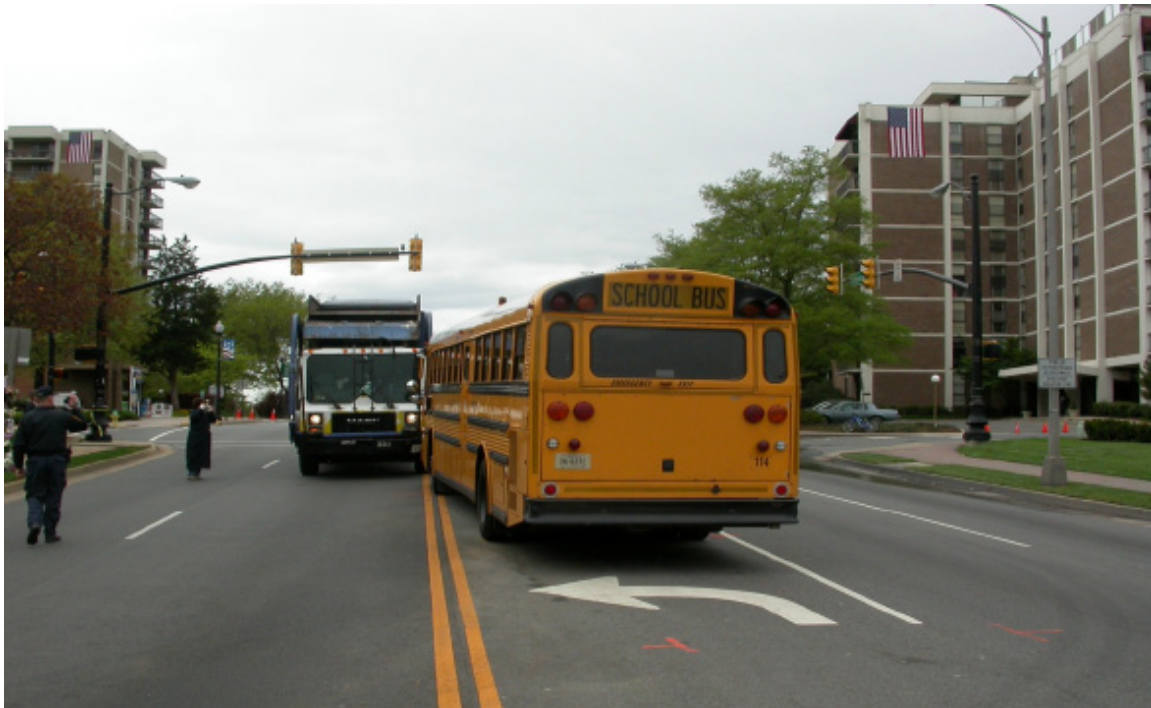
Witness reports and physical evidence suggest that leftward deviation from their lanes occurred for both vehicles, and the bus probably encroached slightly into the trash truck's lane, beyond the center lane marking. (See figure 10.) In other circumstances, such slight encroachment would probably have no consequences or, at worst, result in a minor sideswipe incident with few or no injuries. In this case, however, the outcome was different. The trash truck's loading arm struck the bus above its bumper and engine compartment (which provide some structural protection in most front-end collisions) and entered the bus's interior through the windshield. The destructive forces generated by the arm were small in terms of mass and had significant energy, which resulted in "tearing" damage to the bus's sidewall. The arm penetrated the left side of the bus to a depth of several inches, causing the most severe injuries resulting from this accident.

**Figure 10.** View of exemplar school bus and trash truck positioned as the accident vehicles are likely to have been immediately preceding the accident. (Photograph taken during postaccident reconstruction.)
