Bus Loss of Control and Rollover  
Dolan Springs, Arizona  
January 30, 2009

NTSB/HAR-10/01  
PB2010-916201

**Abstract:** On Friday, January 30, 2009, about 4:06 p.m. mountain standard time, a 2007 Chevrolet/Starcraft 29-passenger medium-size bus, operated by DW Tour and Charter and occupied by the driver and 16 passengers, was traveling northbound in the right lane of U.S. Highway 93, a four-lane divided highway, near Dolan Springs, Arizona. The bus was on a return trip from Grand Canyon West to Las Vegas, Nevada, after a day-long tour. As the bus approached milepost 28 at an estimated speed of 70 mph, it moved to the left and out of its lane of travel. The driver steered sharply back to the right, crossing both northbound lanes and entering the right shoulder. The driver subsequently overcorrected to the left, causing the bus to yaw and cross both northbound lanes. The bus then entered the depressed earthen median and overturned 1.25 times before coming to rest on its right side across both southbound lanes. During the rollover sequence, 15 of the 17 occupants (including the driver) were fully or partially ejected. Seven passengers were killed, and nine passengers and the drive

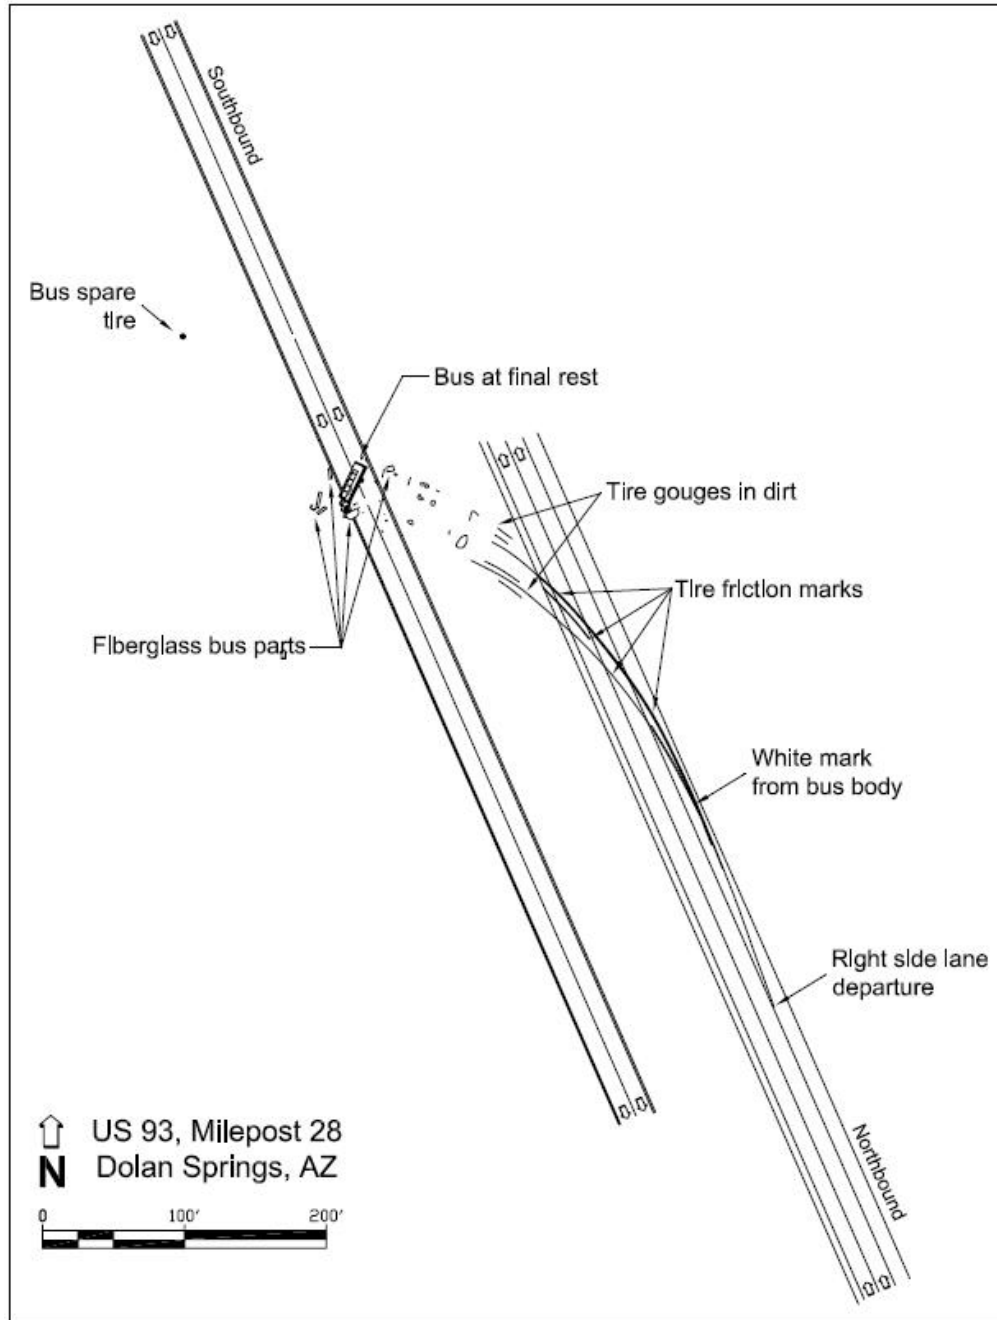
**Figure 2.** Diagram of Dolan Springs accident scene, showing extent of road marks and gouges leading to final rest position of bus (adapted from Arizona Department of Public Safety diagram). Note: Road marks do not reflect the full accident sequence.

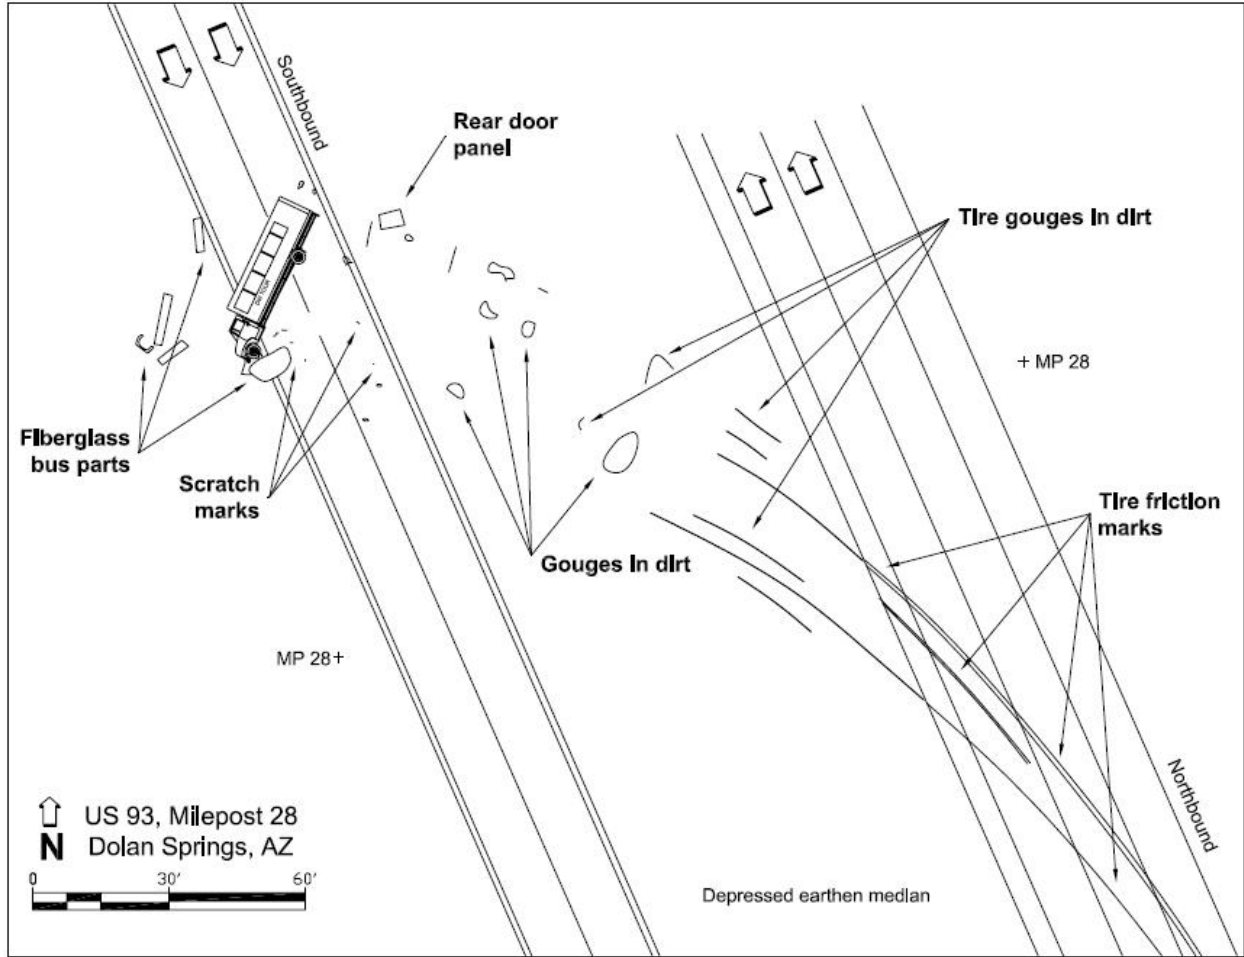
**Figure 3.** Enlarged view of Dolan Springs accident scene diagram, showing detailed gouge marks and wreckage (adapted from Arizona Department of Public Safety diagram).

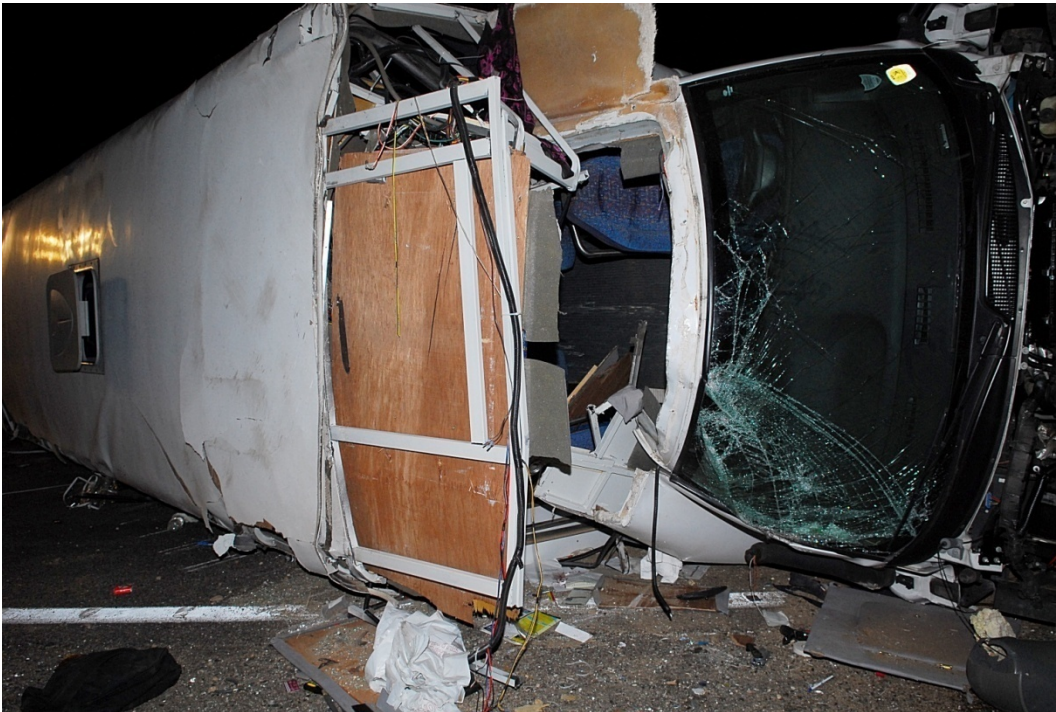
NTSB investigators inspected the accident vehicle from February 2–5, 2009, at an ADOT facility in Kingman, Arizona. The bus body sustained damage to the front fenders, hood, side body skirts, front roof area, driver's side door, and passenger loading door area. The fiberglass front fenders and hood were broken away from the frame, exposing the engine compartment. The metal body skirts below the frame were torn away on both sides. Both rear bumper corners had minor damage. Body damage along the exterior roof of the passenger compartment exposed the metal roof cross rails. The fiberglass front fascia above the driver's seating compartment was severely damaged, as shown in figure 5. The square tubular frame of the fascia was bent and twisted. In the right rear roof corner of the bus, the plywood and fiberglass chassis was cracked and displaced. The right edge of the driver's door was slightly misaligned with the frame along the top and bottom. A large opening was created where the passenger loading door completely separated from its mounting. The bottom two steps of the loading stairwell were bent upward. The rear cargo door and the passenger side exterior rearview mirror were broken off.

**Figure 5.** Bus at final rest, on its right side, showing damage to fiberglass front fascia above driver's compartment.

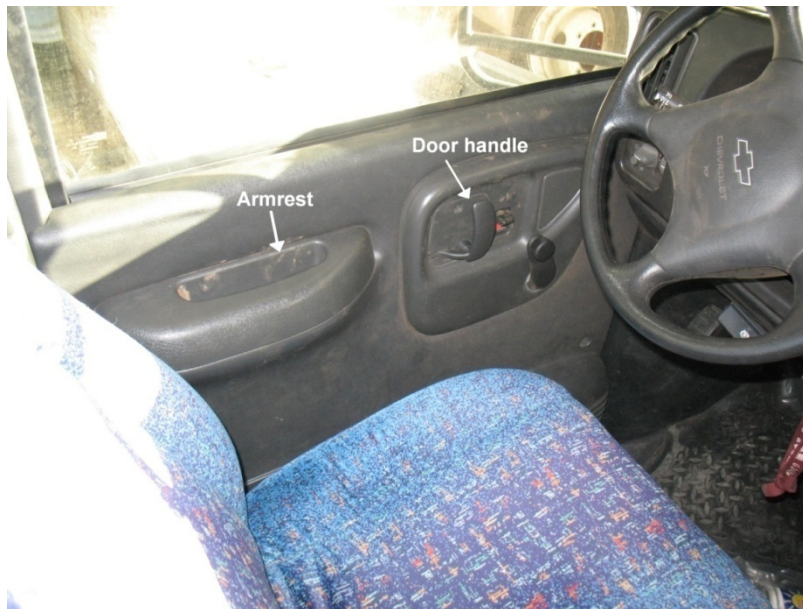
**Figure 7.** Layout of driver's side door, showing armrest located near seatback and interior door release handle adjacent, to the right.

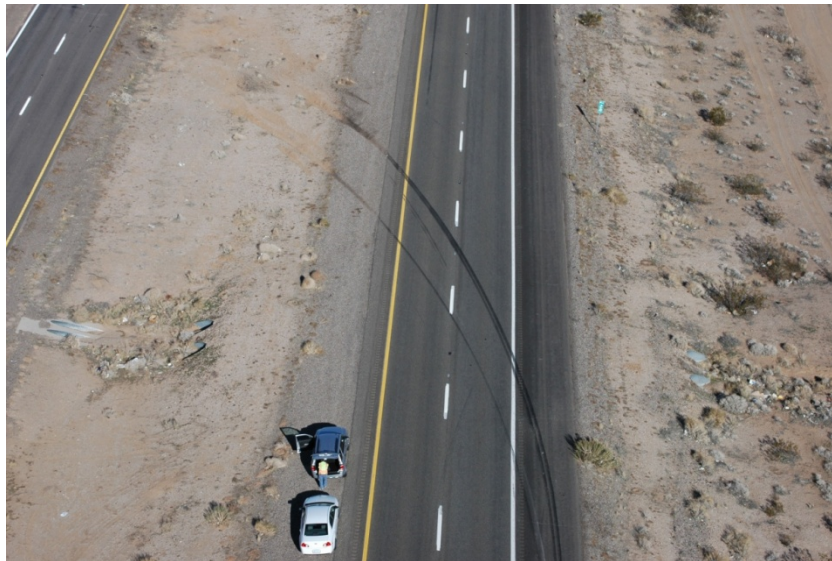
The Arizona DPS mapped the accident scene and located the first visible evidence of tire marks, from the right front bus tire, on the right-hand shoulder. (See figure 8.) Evaluation of the tire marks revealed that the bus had overturned on the depressed earthen median, not on the pavement. Impact marks in the median and on the bus showed that the vehicle overturned 1.25 times during the rollover sequence.

**Figure 8.** Aerial view of two northbound lanes of US 93, showing tire marks extending from right shoulder, across highway, and onto earthen median.

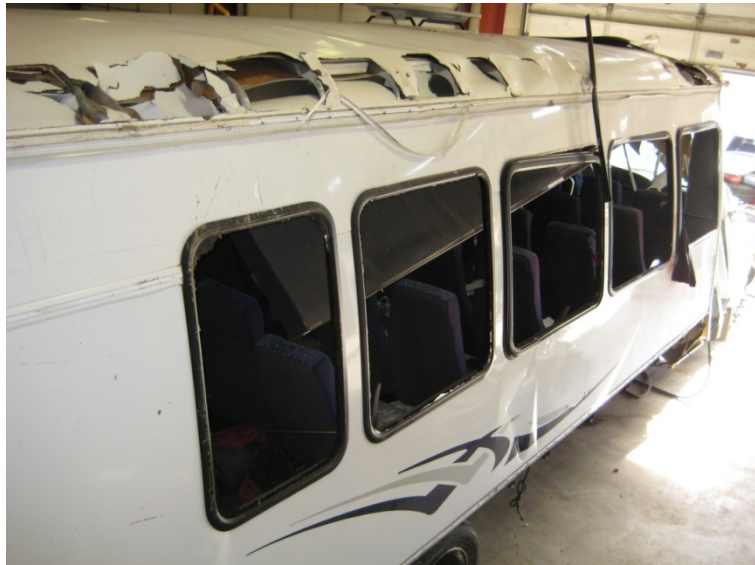
The accident bus was not specifically designed to meet FMVSS 220. With the exception of the luggage racks, the fiberglass roof above the passenger area sustained relatively minor damage during the rollover. (See figure 11.) Several small areas of the roof along the left side were torn away, revealing the metal roof cross rails. The bus body remained intact, and the integrity of the interior was not compromised by crush. Damage was more severe in the front fascia area above the driver's seating compartment, where the fiberglass was broken away. (See figure 12.) All that remained in the area of the driver's seating compartment and the loading door was the square tubular frame, which was bent and twisted. At the left rear corner of the bus, the fiberglass chassis was cracked and displaced.

**Figure 11.** Right side of accident bus roof.

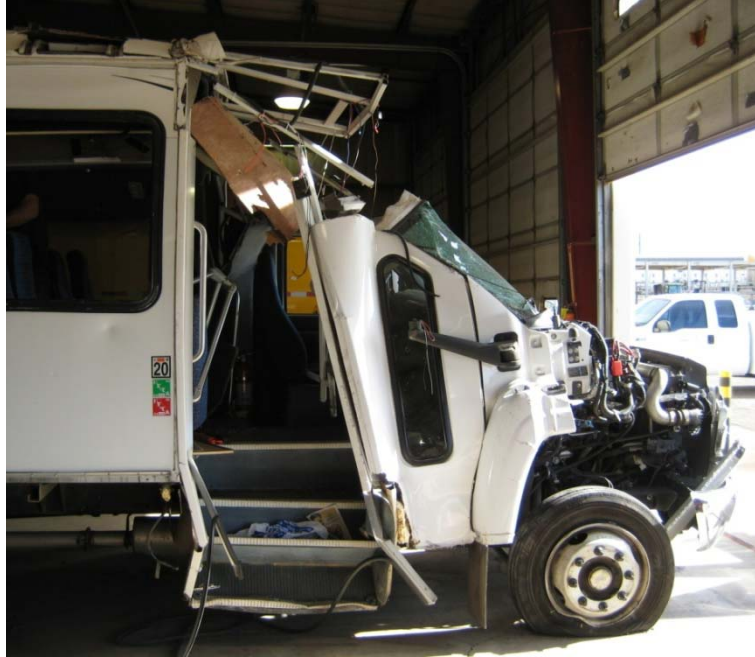
**Figure 12.** Front fascia area above driver's seating compartment and loading door.
