PIPELINE ACCIDENT REPORT

PIPELINE RUPTURE AND RELEASE OF FUEL OIL INTO
THE REEDY RIVER AT FORK SHOALS, SOUTH CAROLINA

JUNE 26, 1996

**NTSB/PAR-98/01
PB98-916502
Notation 6758A
Adopted: November 4, 1998**

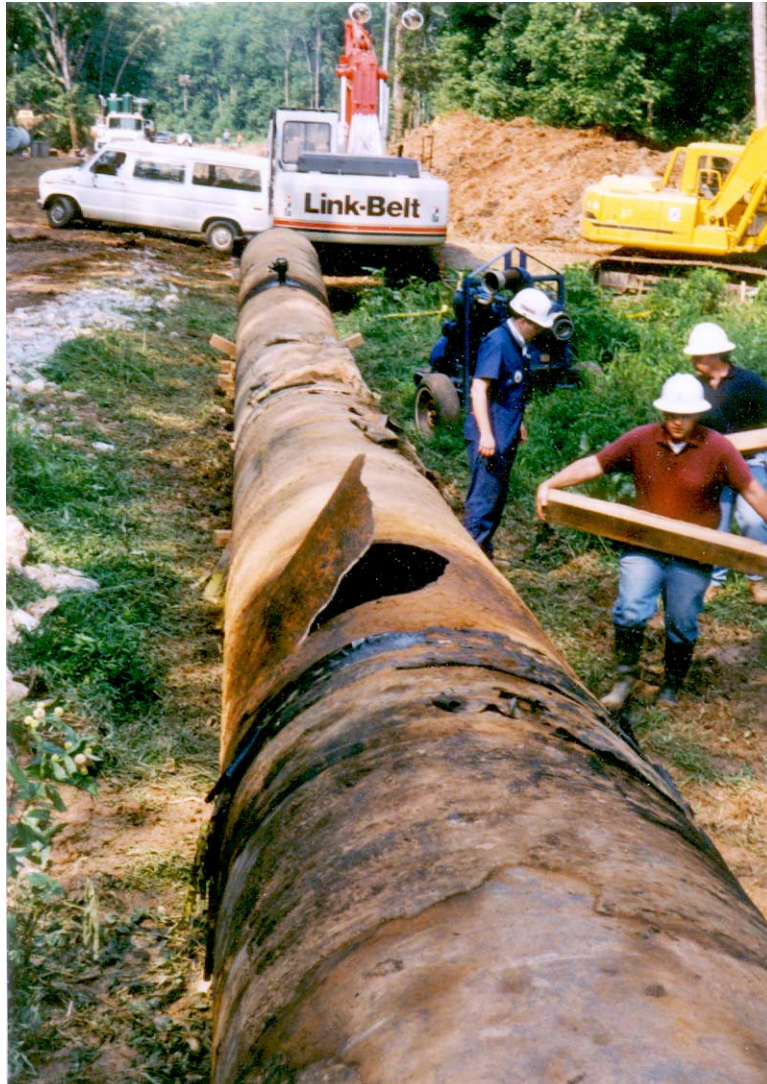
Figure 2. Ruptured pipe after removal from Reedy River

Damage to the pipeline itself occurred only in the immediate area of the rupture. At the rupture itself, a flap of material bulged out about 16 inches from the center of the 34-inch-long crack. (See figure 2.) Safety Board investigators measured the wall thickness of the ruptured section of pipeline after it was removed from the accident site. Near the rupture area, the thickness measured, at its thinnest point, 0.069 inch, which is about 25 percent of the wall thickness specified (0.281 inch) for that pipeline.

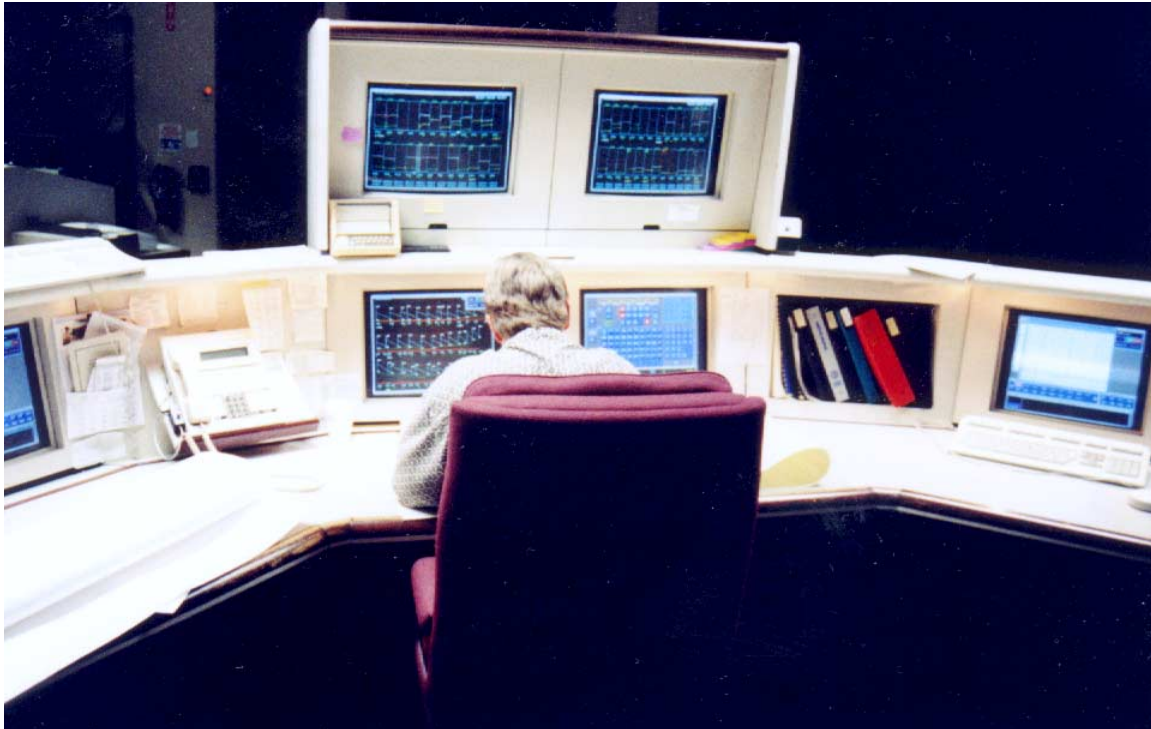
Figure 3. Work station from which controllers monitored and operated line No. 2

The SCADA system for each line at Colonial included a controller's work station with six computer monitors. (See figure 3.) Directly in front of the controller were four monitors arranged in a square of two on top and two on bottom, flanked by single monitors on either side. Generally, the most critical information was displayed on the monitors directly in front of the controller; however, the data available from the SCADA system could be displayed in various screen formats and on various monitors. The number of SCADA screens exceeded the number of monitors available to display them, and controllers had some latitude in determining which screens to display. According to the company, screen selections were based partly on operational needs and partly on the individual preferences of the controllers.

The SCADA displays used were not optimal for recognizing, assessing, and responding to abnormal conditions.
