Pipeline Accident Report

**Natural Gas Pipeline Rupture and Fire
Near Carlsbad, New Mexico
August 19, 2000**

**National
Transportation
Safety Board**
Washington, D.C.

**NTSB/PAR-03/01
PB2003-916501
Notation 7310B
Adopted February 11, 2003**

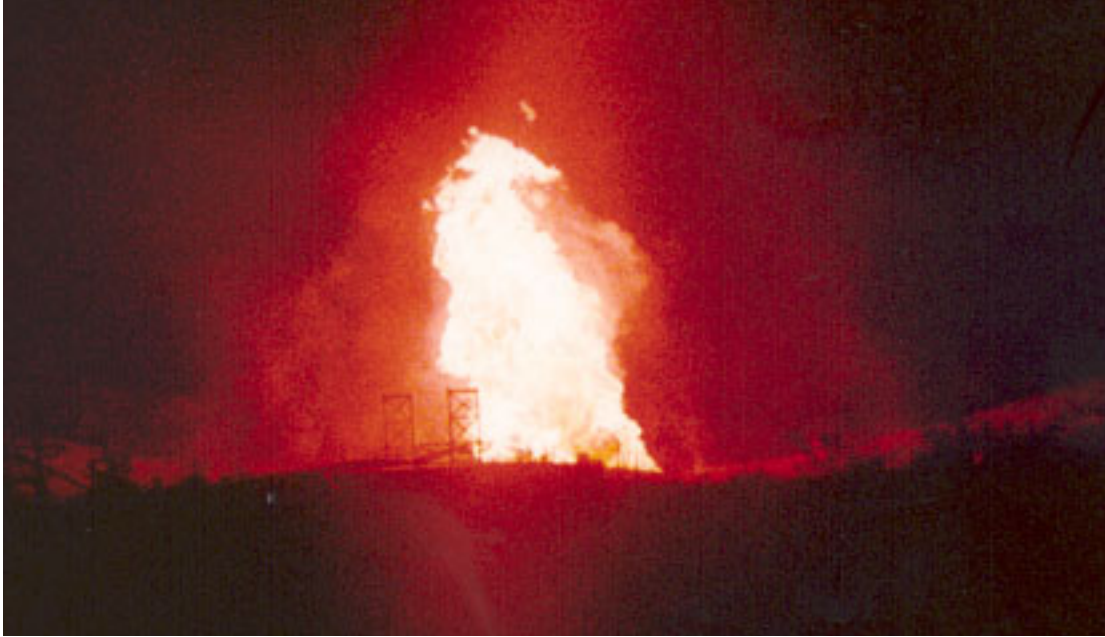
Figure 5. Post-rupture fire. At lower left of fireball can be seen the 85-foot-tall support structures for the pipeline suspension bridges.

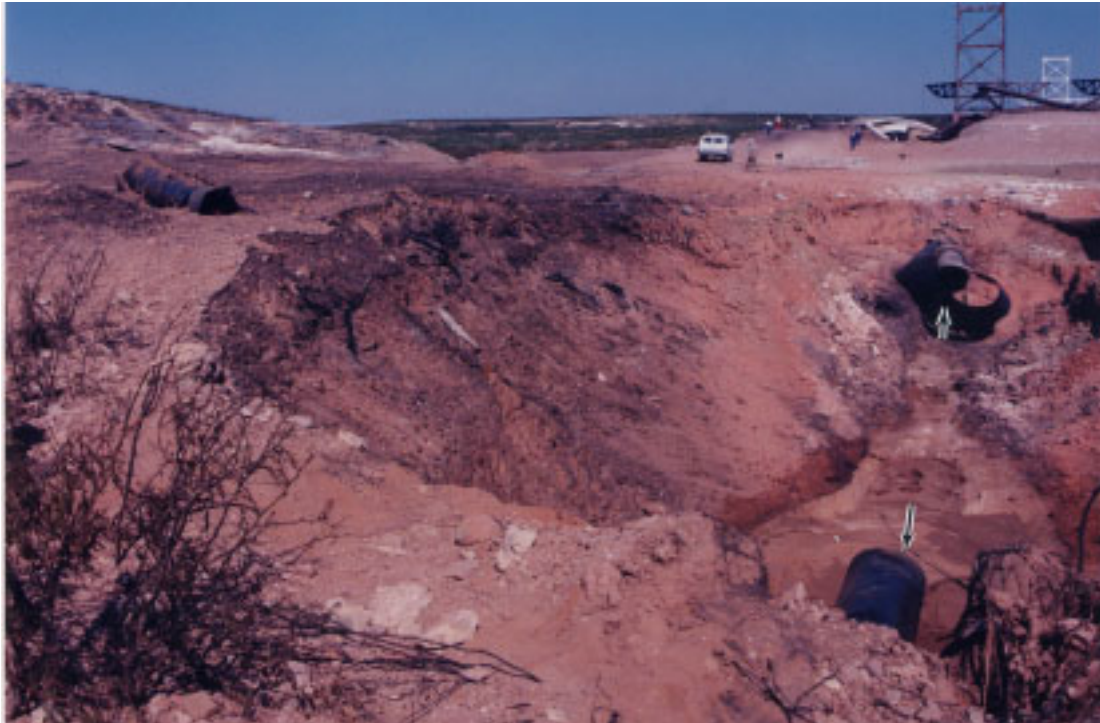
The force of the rupture and the violent ignition of the escaping gas created a 51-foot-wide crater about 113 feet along the pipe. A 49-foot section of the pipe was ejected from the crater in three pieces measuring approximately 3 feet, 20 feet, and 26 feet in length. (See figure 6.) The largest piece was found about 287 feet northwest of the crater in the direction of the suspension bridges. Investigators visually examined the pipeline that remained in the crater as well as the three ejected pieces. All three ejected pieces showed evidence of internal corrosion damage, but one of the pieces showed significantly more corrosion damage than the other two. Pits were visible on the inside surface of this piece, and at various locations, the pipe wall evidenced significant thinning. At one location, a through-wall perforation was visible. No significant corrosion damage was visible on the outside surfaces of the three pieces or on the two ends of the pipeline remaining in the crater. Pieces were cut from the ruptured pipeline segments and shipped to the Safety Board’s Materials Laboratory in Washington, D.C., for further evaluation. (That evaluation is discussed in the “Tests and Research” section of this report.)

Figure 6. Looking west at a portion of the crater created by the rupture. The missing section of pipe between the arrows was ejected from the crater.

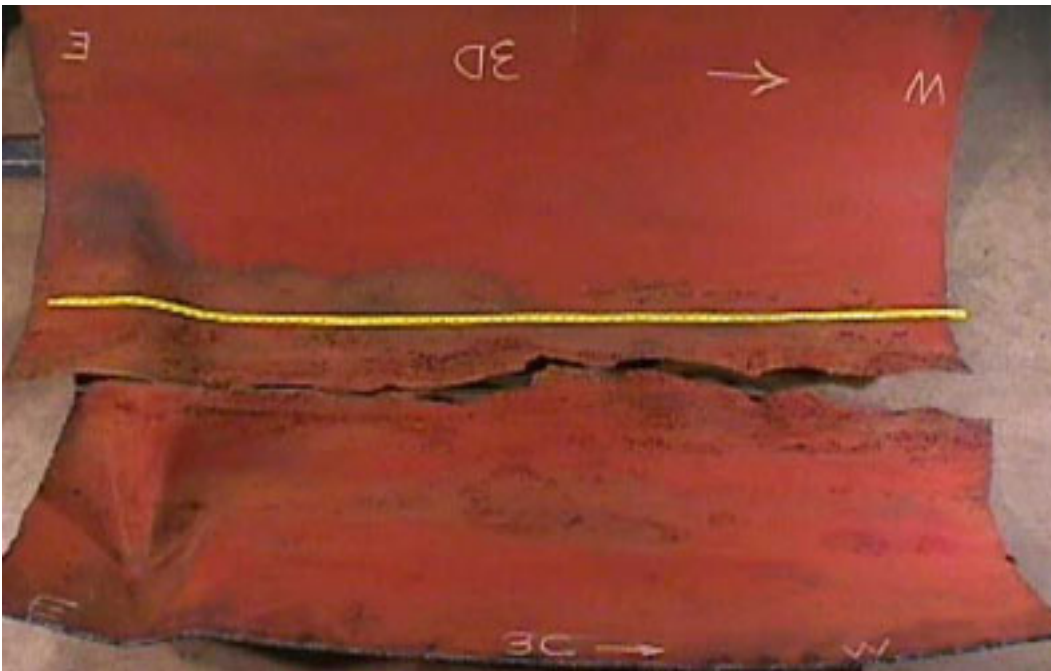
On-site examination of the three pieces of pipe that were ejected from the crater at the rupture site identified severe internal corrosion along the interior bottom of the pipe. (See figure 7.) From these three segments, eight pieces were excised and transported to the Safety Board's Materials Laboratory in Washington, D.C., for further examination. The examination of these pieces revealed no evidence of corrosion on the outside of the pipe or the internal surface across the top half of the pipe (between the 9 and 3 o'clock positions looking downstream/west). Severe wall loss due to corrosion was observed on the inside of the pipe at the bottom.

Figure 7. Fractured section of line 1103.

The area of corrosion damage extended 21 feet 5 inches. Sections of the girth (circumferential) and seam (longitudinal) welds that were in the bottom half of the pipe exhibited damage from internal corrosion similar to that found on the bottom pipe wall. The extent of corrosion damage (metal loss and number of pits) was most severe along the bottom of the pipe; the most severely corroded area reduced the original pipe wall thickness by 72 percent. (See figure 8.) The wall of many of the corrosion pits contained striations that extended around the pit. (See figure 9.) Within this length of corrosion damage were five circumferential wrinkles¹⁹ in the pipe wall on the top of the pipe.

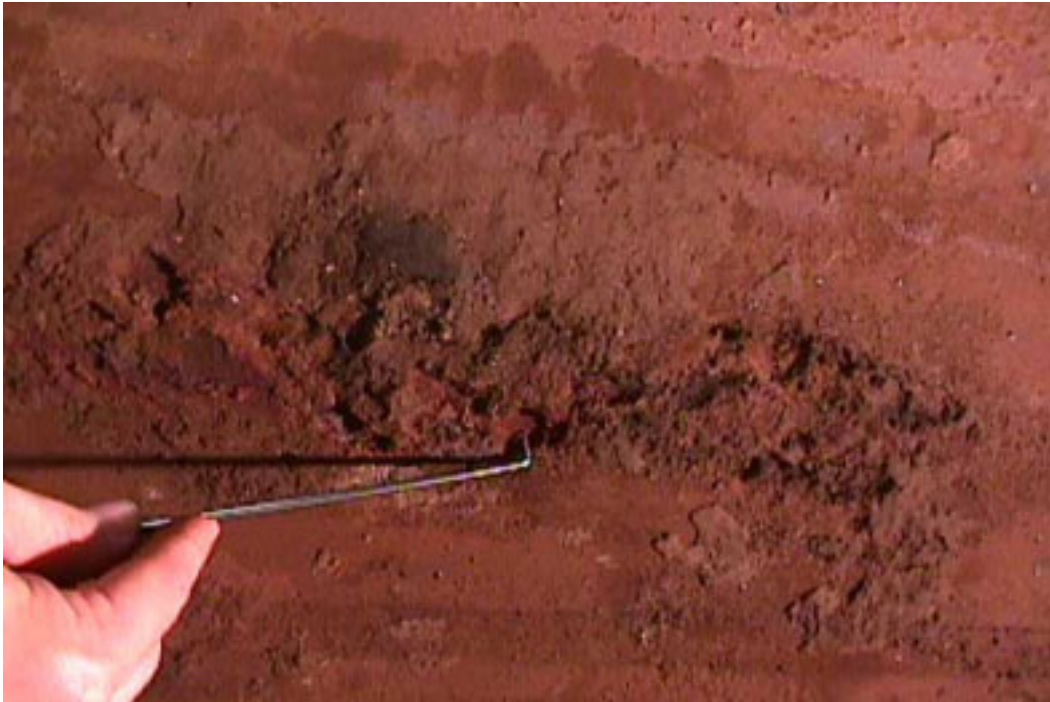
Figure 8. Corrosion pitting on inside of pipe near rupture site.

Examination of the fractures showed that a fracture face extended between the internal corrosion areas and the external wall of the pipe. The fracture faces resulted from overstress separation with no evidence of fatigue cracking or corrosion degradation, indicating that corrosion had not penetrated the wall of the pipe at the rupture point.

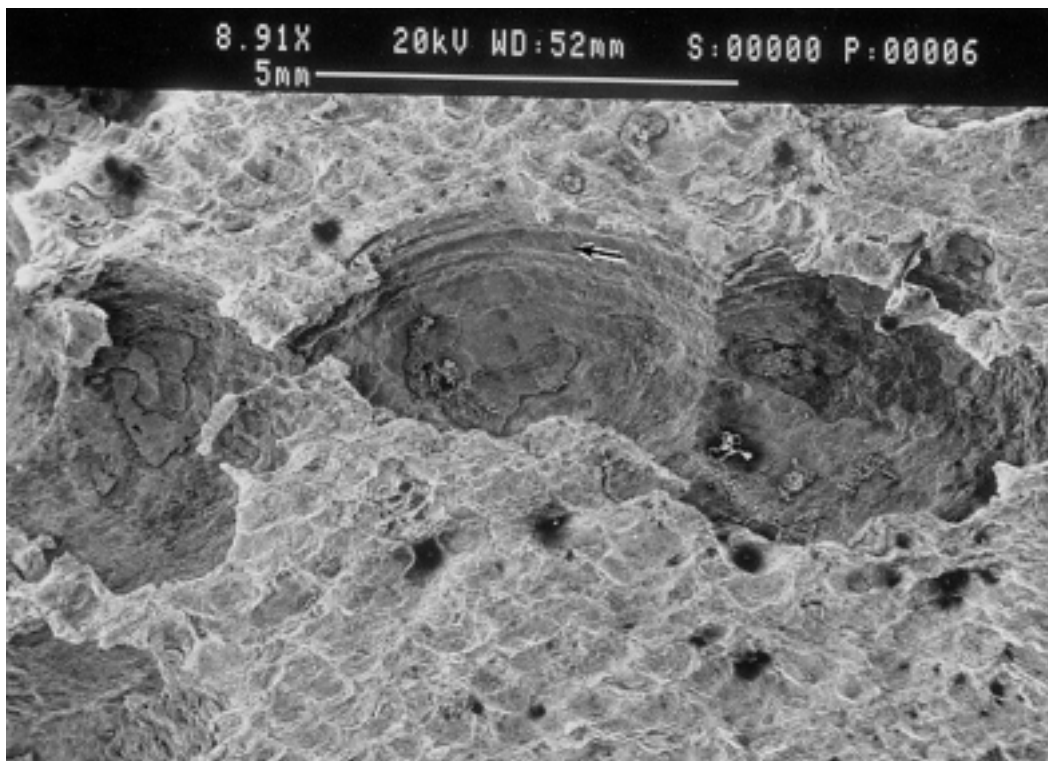
Figure 9. Microscopic view of corrosion pit showing striations

The Safety Board's Materials Laboratory performed x-ray dispersive spectroscopy analysis on material removed from corrosion pits and areas containing corrosion damage, both from the inside of the pipe. The analysis found high levels of chlorine and sodium in the material.

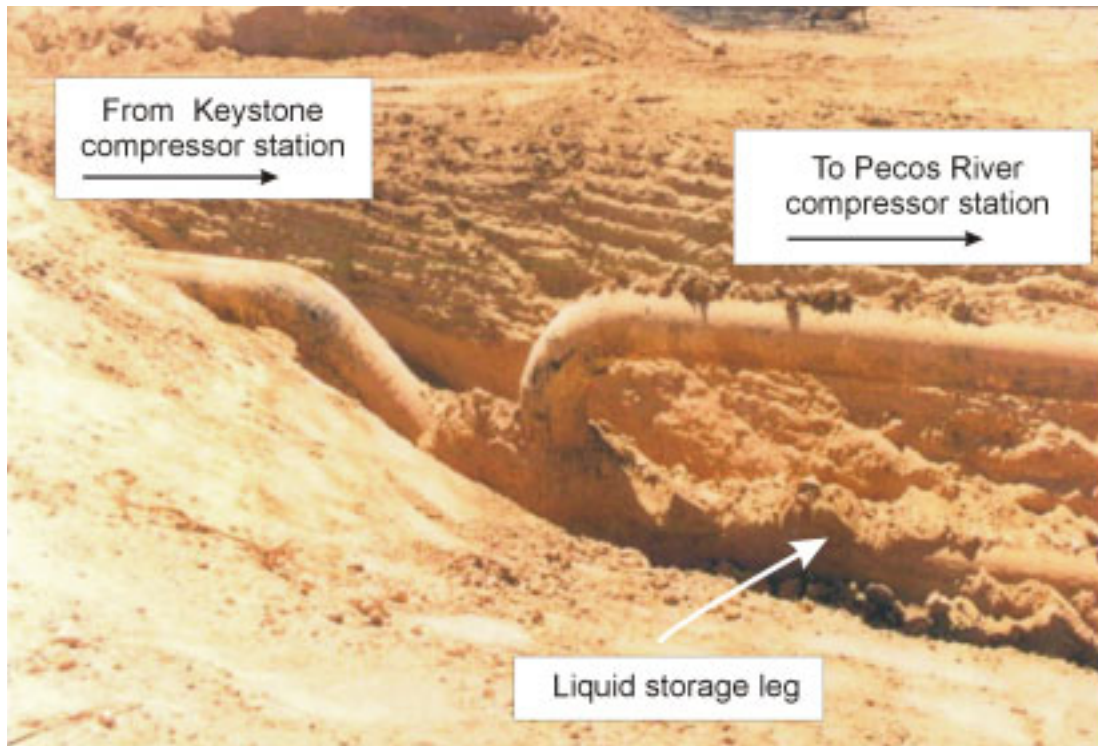
The drip¹⁷ between block valve No. 6 and the rupture site was removed from the pipeline and visually examined. The drip was found to contain a blackish oily-powdery/grainy material. At the area of its heaviest concentration, about 13 feet from the drip opening, this material filled approximately 70 percent of the cross-sectional area of the drip. No significant material was observed in the area just underneath and several inches away from the siphon drain at the closed end of the drip. No significant internal corrosion was observed in the drip.

Figure 10. Line 1103 drip after excavation.
