CHAPTER 4 – CULVERT ASSESSMENT AND DECISION-MAKING EXAMPLES

CONCRETE BOX CULVERT ASSESSMENT AND DECISION-MAKING EXAMPLE

The following example is a 6 foot wide x 9 foot rise reinforced concrete box conveying Adler Creek under Wawona Road (Route 14) in Yosemite National Park. The inspection was performed on September 2nd, 2009 by two knowledgeable hydraulic engineers from Central Division of FLH and an experienced consultant inspector, and took approximately 15 minutes. The completed Culvert Inspection Form is shown in the following Figure 33. The culvert received an overall rating of Poor.

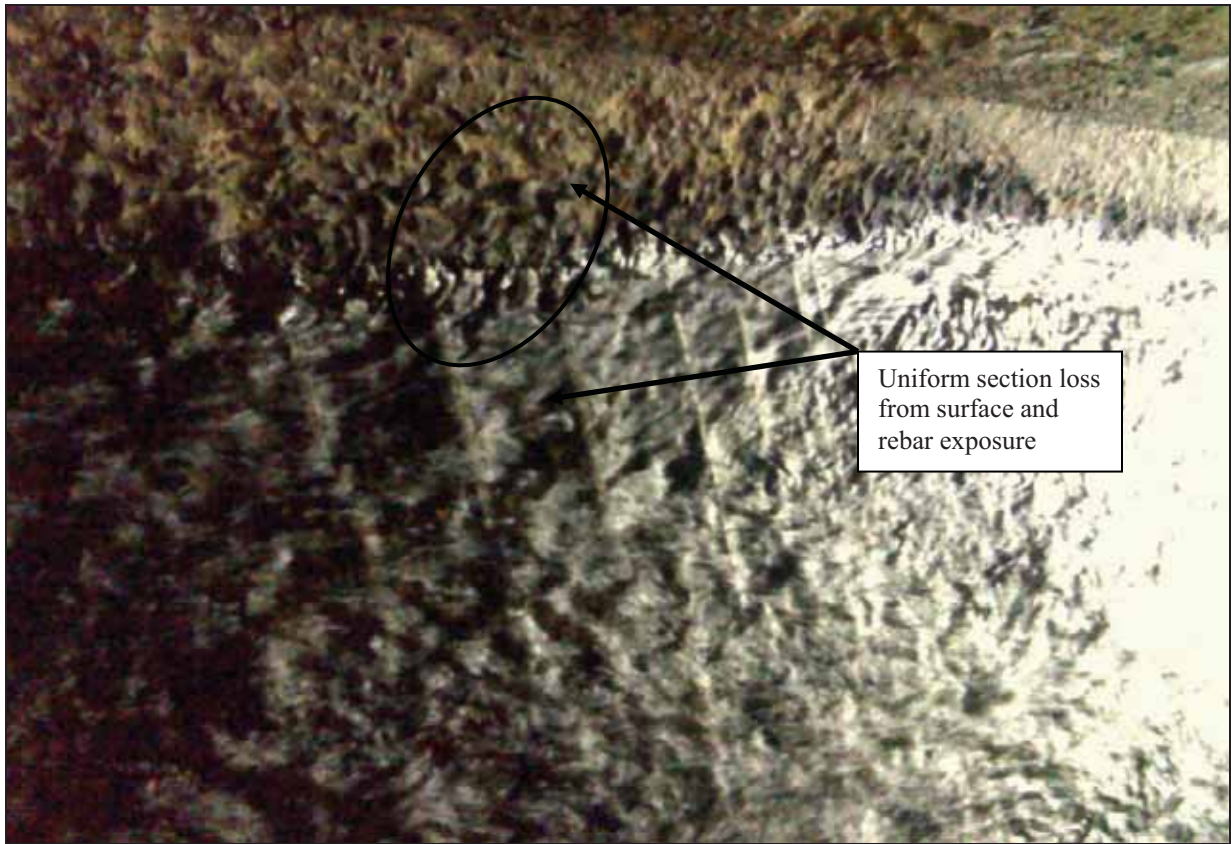
Figure 37. Photo. Invert abrasion damage with concrete section loss and exposed/corroding rebar.

The Invert Abrasion and Invert Deterioration were rated as Poor due to heavy invert abrasion, section loss, and exposed and corroding rebar, as shown in following Figure 37.

Based on the ratings and conditions determined in the Culvert Assessment Guide and material specific flow chart, a localized man-entry type of repair is recommended at this structure. Using the Localized Man-Entry Repair Selection Matrix, the following rehabilitation types would be recommended: Crack Epoxy Injection/Mortar, Crack/Spall Patching and Rebar Coating with Epoxy Grout, and Invert Lining. Note that although cracking was rated Fair, since repairs will be recommended for the Poor joints and invert, it is assumed other observed deterioration such as the Fair cracks will be repaired as well.

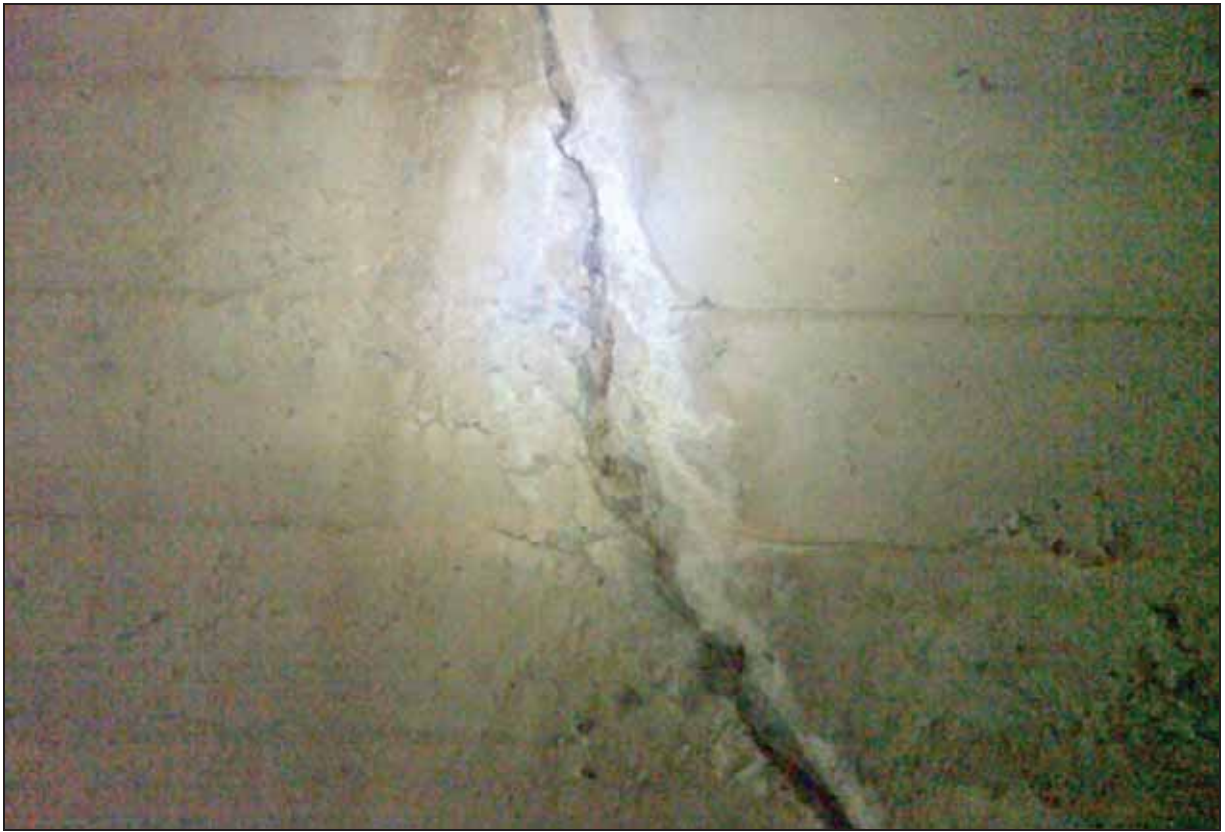
Figure 38. Photo. Vertical crack in culvert wall with exudence.

Cracking was rated as Fair due to multiple cracks in the walls up to $\frac{1}{4}$ inch wide with exudence and minor spalling and infiltration of water, as shown in the following Figure 38 and 39. Joints & Seams were rated as Poor because the joints were spalled and open near the invert in some areas as shown in Figure 39, allowing water to infiltrate. Cracking in close proximity to joints was considered as deterioration to the joint, rather than categorically as cracking.

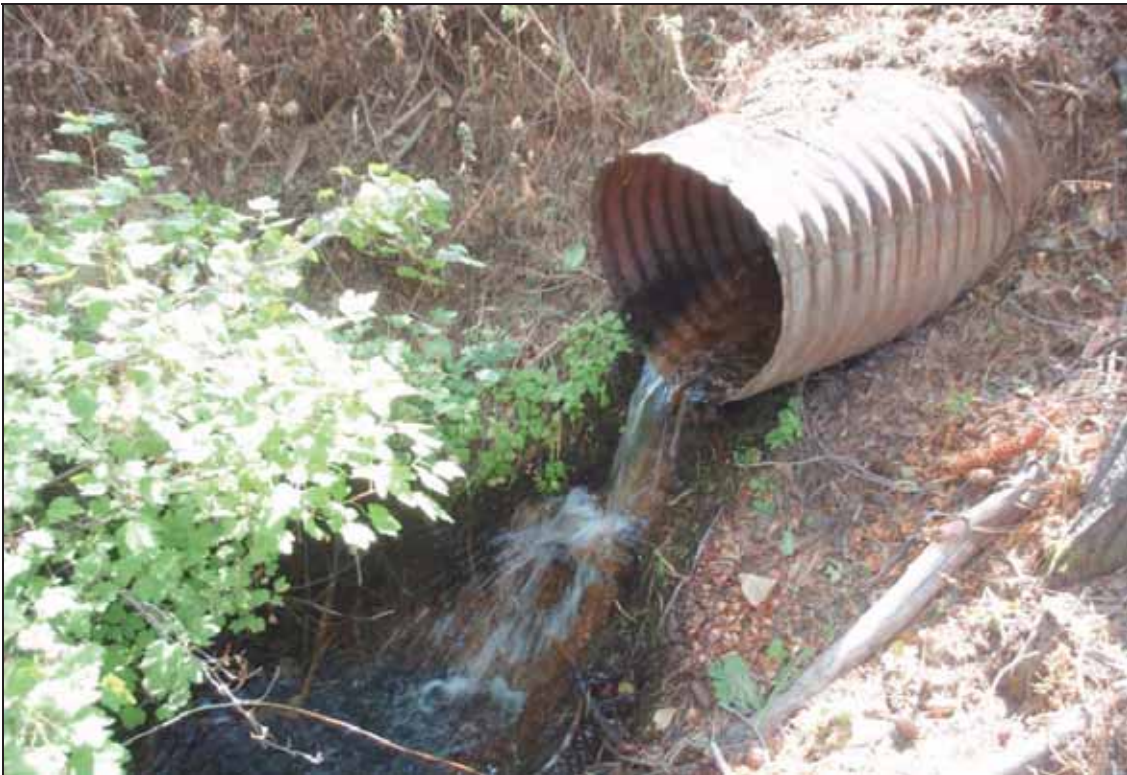
Figure 45. Photo. Light invert deterioration and minor local scour erosion at outlet of CMP example.

The cross section deformation was rated as Fair due to minor deformation of the crown at the outlet, as well as possibly inside the barrel near the outlet. Invert deterioration was rated Fair based on the conditions visible at and near the pipe ends, which included general corrosion, staining, coating loss and minor pitting. Very minor surface rust extended above the normal invert and flow line delineation, likely to the high-flow event level; therefore, the corrosion/chemical category was rate as Good based on the end-only observations. The initial overall culvert rating was Fair, based on the limited Level 1 end-only assessment.

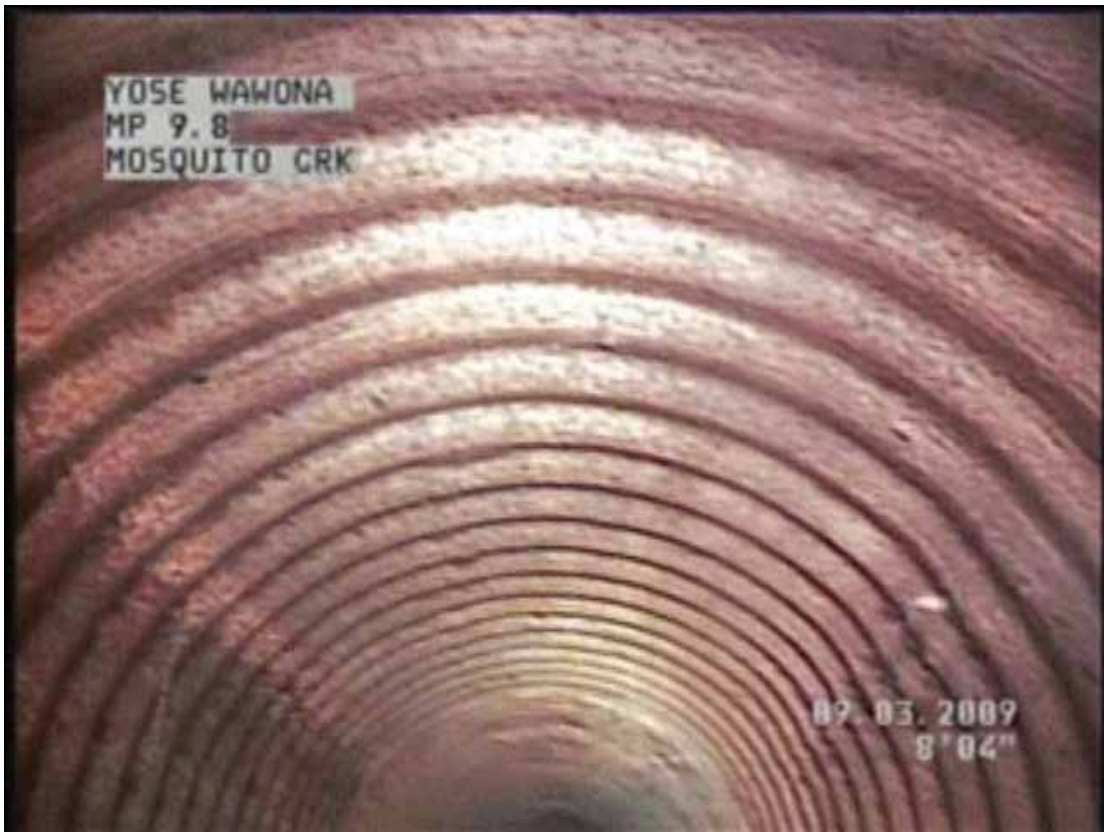
Figure 49. Photo. ROV video of CMP example showing typical corrosion above flow line.

The Level 2 investigation using the pipe-crawler ROV revealed significant crown bulging and cross-section deformation under the roadway, section loss and holes at multiple joints above the flow line, suspected water exfiltration below the flow line, structural cracking in the crown of the pipe, and 50 to 100 percent section loss in the invert due to corrosion and abrasion. Heavy corrosion, pitting and section loss was observed at and above the invert throughout the pipe; however, no significant soil or water infiltration was observed. Based on these findings, the overall condition of the culvert was changed to Poor, which initiated the decision-making process for determining repair and replacement recommendations. The following Figures 48 through 52 show the ROV unit and video screenshots of internal pipe deterioration that it observed.

Based on the ratings and conditions determined in the Culvert Assessment Guide and material specific flow chart, a liner repair is recommended at this structure, as shown in the following Figure 54. Using the Liner Selection Matrix, with prime consideration given to the localized bulges and cross-section deformations, the Spray-On Cement Mortar or Epoxy Lining types might be recommended; however, additional issues and pipe conditions eventually rule out these methods.

The pipe is rather long, with a bend and low-point in the middle where groundwater infiltration through the lost invert will likely pool water and prevent setup of the mortar. The longer length, bend in the middle, and bulges and deformations present possible issues with pulling the sled through the pipe at the steady rate required to control thickness of application. Lastly, the extent of invert loss may exceed the coating capabilities of this application method, requiring the use of local patches and/or reinforcement that require manned-entry. These added considerations suggest the spray-on liners may not be appropriate for this application. A note at the bottom of the Liner Selection Matrix directs the user to proceed to the Localized Man-Entry Repair or Replacement Matrix as appropriate if no liner can be selected. The combination of small size, long length and location of the worst deterioration at the middle of the run create conditions that may not be conducive to man-entry work. Although the 10 foot depth of cover exceeds the 4 foot delineator described in this procedure, there is room for road excavation equipment and traffic diversion is possible. Referencing the culvert Replacement Flowchart D.8 and the Culvert Replacement Techniques Matrix and comparing cost information, the recommended action is Open-Trench Excavation.

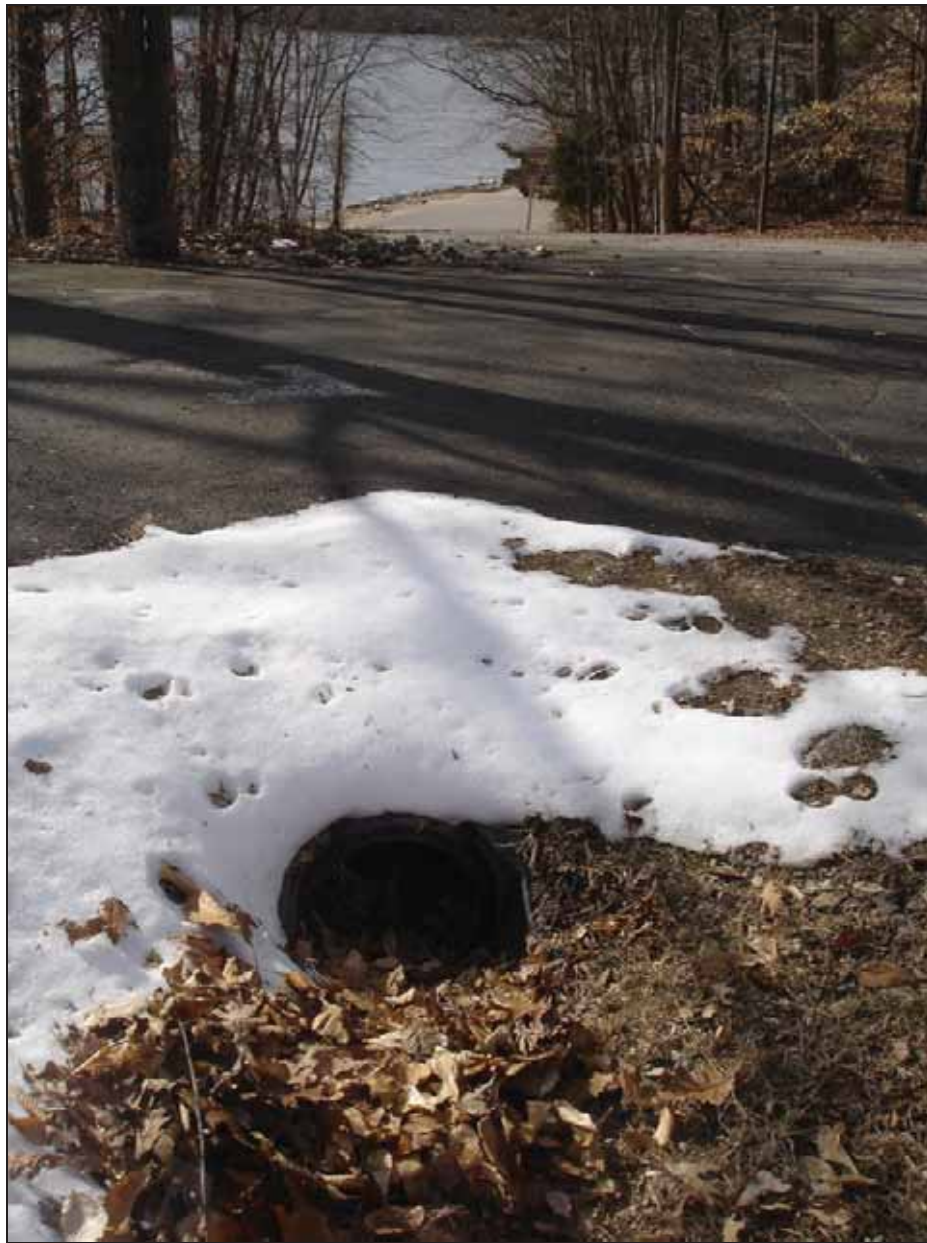
Figure 55. Photo. View of inlet of plastic HDPE example in Fountainhead Regional Park, Fairfax, Virginia.

The following example is a 15 inch diameter High Density Polyethylene Pipe (HDPE) pipe is one of two pipes inspected at Fountainhead Regional Park in Fairfax, Virginia, on January 7th, 2010. The assessment was performed by a two-person consultant team in approximately twenty minutes. The culvert and roadway are shown in the following Figures 55 through 57. The completed Culvert Inspection Form is shown in Figure 58. The culvert received an overall rating of Unknown, with additional notes made regarding the clogging throughout the pipe and completely buried outlet, which will lead to constant roadway overtopping and possible damage to the roadway and embankment.

Notes / Recommendations:
Pipe is approx 1/2 full of bedload at entrance. Outlet is completely covered with riprap which will lead to frequent overtopping. Structural characteristics could not be evaluated. Recommend Maintenance.
 Additional notes / Sketches on back of form.

Based on the results for the partial Level 1 assessment and decision-making process, the recommended action is to immediately uncover the outlet and clean out the pipe to enable a complete Level 1 assessment. It is recommended that the Level 1 maintenance be done immediately to prevent roadway overtopping and possible embankment and roadway damage. Due to the small culvert size and presumably low, cross-drainage nature of the flows conveyed, total failure of the culvert is not anticipated to cause public safety issues; therefore, the culvert was not rated Critical, despite the urgency of the maintenance recommended.
