CHAPTER 4 – SUBJECTIVE OBSERVATIONS

COMPARATIVE SUBJECTIVE INSPECTION SYSTEM

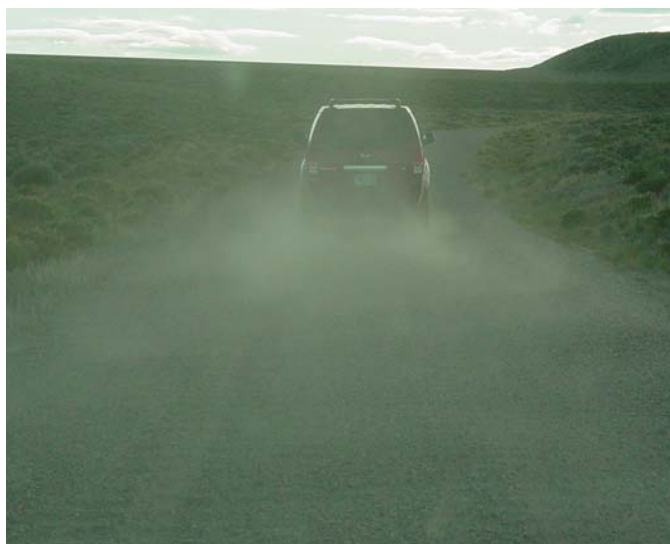
Figure 11. Photo. Monitoring for dust.

Looking at the Figure 10 plot for dust, the products can be separated into three dust abatement groups. The columns represent for each product the overall average score it received for the entire monitoring period. In the first group, Mag/Lig and Lignosulfonate showed the least amount of airborne particles. In the second group consisting of PermaZyme,

Caliber, and TerraZyme; more dust was generated relative to the first group. In the third group was Soil Sement that exhibited the most dust.

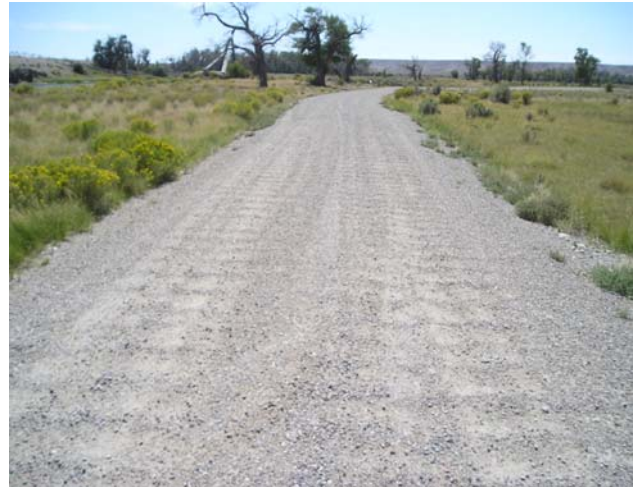
In the second group, showing more washboarding were the enzyme products - TerraZyme and PermaZyme. In the third group was Soil Sement that had the highest level of washboarding as shown in Figure 12. It should be noted again that the scores given in Table 10 for each monitoring event are not absolute scores in reference to some objective criteria, but rather ratings given in comparison to a baseline section.

**Figure 12. Photo. Section IV Washboarding.**

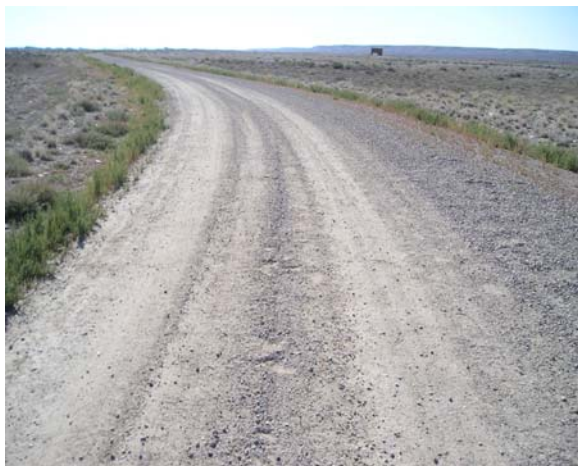
Lignosulfonate was the best performing product and generally showed less loose material on the road surface than any of the other sections. In fact, the Lignosulfonate surface course appeared hardened from the first monitoring event as the applied product was visible consistently throughout the section – not blotchy as in other sections. By the 20-month event, however, the product was appearing more grayed-out than it had in previous monitoring events.

**Figure 13. Photo. Raveling.**

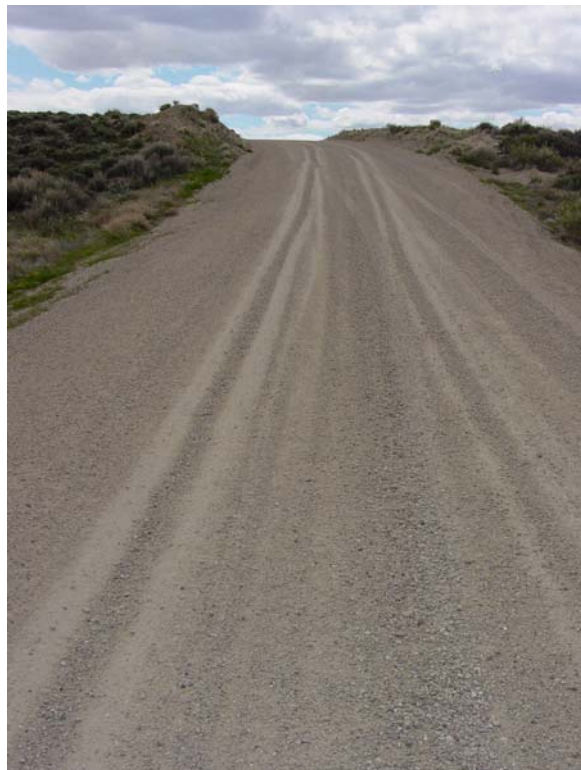
The team did not consider worn tracks in the roadway as ruts if the condition appeared to be linked to raveling. At the beginning of monitoring, the team thought there could be greater potential for more pronounced rutting on a 3.7-m (12-ft) wide road than on a 5.5-m (18-ft) one because the traffic would be concentrated into one path. The sections stabilized with the Soil Sement and Caliber products, were only 3.7 m (12 ft) wide. The team did observe that on the 3.7-m (12-ft) wide sections there were two wheel paths, whereas on the 5.5-m (18-ft) wide sections there were at least three. But overall, there was very little rutting in any of the sections. The Figure 10 plot reflects this because the rutting columns representing the overall average score for each product are all close to the same height. One exception was the Permazyme Section III where rutting was apparent on a steep hill as shown in Figure 14. This rutting appeared in May of 2005 after heavy winter snows and a quick spring thaw. Most likely, it was caused by one vehicle being in the area when conditions were extremely wet and having a hard time getting up the hill. The rutting on this hill appeared to repair itself over time; it was not noticeable at the 23-month monitoring event.

**Figure 14. Photo. May 2005 ruts in PermaZyme Section III.**

The design geometrics of the sections appeared to have influence on performance of some of the products. The TerraZyme Section I had more curves which may have affected the amount of raveling and possibly washboarding that occurred over the two-year study period. During the first monitoring event, ruts approximately 18 m (60 ft) long were observed on a fairly steep hill

in the PermaZyme Section III. It is possible that a heavy vehicle went up the hill in saturated conditions and may have spun its wheels to get to the top. No ruts were apparent in the remainder of this section or in the Caliber Section V that has a gradual hill climbing up away from the river. This same section, however, suffered erosion damage from rapid melting of winter snows as discussed earlier in this report.

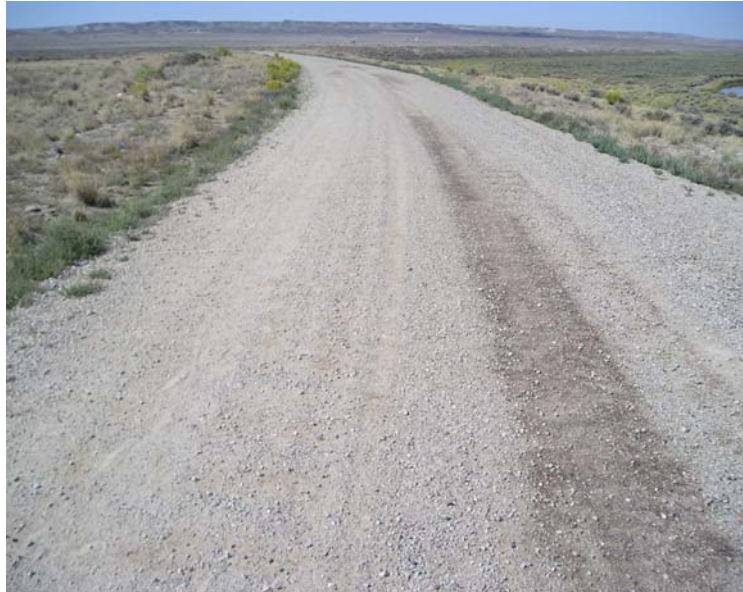
Since the roadway, which varied from 3.7 to 5.5 m (12 to 18 ft) wide, was reconditioned using a 3-m (10-ft) wide CMI 650 pulverizer, the team expected to see areas of concentrated treatment where the two passes overlapped. At the 8-month event, this effect was observed only in the Lignosulfonate section as shown in Figure 15. The overlapping was quite pronounced at this first monitoring event but diminished over time. The Mag/Lig section had a blotchy appearance in the wheel paths rather than in the center as was seen in the Lignosulfonate section.

**Figure 15. Photo. Lignosulfonate Section II product still showing two years after application.**

As of the last 23-month monitoring event in August 2006, the Lignosulfonate Section II still had some product showing as blotches throughout its length. A small amount of the Caliber product in Section V could also be seen at its end near the cattle guard that marks the Refuge boundary.
