CHAPTER 6 – PRESENTATION OF RESULTS

DESCRIPTION OF SITES

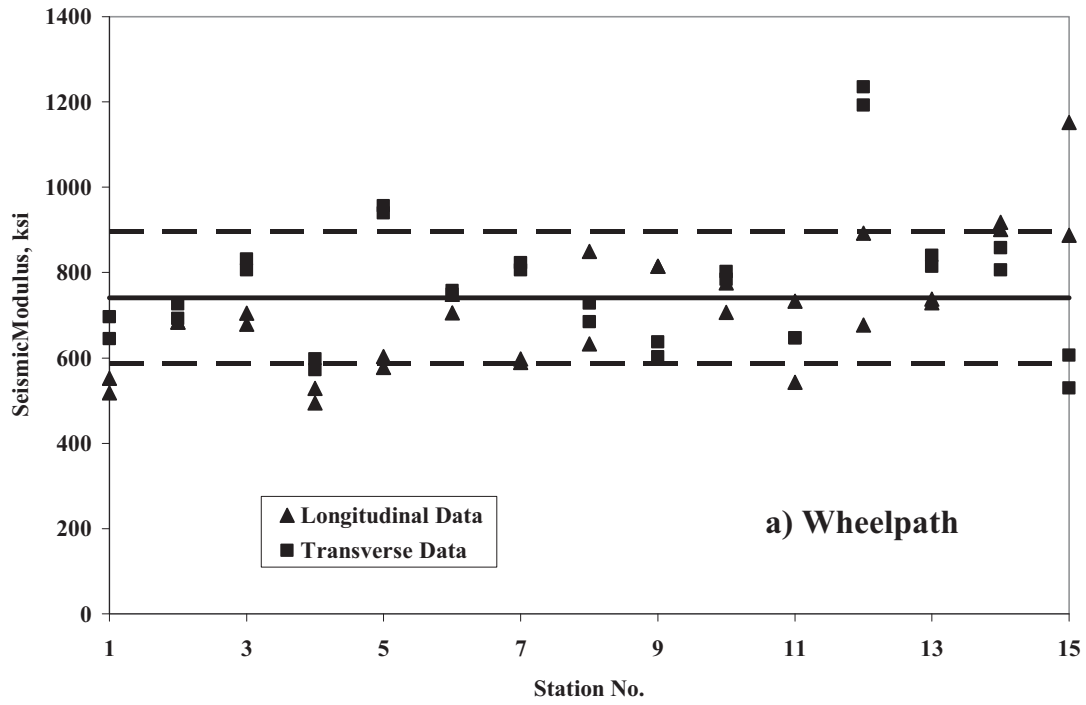
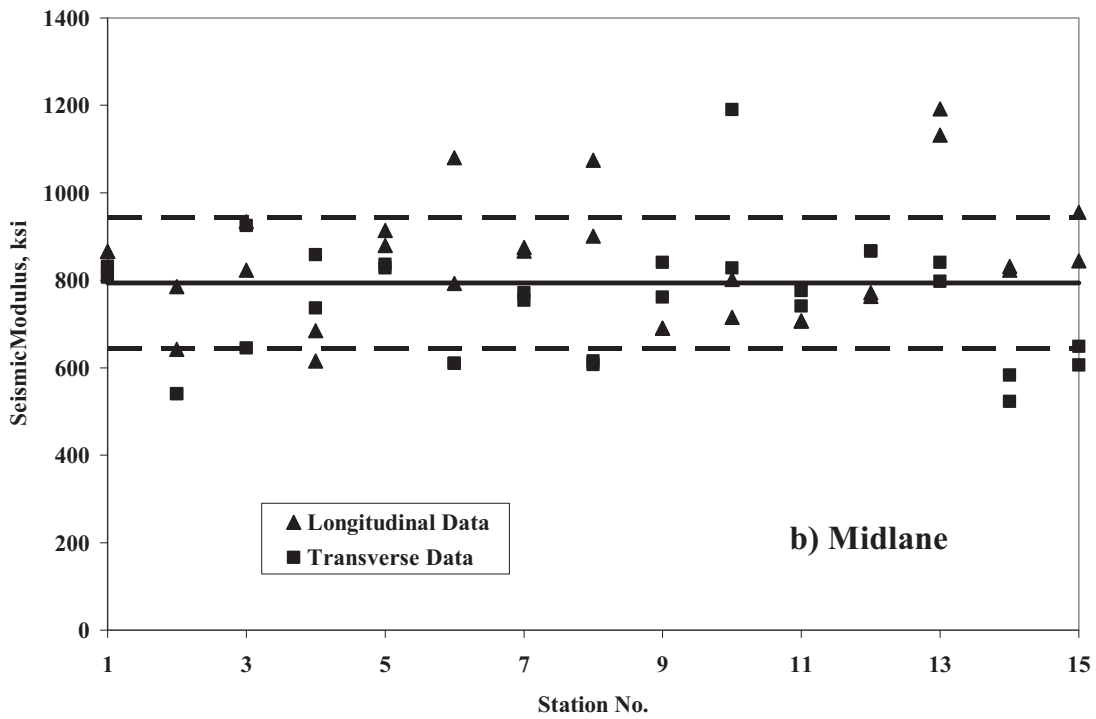
Figure 25. Graph. Variation in Modulus with PSPA along Site 1.

The variations in PSPA modulus along the wheel path and midlane for Site 1 are shown in Figure 25. As indicated before, the top layer at this site was a thin double surface treatment. The average seismic modulus at this site is about 760 ksi which translates to an approximate design modulus of about 250 ksi. This value seems to be reasonable for such a surface. The coefficient of variation is about 20% which reflects the quality anticipated from surface treatment.

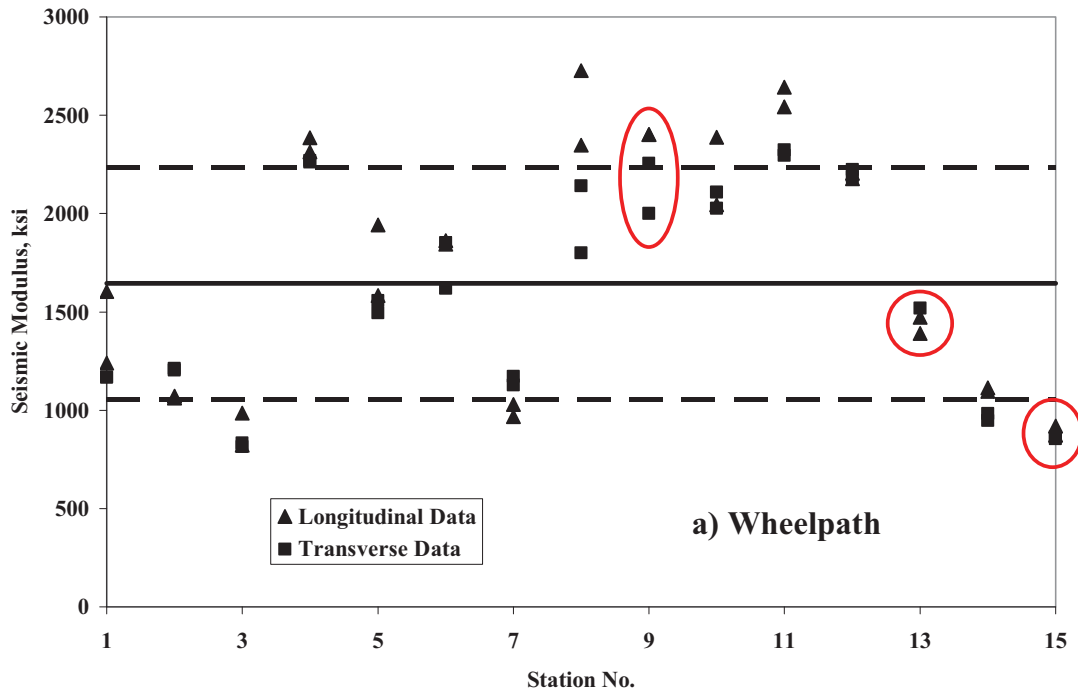
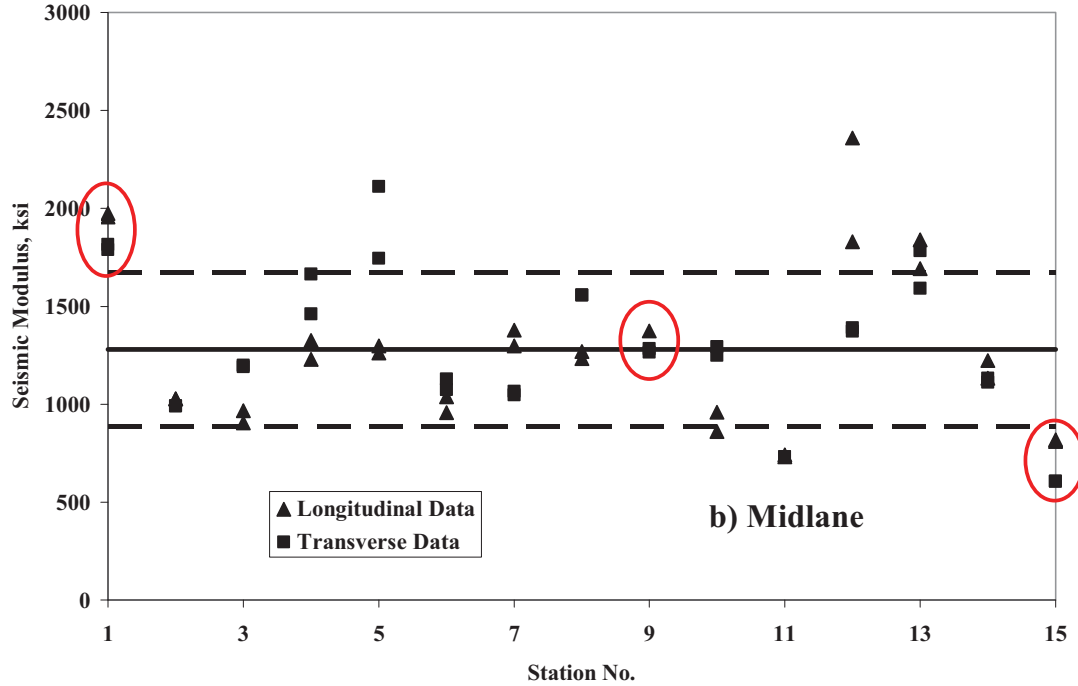
Figure 26. Graph. Variation in Modulus with PSPA along Site 2.

At site 2, as reflected in Table 3, the average seismic modulus is about 1460 ksi. The variations in PSPA modulus along the site are shown in Figure 26. For the wheel path, the first three and last two points exhibit lower moduli with the middle points generally being significantly stiffer. Along the midlane, the moduli are more uniform and generally lower than the wheel path. This trend is typically observed on the older pavements, where the vehicular traffic would typically consolidate the material in the wheel path. The VTM for the wheel path, as shown in Table 5 is about 2% whereas for the midlane the VTM is closer to 4%. The observed point-to-point variability is also normal for aged pavements that contain micro-cracking and have experienced consolidation.

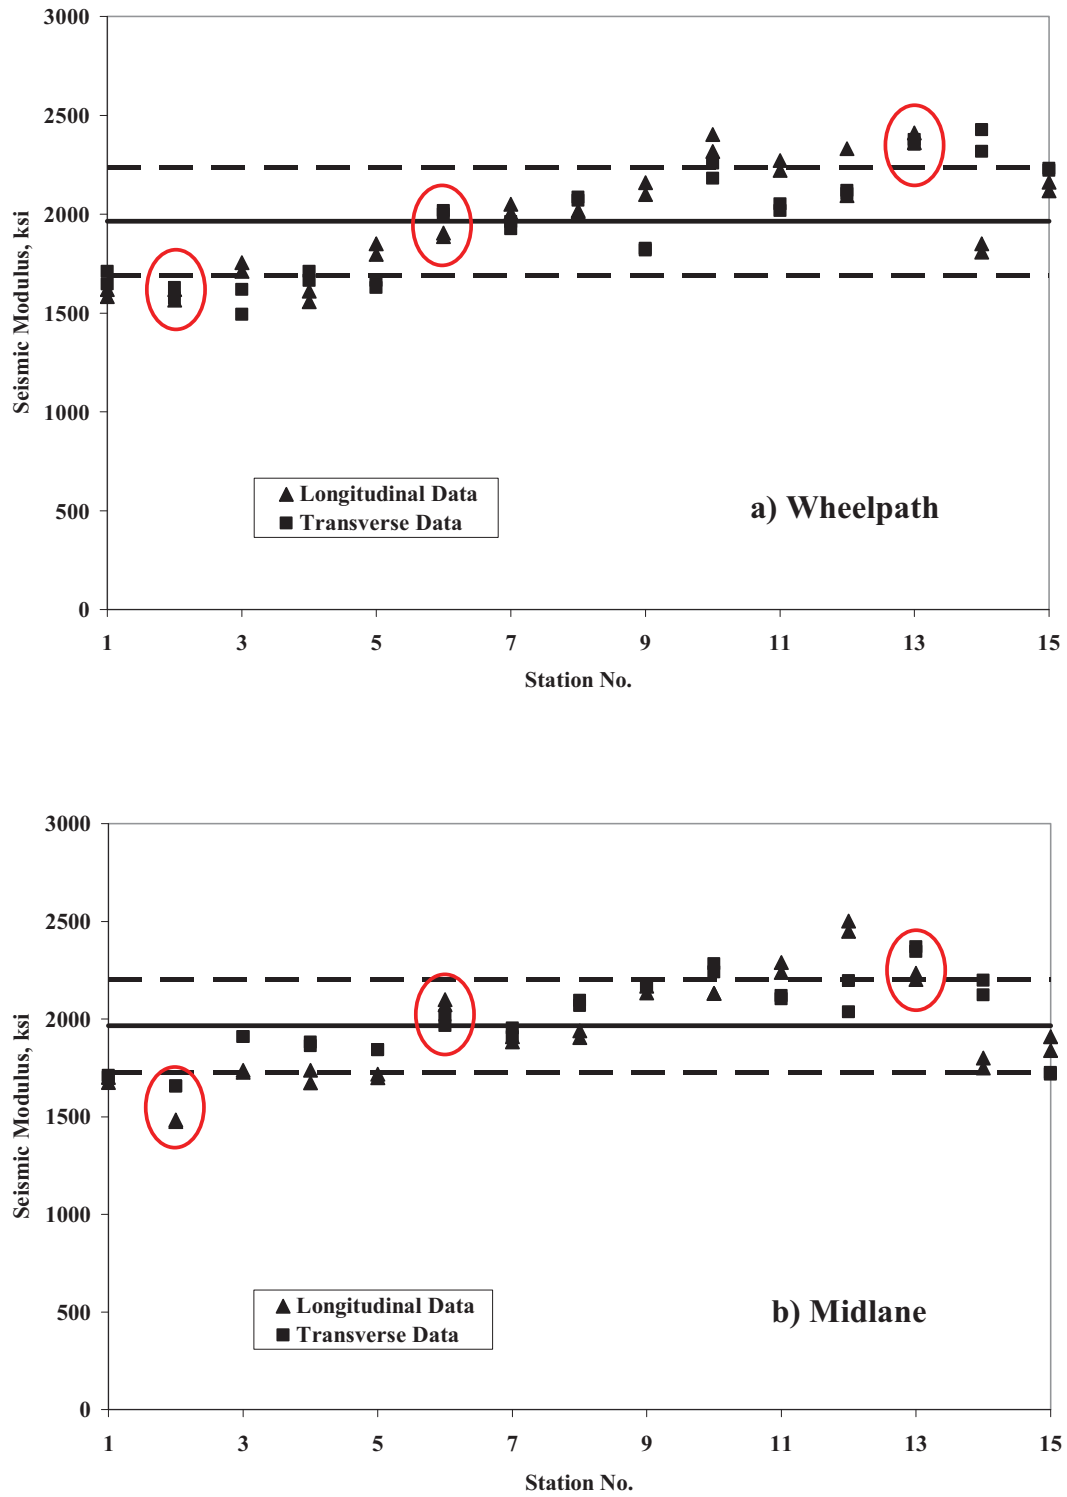
Figure 27. Graph. Variation in Modulus with PSPA along Site 3.

Contrary to Site 2, Site 3 exhibits fairly uniform behavior along the site (see Figure 27). This trend is also anticipated because Site 3 was newly constructed. The average seismic moduli along the wheel path and the midlane are fairly close since the site is not extensively trafficked. The quality of construction can be observed in Figure 27. The first half of the site demonstrates consistently lower moduli perhaps because of compaction efforts. This increase in modulus was not only apparent on the PSPA results but also on seismic tests performed on cores.

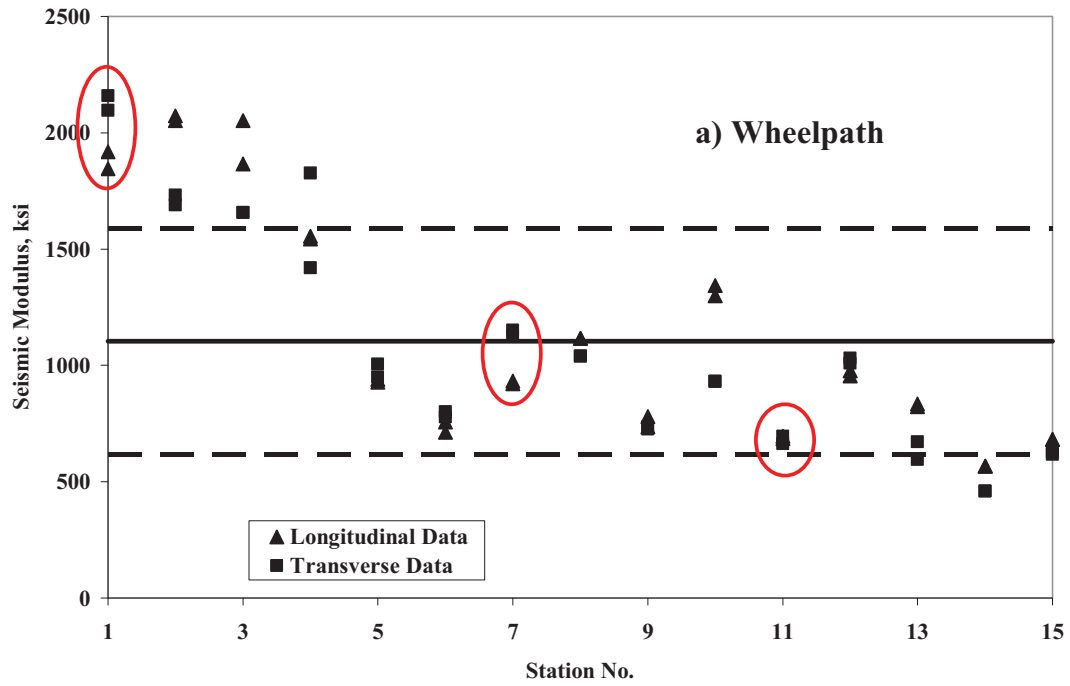
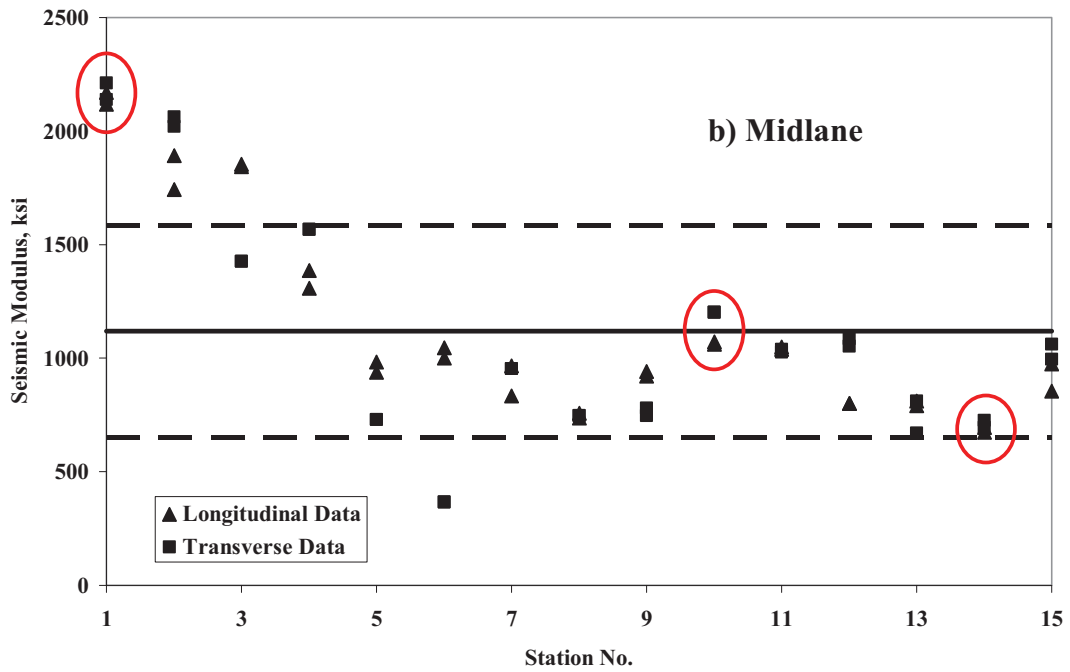
Figure 28. Graph. Variation in Modulus with PSPA along Site 4.

Site 4 consists of 2 in. of overlay over an old ACP. An inspection of cores (see Figure 46) and dispersion curves (see Appendix D) indicated that at the beginning of the section the overlay is thicker as compared to the remainder of the section. The inspection of the cores also indicated that the original ACP is of poor quality. The variations in PSPA modulus along the wheel path and midlane are shown in Figure 28. The moduli along the section are initially high. Past Point 5, the moduli are much lower than the initial points, indicating the lower quality materials. The close relationship, between the observed quality of the cores and the results from the PSPA is a good indication of the usefulness of the PSPA in determining the properties of an AC layer.

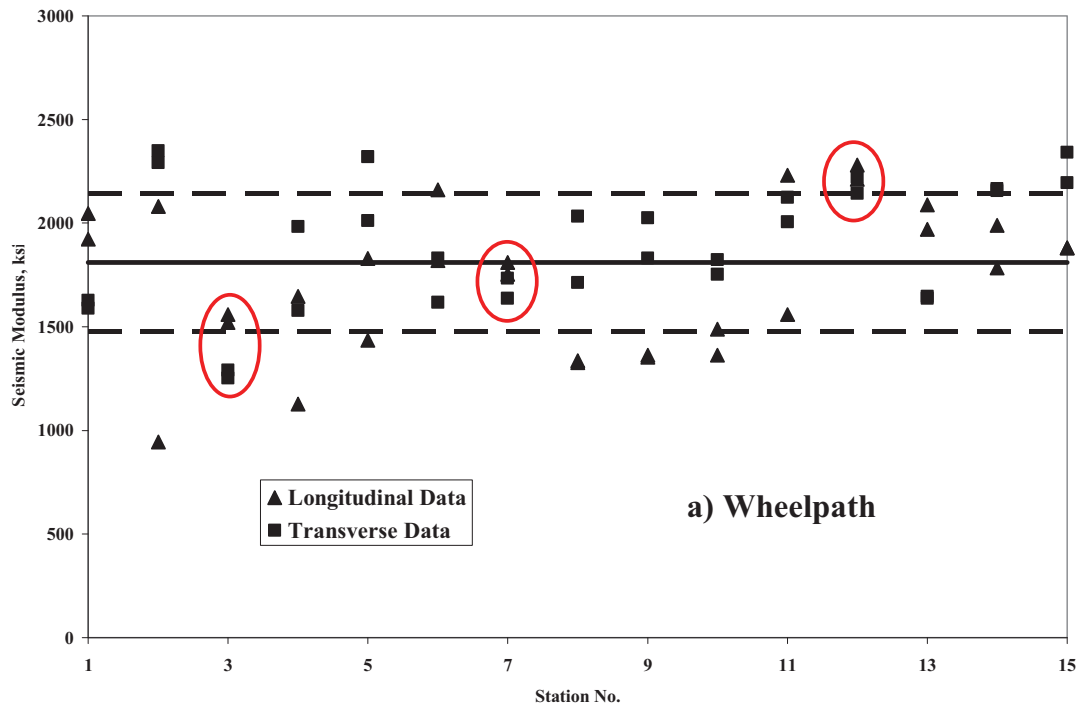
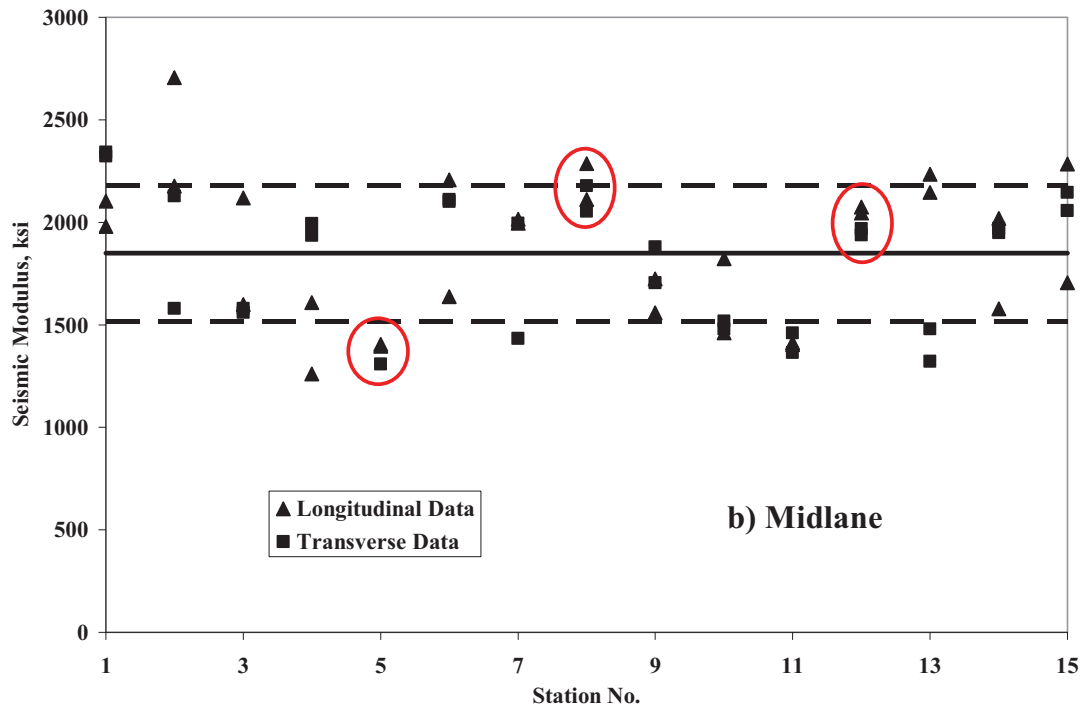
Figure 29. Graph. Variation in Modulus with PSPA along Site 5.

Site 5 again consists of 2 in. of overlay over a recycled asphalt layer. The average PSPA modulus at this site is about 1830 ksi with a coefficient of variation of about 18%. The variations in PSPA modulus along the wheel path and midlane are shown in Figure 29. The variation is rather random along the site, indicating variability in the properties of the recycled ACP layer. Also the moduli in the longitudinal and transverse directions at some points, especially along wheel path, are different, maybe demonstrating directionality of compactions of recycled materials.

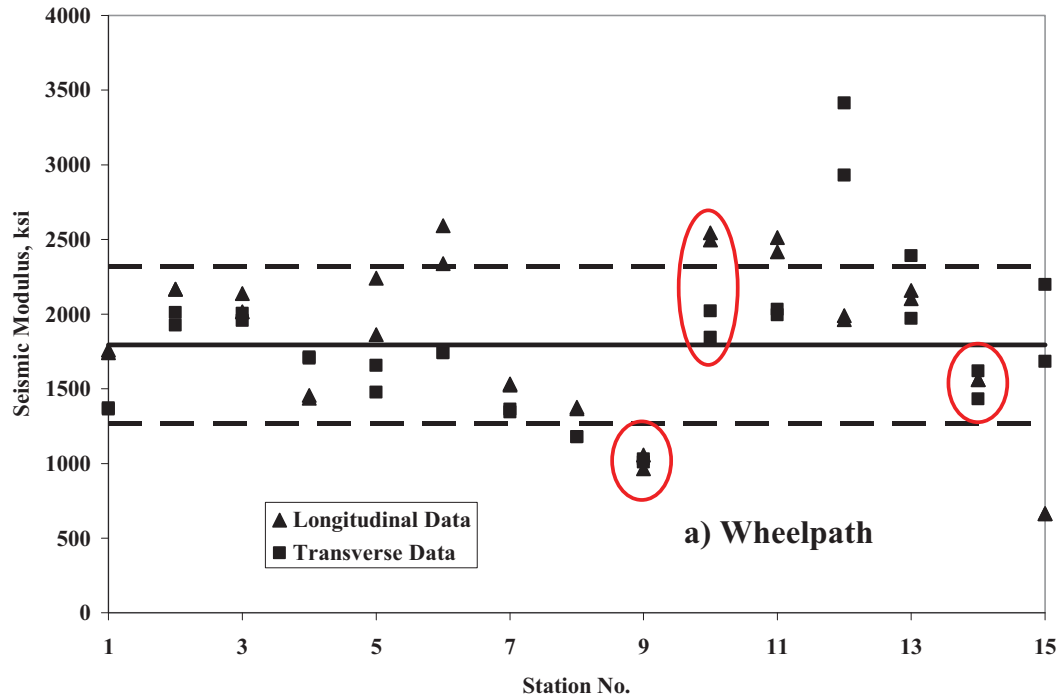
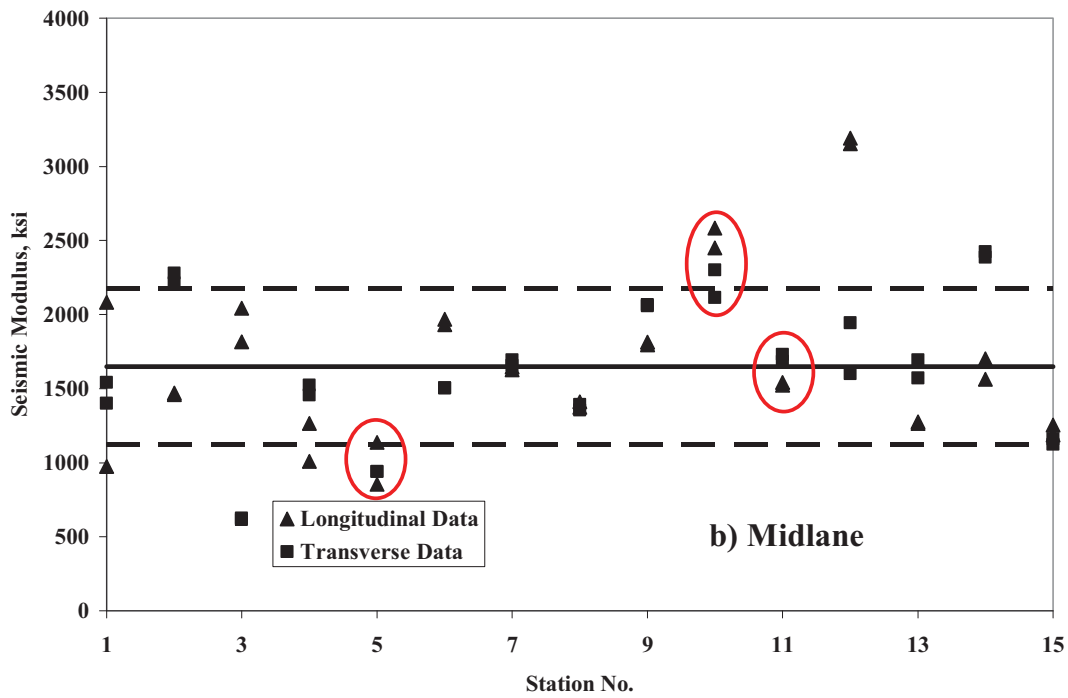
Figure 30. Graph. Variation in Modulus with PSPA along Site 6.

Finally, the results from PSPA at Site 6 are shown in Figure 30. This site consisted of an old, cracked, road. As anticipated the coefficient of variation is rather high at about 31%. The average modulus of the wheel path is greater than the midlane, once again because of consolidation of the ACP under traffic.

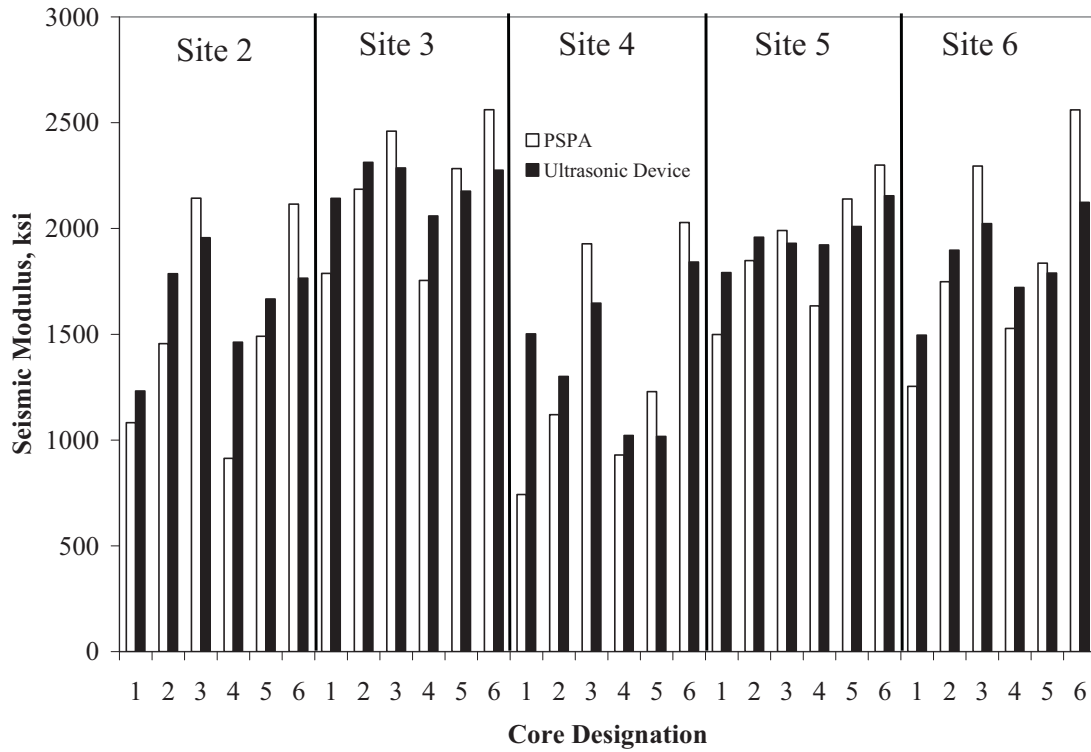
Figure 31. Graph. Comparison of Moduli Obtained by Ultrasonic Device and PSPA at all Sites.

A comparison of the seismic moduli obtained with the ultrasonic device on the cores and the PSPA moduli obtained at the respective core location is presented in Figure 31. In general, close agreement between the two moduli was observed. The exception is Core 4 for Site 2 that contained micro-cracks and Core 1 of Site 4 that was badly stripped (see picture of cores in Appendix A). To further quantify the comparison between the two moduli, they are plotted against one another in Figure 32. The differences between the two moduli are generally less than 20%. The reasons for differences, aside from any experimental errors are itemized in Chapter 5.
