APPENDIX A – PHOTO ALBUM

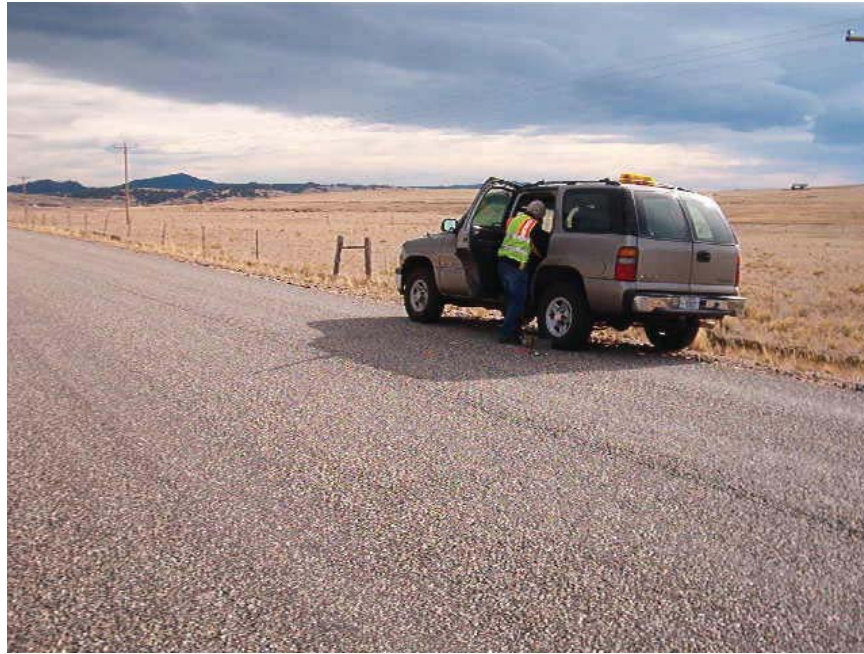
Figure 33. Photo. Measuring with the PSPA on the Side of the Road at Site 1.

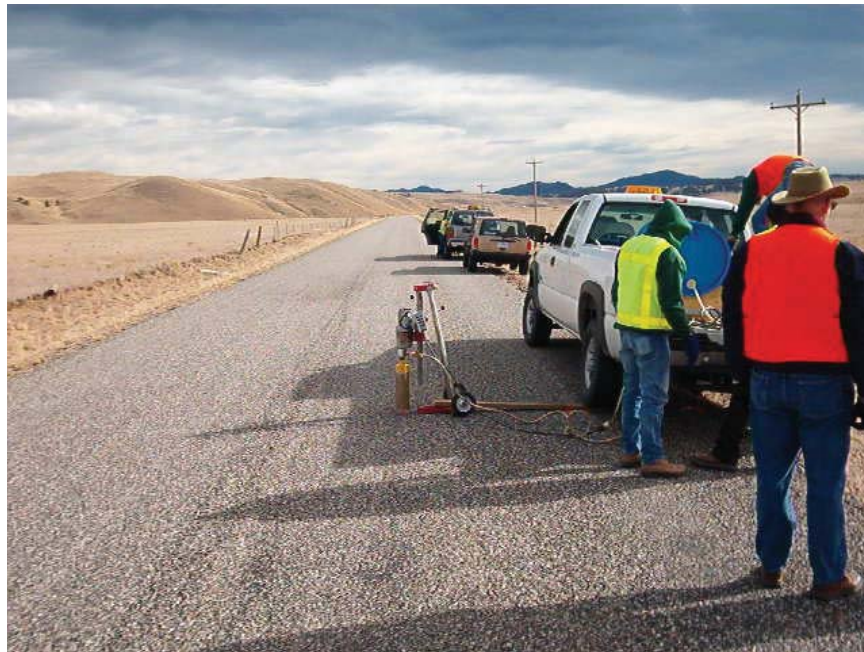
Figure 34. Photo. Coring at Site 1.

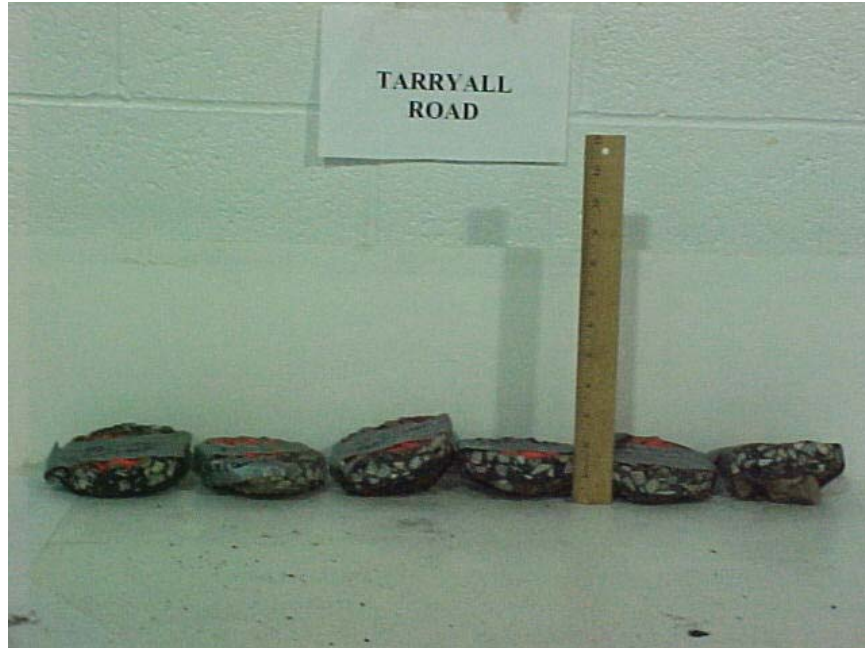
Figure 35. Photo. Cores from Site 1.

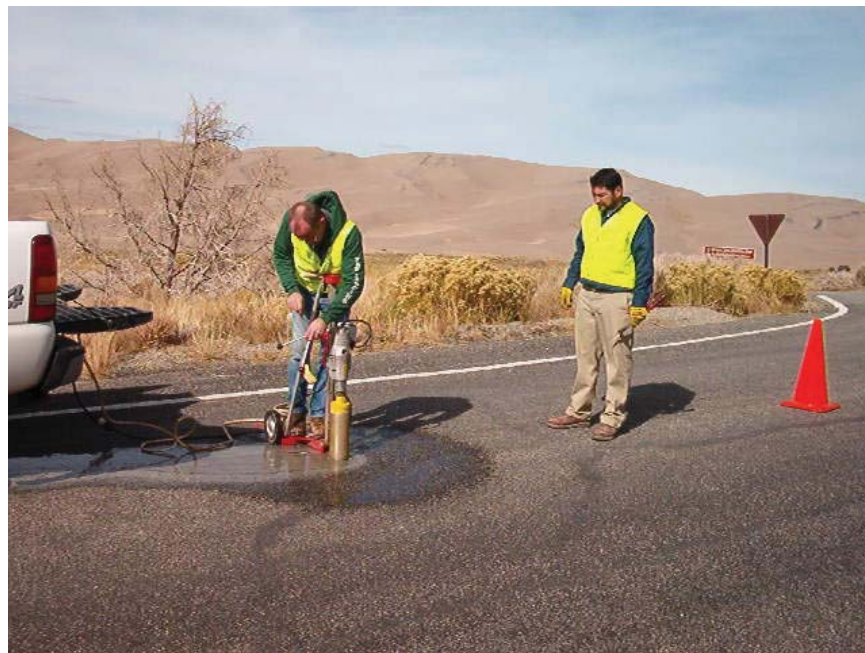
Figure 36. Photo. Coring at Site 2.

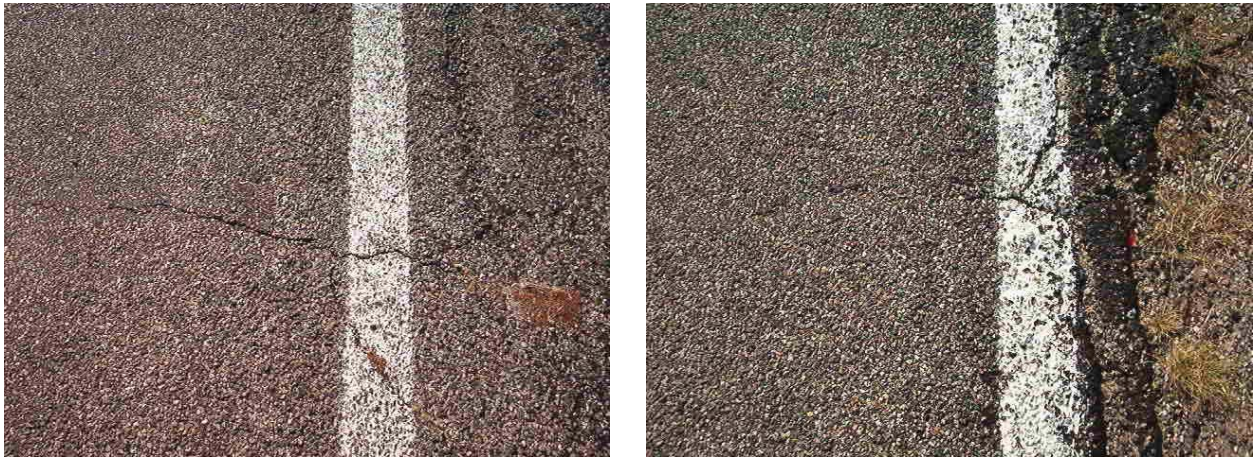
Figure 37. Photo. Examples of Cracks at Site 2.

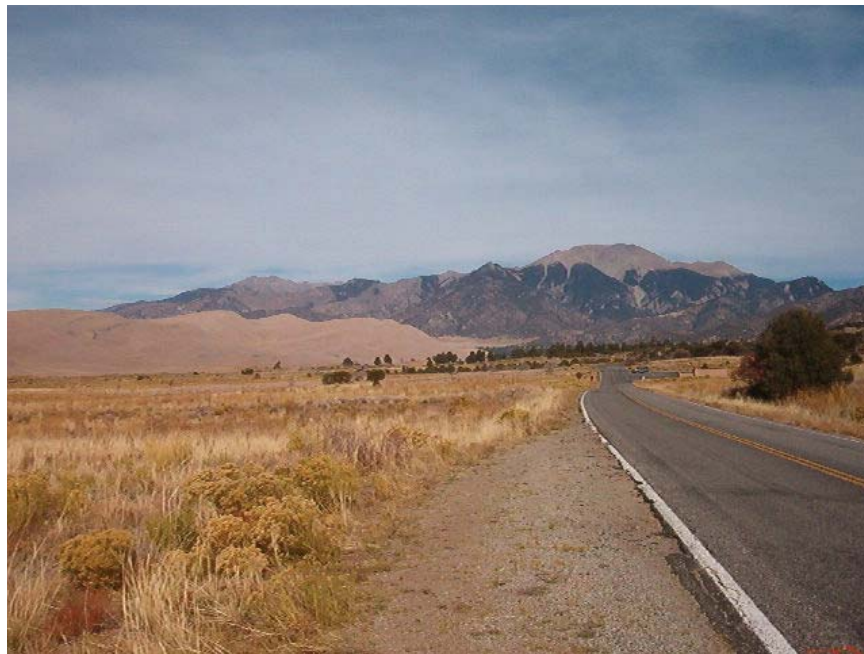
Figure 38. Photo. View of Site 2.

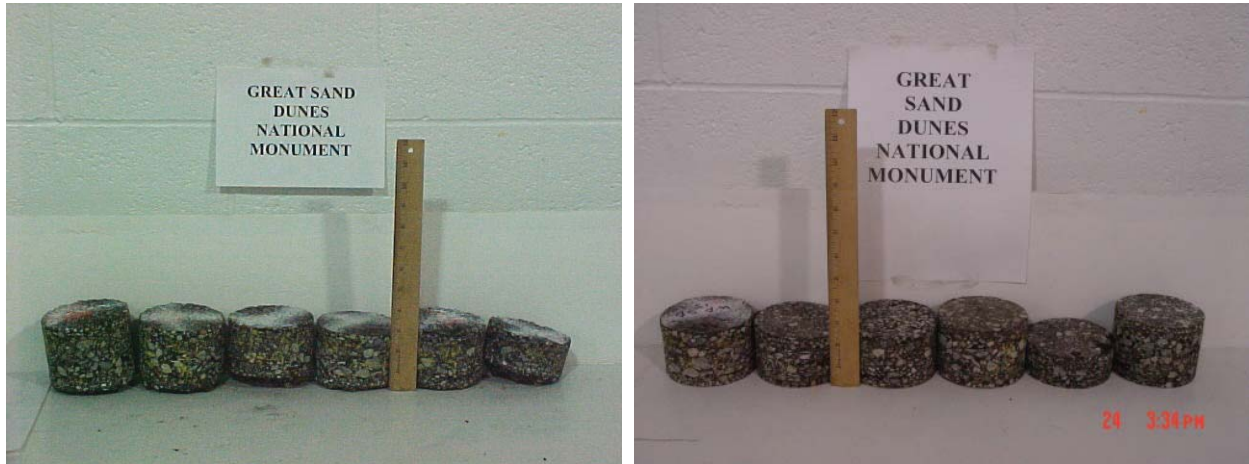
Figure 39. Photo. Cores from Site 2.

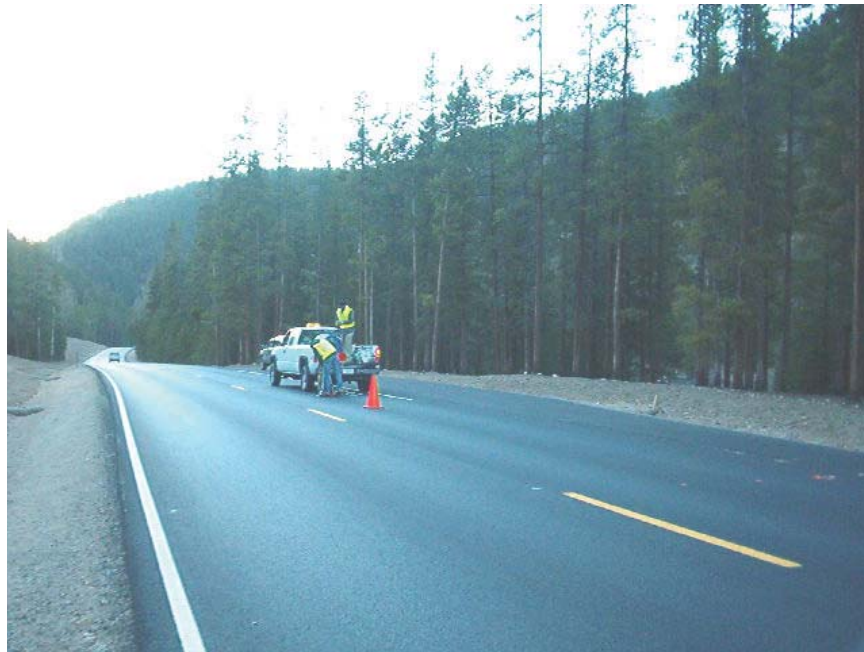
Figure 40. Photo. View of Site 3.

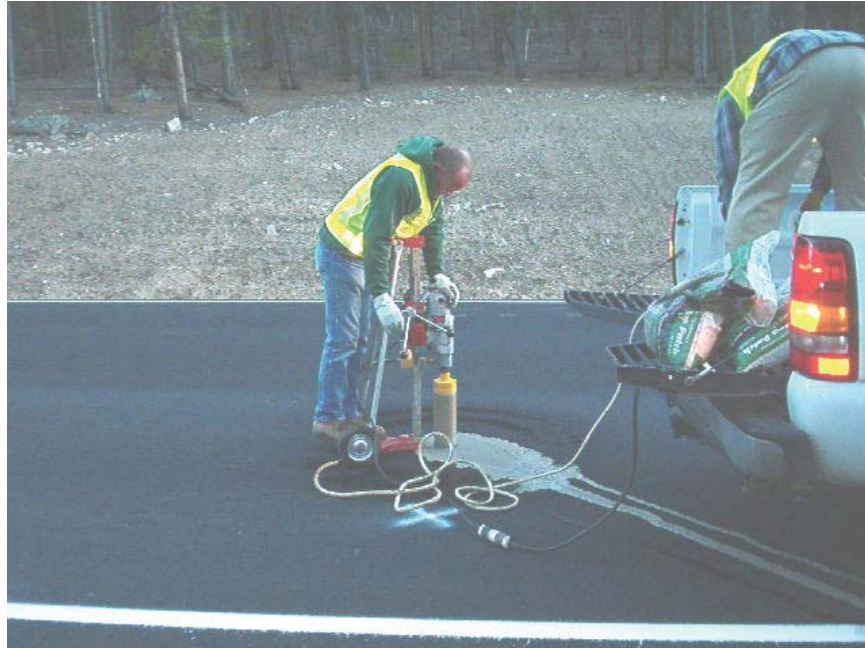
Figure 41. Photo. Coring at Site 3.

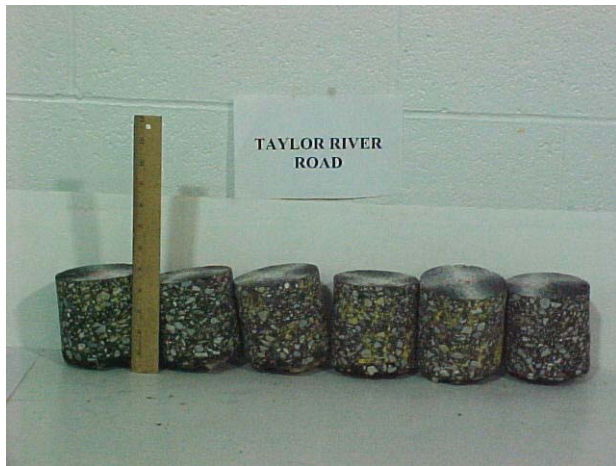
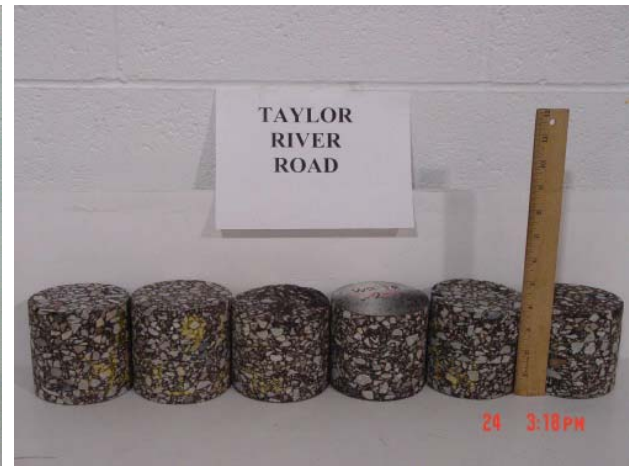
Figure 42. Photo. Cores from Site 3.

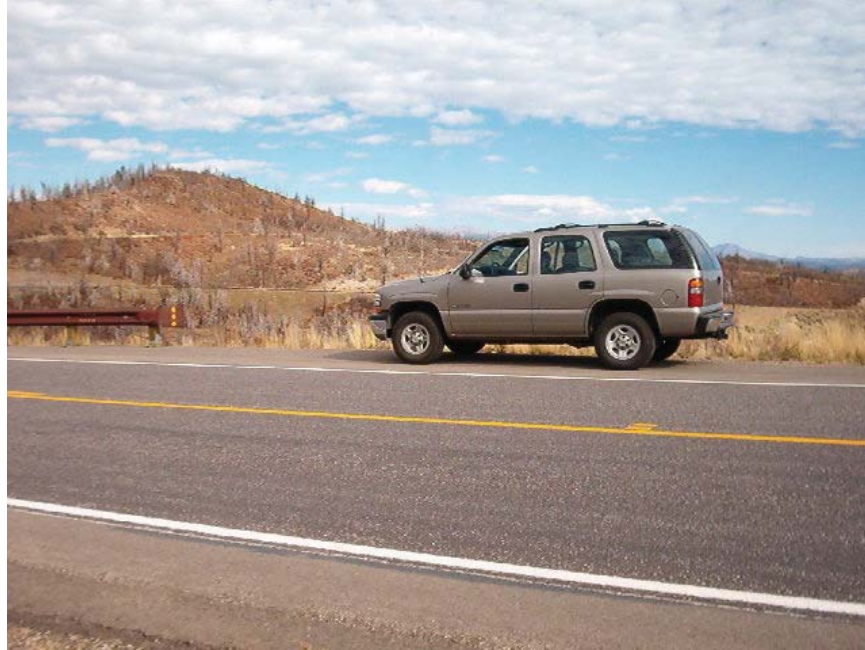
Figure 43. Photo. Close up of Site 4.

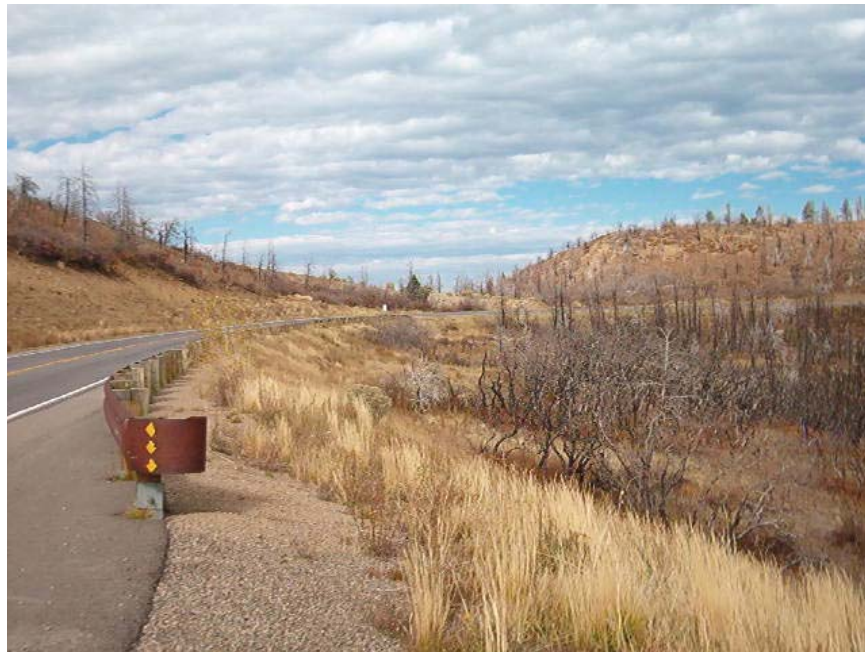
Figure 44. Photo. View of Site 4.

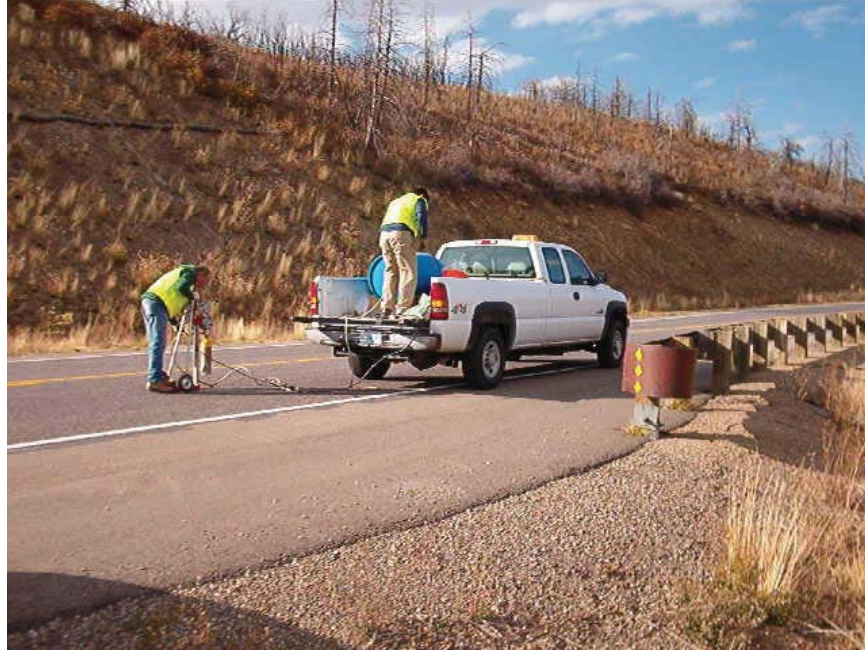
Figure 45. Photo. Coring at Site 4.

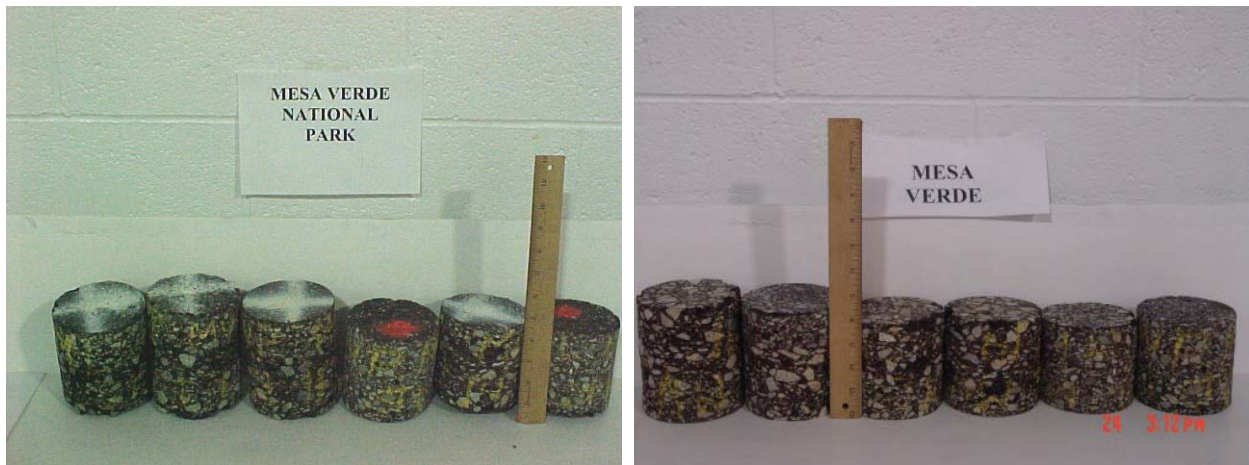
Figure 46. Photo. Cores from Site 4.

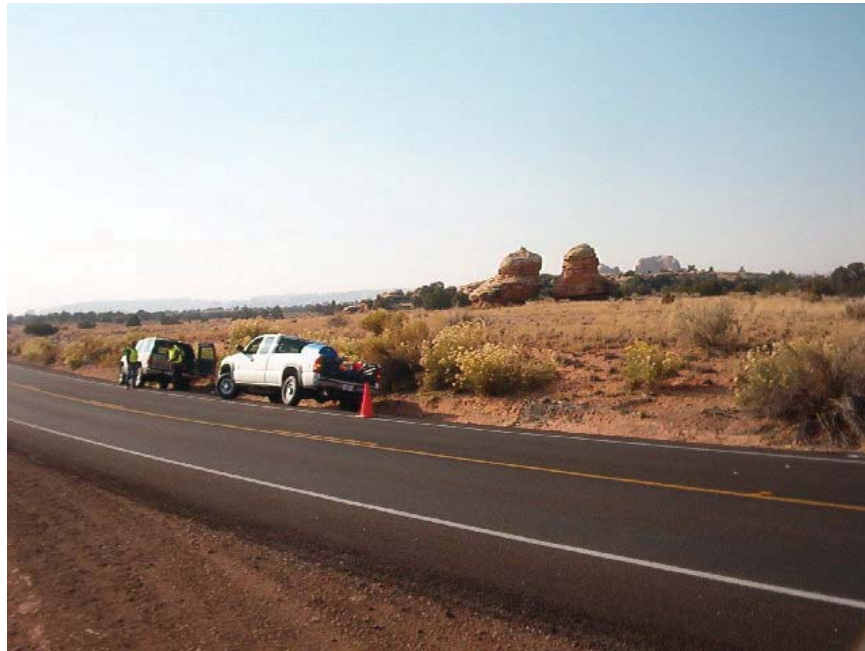
Figure 47. Photo. Close up of Site 5.

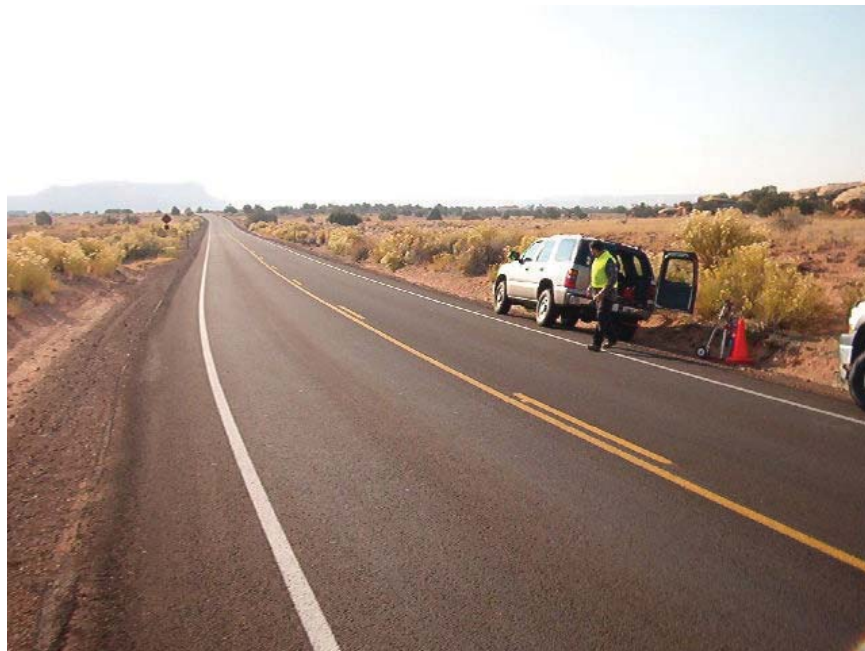
Figure 48. Photo. View of Site 5.

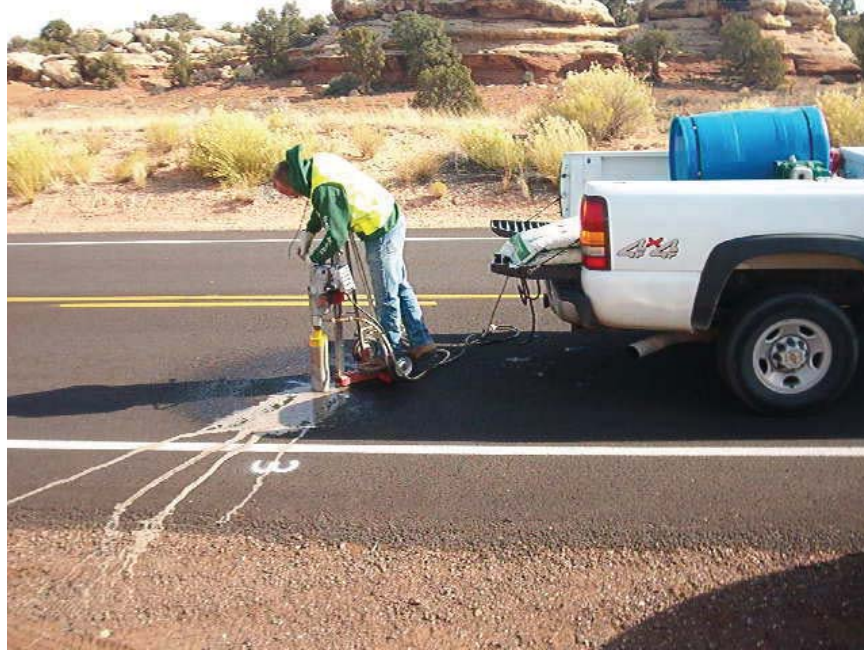
Figure 49. Photo. Coring at Site 5.

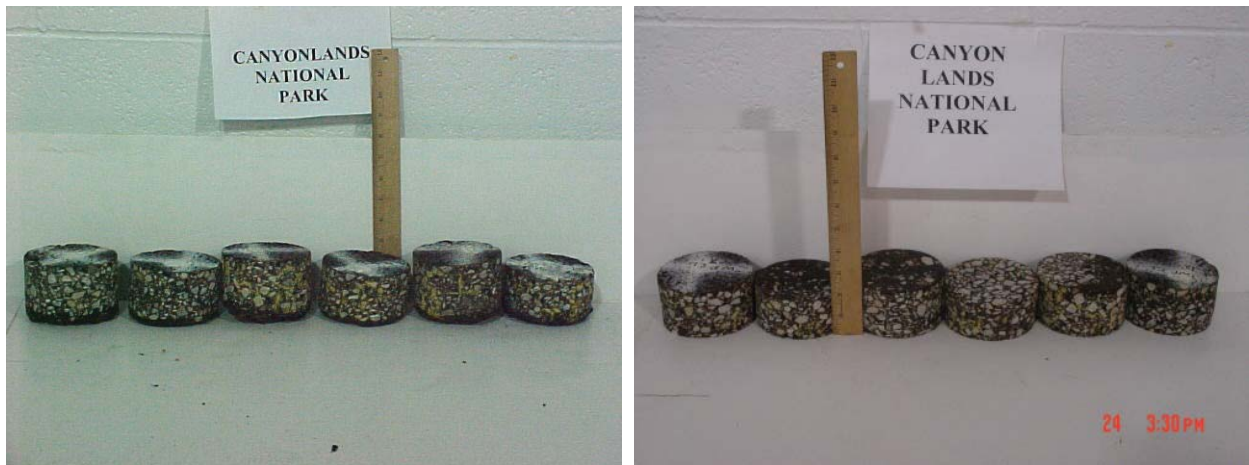
Figure 50. Photo. Cores from Site 5.

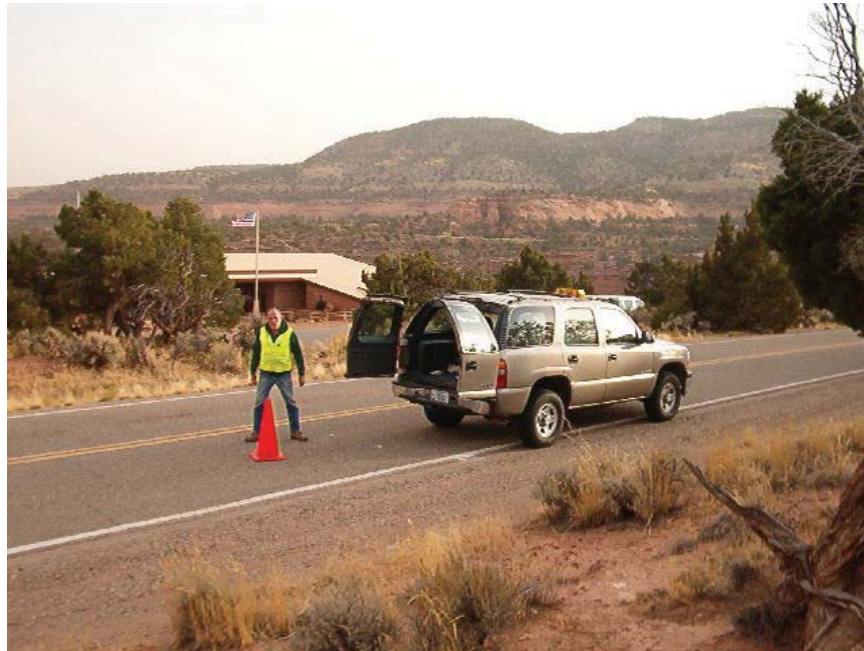
Figure 51. Photo. Close up of Site 6.

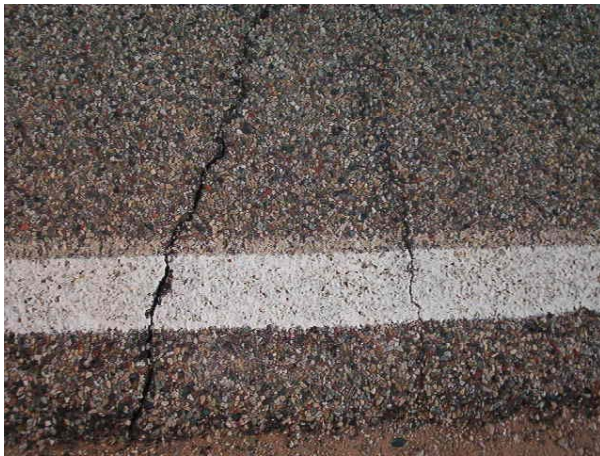
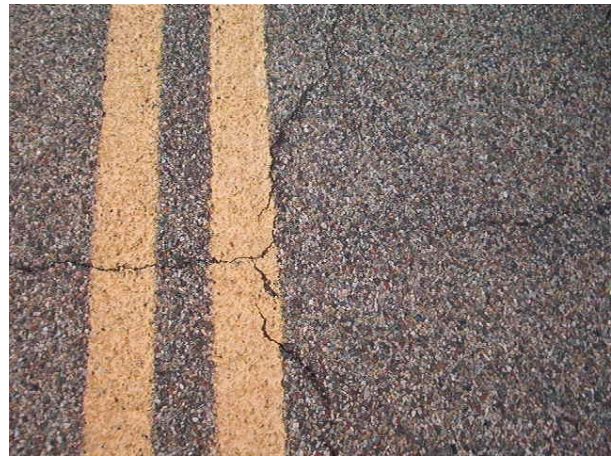
Figure 52. Photo. Cracking at Site 6.

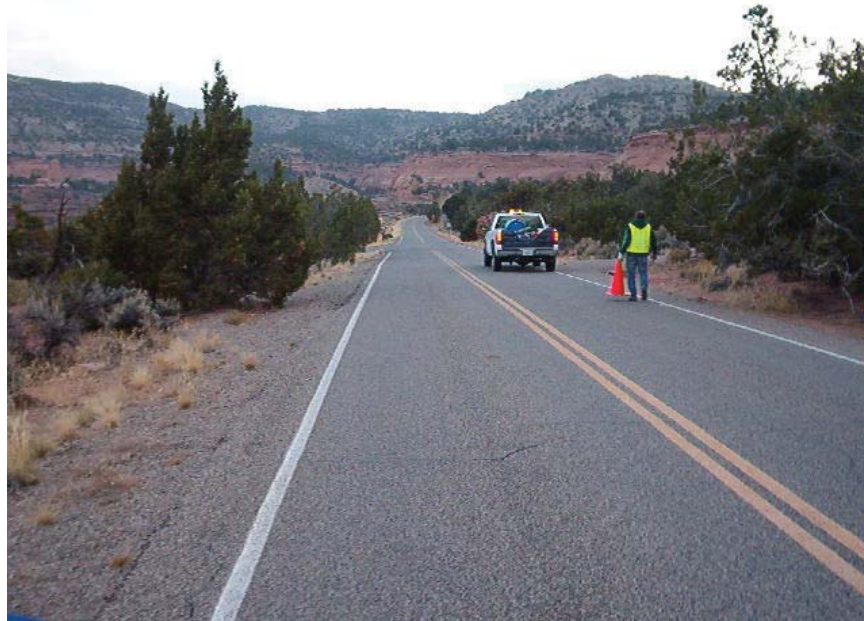
Figure 53. Photo. View of Site 6.

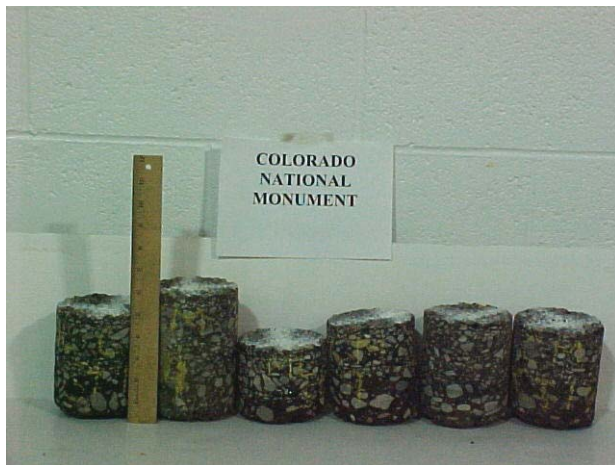
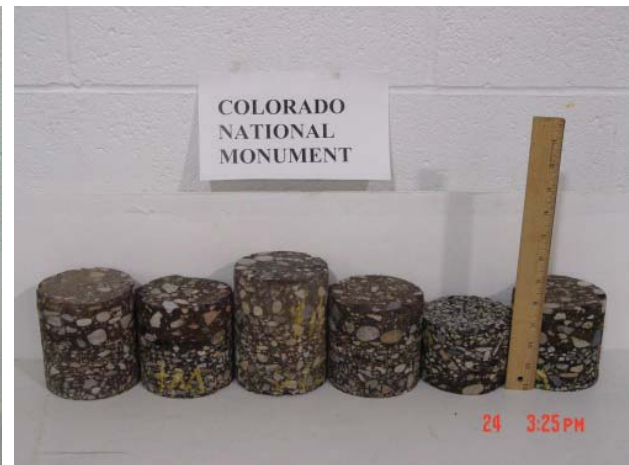
Figure 54. Photo. Cores at Site 6.
