COLUMBIA

ACCIDENT INVESTIGATION BOARD

REPORT VOLUME I
AUGUST 2003

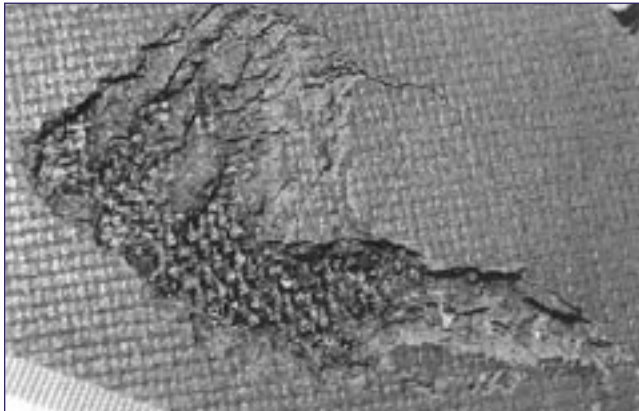
Figure 3.3-2. Damage on the outer surface of RCC panel 10-right from *Atlantis* after STS-45.

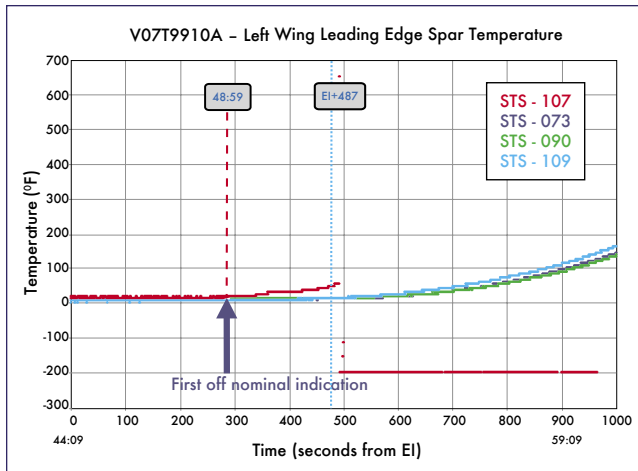
Figure 3.6-4. This temperature thermocouple (Sensor 2) was mounted on the outside of the wing leading edge spar behind the insulation that protects the spar from radiated heat from the RCC panels. It clearly showed an off-nominal trend early in the re-entry sequence and began to show an increase in temperature much earlier than the temperature sensor behind the spar.

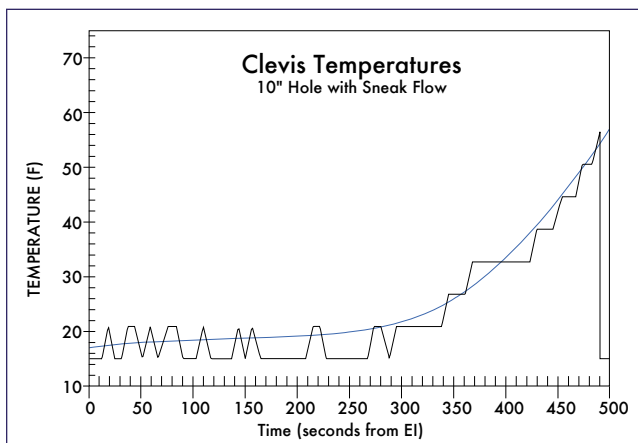
Figure 3.6-5. The analysis of the effect of a 10-inch hole in RCC panel 8 on Sensor 2 from EI to EI+500 seconds. The jagged line shows the actual flight data readings and the smooth line the calculated result for a 10-inch hole with some sneak flow of superheated air behind the spar insulation.

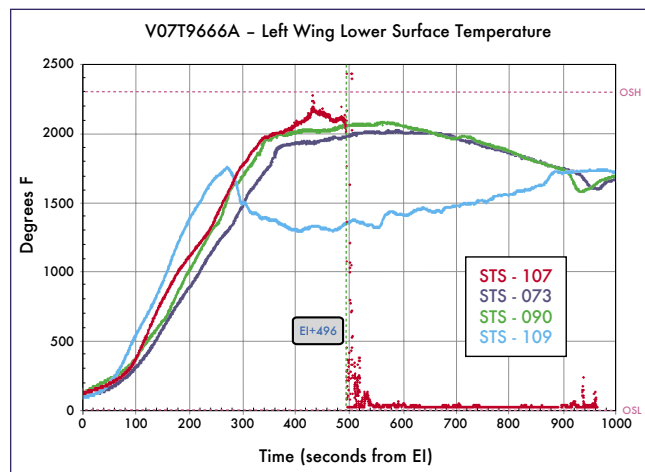
Figure 3.6-6. As early as EI+370, Sensor 3 began reading significantly higher than on previous flights. Since this sensor was located in a thermal tile on the lower surface of the left wing, its temperatures are much higher than those for the other sensors.

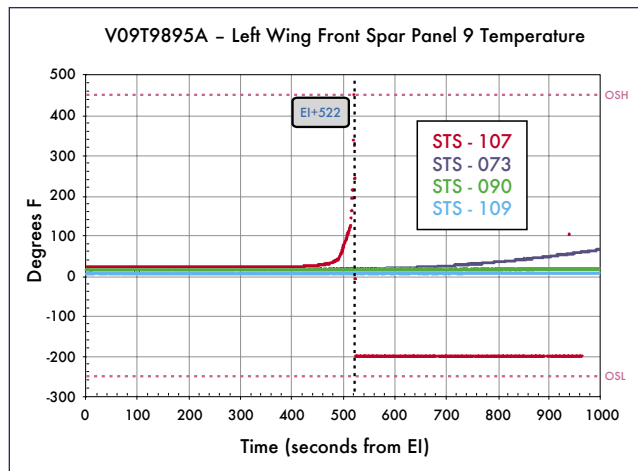
Figure 3.6-7. Sensor 4 also began reading significantly higher than previous flights before it fell off-scale low. The relatively late reaction of this sensor compared to Sensor 2, clearly indicated that superheated air started on the outside of the wing leading edge spar and then moved into the mid-wing after the spar was burned through. Note that immediately before the sensor (or the wire) fails, the temperature is at 450 degrees Fahrenheit and climbing rapidly. It was the only temperature sensor that showed this pattern.

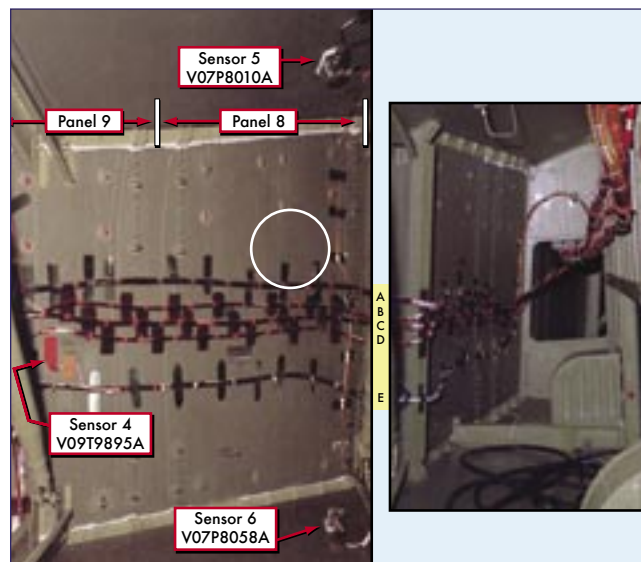
Figure 3.6-8. The left photo above shows the wiring runs on the backside of the wing leading edge behind RCC panel 8 – the circle marks the most likely area where the burn through of the wing leading edge spar initially occurred at EI+487 seconds. The right photo shows the wire bundles as they continue forward behind RCC panels 7 and 6. The major cable bundles in the upper right of the right photo carried the majority of the sensor data inside the wing. As these bundles were burned, controllers on the ground began seeing off-nominal sensor indications.

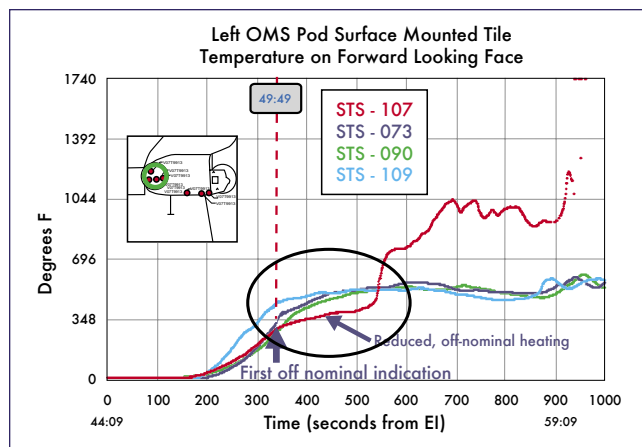
Figure 3.6-9. Orbital Maneuvering System (OMS) pod heating was initially significantly lower than that seen on previous Columbia missions. As wing leading edge damage later increased, the OMS pod heating increased dramatically. Debris recovered from this area of the OMS pod showed substantial pre-breakup heat damage and imbedded drops of once-molten metal from the wing leading edge in the OMS pod thermal tiles.

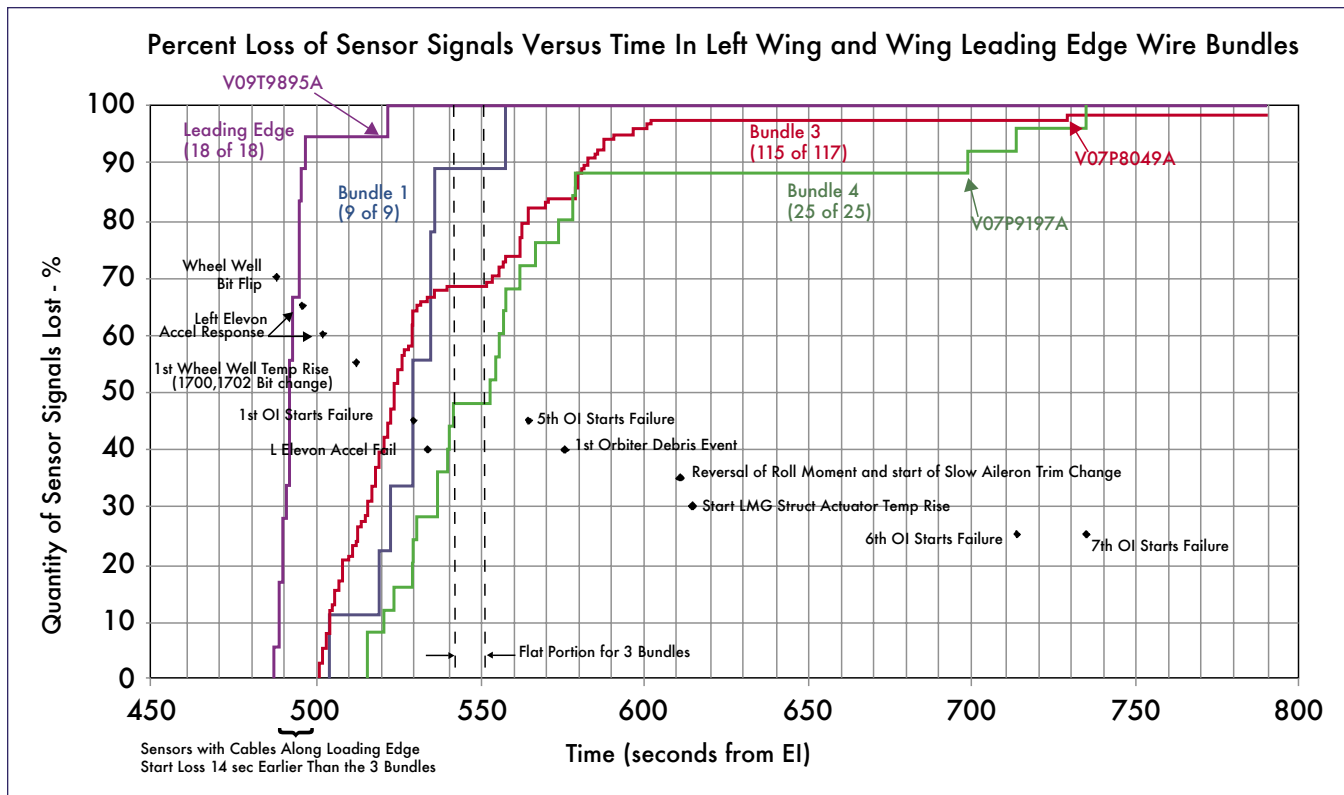
Figure 3.6-10. This chart shows how rapidly the wire bundles in the left wing were destroyed. Over 70 percent of the sensor wires in the wiring bundles burned through in under a minute. The black diamonds show the times of significant timeline sensor events.

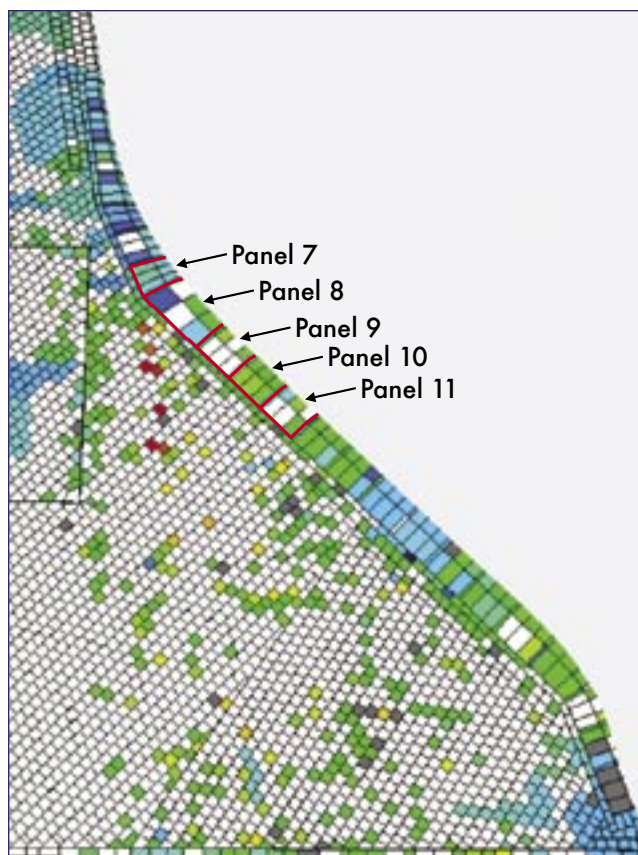
Figure 3.7-6. The tiles recovered farthest west all came from the area immediately behind left wing RCC panels 8 and 9. In the figure, each small box represents an individual tile on the lower surface of the left wing. The more red an individual tile appears, the farther west it was found.

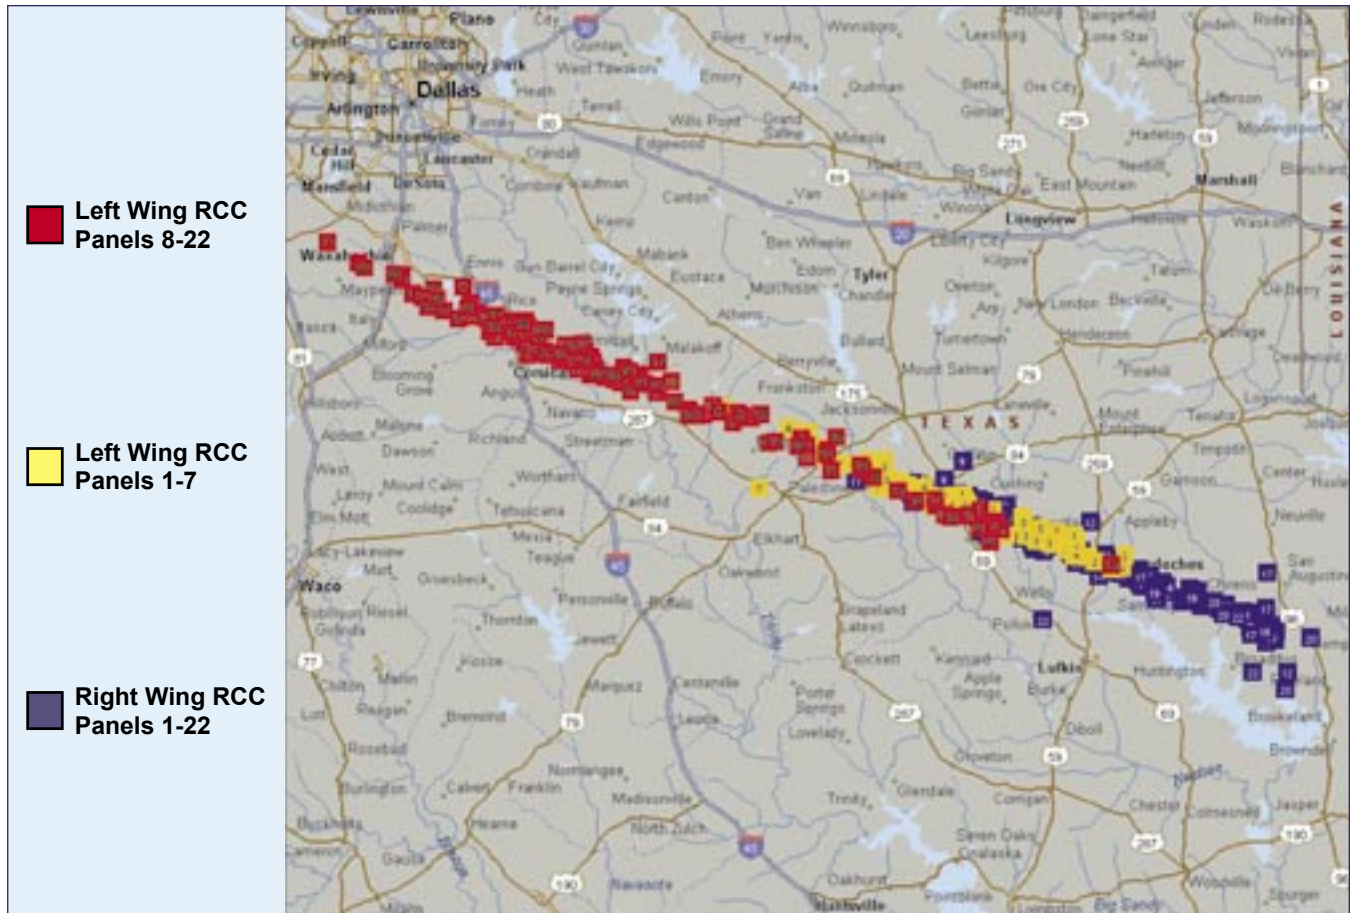
Figure 3.7-5. The location of RCC panel debris from the left and right wings, shown where it was recovered from in East Texas. The debris pattern suggested that the left wing failed before the right wing, most likely near left RCC panels 8 and 9.

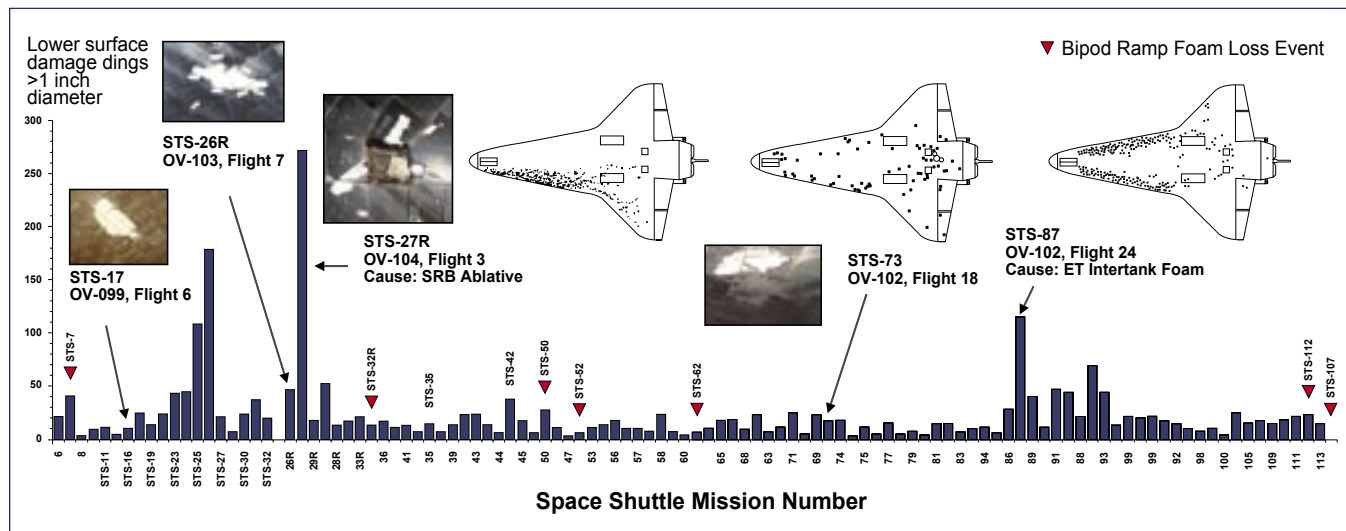
Figure 6.1-6. This chart shows the number of dings greater than one inch in diameter on the lower surface of the Orbiter after each mission from STS-6 through STS-113. Flights where the bipod ramp foam is known to have come off are marked with a red triangle.
