SANDIA REPORT

SAND93-1380 • UC-261

The Application of Non-Destructive Techniques to the Testing of a Wind Turbine Blade

Herbert Sutherland, Alan Beattie, Bruce Hansche, Walt Musial, Jack Allread,
Jim Johnson, Mike Summers

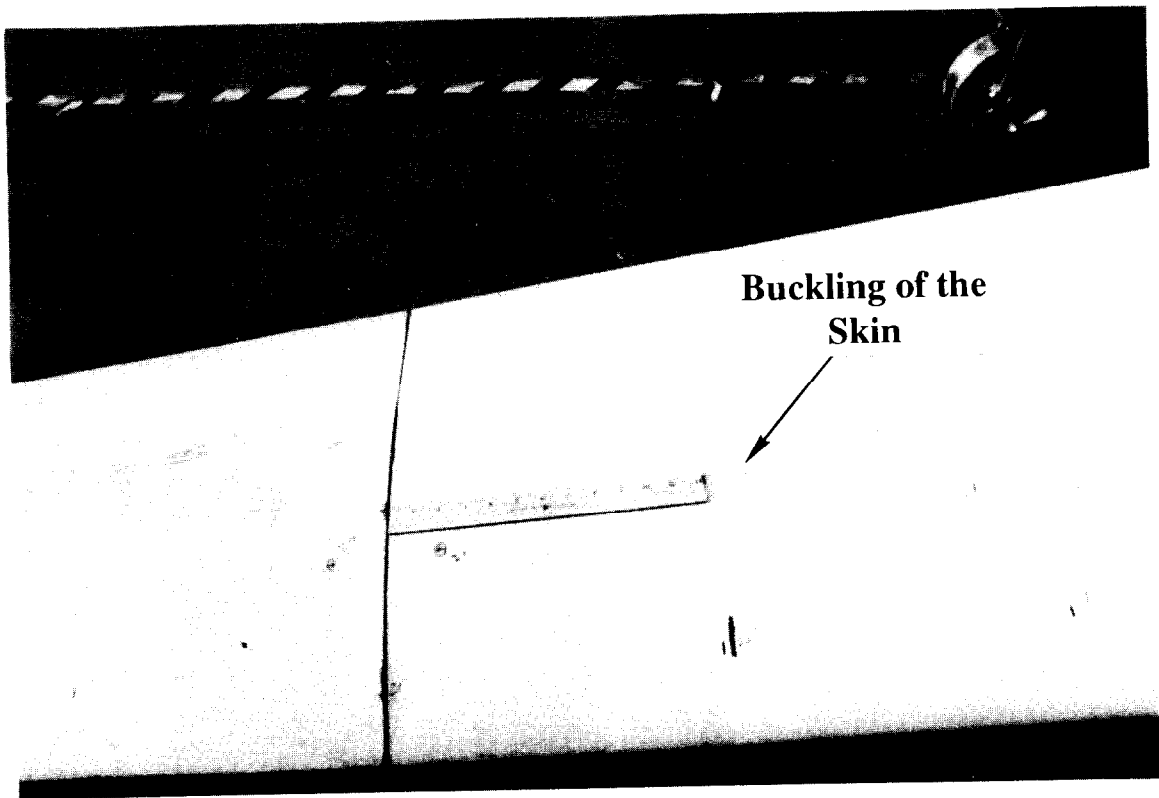
The Phase 1 test resulted in a failure of the blade at approximately station 240. This station is located approximately 12 in. (30.5 cm) inboard from the split line of the pitchable tip at station and approximately 6 in. (15.2 cm) inboard from the middle saddle used to load the blade. The failure occurred near the point where the internal spar (shear web) was terminated and the pitch shaft transitions to a smaller diameter shaft. The peak load recorded at failure was 3925 lb (17.5 kN) on the load cell; see Figure 6a. This load results in a root failure load of 72,528 ft-lb (97.9 kN-m). The bending moment at the failure location due to the force on the outer two saddles was 3596 ft-lb (4.8 kN-m). The failure appeared as a cordwise crease in the skin on compression surface.

Visual examination of the primary (Phase 1) failure at station 240 showed that the steel pitch shaft of the tip spoiler mechanism (see Figure 15) was bent inboard of the cam mechanism. The skin was also buckled on the low pressure side of the blade in the same radial location as the failure of the steel tip mechanism itself; see Figure 16. This failure location also coincides with the termination of the internal shear webs; see Figure 15.

Figure 16. Blade failure for Phase 1 loading, buckled skin at station 240.

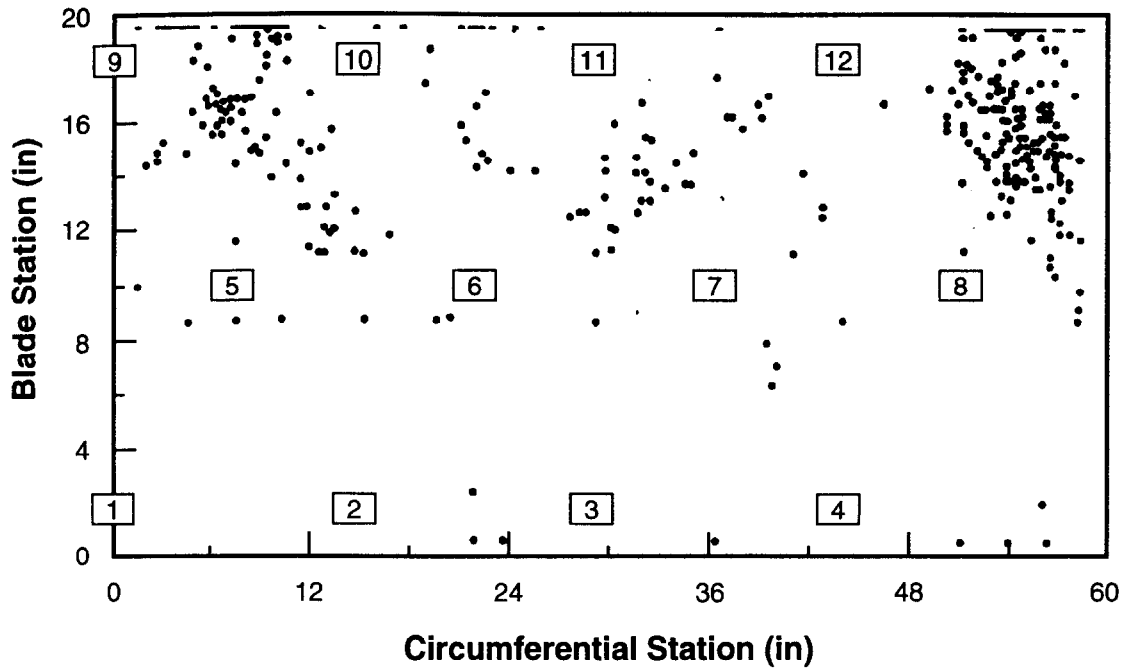
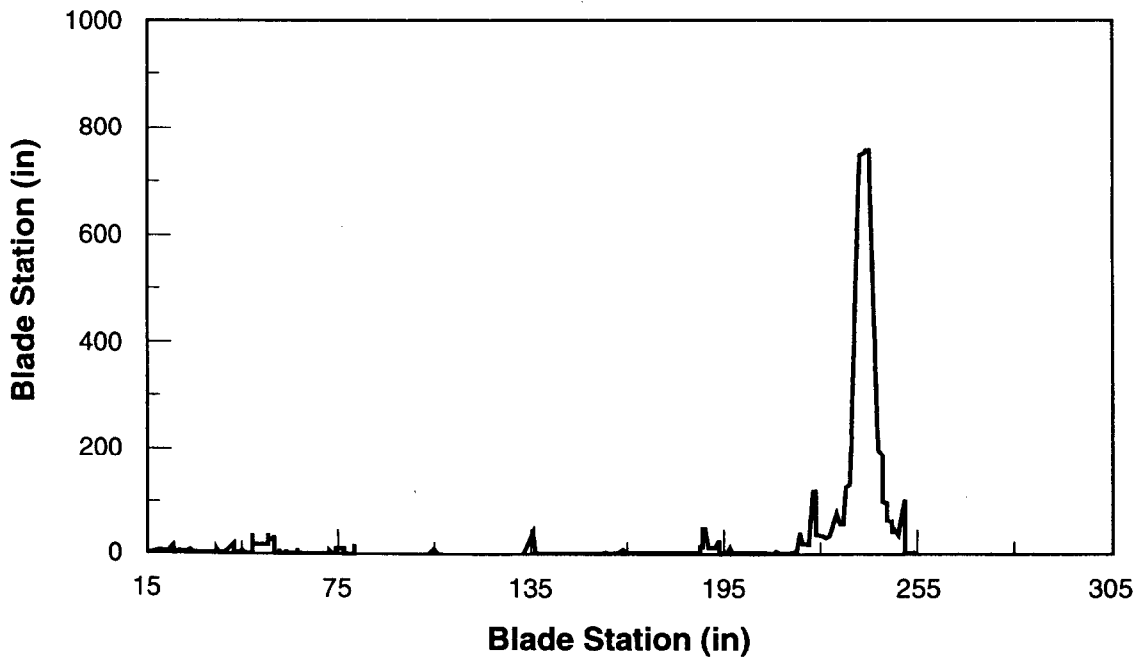
Figure 20a is the “location plot” for the AE events in the root of the blade during Phase 1 loading of the blade. As can be seen in these plots, most of the emissions came from the compression side (top) of the blade, between transducers 9 and 12. As seen in this plot, the events were located primarily between blade stations 12 to 20. Figure 20b shows a similar plot along the length of the blade. There was a small cluster of events between stations 40 and 55, near sensor 14. Most of the events were from a region near station 240 (between sensors 20 and 21).

Figure 20. AE locations for Phase 1 loading.

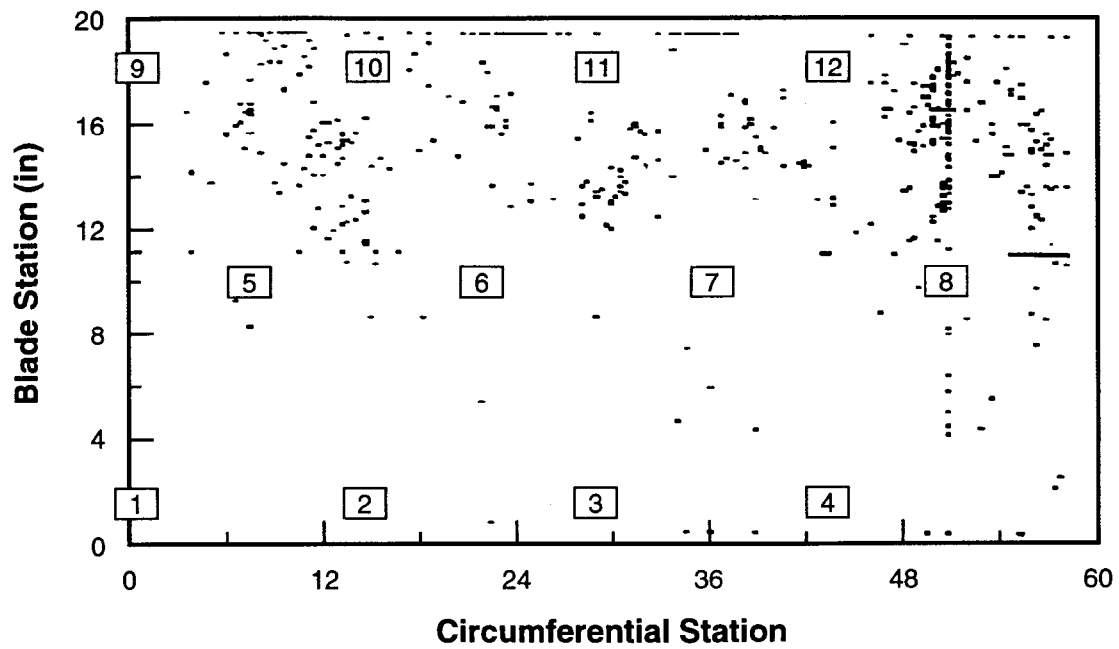
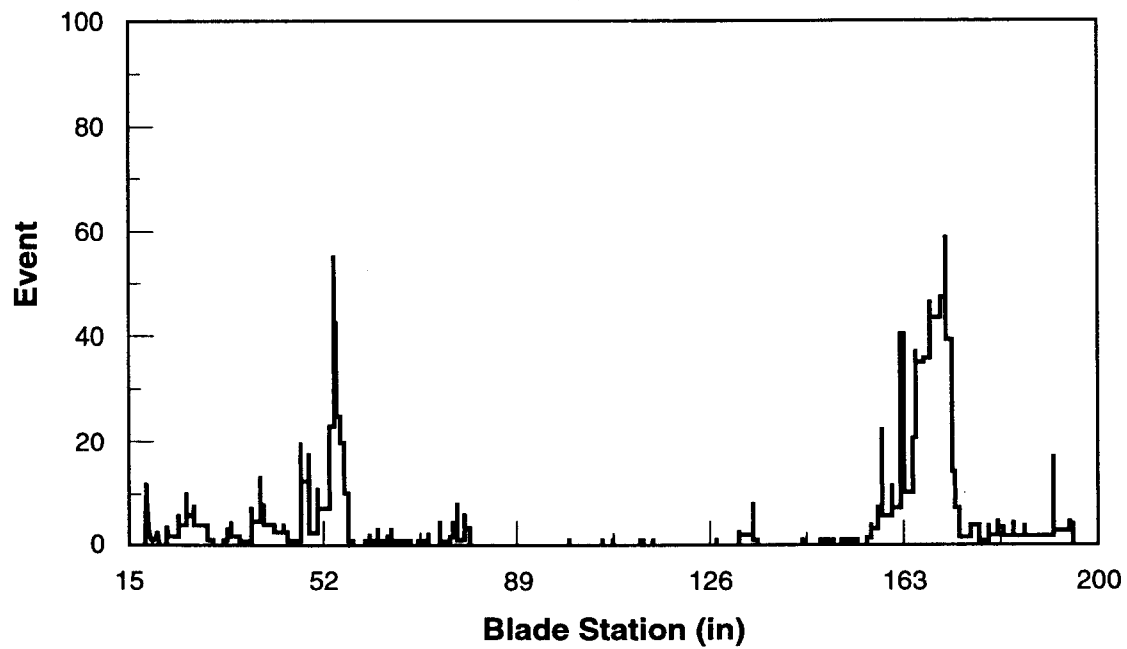
The root location plot is shown in Figure 23a. This figure is similar in appearance to Figure 20a, which shows the locations for this region during the Phase 1 loading. This figure shows continuing widespread damage and it indicates that flaws are coalescing into cracks and growing. The main difference between the two figures is the appearance of lines of located events near sensors 8 and 12. Both the vertical and horizontal lines shown in Figure 23a are artifacts of the location algorithm.*

Figure 23b shows the location graph for the blade region for Phase 2a loading. The emission near blade station 15, sensor 13, is an extension of damage seen in the root region. The events near station 50, sensor 14, are a continuation of the damage seen in Figures 20b. Note that the number of emissions from this area in the two figures is approximately the same. The emissions just beyond station 165, sensor 18, are emanating from the load fixture (saddle). As this fixture is being used to supply the entire load on the blade (one saddle instead of three), the bottom of the blade was beginning to crush.

Figure 23. AE locations for Phase 2a loading.

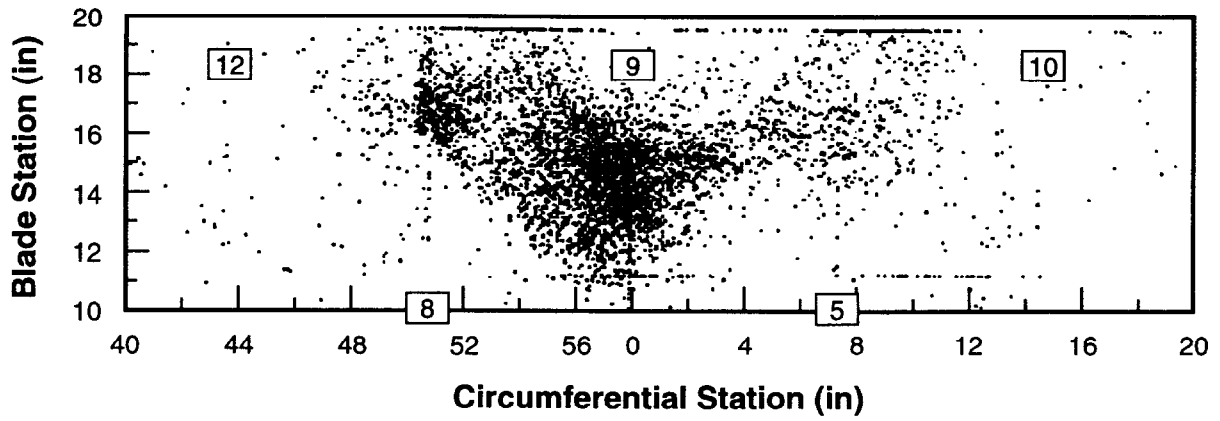
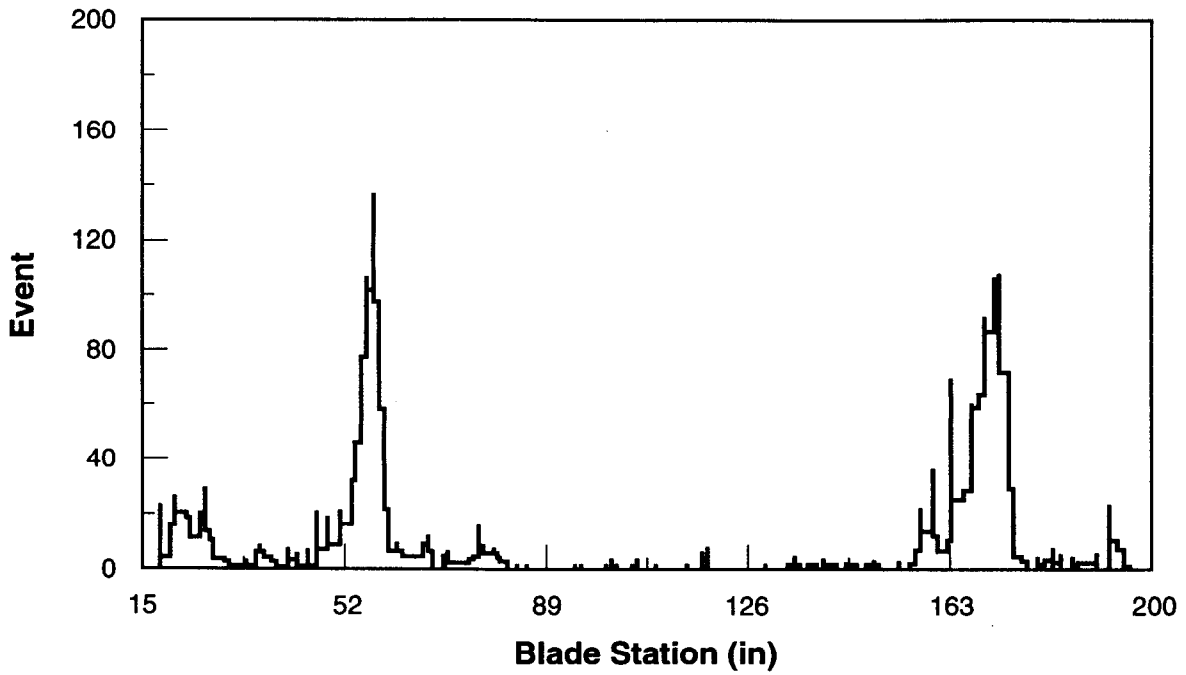
As discussed above, the straight lines of points shown in Figure 26a are artifacts of the algorithm used to locate the AE events.

In Figure 26b, the damage near station 50 continues for this loading sequence, and the breakup of the blade bottom under the loading fixture near station 170 is still obvious. Figure 25c shows the event versus time curve for this region. There was not as much damage occurring during the load holds here as there was in the root region.

Figure 26. AE locations for Phase 2b loading.

The location map for Phase 2b loading (Figure 26a and 28) shows large scale destruction of the fiberglass. Figure 27c is the “energy” versus load curve for sensor 9 during this loading sequence. The amount of emission “energy” increases during each load hold. Most of this “energy” comes from the compression side (top) of the blade. The most probable failure mechanism is delamination of the fiberglass. In Figure 28, there is only a slight concentration of events in the triangle formed by sensors 6, 7, and 11. This area is in tension. The conclusion is that the fiberglass structure in the root region still has adequate strength under tension at the 8996 lb (40.0 kN) load [peak root bending moment of 125,944 ft-lb (170 kN-m)] but cannot support the compression stresses without damage above a load of 3925 lb (17.5 kN) [root bending load of 72,528 ft-lb (97.9 kN-m)] seen on the first loading.

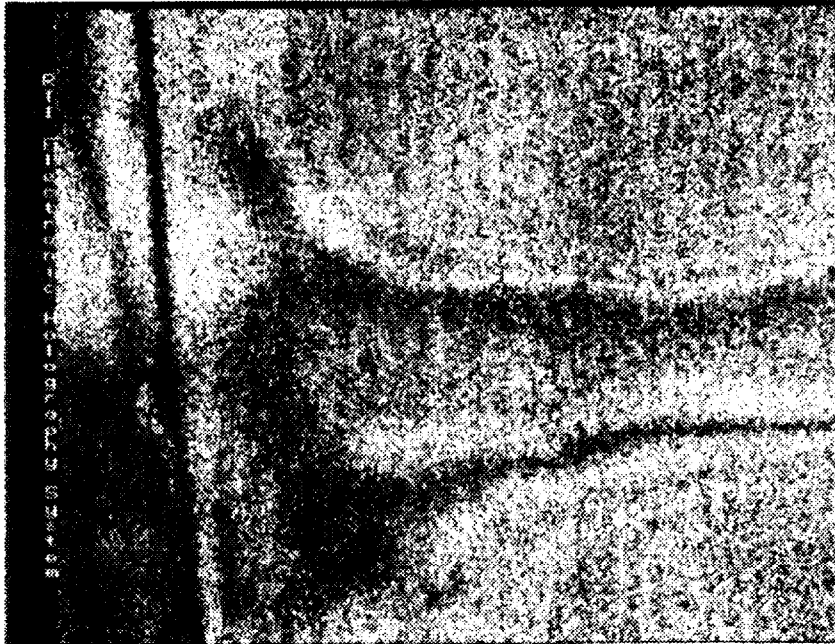
In fact, very few obvious flaws were detected on this blade by coherent optics. Various subsurface structure such as the spar webs and lamination thickness changes were readily visible, as shown in Figure 36. This shearograph highlights the tip actuator mechanism and the main spar, between stations 240 and 252 in Figure 19b. Several anomalous areas, as well as the apparent substructure, were marked on the blade for possible post-test examination. One of the anomalous areas over the spar, between stations 36 and 48 in Figure 19b, was selected for observation during the test.

Figure 36. Pre-test shearogram using thermal stress, station 240 to 252.

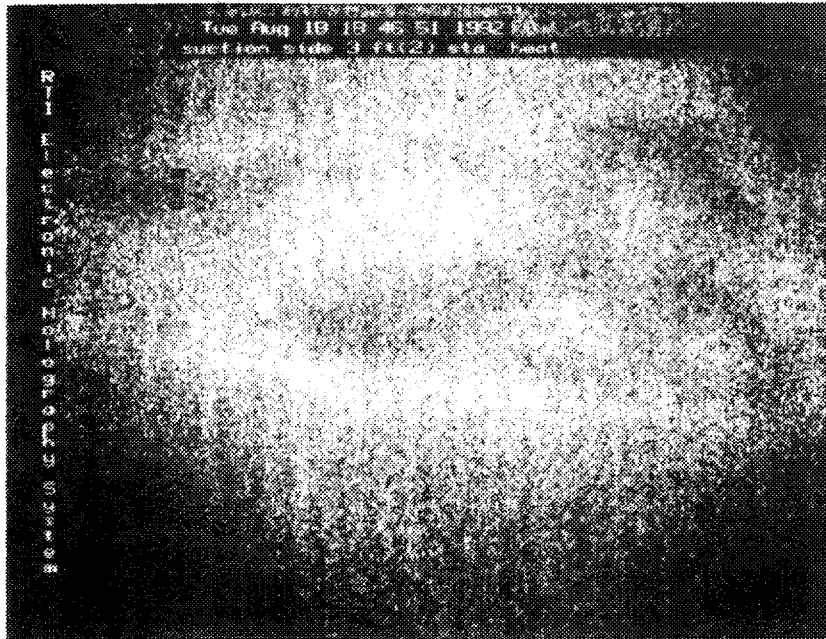
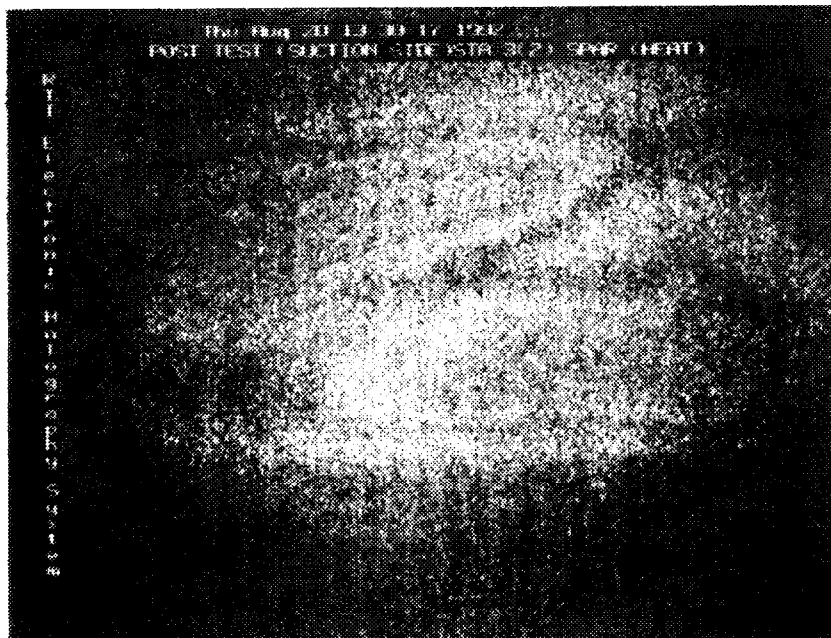
Several small flaws were noted and marked on the blade skin during the pre-test examination. Two flaws, near the transition from the circular root to an airfoil blade section, had significant AE activity during the blade loading. Post-test shearographic inspection of this area using thermal stress revealed that the two flaws had grown in size. Both flaws appeared to be small [approximately 1.4 in. (3.5 cm) in diameter], near-surface delaminations, and probably were not structurally significant. A shearogram of one of these flaws is shown in Figure 39. A post-mortem examination of one of the flaws showed that it was a region of high porosity (a manufacturing “bubble”) near the surface of the blade. Under microscopic examination, the flaw showed evidence that it had grown (approximately doubling in size) during the course of the experiment.

Figure 38. Shearograms using thermal stress, station 36 to 48.

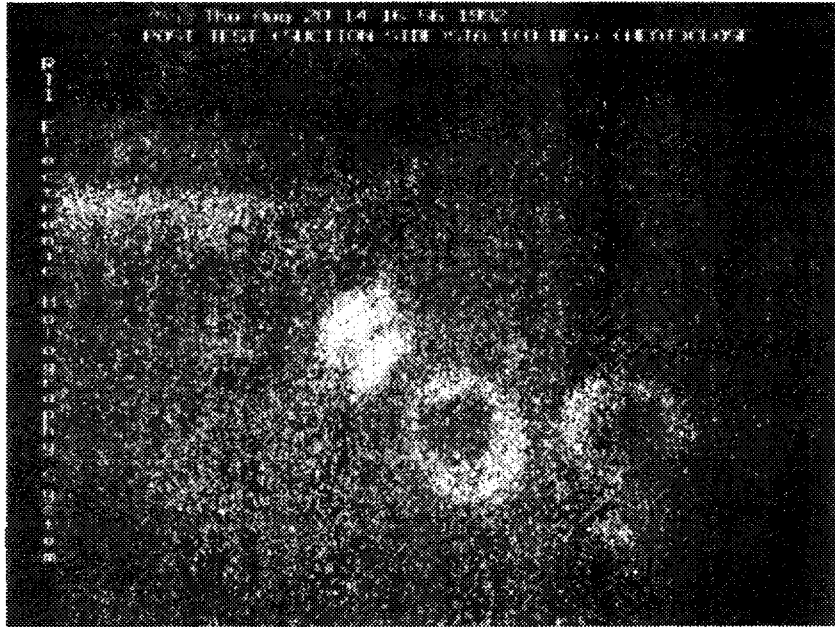
Figure 39. Shearogram of the flaw at station 24. The two circles with dark centers are where acoustic emission sensors 13 and 9 were located—the remaining adhesive caused these indentions. The bright circle above and left of the transducer locations is the flaw.
