ACOUSTIC EMISSION MONITORING OF A WIND TURBINE BLADE DURING A FATIGUE TEST^{*Ψ}

A.G. Beattie
Department 9742
Sandia National Laboratory
Albuquerque, NM 87185

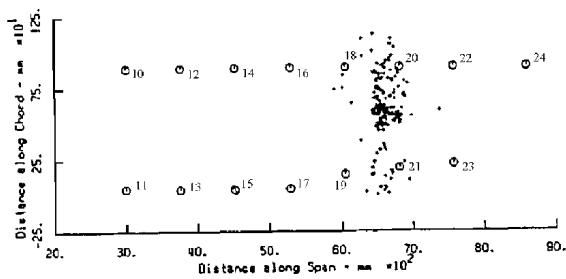
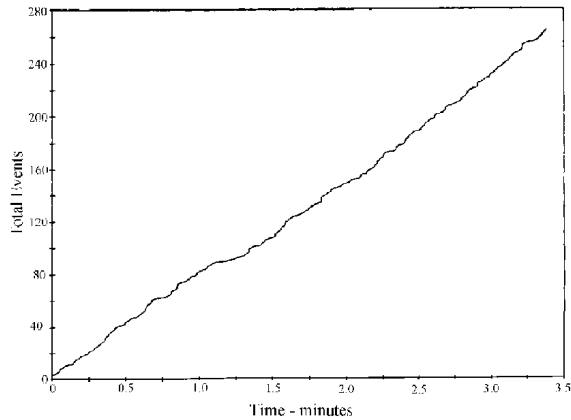
Figure 3. Event Locations and events as a function of time for Stage 1

The acoustic emission system was set up and run for about 3.4 minutes without the voltage controlled gate. The data set was filtered to remove all sources which appeared to occur at times other than at the peak load. Figure 3 shows the location of these sources and the sum of the number of located sources as a function of time. There were about 260 located events in 150 cycles. Thus there was at least one event in every cycle in the 18,19,21,20 rectangle. The damage appears to have started at the first cycle which reached full load. The other oil can region, which occurred in the rectangle 12,13,15,14 showed no sign of locatable emission during this short run. No located emissions were seen in the root area covered by sensors I through 9.

The steady occurrence of locatable emission at the peak load of almost every cycle, as shown in Figure 3, strongly indicates that the peak test load exceeded the strength of this blade design in the region of rectangle 18,19,21,20.

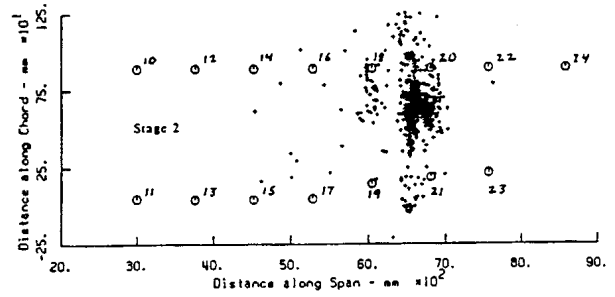
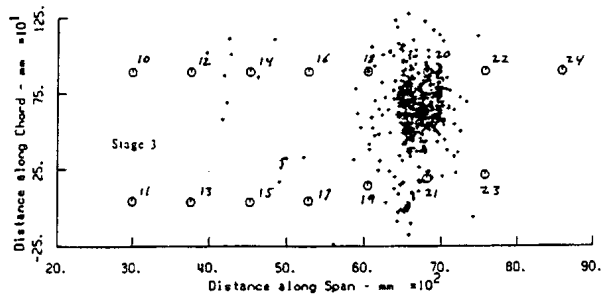
Figure 4. Event locations for Stage 2 and Stage 3

Figure 4 shows the located emissions in stages 2 and 3. Again most of the emissions appear to come from the oil can distortions in rectangle 18,19,21,20. Figure 5 shows the sum of the located sources as a function of time. Thirty-two minutes into the stage 2, there was an order of magnitude decrease in the rate of locatable emissions. A similar behavior is seen in stage 3 (the step between 20 and 28 minutes occurred when the loading was temporarily stopped) Notice that the temporary halt in loading did not change the event rate. The event rate did decrease at 78 minutes. A lower rate then continued, with some fluctuations, to 268 minutes. The rate again declined and ceased entirely at 549 minutes. The overall acoustic emission rate from the blade remained constant for the 23 hours of stage 3 but no events occurred where the acoustic burst excited sensors at all four corners of a

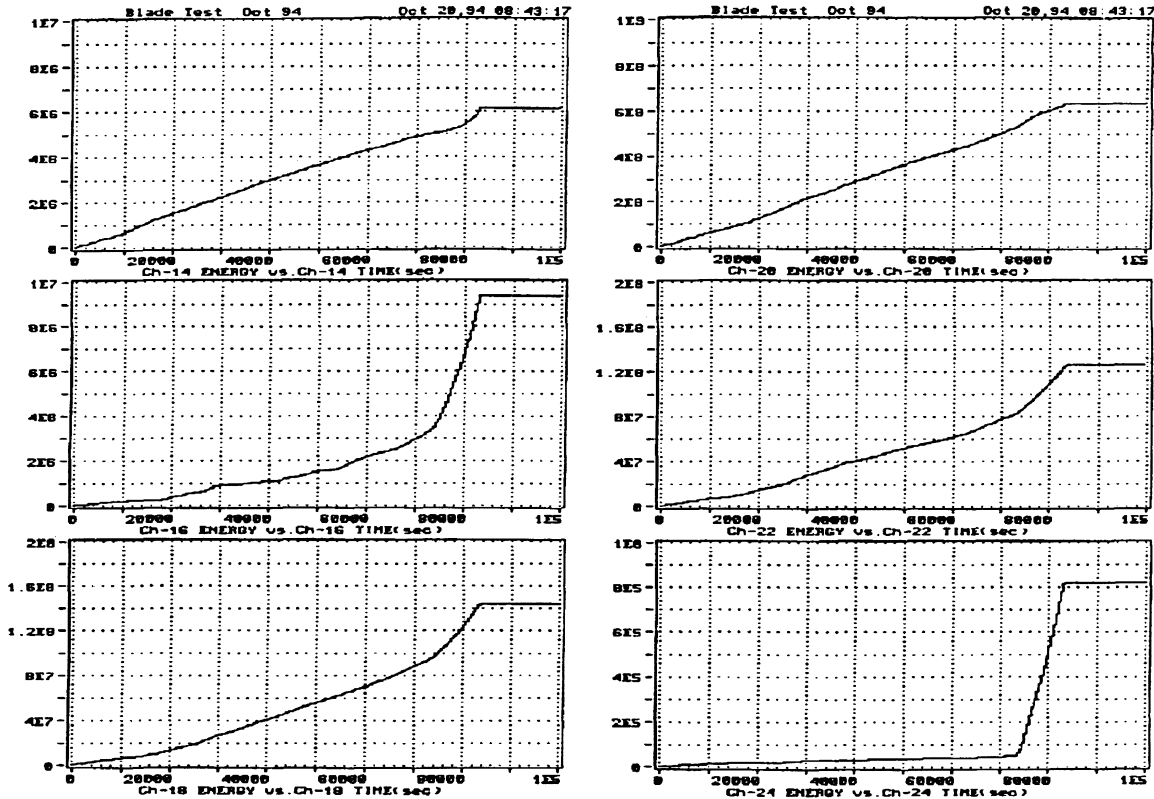
Figure 6. Total "energy" as a function of time for the leading edge sensors

Another way to examine the acoustic emission data is to plot hits from each sensor individually. Figure 6 shows totalized plots of the "energy" (actually the signal strength for each emission burst) as a function of time for sensors on top of the spar. Note that there are no significant changes in slope in any of these curves at 78 minutes (4680 seconds), 268 minutes (16,000 seconds) or 549 minutes (33,000 seconds). Thus the rates of located events have no correlation with acoustic emission rates seen at the individual sensors. Also notice that there was an increase in the "energy" rate around 72000 seconds (20 hours) for all sensors except 20. Closer examination showed that except for sensors 20, 21 and 24,7 there was an increase in the average "energy" per burst after 20 hours. Sensors 20 and 21 are located near the region where maximum damage occurred. There was very little sound material left in the skin in rectangle 18,19,21,20 by this point in the test. It is probable that this region weakened, transferring more load to the surrounding regions. This should increase the damage and lead to more acoustic energy being produced in each burst. Sensor 24 is a different case. Here the separation from sensor 22 (60 inches) is far enough so that the attenuation would allow few, if any,

signals to excite both sensors. The increase here was much larger, proportionally, than that seen in other sensors. The sensor was positioned to try to detect any damage occurring near the loading point on the blade and such damage is probably what is being seen. The average "energy" per burst decreased for sensor 24 beyond the 20 hour point which reinforces the assumption that this is a different mechanism from that seen in the other sensors.

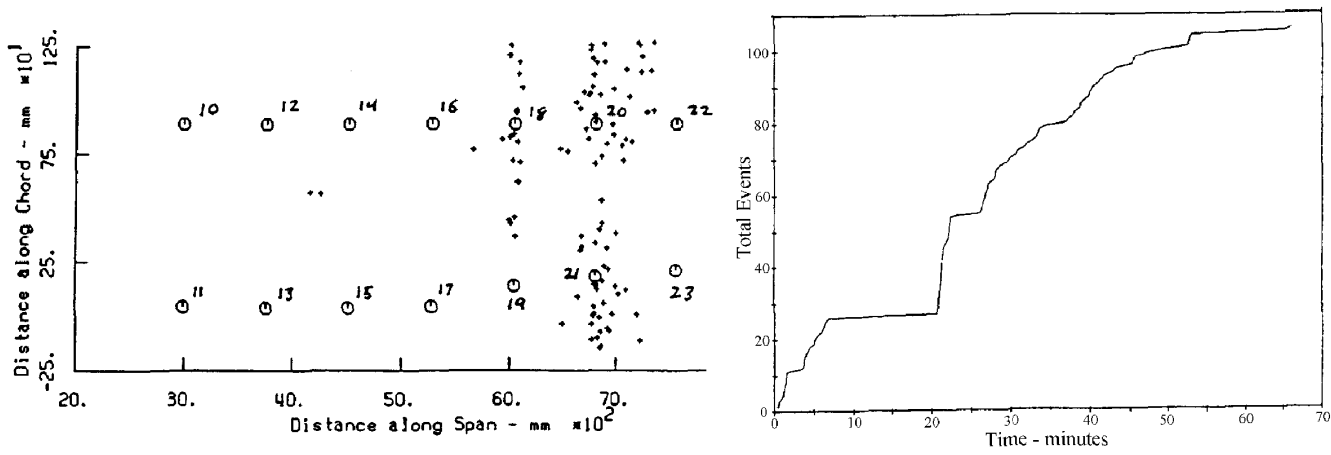
Figure 7. Event Locations and Events as a function of time for Stage 4

Stage 4 covered less than an hour of testing time. There were several halts during the test. The test was terminated at 66 minutes when the blade failed. A halt at 53 minutes was taken just after the skin ripped and separated from the top of the front spar. The test was restarted at 64 minutes and lasted about two minutes when the top skin buckled and ripped from the front spar toward the rear spar. Sensor 20 was just about over the rip and the failure broke the silicone rubber bond and launched sensor 20 skyward.

Figure 7 shows the map of located events for this stage and the located events as a function of time. There were not a large number of events located during this stage. The reason is not the lack of emission, but rather the gross damage in the skin which increased the acoustic attenuation, and the separation of the skin from the spar which interrupted the acoustic path to the rear sensors. These mechanisms prevented the acoustic bursts generated by even very energetic events from triggering all four sensors in a rectangle.

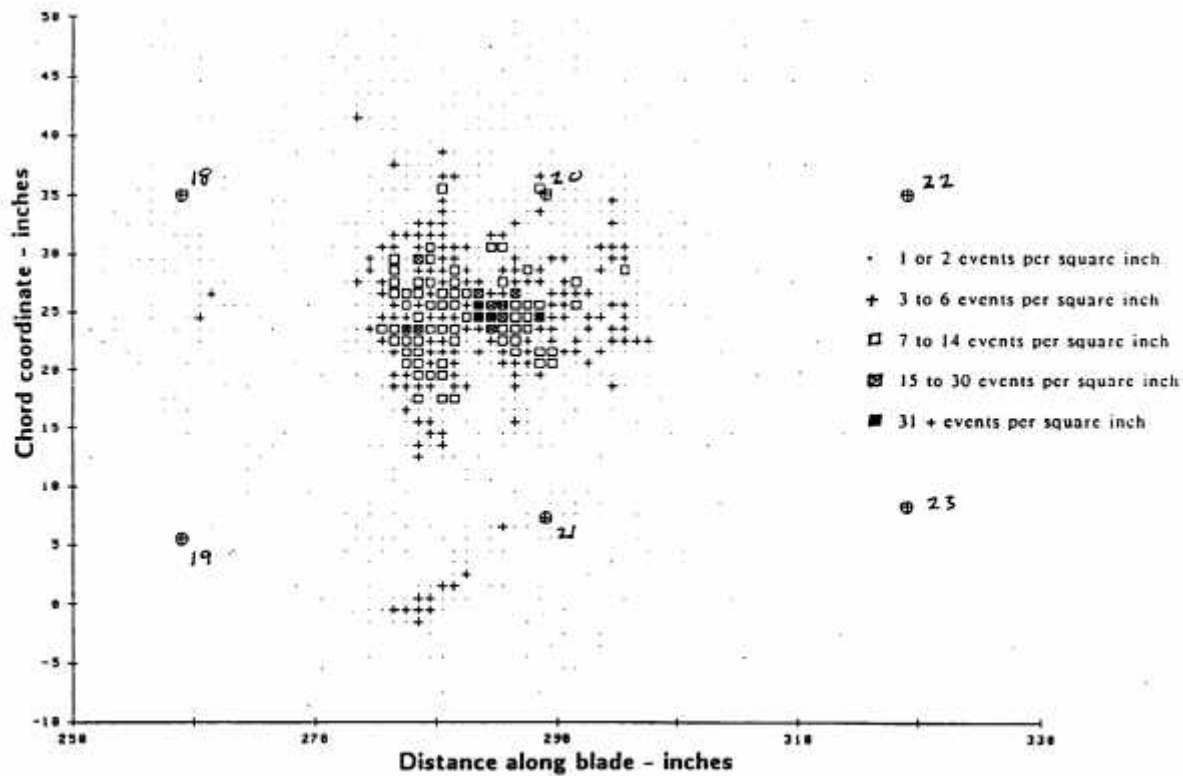
Figure 8. Density of located events for the entire test

The location data from all four stages was combined. Figure 8 shows this data plotted in the critical rectangle 18,19,23,22. The symbols on the plot indicate the number of located events per square inch. The highest density is right in the middle of the region

From this table one can see that the center of the damaged area is between sensors 20 and 21 and part way back toward sensors 18 and 19. This corresponds very well with Figure 8.

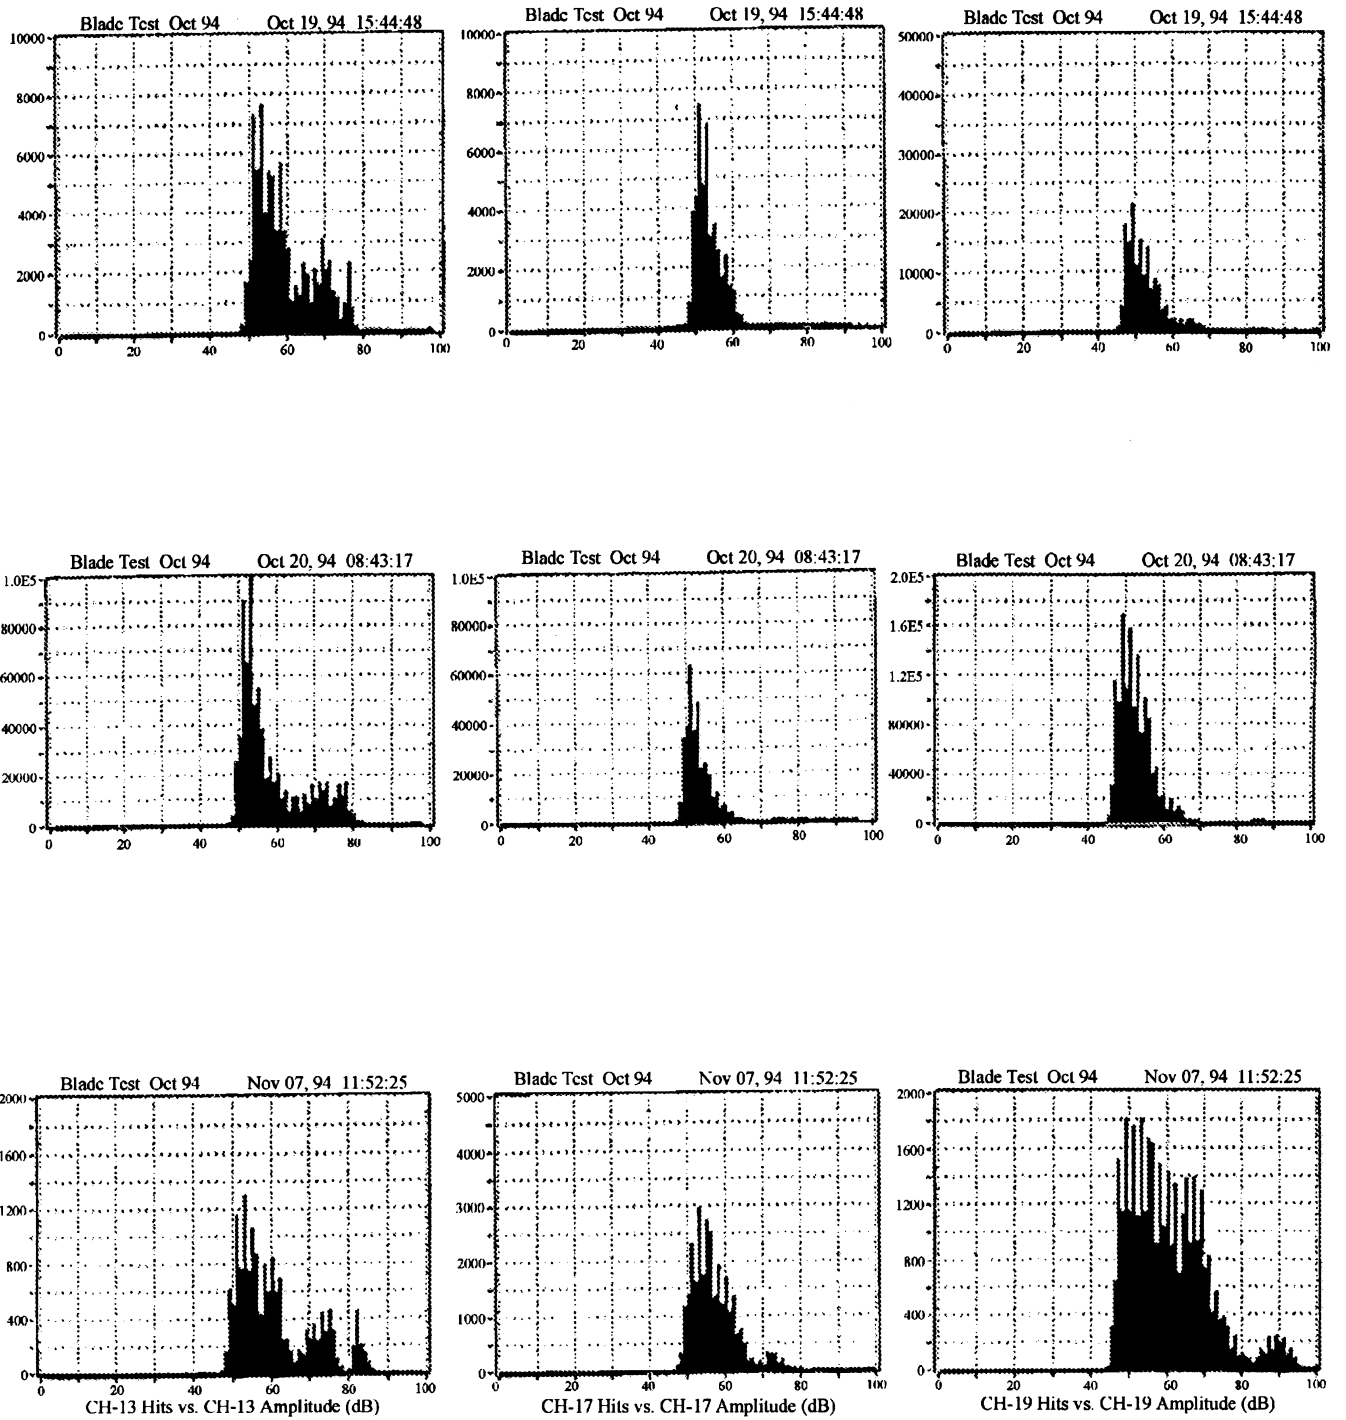
Figure 9. Peak amplitude distributions from Stages 2 (top), 3 (middle) and 4 (bottom) for sensors 13, 17 and 19

Another way to look for damage is to look at the peak amplitude distributions for different sensors. For a given sensor and material, a higher peak amplitude usually indicates greater damage. (Note that the peak amplitude is measured on a logarithmic scale such that 20 dB corresponds to one order of magnitude). Figure 9 shows the peak amplitude distributions from sensors 13, 17 and 19 for stages 2, 3 and 4. The top graph is stage 2, the middle, stage 3, and the bottom is stage 4. For Stage I, except for sensor 21, there was essentially no emission with peak amplitudes at or above 80 dB. In stage 3, all sensors but 13 have shown a few hits above 80 dB but they are still in a distinct minority. In stage 4, there are far fewer hits on each sensor but some of the distributions have changed. Sensor 19 now has a distinct peak around 90 dB while 17 is still lacking any signals above 80 dB. This agrees with all of the previous data which indicates failure between sensors 19 and 21. However, we now see peaks with amplitudes above 80 dB for sensor 13. These peaks were not seen in data from sensors II, 17 nor from sensors 10, 12, 14, and 16. There are few located emissions near the rear spar in this region. The most plausible explanation for this data

is that new damage occurred during stage 4 behind the rear spar between sensors 13 and 15. The damaged region would be far enough behind the spar that the attenuation prevents the detection of the signals at sensors 12 and 14.
