NONDESTRUCTIVE EVALUATION (NDE) OF COMPOSITE/METAL BOND INTERFACE OF A WIND TURBINE BLADE USING AN ACOUSTO-ULTRASONIC TECHNIQUE*

John H. Gieske and Mark A Rumsey
Sandia National Laboratories
P.O. Box 5800, MS 0615
Albuquerque, NM 87185-0615

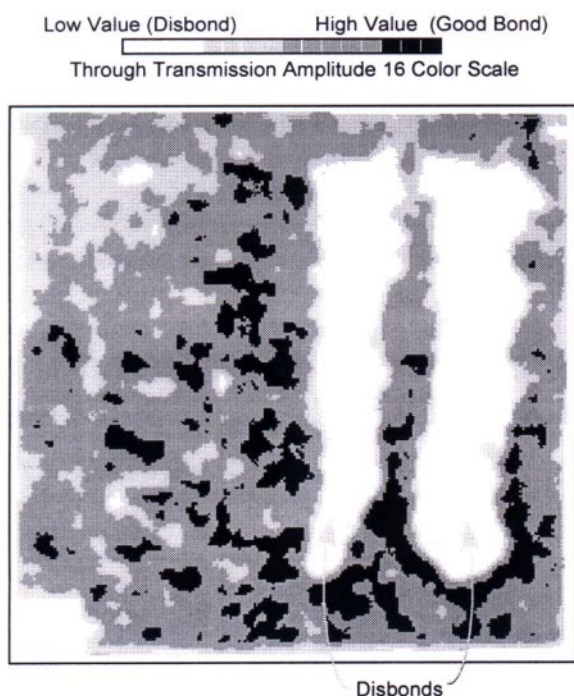
Figure 3. C-scan image of the through transmission amplitude for a 305 mm square test sample of the composite bond and steel insert where 2 disbands were constructed into the adhesive interface.

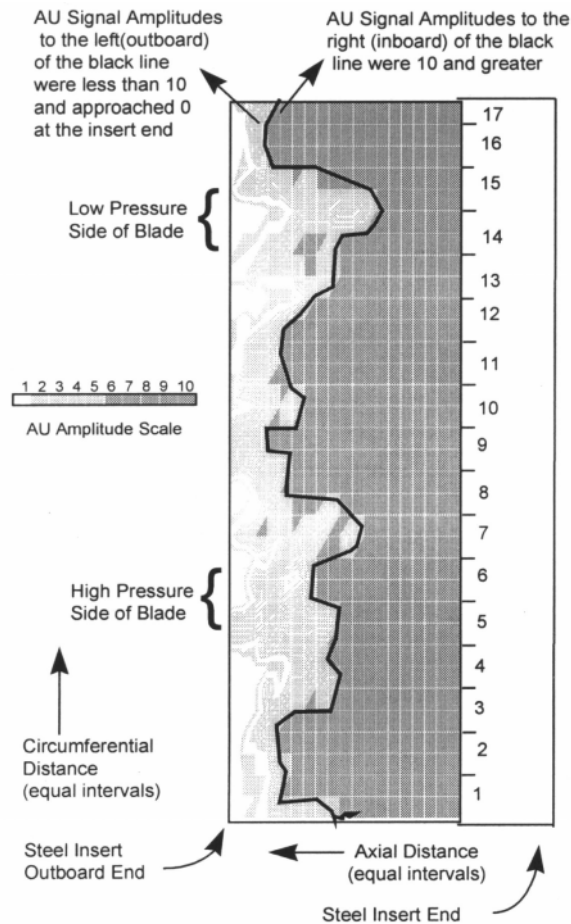
Figure 6. Contour plot of the amplitude levels of acousto-ultrasonic signals taken around the root bond area at the steel insert of wind turbine blade joint #1.

A color contour plot of the tabular data was made by entering the AU data into a Microsoft Excel spreadsheet. Figure 6 displays an equivalent gray scale mapping of the AU data over the steel insert area of the blade. The AU data in Figure 6 indicated that some damage was present at this stage in the fatigue cycle schedule near the high and low pressure sides of the blade as referenced in the sketch of Figure 5. Maximum loading occurs at the outboard end of the steel insert during the fatigue test and during the normal operation of the blade in these two areas. After the AU examination was performed, the blade was fatigue tested to failure. It is noted that the failure of the blade was expected and it did occur in these two areas of the blade.

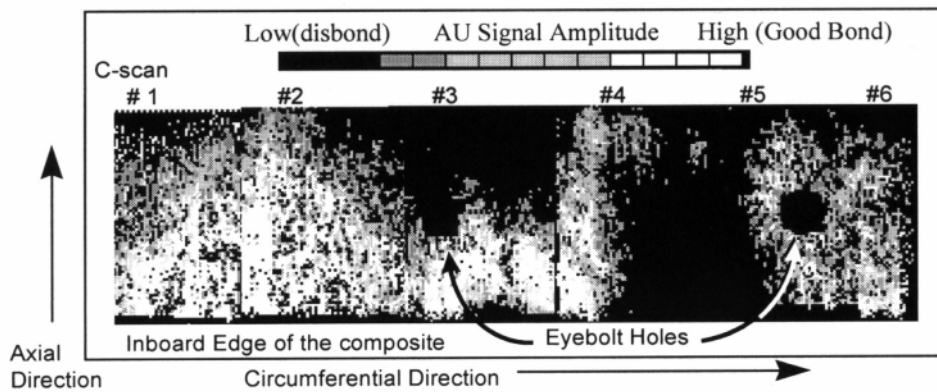
(a) Acousto-ultrasonic amplitude C-scan image of the entire root bond area of the steel insert for turbine blade #2.

assessment of the disbonded area is clearly indicated in the gray scale images. The area of Figure 7(a) shown in black where a low AU signal amplitude was recorded indicated the area of disbond.

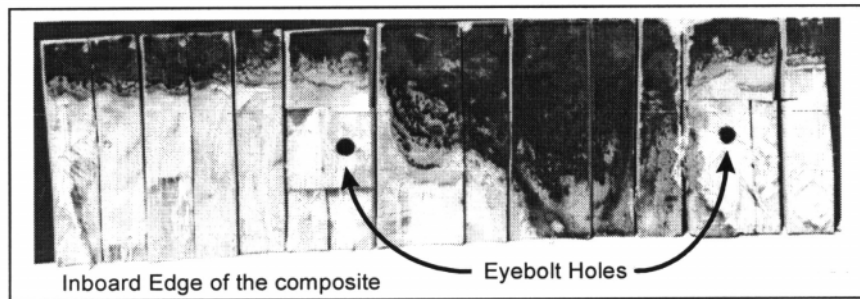
(b) Photograph of pieces of the composite removed from the steel insert root bond area in small sections and placed together in the same orientation as the C-scan image in (a) above.

Figure 7(b) shows the corresponding visual examination of the bond interface of this blade by cutting the segments of the composite and removing them from the steel insert. The removed pieces of the composite were then reassembled with the metal-to-composite bond interface facing outward. A photograph of the reassembled pieces is shown in Figure 7(b) where the bond failure is shown in black due to a dark metal oxide present on the adhesive surface of the failed area. A comparison of Figures 7(a) and 7(b) shows that the AU data correlated well with the disbond visually observed after removing the composite with the exception of two small areas. The area to the right of center in Figure 7(a) indicated an area of low AU signal but not completely disbonded. It is possible that the composite was held in compression against the metal surface so

that a so-called kissing bond existed in this small area. Also, the area just above the left eyebolt hole in Figure 7(a) is shown in black because the metal path to the receiver was obstructed by the eyebolt hole. This area does not show a disbond in Figure 7(b).

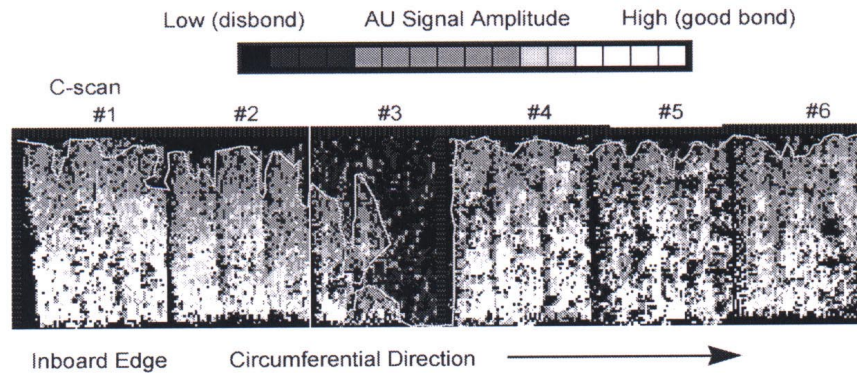
The steel insert area of a third blade joint was also examined with the PC data acquisition and display system. A manufacturing defect was suspected in this blade but the location and extent of the defect was not known. Figure 8(a) shows the montage of the 6 C-scans of the AU signal amplitude. The AU signal amplitude data was processed so that a black color was assigned to signal amplitudes below a given threshold value. The result is shown in Figure 8(b). The area of the defect is then clearly indicated in Figure 8(b) by the area in black. After the AU examination was made, a partial removal of the composite skin at the area of C-scan number 3 showed that a large void existed in one of the

(a) Acousto-ultrasonic amplitude C-scan image for the entire root bond area of the steel insert.

layers in the composite and the void area correlated well with the C-scan image number 3.

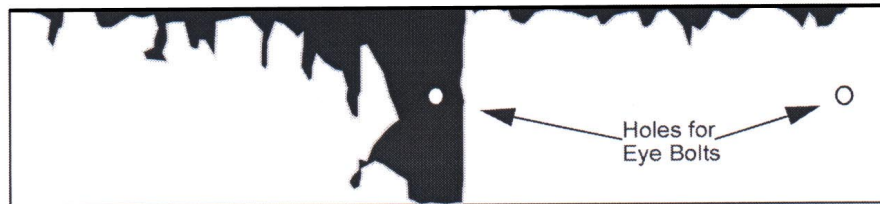
(b) Processed AU signal amplitude showing all signals below a threshold value in black.

Figure 8 . C-scan image (a) and processed data (b) of the AU signal amplitude taken over the root bond area at the steel insert of wind turbine blade joint #3.
