Marine Accident Brief

Accident No. DCA-11-LM-016
Location Texas City Channel and Gulf Intracoastal Waterway at statute mile 350.8, near Galveston, Texas
Date August 17, 2011
Time 0805 central daylight time (CDT)¹

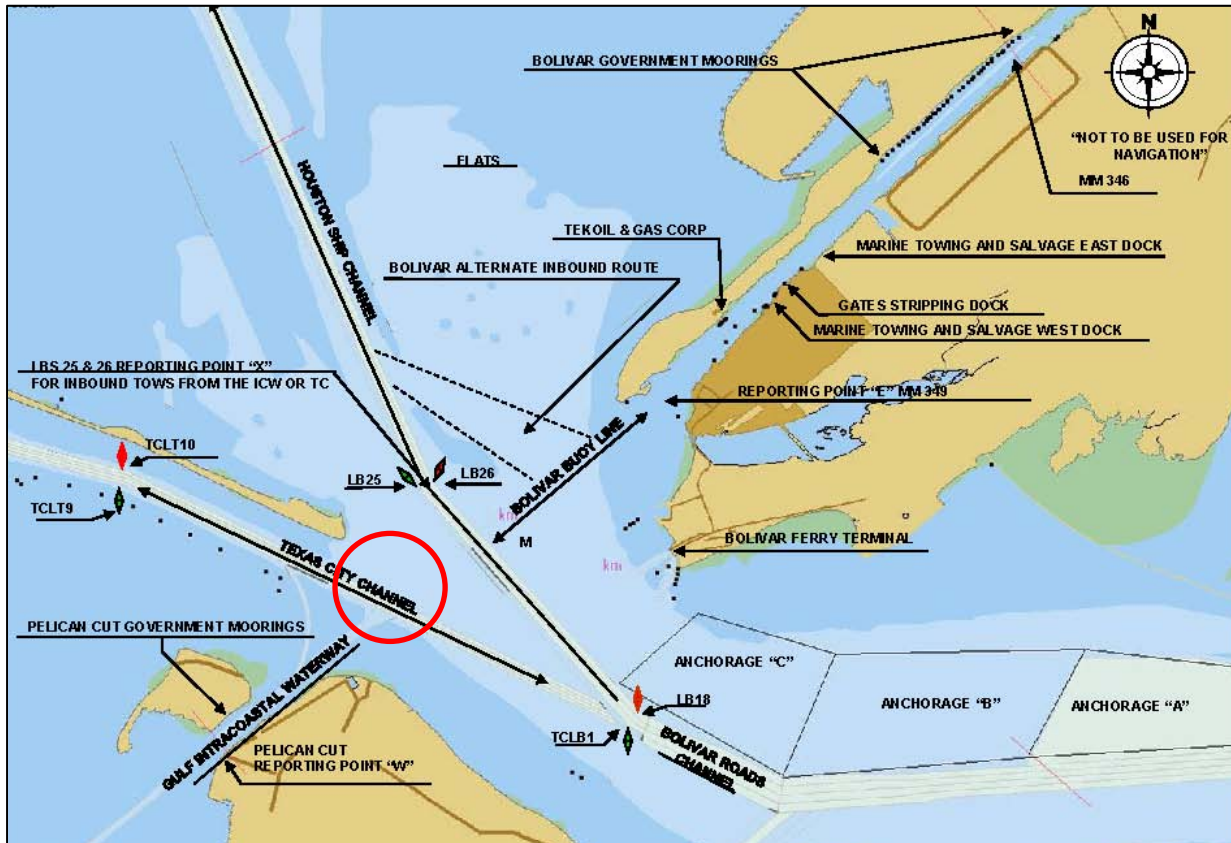
transiting northeasterly in the Gulf Intracoastal Waterway (GIWW).³ The bow of the lead tank barge, the *MMI 3024*, contacted the hull of the passing tankship *Naticina*. The location of the accident is shown in figure 1.

Figure 1. Chart extract from Vessel Traffic Service (VTS) Houston–Galveston with location of collision circled in red.

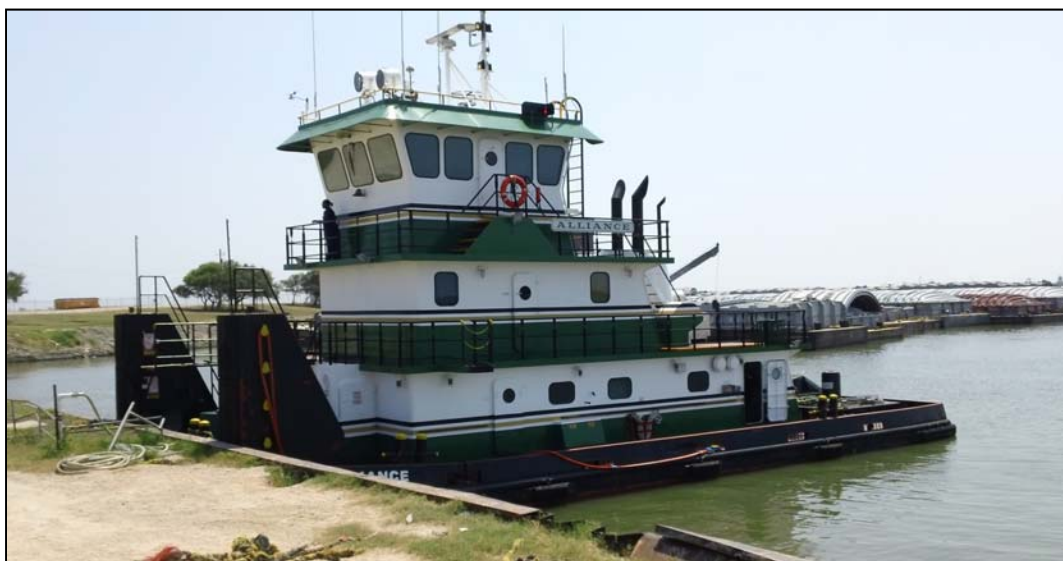
Figure 2. Uninspected towing vessel *Alliance*, postaccident.

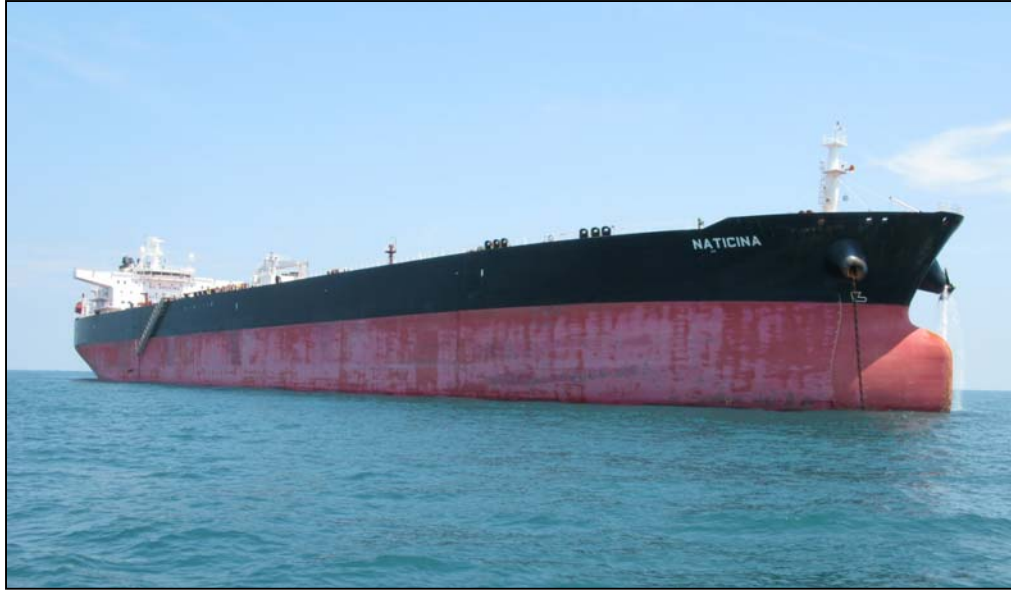
As a result of the accident, the *Naticina* sustained an inset and tear in the hull plate approximately 16 feet by 1 foot in the No. 5 starboard ballast tank. The *MMI 3024* sustained a small fracture in the steel plate at the port corner of the bow rake. No crewmembers on the *Alliance* or the *Naticina* were injured, and the accident caused no pollution or disruption to other vessel traffic in the area. The U.S. Coast Guard served as lead Federal agency in the investigation of this accident, and the National Transportation Safety Board (NTSB) was a participant in the investigation.

Figure 3. Tankship *Naticina* at Galveston Fairway Anchorage, postaccident.

The bow of the lead barge, *MMI 3024*, struck the *Naticina* at 0805 and punctured the No. 5 starboard ballast tank of the doubled-hulled *Naticina*.¹⁵ The barge sustained only a minor fracture in the bow rake, and no product was released. No injuries were reported, and the waterway remained open to vessel traffic.

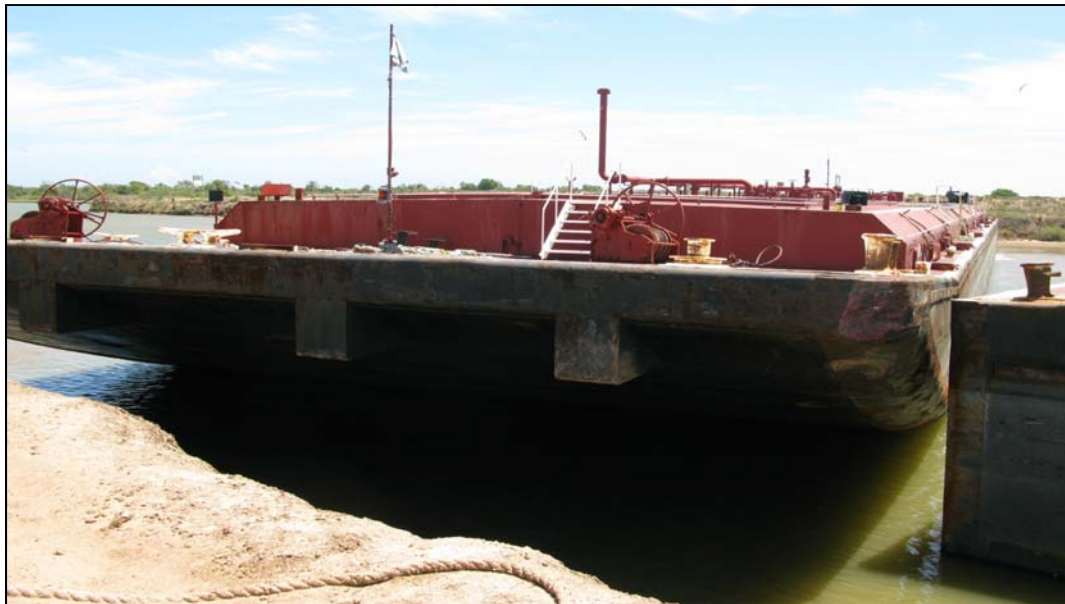
Figure 4. Tank barge *MMI 3024* at repair facility, postaccident.

The National Transportation Safety Board determines that the probable cause of the collision was the encroachment by the master of the *Alliance* and its two barges into the Texas City Channel and into the path of the *Naticina* despite the crossing agreement.
