# PV Module Arc Fault Modeling and Analysis

Presented to the NREL PV Module Reliability Workshop

# Module Failure Analysis

This presentation will help to answer the question of the potential for electrical arcing in the ubiquitous module busbar solder joint failures, as well as provide insights into the time domain of these failures and material effects.

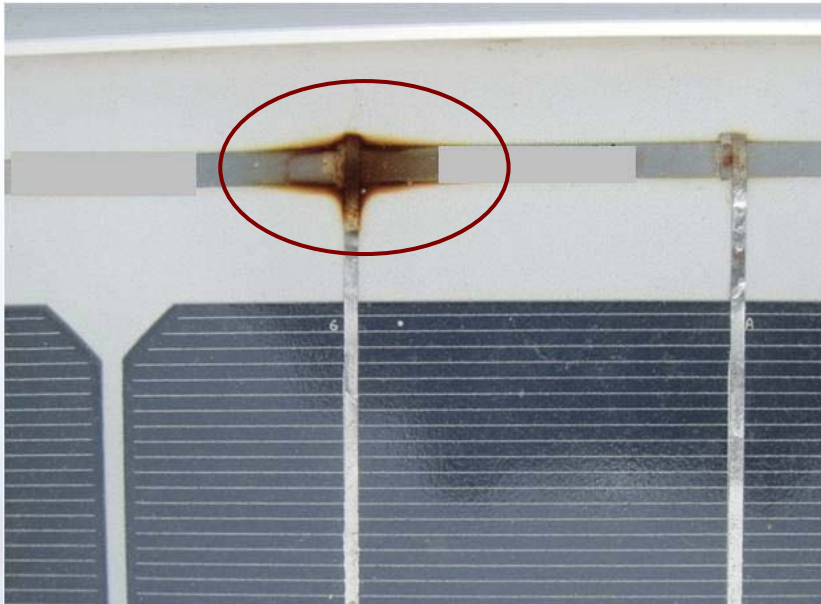
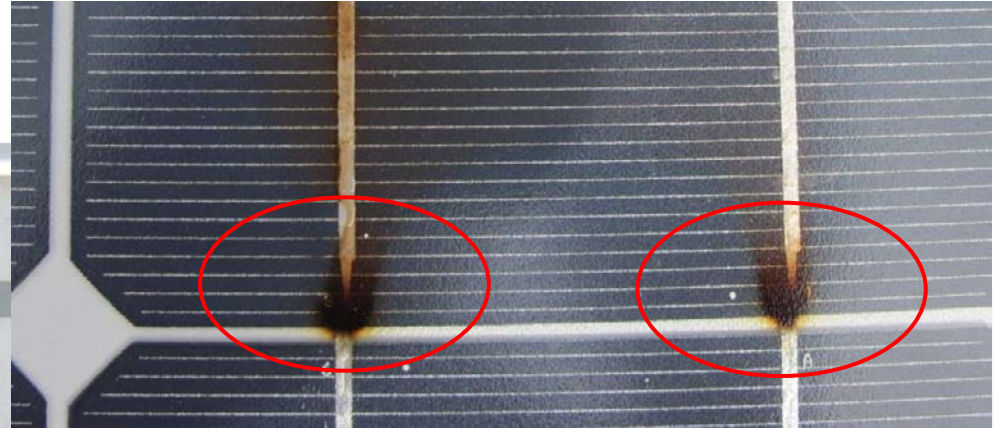
Busbar discoloration shown below. Collector ribbons appear to be shifted to the right and the solder joint between the ribbons and busbar appears to be broken.

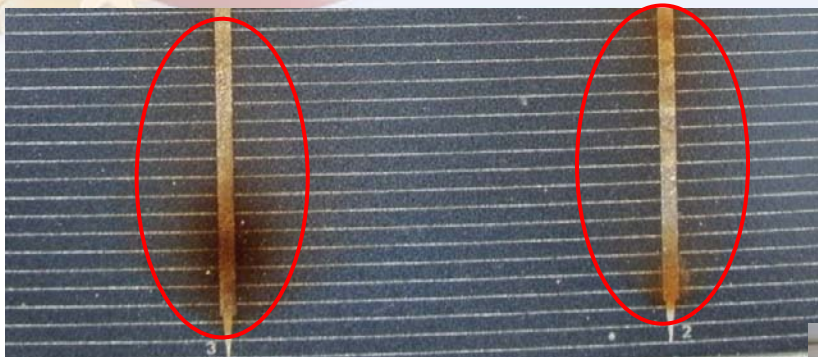
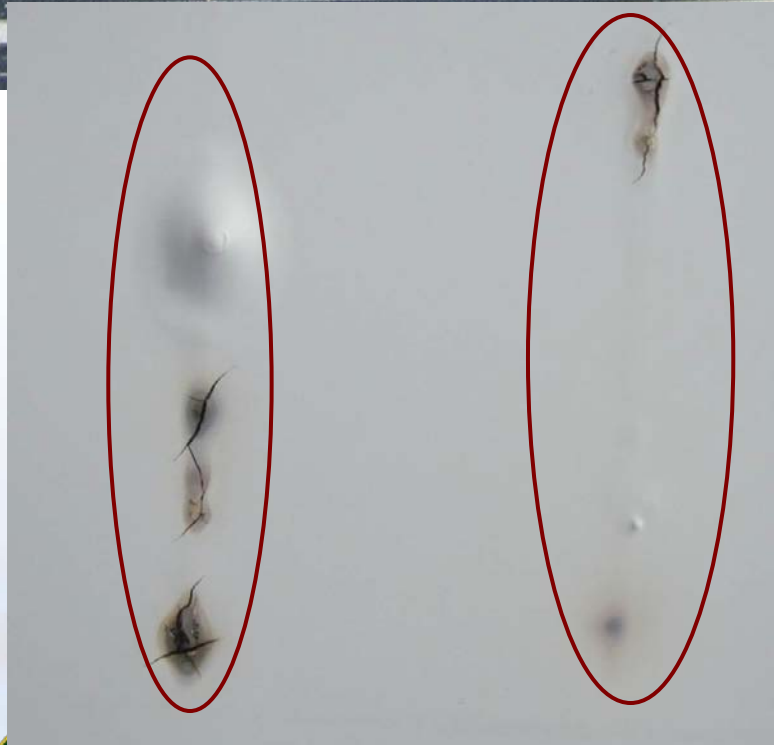
Discolored collector ribbon as they pass from the top of the PV cells to the backside contact.

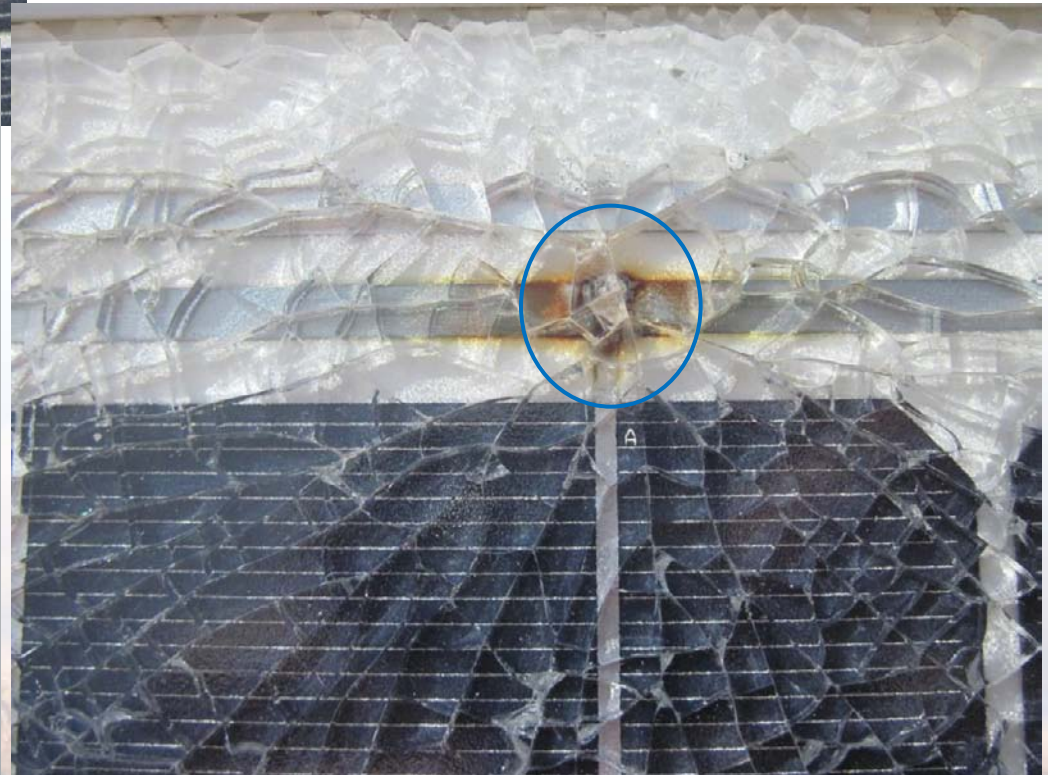
3. **Discoloration in the middle** of the topside grid collector ribbon
- All 3 of these failure modes have **charring, burning and backsheet bubbling** on the backside of the modules.
  - The busbar discoloration appears to be linked to the front side glass fracture in one case
    - Note radial fracture pattern in glass, centered at busbar **color**

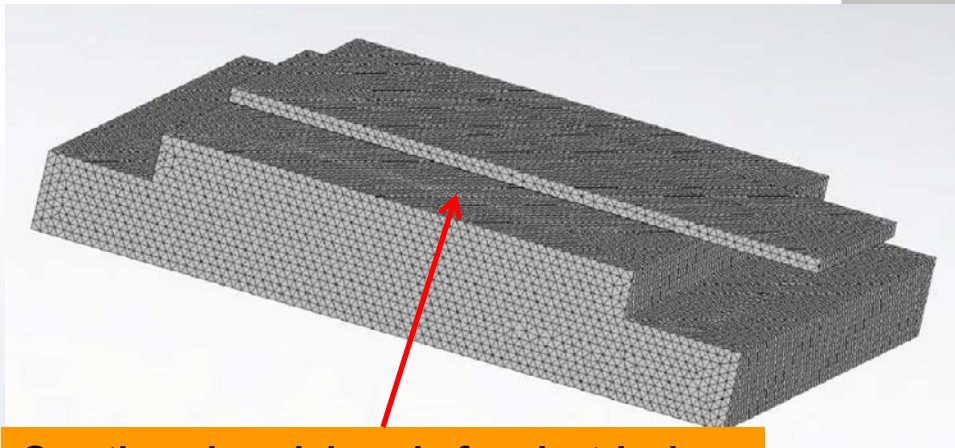
Greatly reduced domain for electrical discharge study. Mesh accounts for 5 micron air gap between parts.

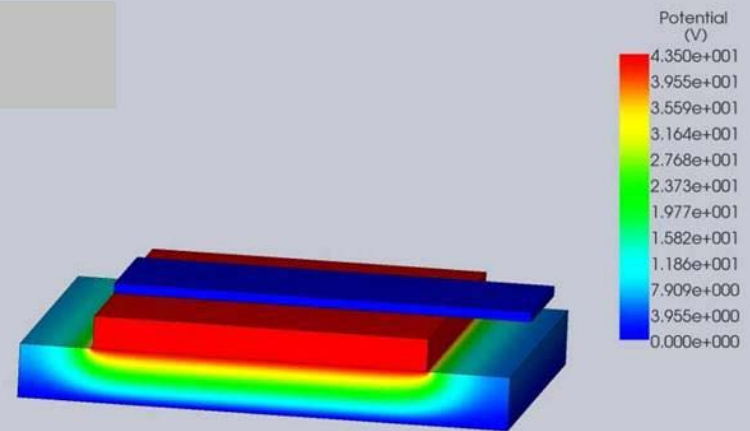
43.5 V potential input. Voltage potential makes it part way through the EVA and Tedlar back sheet.

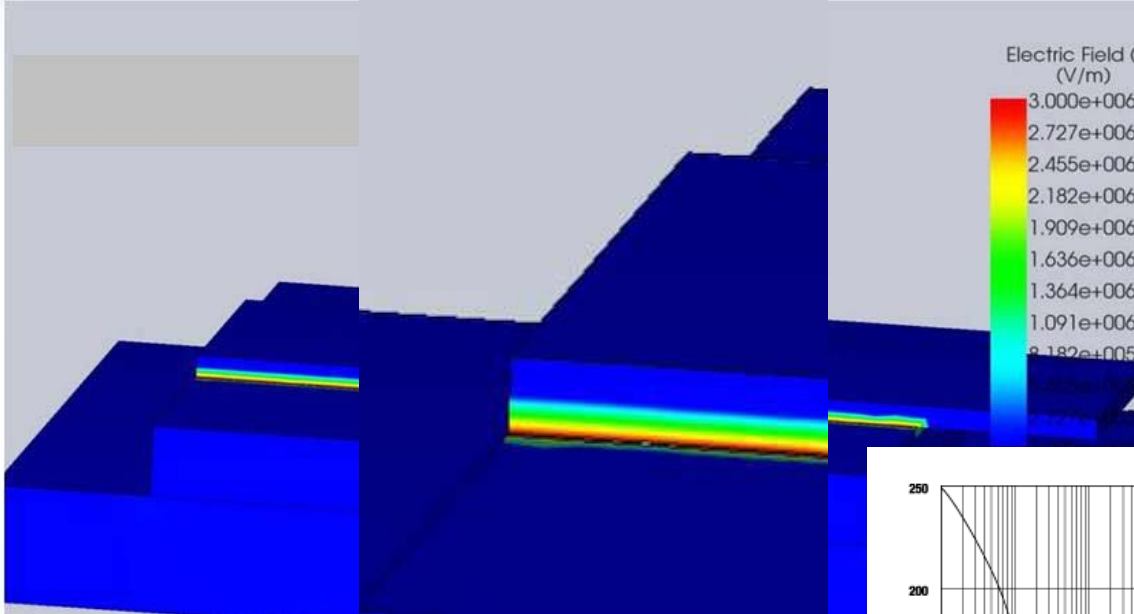
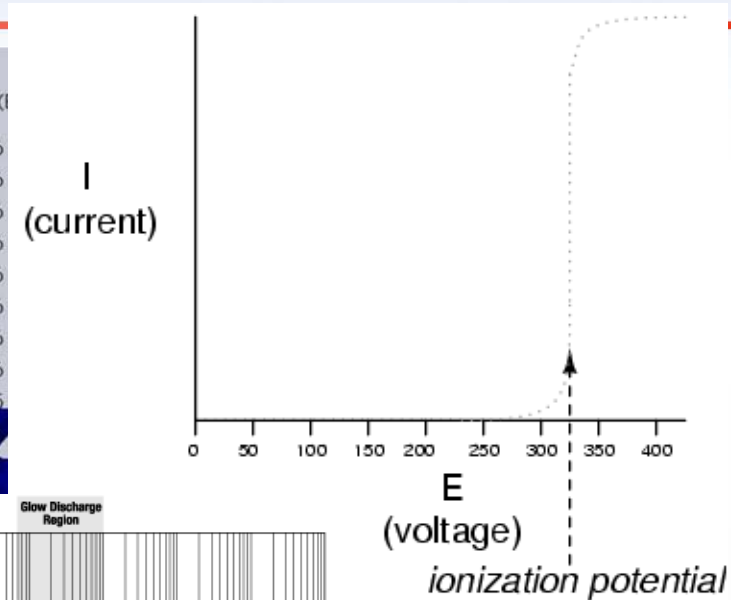
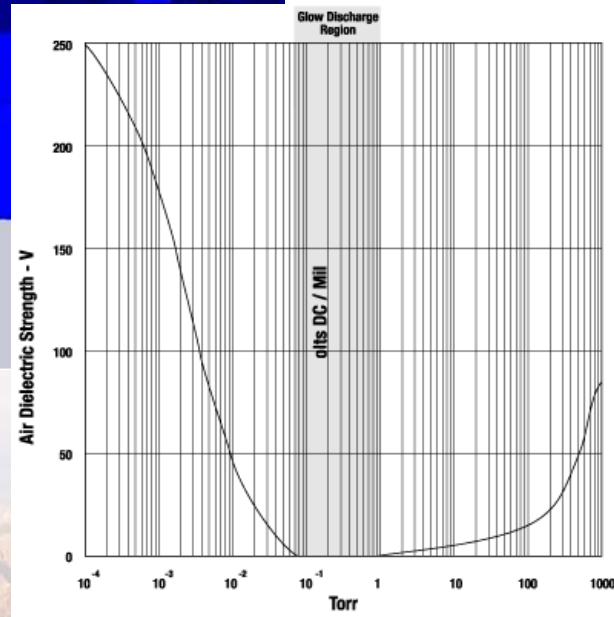
With 43.5 V potential input, the electric field is just starting to exceed 3 kV/mm in the 5 micron gap when calculated with the full integral solution, which is lower than the linear

$$\frac{43.5\text{V}}{5\text{micron}} = 8.7 \frac{\text{kV}}{\text{mm}}$$

At 1 atm pressure, air dielectric strength is about 3 kV/mm, or 75 V/mil. Above this electrical potential, the air stops acting like a perfect insulator, and conducts very well.

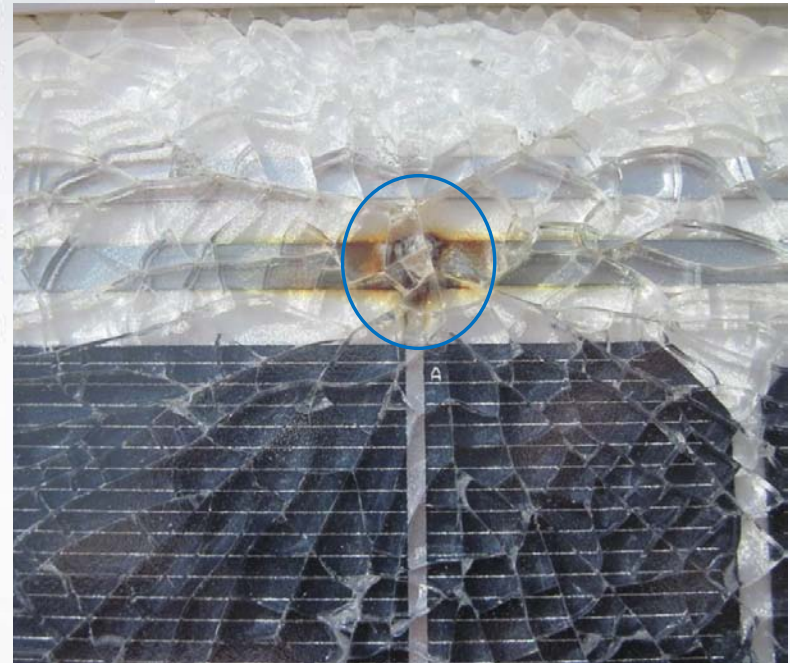
**State of thermal expansion stress after 2 seconds of arcing on the  $\sim 0.4 \text{ mm}^2$  area. Heat tempered glass has a modulus of rupture of *at most* 160 Mpa, and near 100 Mpa is more likely for glass that has a texture or pattern, as the module does. Conclusion: Glass fractured into small pieces from this temperature.**

**The thermal expansion of the area above the arc puts the surrounding areas into tension, which is the weaker direction for glass and ceramics, resulting in fracture centered at the heat source, with the small size pieces being typical for tempered glass.**

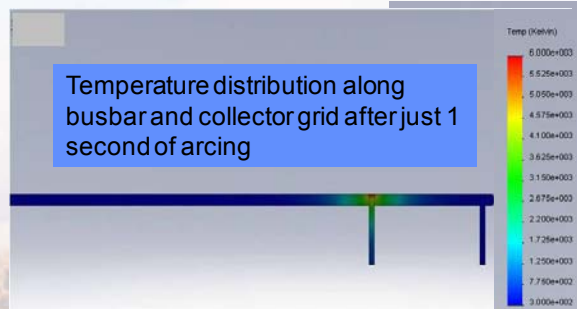
Temperature distribution along busbar and collector grid after just 1 second of arcing

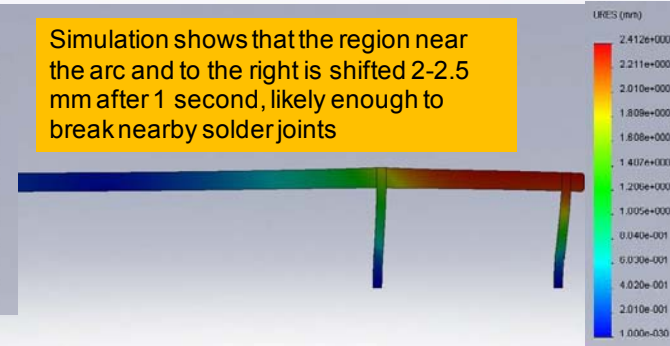
Simulation shows that the region near the arc and to the right is shifted 2-2.5 mm after 1 second, likely enough to break nearby solder joints

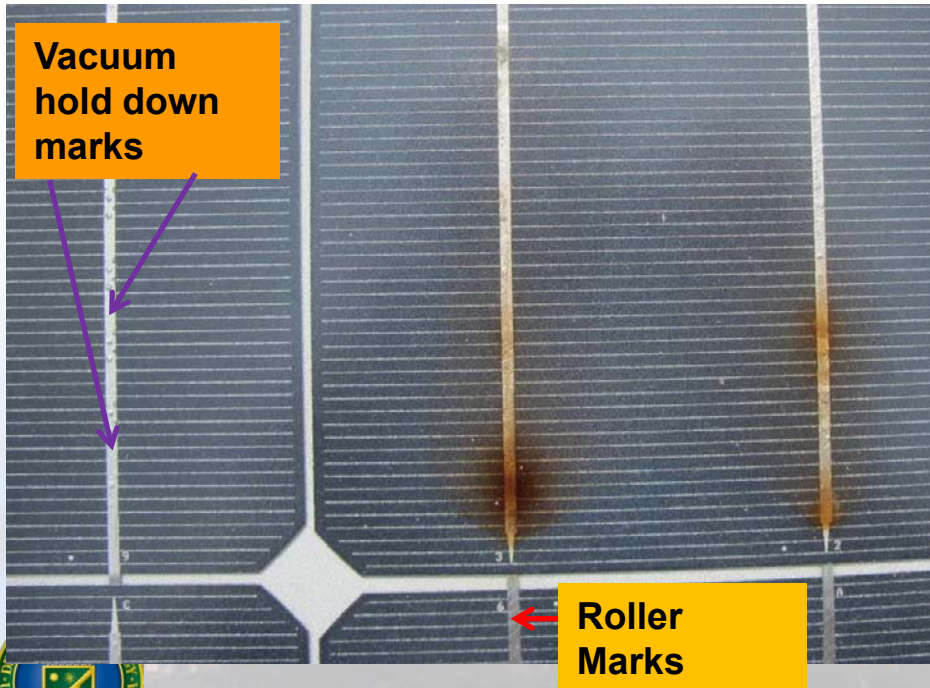
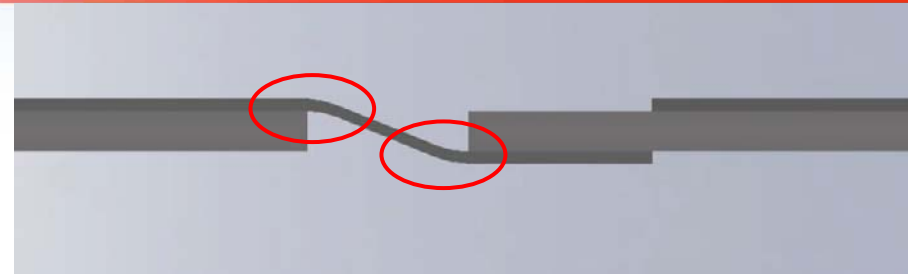
- It appears likely that some or most of the failures observed in the modules are due to high temperatures at (relatively) short durations, such as would be seen in an arcing event.
- It also appears that areas of the module that were under vacuum hold down were less susceptible to failure than those areas that were rolled, as shown below.

- Side view of ribbon from back contact to top of cells.
- Diurnal temperature shifts could have strained and broken the ribbon at either bend, leaving a tiny gap that could have arced any day the module is in the sun afterwards, leading to a common failure observed: burned collector ribbon between cells.
- Studies of Joule heating in oxidized backsheet to ribbon connections show insufficient temperatures to cause all observed effects.
- Future studies on thermal strain due to diurnal temperature fluctuations on the failed ribbons will be performed.
- Future study on limits of the current generation of Tyco Junction Boxes as well as effects of new connector materials to be performed as well.
