SOLAR MODULE ARC FAULT MODELING AT SANDIA NATIONAL LABORATORIES

Jason Strauch, Michael Quintana, Jennifer Granata, Ward Bower, Scott Kuszmaul
Sandia National Laboratories*
1515 Eubank Blvd SE
Albuquerque, NM 87123
jestrau@sandia.gov, 505-284-6114 ph., 505-284-67690 fax

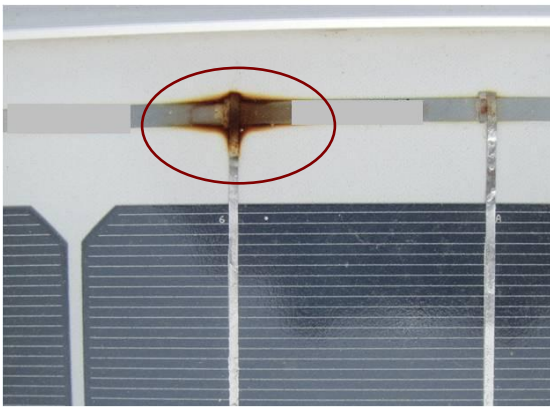
1. Busbar discoloration, which was prevalent in virtually all failures. Some had associated busbar shifting and bending.
2. Discoloration at the location that the interconnect ribbon goes from the cell back contact to the front side grid. Common.
3. Discoloration along the interconnect ribbon occurred along the edge of the cells as well as inboard, closer to the center of the cells
4. Front side glass cracked above burned spot.

Figure 3: Collector Ribbon to Busbar Browning and Connection

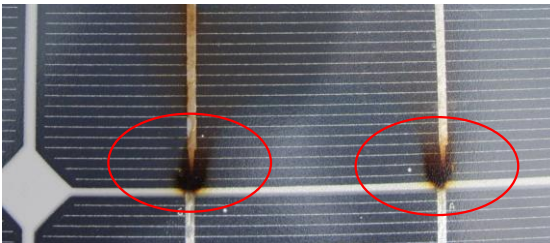
Figure 4: Collector Ribbon Front to Backside Discoloration

A major location of the arc fault failures is the interconnect ribbon where it connects the top side grid lines to the next cell's backside contact. This can be seen in Figure 4 in Section 2.2. A side view of this feature created for the model is shown below.

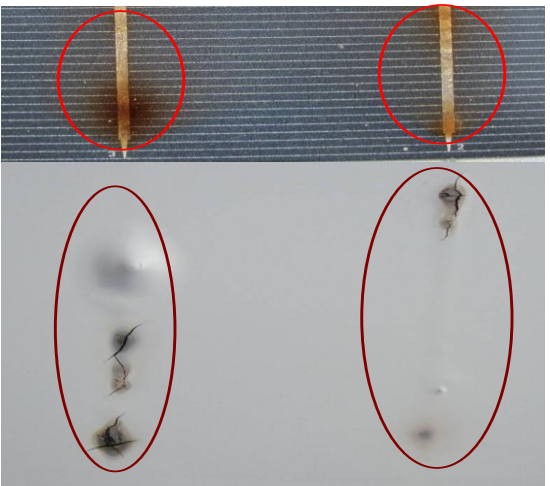
Figure 5: Front and backside views of damage where interconnect ribbons attach to the cell metallization

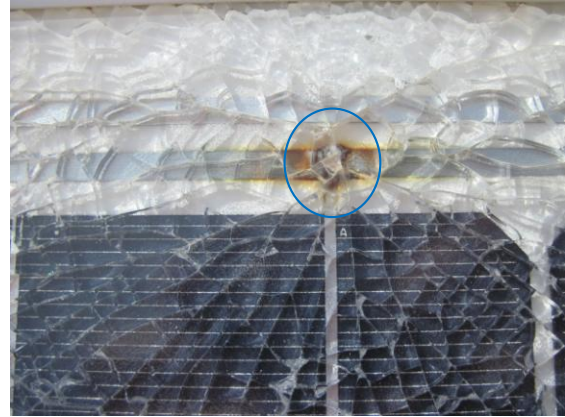
according to electrostatic and thermo-mechanical first principle physics. Another case analyzed is a busbar discoloration with an associated glass fracture of the top glass in the module and is shown in Figure 6

Figure 6: Ribbon to Busbar Burn Causing Glass Fracture

The module with the glass fracture directly above a burned ribbon-to-busbar joint, shown in Figure 6, is analyzed next. This analysis was focused on both the temperature scale and time scale for the heating. For the glass fracture, a 40x40 mm subdomain through the thickness of the module stack, and centered over the burned busbar connection was modeled. Although the

The heat of the arcing expands the glass region directly above the arc, putting the immediate surrounding area into tension, resulting in the radial break pattern. Since the glass is tempered, the entire pane fractures into small pieces.

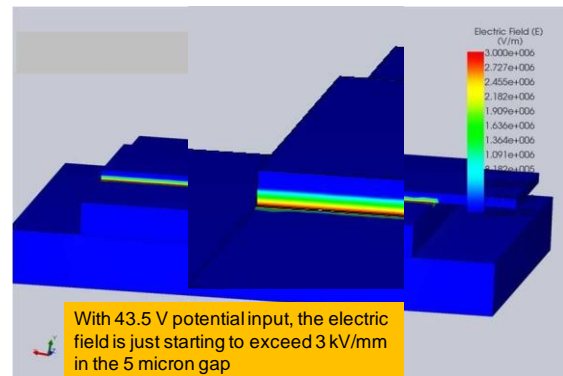
The predicted electric field strength for a 5 micron gap with a 43.5 V potential across it is almost triple the dielectric strength of air, or about 8.7 kV/mm. With flat plate surfaces, the modeled joint readily exceeds the dielectric breakdown strength and an arc flash with possible sustained arcing can occur. The electric field strength developed across the busbar and connector ribbon is shown in Figure 9.

With 43.5 V potential input, the electric field is just starting to exceed 3kV/mm in the 5 micron gap

Figure 9: Electric Field Strength with Module Open Circuit Voltage Applied across a 5 micron gap

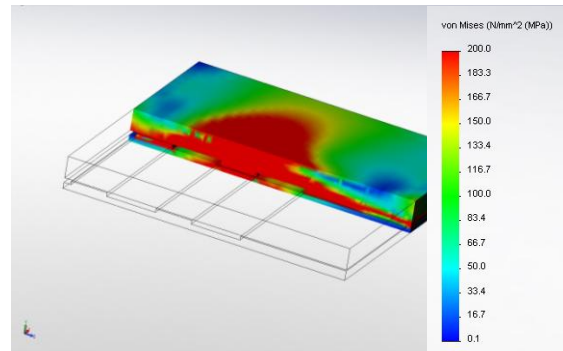
The front glass breaks when the temperature induced state of stress, due to localized expansion near the arc, exceeds the modulus of rupture of the glass. Flabeg quotes the modulus of rupture of their tempered glass as 120 MPa and 90 MPa with a stipple pattern. Other manufacturers of solar glass, such as Saint Gobain, quote similar values for tempered and less for float glass or simply heat strengthened. The Modulus of Rupture for the Finite Element Analysis was assumed to be 100 MPa, though changes in this value will just change the time to rupture. The state of stress for the module stack and glass are shown in Figure 12.

Figure 12: Glass Stress after 2 seconds of arcing exceeds the rupture strength by 100%

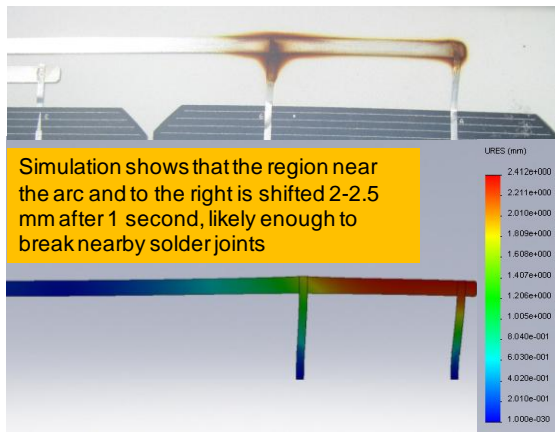
Applying the 6000K temperature heat load to the busbar structure as in the prior analysis, and calculating the displacement due to the thermal expansion shows that it is plausible that the busbars were deformed in the module stack by the arc that burned the connection. This is shown in Figure 14.

Figure 14: Busbar Deformation due to arc heating

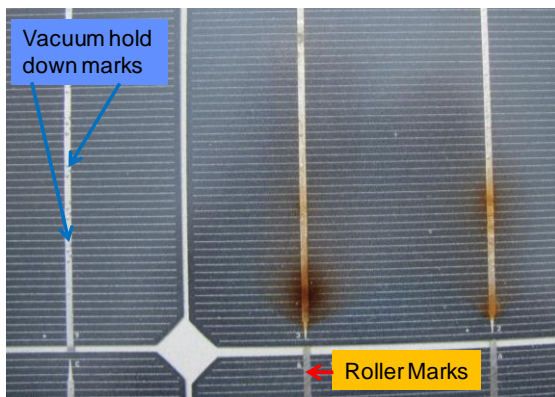
The final failure mode, interconnect ribbon burning in the mid-region of cells was not investigated. Based on the thermo-electrical modeling of the other failures, it is likely that high temperatures generated by arcing caused the burns. What isn't known is whether the arcing was due to interconnect ribbon to grid line contact problems or interconnect ribbon to backside contact on the cells. The Tedlar and EVA charring appears more severe on the backside of these mid cell failures, as may be seen in Figure 5 in Section 2.2. The figure below shows that more than one technique was used to create cell strings. Soldering cells into strings requires controlled time, temperature and pressure. It appears that the areas of the modules that were assembled with a roller process were more susceptible to poor contacts and the associated arc faults between the ribbons and the cells.

Figure 15: Different module fabrication methods showing arcing in the roller section
