RE: Response to Notice of Probable Violation and Proposed Civil Penalty CPF 1-2012-1014

Millennium Pipeline Cathodic Protection History and Remedial Plan

MILLENNIUM PIPELINE
30" STEEL PIPELINE
CATHODIC PROTECTION LOW POTENTIAL LOCATIONS
SCHEMATIC PLAN - HULLSVILLE RD. TO E. MAINE RD.
& JACOBS ROAD TO RAMAPO STA.

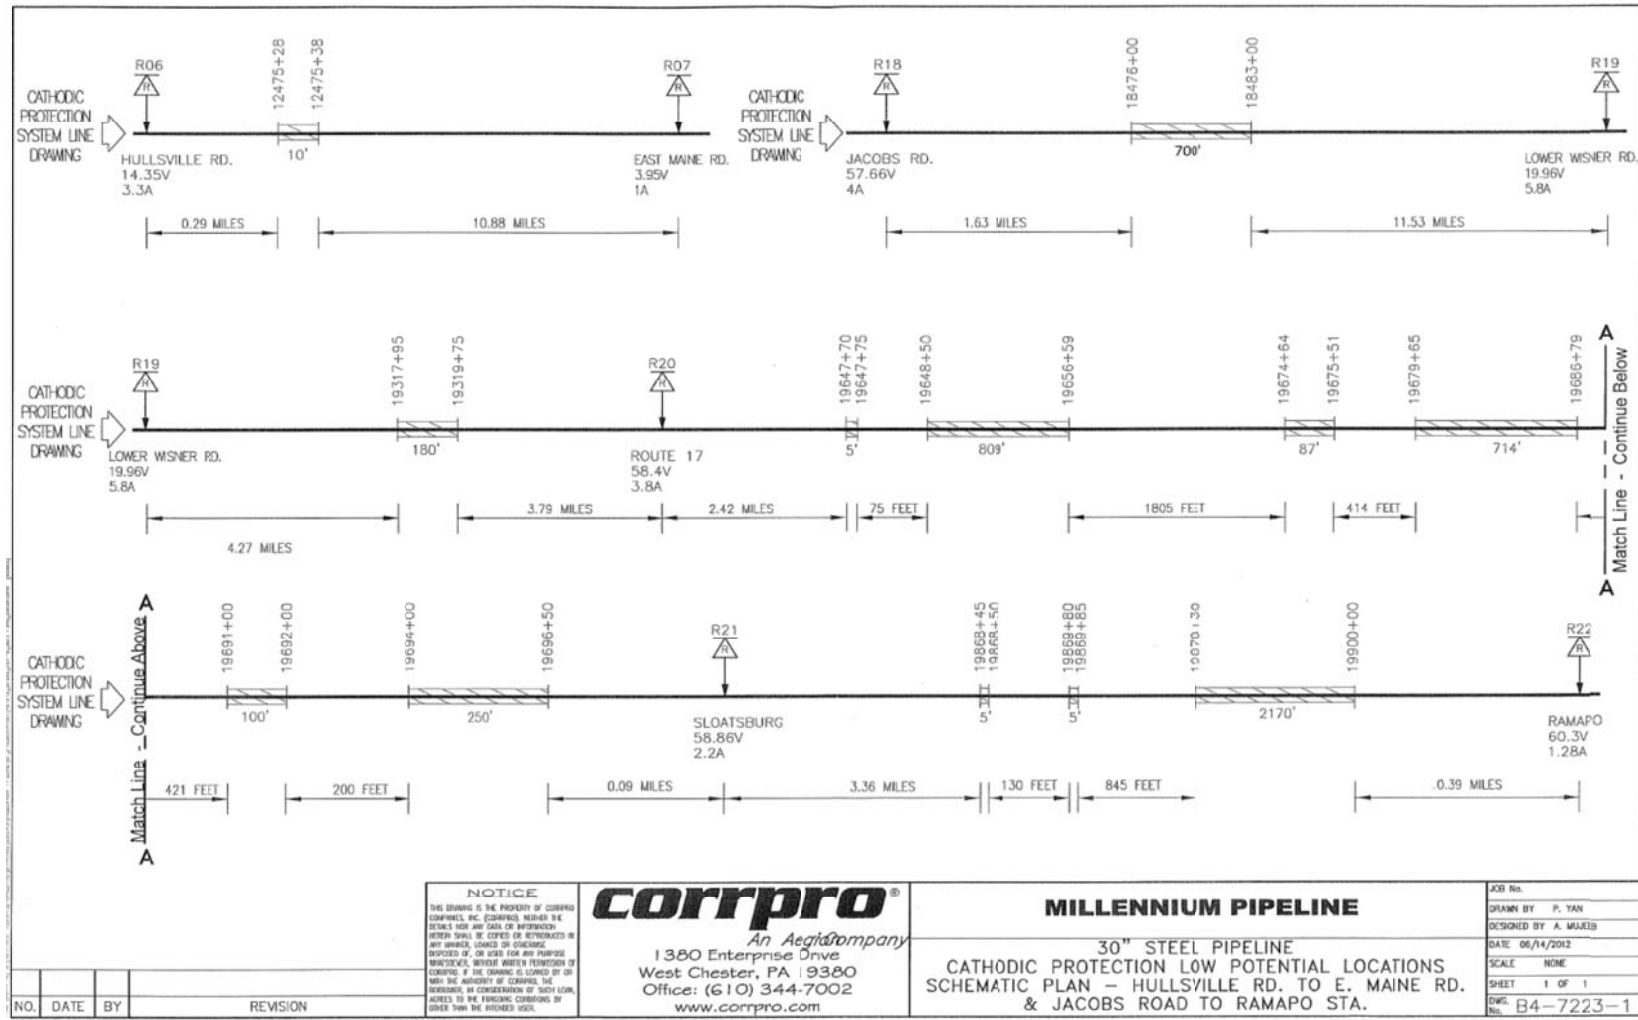
Depiction of Areas Not Meeting an -0.85 Volt off Cathodic Protection Criteria

The rectifiers were again adjusted and the entire system was rebalanced, after which a follow-up CIS was conducted between the NY 17 Rectifier and Ramapo to determine if the remedial measures were effective. The survey indicated that there are several small areas that still may not meet a -850 millivolt off CP criteria (see chart below).

The areas east of NY Route 17 are proving troublesome to demonstrate adequate CP because of high resistivity soil characteristics. Since rectifier current flow has an inverse relationship with the path resistance (the ground between the anodes and the pipeline), high resistivity soils can greatly hinder current flow to some sections of the pipeline. Further difficulties were encountered during commissioning in that the non-homogeneous nature of the soils create the possibility that while increasing current to ensure cathodic protection along the entire pipeline, resulting high voltage potentials in areas close to groundbed locations increase interference with foreign pipelines and can, over time, damage Millennium's pipeline coating. Additionally, the high telluric current activity makes it nearly impossible to perform depolarization testing of the pipeline to demonstrate cathodic protection through the more accurate and less conservative 100 mV polarization shift.

The design and installation of the groundbeds at Sloatsburg and Ramapo were hindered by the New York state permitting process and location restrictions in Harriman State Park. Initial system design was changed to accommodate the State's requirements which led to a less than optimal design of the systems.

A meeting with Corrpro was held on Thursday June 14, 2012 to discuss the results of the recent re-survey and to update plans for further remediation. The plan is to address the specific issue at Station 12475+28 (~10' of low potential) through interference testing with the foreign pipeline (NYSEG) that crossing in the immediate vicinity. Installation of a bonding test station or current draining test station will be a likely outcome of this testing. .

The low area at 18476+00 (~700' of low potential) and at 19317+95 (~180' of low potential) will be retested after increasing the outputs of the rectifiers at Jacobs Rd, Lower Wisner Road, and Route 17. It's expected that rebalancing these units will remediate the low potentials. NGT&S is currently coordinating with Corrpro to complete this work and retest the areas.

The remaining areas showing possibly inadequate cathodic protection (all east of station 19647+70) will require engineering due to rocky, high resistivity natural soils throughout the region and right of way. The plan is to utilize the CP contractor (Corrpro) to design and reconfigure all or part of the groundbeds at Ramapo and Sloatsburg to more efficiently push current to the pipeline where needed.

The remediation planning for all sections east of station 19647+70 has begun and review, planning, and permitting are planned with cathodic protection system construction proceeding as soon as possible. Resurvey to document adequate cathodic protection will be completed as soon as mitigation projects are completed.
