**State of Louisiana
Department of Natural Resources
Coastal Engineering Division**

**2006/2007 Annual Inspection
Report**

**CLEAR MARAIS SHORE
PROTECTION PROJECT
(CS-22)**

November 8, 2006
Cameron Parish

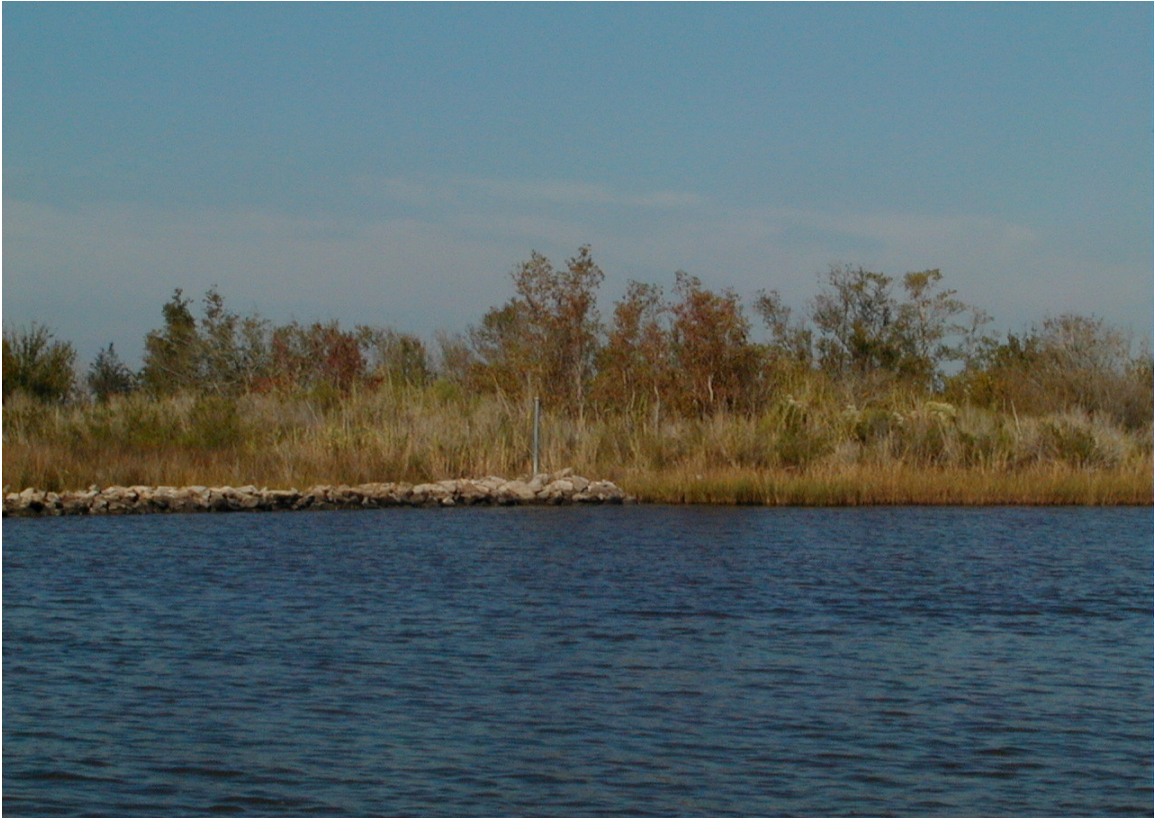
Photo 1—East tie-in at Alkali Ditch

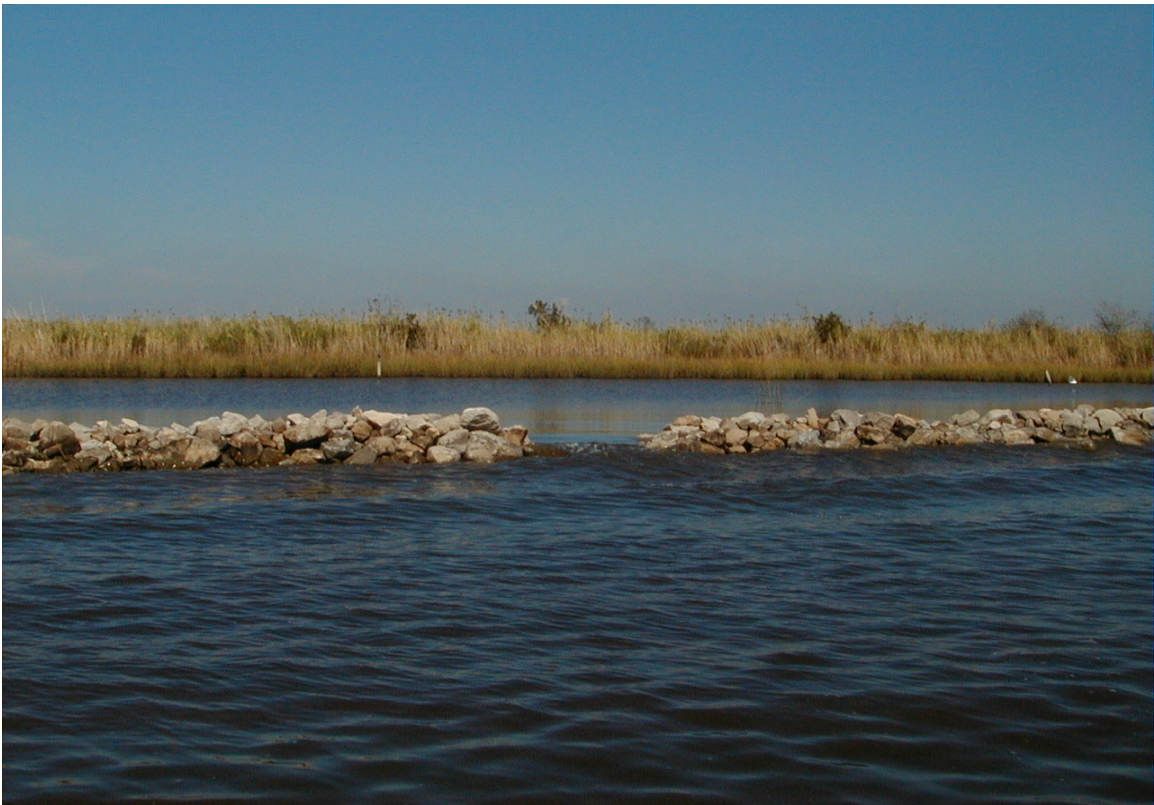
The dike is in fairly good condition. As noted on previous inspections, approximately 4,000 to 5,000 linear feet of dike is slightly below constructed elevation. This appears to be the result of slight settlement rather than displacement. Several of the settlement plates placed during construction are broken/leaning/damaged/ etc. and are no longer useful. One section of dike, approximately 0.5 miles from the Alkali Ditch, has apparently been removed by hunters and or fishermen. This section is only about 4 feet wide with rock removed to an approximate +0.5 NAVD elevation. It has been noted in previous inspections and has not worsened. Three other sections appear to have been displaced by barges nosing up on the bank. This is a problem noted on several other rock dikes along the GIWW. A staff gauge will need to be installed in the vicinity. No apparent need for any other maintenance at this time. (Photos: Appendix B, Photos 1-4)

Photo 2—vandalized area of dike

Overall, the Clear Marais Shore Protection Project is in good condition and functioning as designed with only minor problems noted. Stand pipes on the settlement plates installed on future projects of this type should be much shorter in height. Damage to these plates has apparently been caused by barges or other similar type traffic running in to or tying up to these pipes making them useless for any post-construction settlement information. A much shorter pipe should serve to protect these pipes and/or discourage people from using them as mooring devices. Maintenance recommendations for CY 2007:

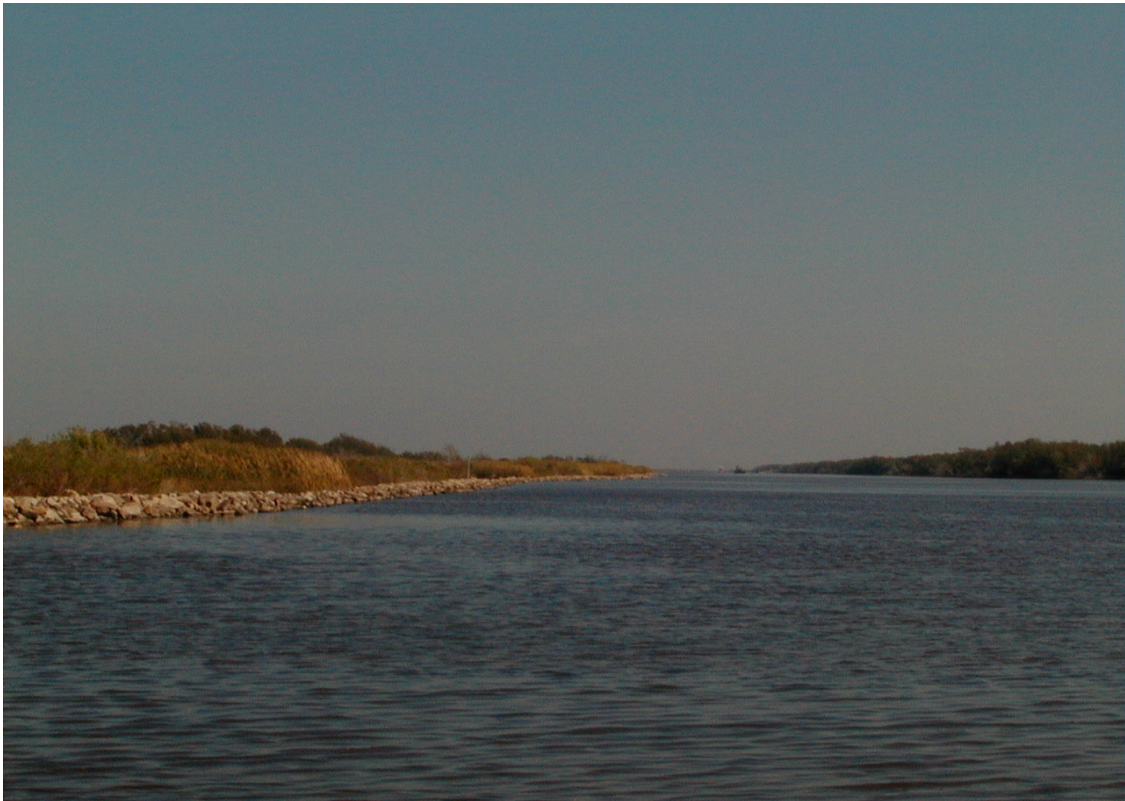
Photo 3—typical section of dike

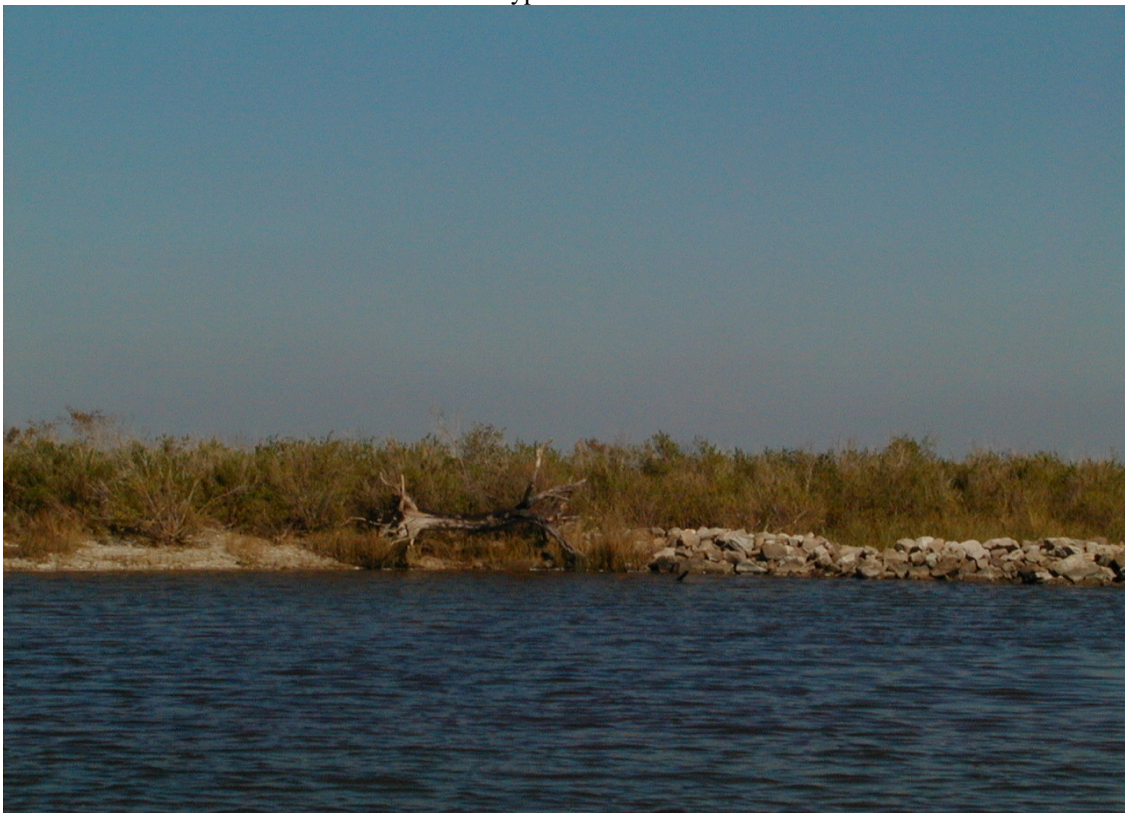
Photo 4—western tie-in of dike
