2012 Operations, Maintenance, and Monitoring Report

Clear Marais Shoreline Protection

State Project Number CS-22
Priority Project List 2

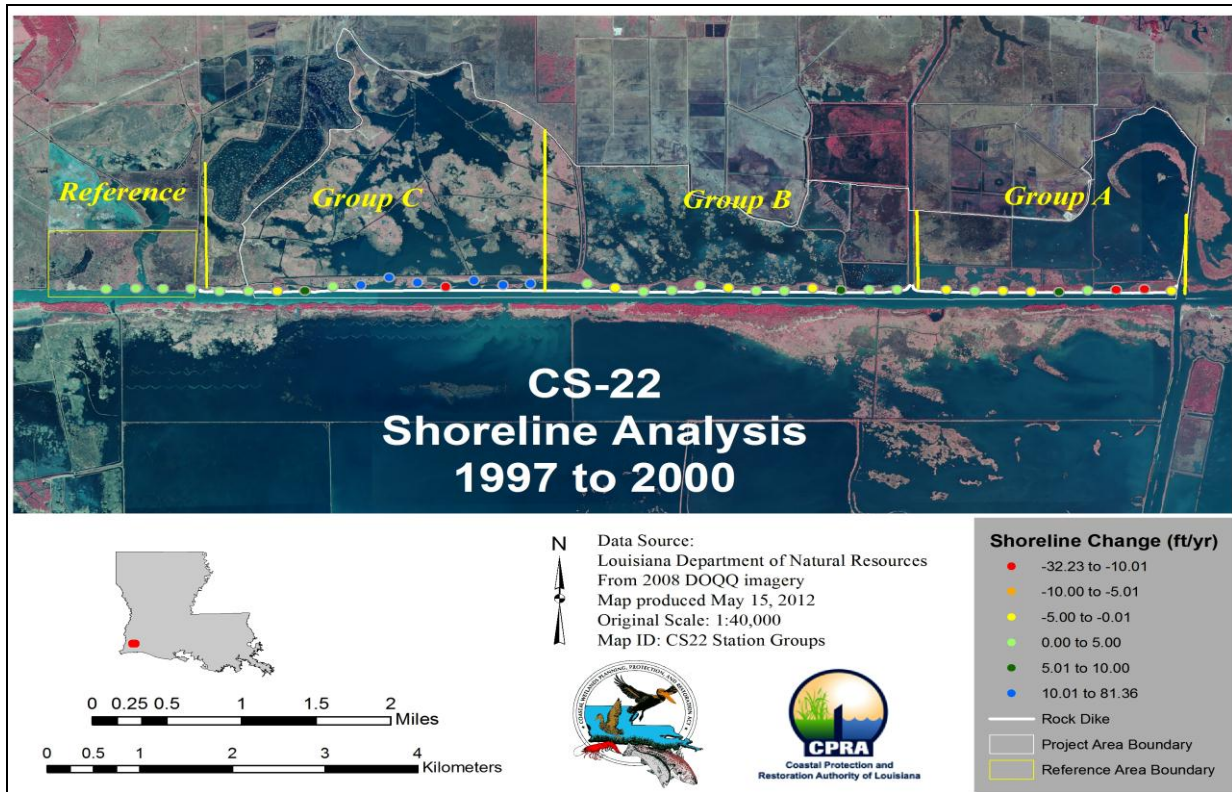
Shoreline change rate maps (figures 6-10) indicate a large loss of shoreline in Group C at station CS22-26 from 1997-2000 (figure 6). This is due the shoreline being located behind a small group of broken islands and 200 to 300 feet behind the rocks. Subsequent years indicate that the shoreline has progressed southward toward the small broken islands. From 2003-2010 the area behind Group C which previously indicated shoreline loss has been curtailed and shoreline gains are now taking place (figure 9). This is due to sedimentation building behind the islands, which act as a secondary buffer, allowing the vegetation to expand southward toward the islands.

Figure 6. Shoreline change rates (ft/yr) within each group and reference area from 1997 – 2000.

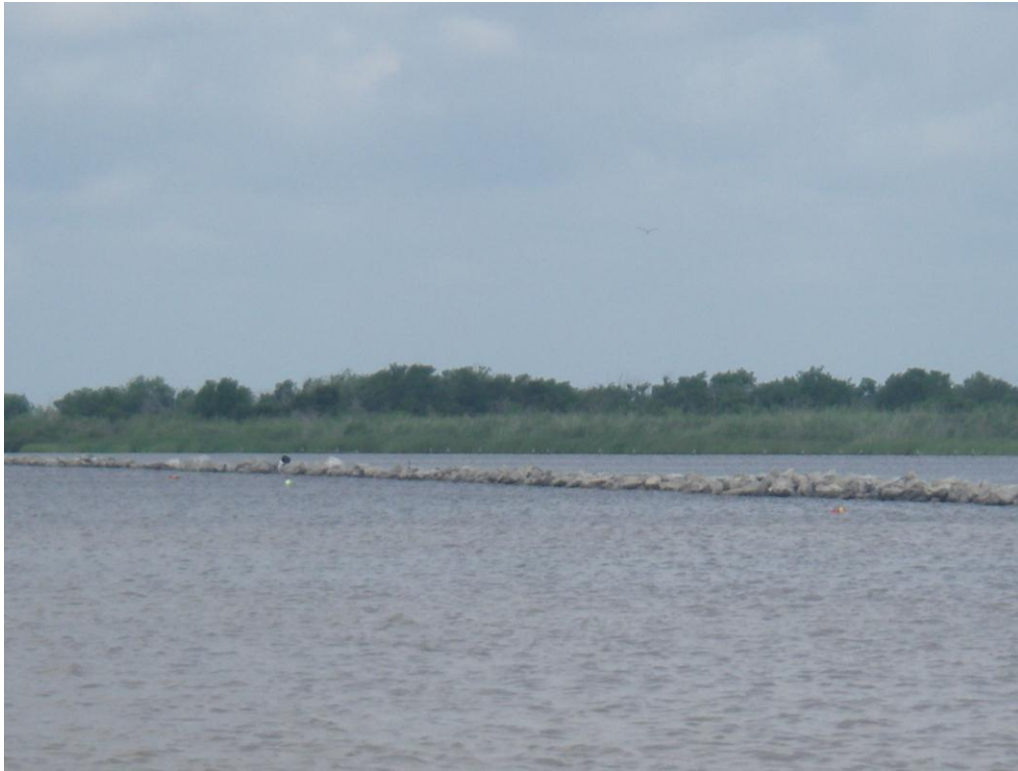
The dike is in good condition. As noted on previous inspections, approximately 4,000 to 5,000 linear feet of dike is below constructed elevation. This appears to be the result of slight settlement rather than displacement. Settlement of the rock dike has not worsened since originally noted and appears to have stabilized. There were two to three gaps approximately 30 feet wide where rock has been displaced by barges nosing up to the dike. These have also been noted on previous inspections and have not worsened or caused a negative impact on the project. Problems such as this are also noted on several other rock dikes along the GIWW. The dike is still functioning as intended and will continue to be monitored. There is no apparent need for any maintenance at this time. (Photos: Appendix A, Photos 1-3)

Photo 1. Typical Rock Dike

Item	Condition	Physical Damage	Corrosion	Photo #	Observations and Remarks
Steel Bulkhead / Caps	N/A				
Steel Grating	N/A				
Stop Logs	N/A				
Hardware	N/A				
Timber Piles	N/A				
Timber Wales	N/A				
Galv. Pile Caps	N/A				
Cables	N/A				
Signage / Supports	N/A				
Rip Rap (fill) (foreshore dike)	Good			1-3	Good Condition. Some settlement. Two 30 foot gaps noted in dike. Good vegetation behind dike.
Earthen Embankment	N/A

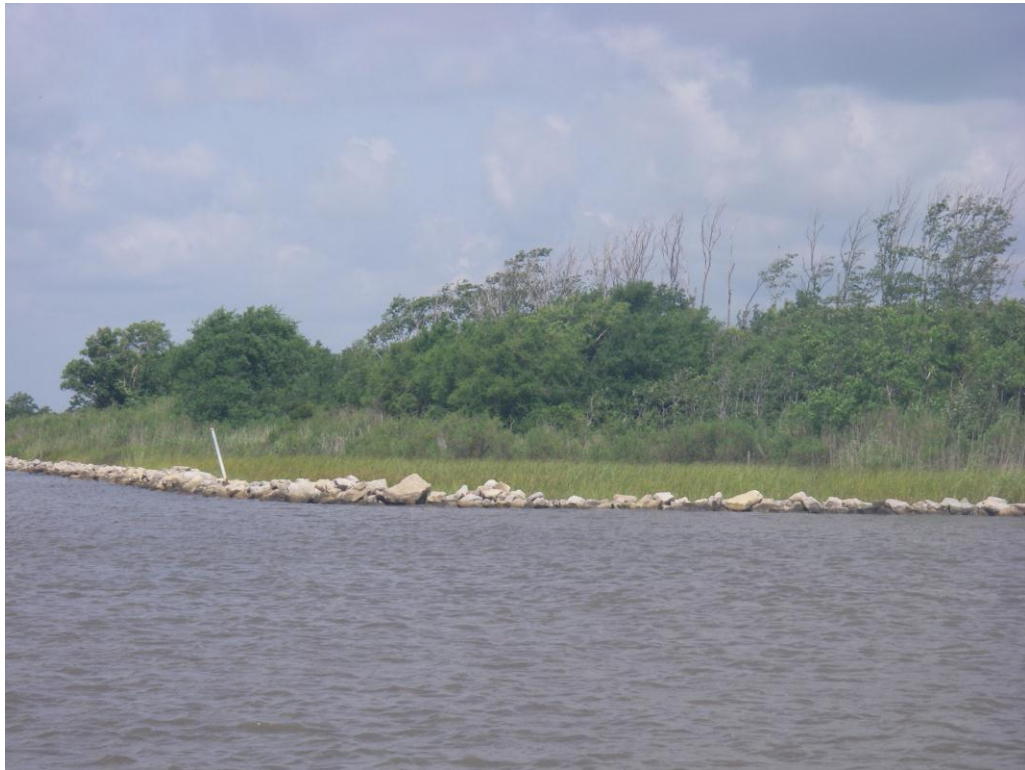
The riser pipe on the settlement plates have been damaged by barges and possible use by vessels for mooring. This could be prevented by reducing the length of the risers.

Photo 2. Vegetation behind Rock Dike and damaged settlement plate

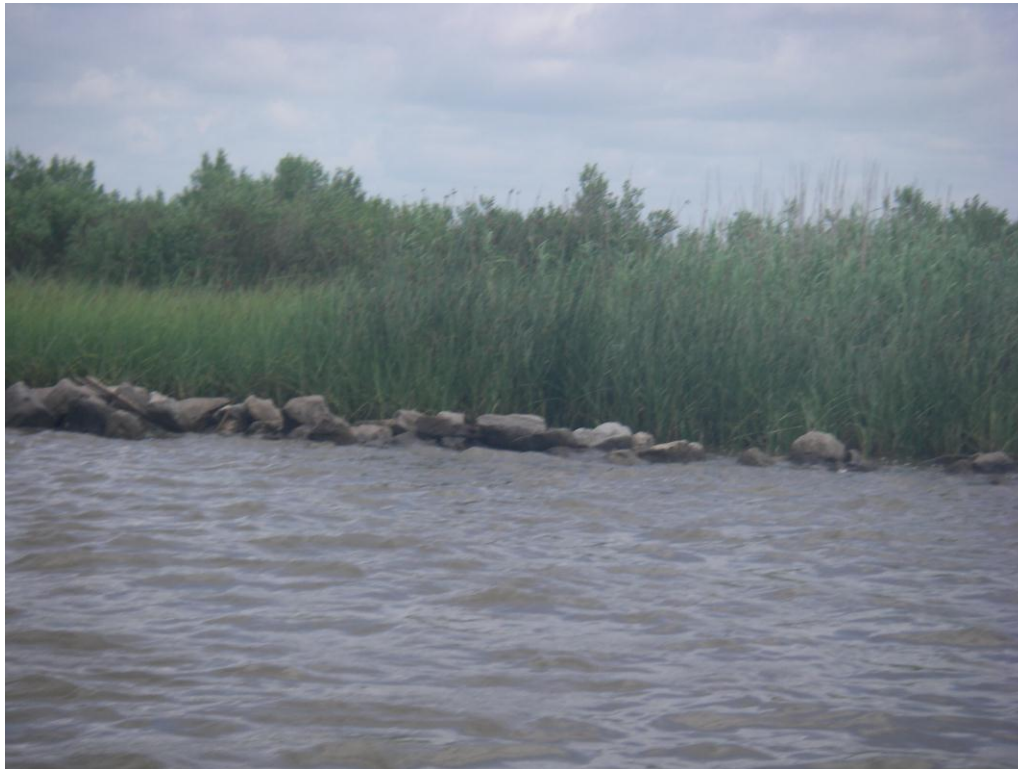
Photo 3. Vegetation and Settled Rock Dike

The rock dike will continue to be monitored; however, a structural assessment survey performed by a licensed engineering/land surveying firm may be needed in the future to evaluate settlement of the rock structure along with accretion on the land side of the rock structure.
